SUMMARY DOCUMENT

Evaluation of Nonmetallic Components in the Hanford Waste Transfer

March 31, 2017

Amer Awwad, M.S., P.E.

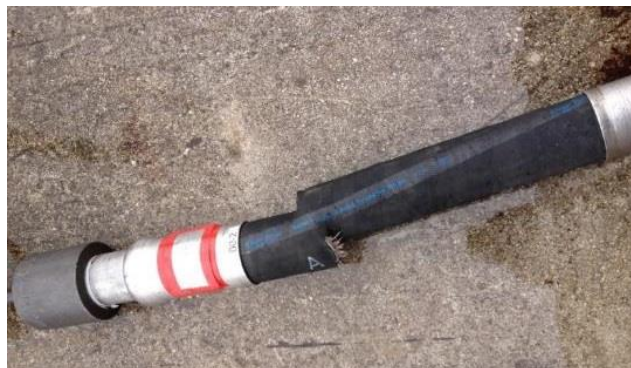
Each specimen experienced a rupture type failure, with the average maximum pressure at 1.93×10^7 Pa. Each specimen also experienced a permanent deformation in their lengths, which averaged 0.02 m. A photo of a typical failed hose specimen is shown in Figure 1.

Figure 1. Ruptured HIHTL test specimen.

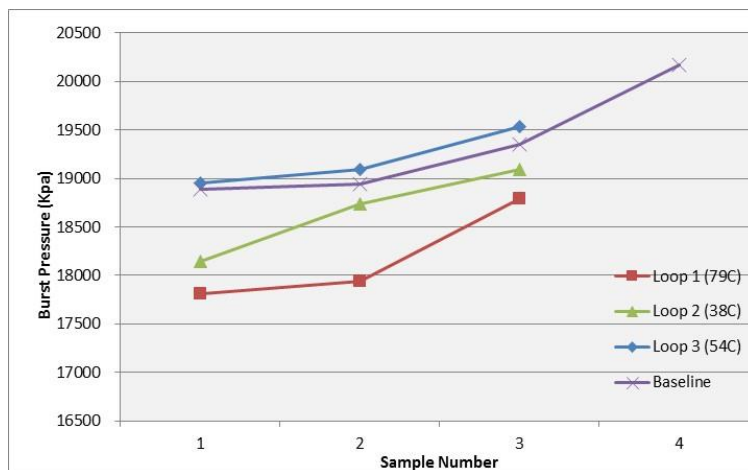
Three aged sample hoses from each loop were pressurized until rupture. Their pressure profiles as well as initial and final lengths were measured. The rupture pressure was compared to the baseline values. Figure 6 shows the results of the 6-month aged hose burst pressure tests and Figure 7 shows a ruptured hose section.

Figure 6. HIHTL burst pressure profiles.

Data from the aged HIHTL coupons (Figure 6) provided inconsistent results. Coupons aged with the higher temperatures did have lower burst pressures but burst pressures associated with the operating temperature conditions (54°C) were higher than the room temperature specimens (38°C) and very close to the baseline pressures. However, it should be noted that changes in the burst pressures were minimal and all were well above the minimum requirement for operation of 4 x the pressure rating (425 psi).

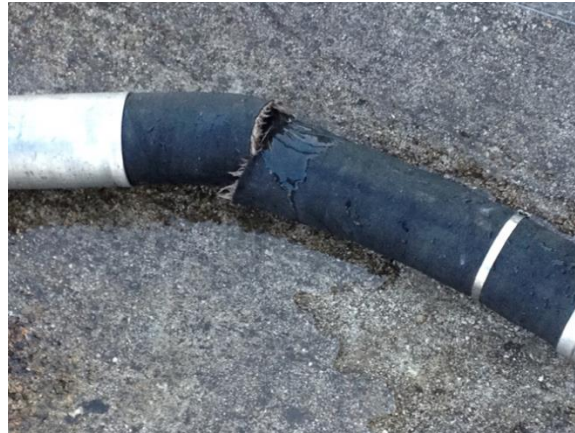
Figure 7. Ruptured hose section.

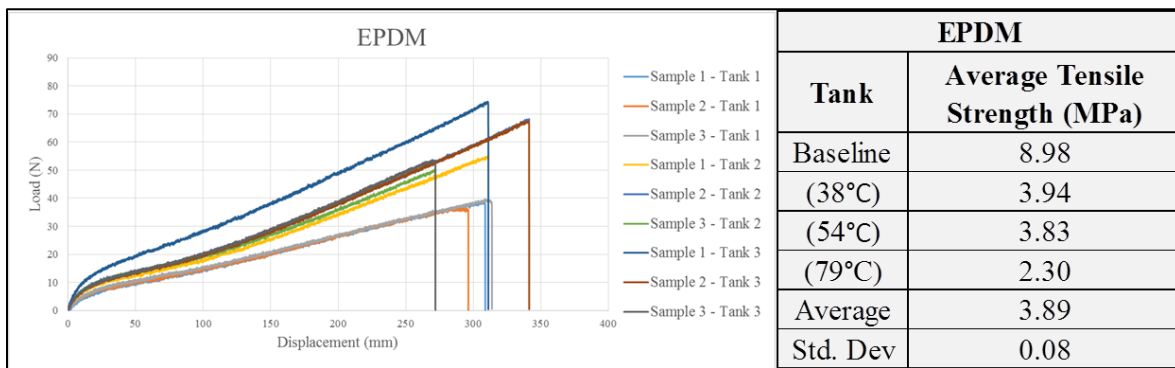
Figure 8. EPDM coupon tensile strength.

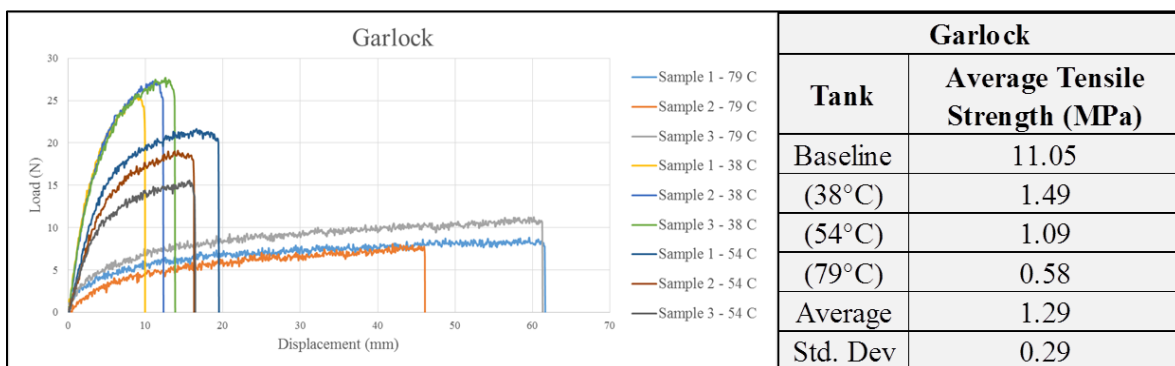
Figure 9. Garlock® coupon tensile strength.

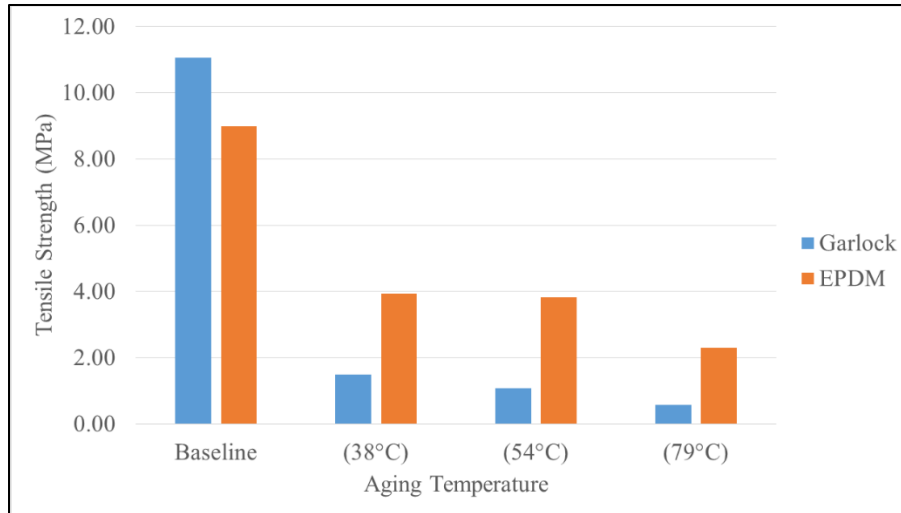
Figure 10. Coupon tensile strength comparison to baseline data.

Tensile testing of the Garlock® and EPDM coupons demonstrated a significant change in elastic modulus and tensile strength. Figure 10 clearly shows that as the aging temperature is increased, the strength was reduced as compared to the baseline data. Changes in the elastic modulus can be observed in Figures 8 and 9. Data show that the highest temperature had the greatest reduction in the modulus with the room and operating temperatures having similar moduli.
