## SUMMARY DOCUMENT

# Baseline Testing Results of Nonmetallic Materials in Hanford's HLW Transfer System

April 8, 2016

**Applied Research Center**

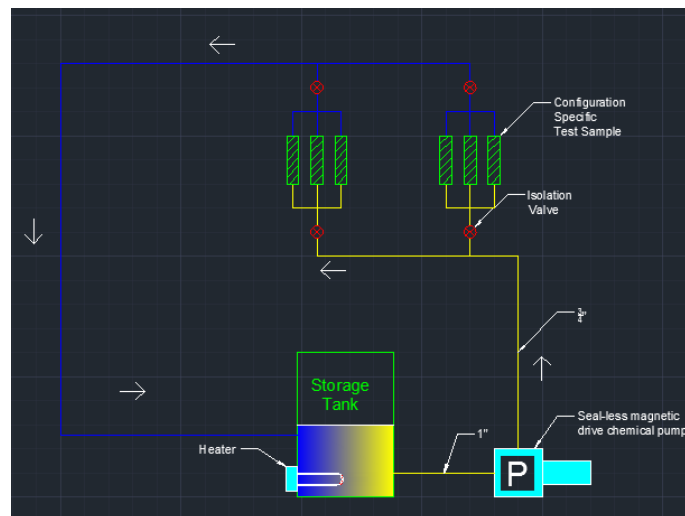
Figure 1. In-service component aging loop.

The in-service configuration aging experimental setup will consist of 3 independent pumping loops with two manifold sections on each loop (Figure 1). Each of the 3 loops will be run at a different temperature (85°F, 130°F and 180°F). Each manifold section can hold up to three test samples and be used for a corresponding exposure time of 180 and 360 days. Three samples of the EPDM inner hose and three samples of the O-rings and gaskets will be placed in a parallel manifold configuration. Isolation valves on each manifold will allow removal of samples without affecting the main loop and the rest of the samples. The temperature of the chemical solution circulating within each loop will be maintained at a preset temperature by an electronically controlled heating system. This configuration requires 6 test samples (for the inner hose, gaskets and O-rings) for each of the three test loops, requiring a minimum of 18 test samples of each the inner hose, gaskets and O-rings. A 25% sodium hydroxide solution will be used as a chemical stressor that will circulate in each of the loops. The chemical stressor will be sampled every 30 days to ensure that the concentration levels remain constant.

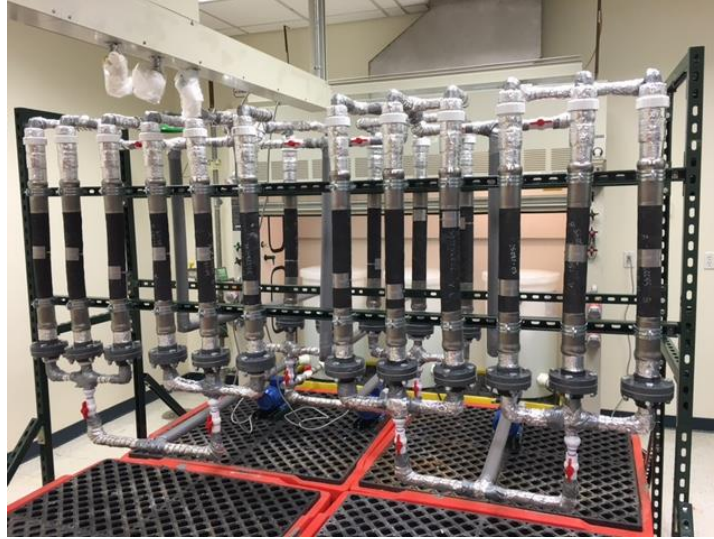
Figure 3. Aging test loop.

Each loop also has six in-configuration test sections on it that are connected by a common manifold. In-configuration test sections are oriented vertically and are comprised of a HIHTL inner hose with a Garlock® gasket in a 2" PVC 150-lbs flange on the bottom and an EPDM O-ring in a 2" PVC coupling on top. Figure 2 shows the in-configuration test sections. Each test loop is also instrumented with electronic flow meters and pressure transducers as well as a thermocouple to measure the flow rate, pressure and temperature with the loop. The completed aging set up is shown in Figure 3.

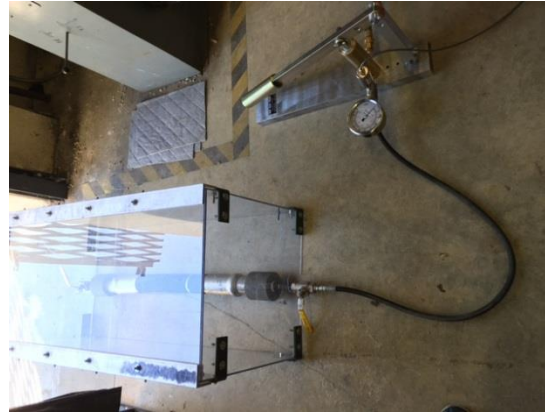
Figure 4. Hose rupture pressure testing assembly.

For the HIHTL coupons, burst pressure tests were conducted on four specimens to establish a baseline for the nominal pressure the coupons can withstand. As shown in Figure 4, a hydraulic pump capable of pressurizing the coupon to 10,000 psi was connected to the coupon which was enclosed in a containment structure manufactured from Plexiglas. Pressure data was acquired using a Barksdale model 425H3-17 pressure transducer, which measures pressures between 0 and 7500 psi at an accuracy of  $\pm 0.25\%$ . The pressure data was acquired via a data acquisition system that acquires and logs the data at intervals of 500 ms. Additional data such as water temperature and ambient temperature, was determined prior to testing each hose specimen and transcribed onto its own *Burst Pressure Verification Data Sheet* (see Appendix).

After each hose specimen was securely fastened to the testing assembly, any remaining air was purged from the system. After verifying that no air remained in the system, pressure testing, data acquisition and video recording began, simultaneously. Pressure was increased at a rate between 800-1200 psi/min. The specimen burst pressure and type of failure (rupture, hose split, termination failure, ply separation) was recorded on the *Burst Pressure Verification Data Sheet*. Table 2 provides all the measurements obtained, including the burst pressures, for four specimens.

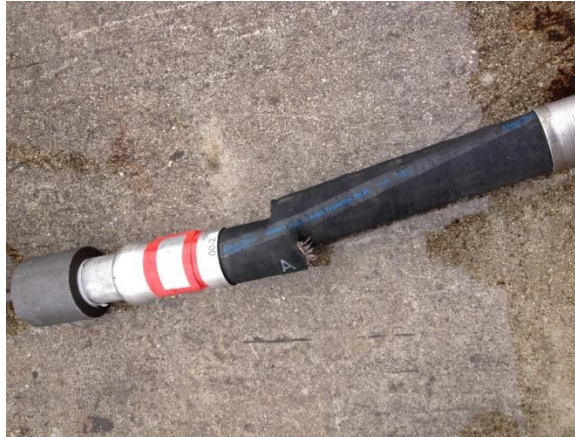
Figure 5. Failed hose specimen H-00-2.

The average burst pressure obtained for the four specimens was 2805 psi. After discussions with site engineers at Hanford and the representatives at Riverbend, these values were similar to tests conducted on other hose samples. Figure 5 shows the rupture from specimen H-00-2. The other three specimens failed in the same manner.

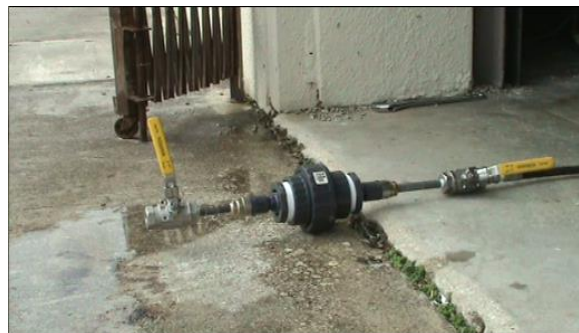
Figure 6. O-ring pressure testing assembly.

To evaluate O-ring in-service configuration specimens, a pressure testing rig was assembled (Figure 6). The assembly included the same hydraulic pump, pressure transducer and data acquisition system used in the HIHTL testing. Similar system data (water temperature, ambient temperature, etc.) was also measured and recorded in the *Holding Pressure Verification Data Sheet* (see Appendix).

Each O-ring specimen was placed in the testing union, which was securely fastened, and any air was purged from the system. After verifying that no air remained in the system, pressure testing, data acquisition and video recording began, simultaneously. Pressure was increased until reaching approximately 235 psi, where it was maintained for 5 minutes, or until failure. The 235 pressure limit was determined by limitations of the schedule 80 PVC unions used for the in-configuration testing. Determination of leakage in the system was verified from examining the pressure data as well as observation of the testing assembly. If the specimen failed to maintain pressure, the time until failure was recorded. Results from the three O-ring tests are provided in Table 3. The results of the testing show that each of the O-rings were able to maintain the desired pressure for the duration of the testing. It should be noted that the pressure applied to the system had slight variations due the limitations of the large range of the hydraulic pump being utilized.

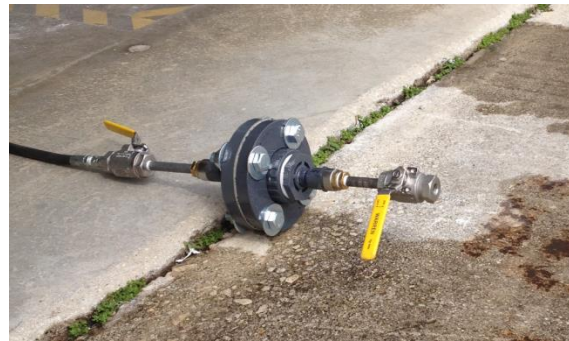
**Figure 7. Gasket pressure testing assembly.**

A pressure testing rig, similar to the O-ring rig, was assembled for the Garlock® gaskets (Figure 7). As before, each gasket was placed in a flange, which was securely fastened, and air was purged from the system. After verifying that no air remained in the system, pressure testing, data acquisition and video recording began, simultaneously. Pressure was increased until reaching approximately 150 psi, where it was maintained for 5 minutes, or until failure. The 150 pressure limit was determined by limitations of the schedule 80 PVC flanges used for the in-configuration testing. Determination of leakage in the system was again verified from examining the pressure data as well as observation of the testing assembly. If the specimen failed to maintain pressure, the time until failure was recorded. Results from three gasket tests are provided in Table 4. The results of the testing showed that each of the gaskets were able to maintain the desired pressure for the duration of the testing.

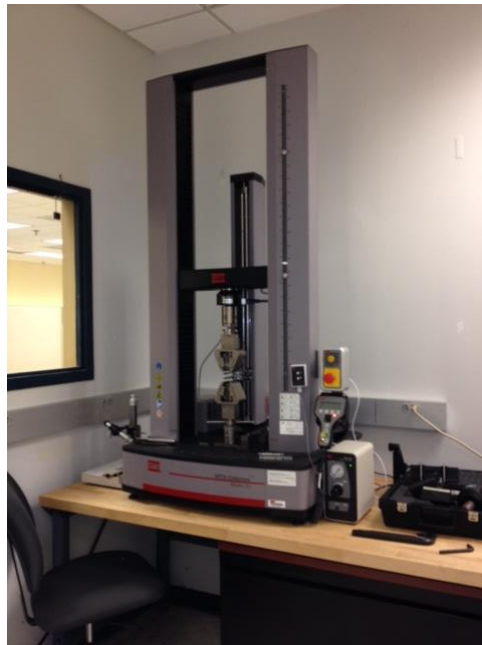
Figure 8. MTS tensile testing machine.

The data for the coupon tensile testing was acquired directly from the MTS machine (Figure 8). To accurately measure the tensile properties/ values, the correct width, thickness and grip separation needs to be entered into the MTS software. For the current specimens, the width was 25 mm and the thickness was 2.38125 mm. The displacement rate for the EPDM was 500 mm/min and was 5 mm/min for the Garlock®.

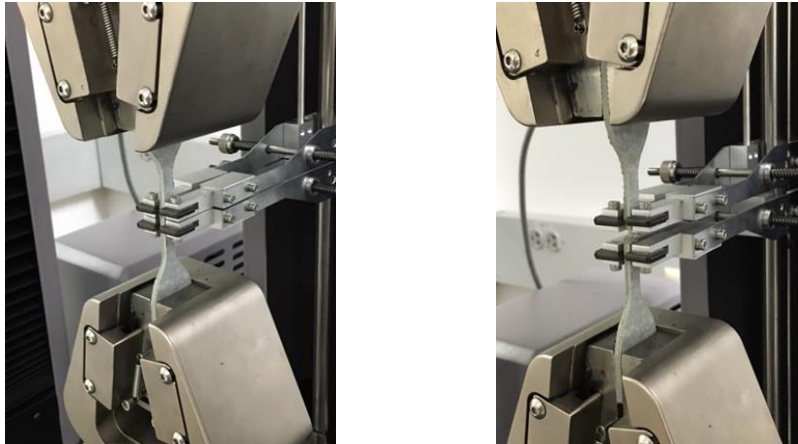
Figure 9. Garlock® MTS testing.

Results below show the average values obtained from the tensile tests for both the Garlock® and the EPDM coupons. The values will be re-obtained for the exposed coupons to evaluate any degradation in the material. Figure 9 and Figure 10 shows typical tests using Garlock® and EPDM specimens, respectively.

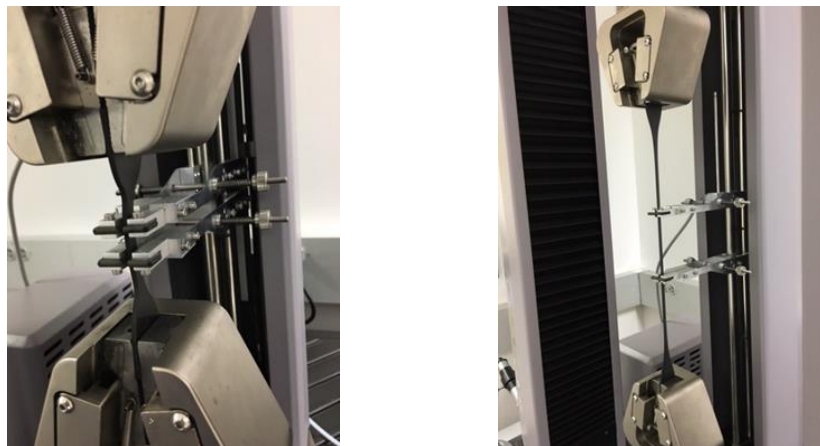
Figure 10. EPDM MTS testing.
