Analysis of Life Expectancy for Waste Transfer Lines Located at Hanford Site

Jennifer Arniella – DOE Fellow, Mr. Dennis Washenfelter – Mentor, Washington River Protection Solutions, Hanford Site, Richland, WA

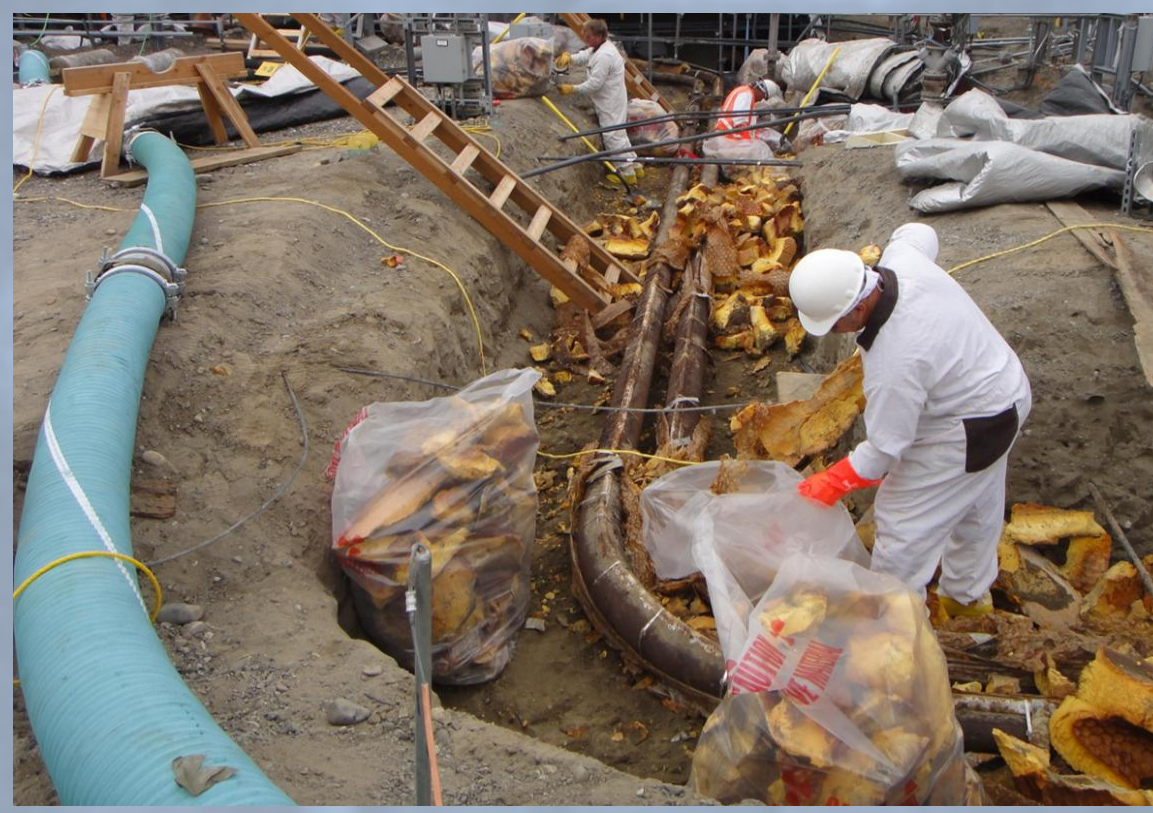
Figure 1. Pipeline Excavation

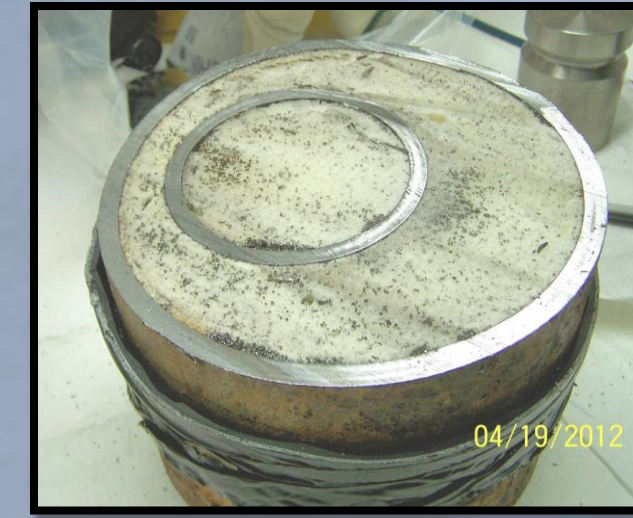
Figure 3. Photograph of the SN-278 Pipe-in-Pipe Section during sample unpacking.
