FIU PROJECT 1

CHEMICAL PROCESS ALTERNATIVES FOR RADIOACTIVE WASTE

FLORIDA INTERNATIONAL UNIVERSITY

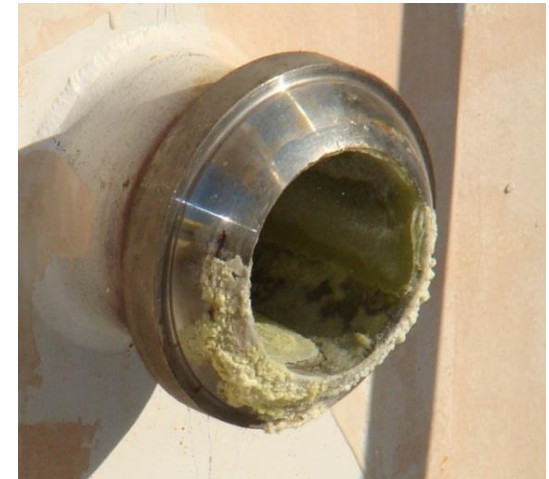
**Supernatant Dried on Nozzle
18 in AP Valve Pit.**

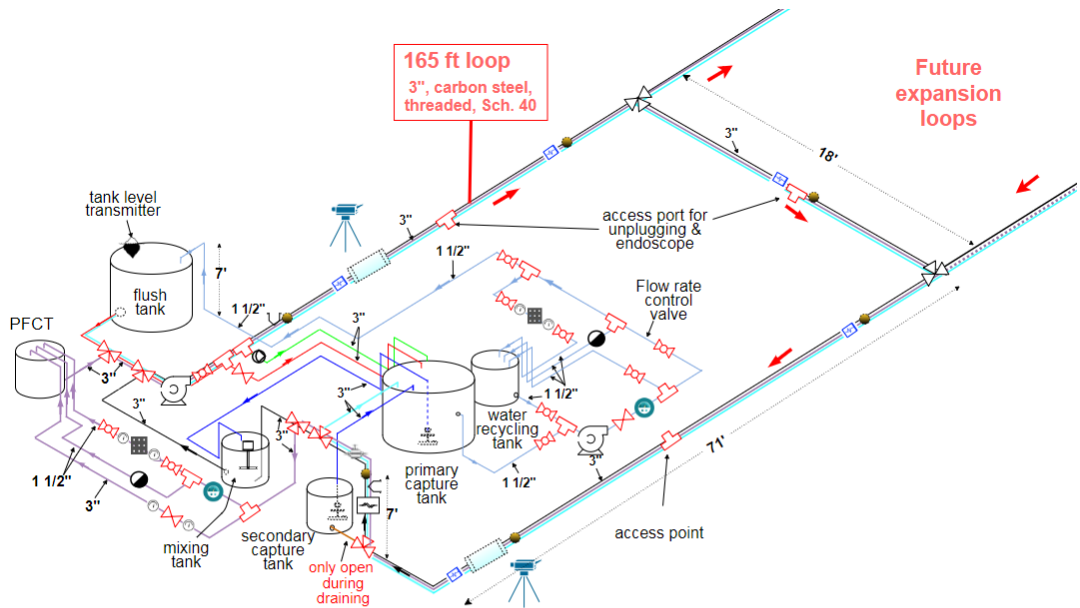
Schematic of Flushing Loop

- Multiples of 165 ft (up to 825 ft) , 3 in Sch. 40 carbon steel
- Circulation, flushing, filtration, water and sediment retrieval, post-flush evaluations

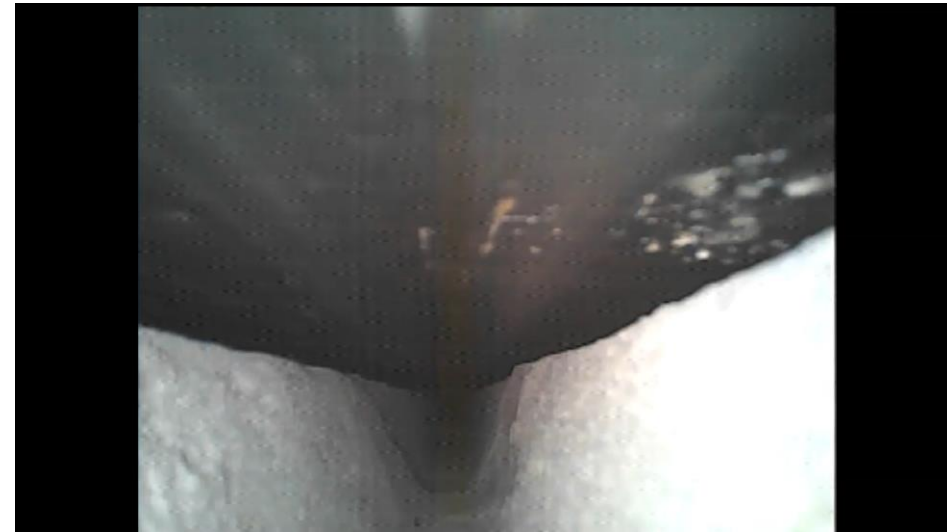
Mini Rover traveling through
the mockup

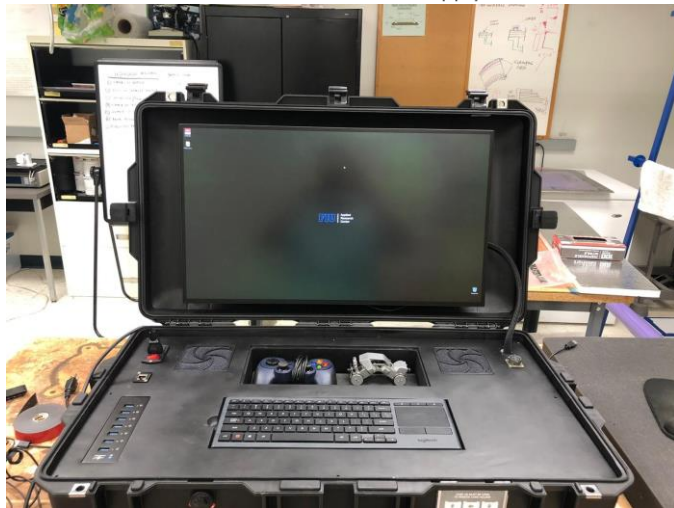
Mini Rover Control Box

- The control box was developed to deliver power and receive quality video beyond 150'.
- With the generic design of the box, it is suitable for all our robotic platforms.
- Control box passed its OSHA approved field evaluation electrical safety inspection.

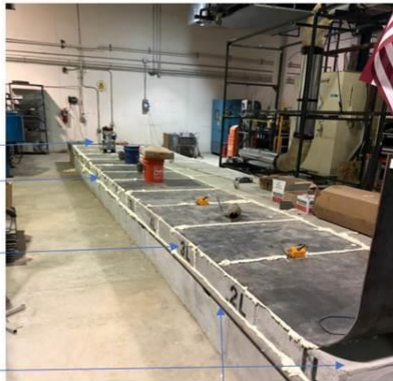
Durability Test (20 Trials)

Insulation foam installed at all the cracks

The durability test is put in place to test the mini rover of its capabilities under harsh environments. The mockup above is at an elevated temperature (~130-degree F).

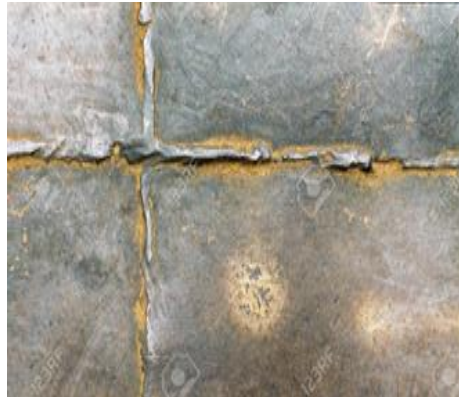
Weld Seams Test (10 Trials)

For the weld seam test, we will introduce weld seams into to mockup and monitor the rover's capabilities of traversing over the weld seams (10 trials).

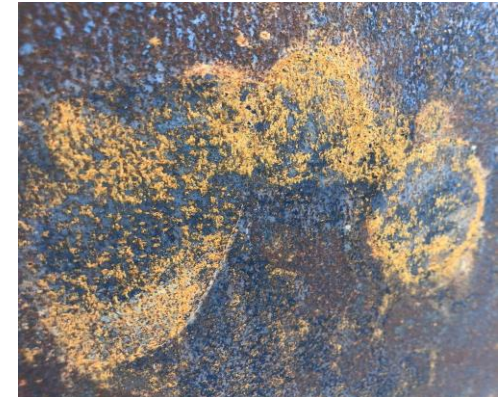
Corrosion Test (2 Trials)

Corrosion test consists of running the rover over a corroded surface and document the rover's capabilities with the material buildup adhered to the magnets.

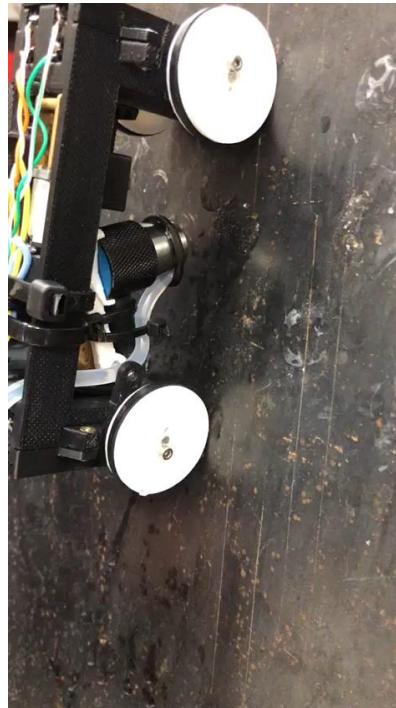
UT Rover obtaining thickness measurement

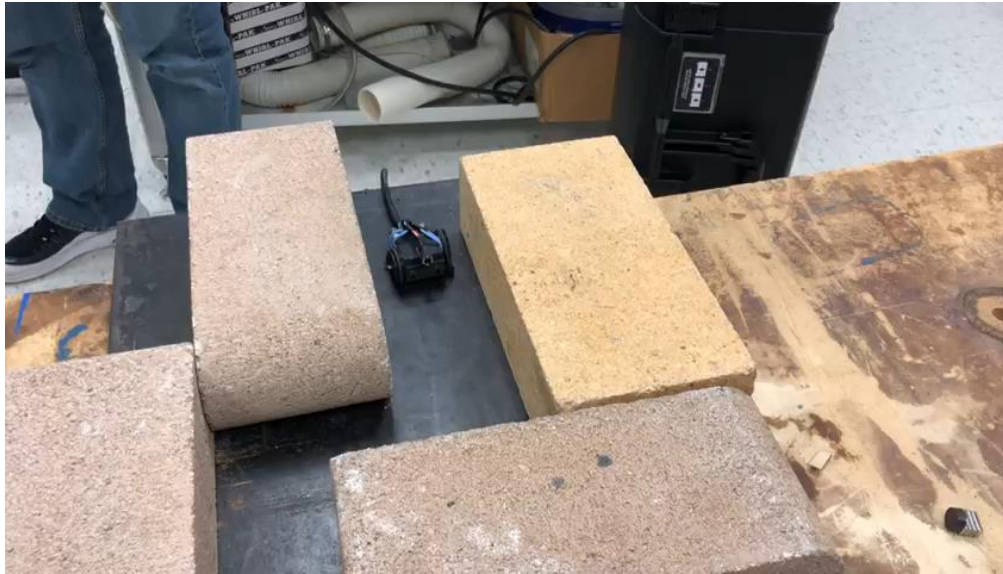
90° Mini Rover for AY-101

Four 90° turns

- This unit is designed to accomplish four 90-degree turns.
- Is equipped with 2 camera printed circuit boards (PCB) to relay live feed video back to the operator.
- Pull force is rated at 3.87 lbs. providing great maneuverability.

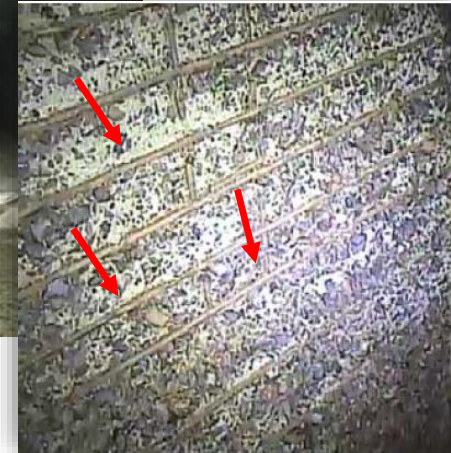
Degraded concrete exposing the steel rebar (red arrows).

Visual inspections of the H-Canyon exhaust (HCAEX) tunnel showed degradation of the concrete walls. Also, a recent tunnel fragility analysis identified safety issues of the affected concrete regarding their strength [1].

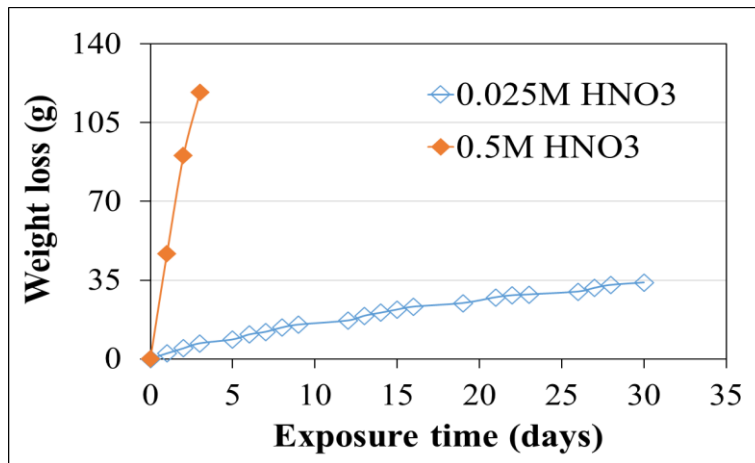
Weight loss

- High conc. (0.5M): greatest weight loss (~45%) in 3 days
- Low conc.(0.025 M): slower weight loss (~13%) in 30 days

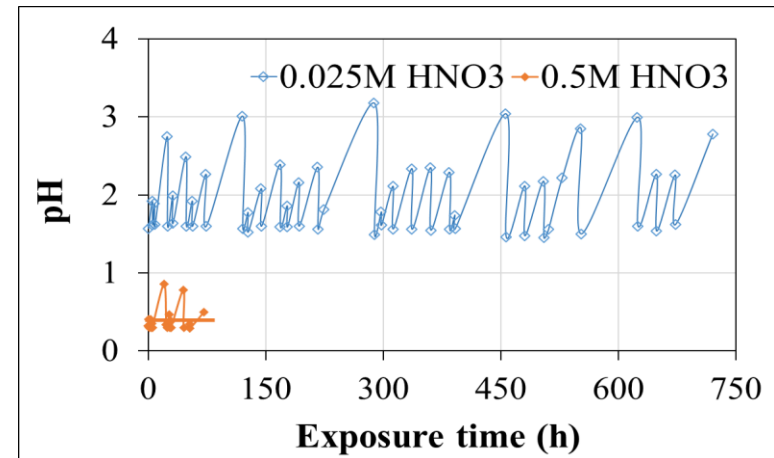
pH (test solution)

- The pH changes (solution) are shown trough the peaks out of the straight lines (0.3 and 1.6).
- pH variations were adjusted by adding concentrated acid.

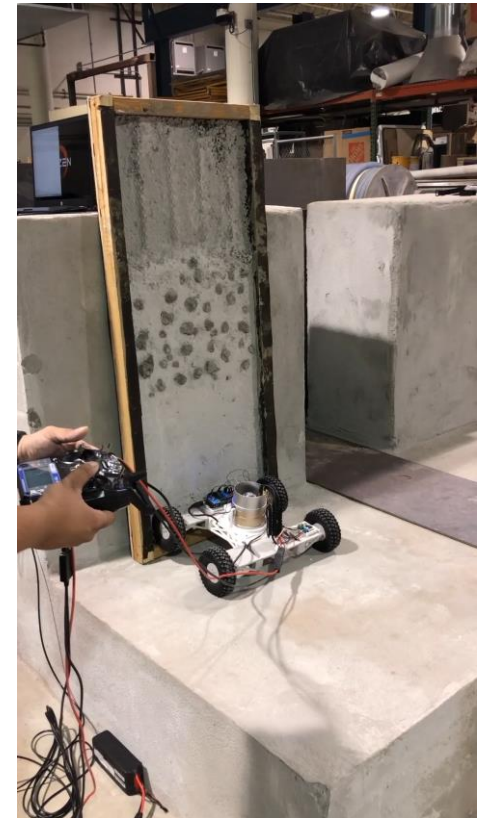
- Constructed scale mockup of concrete wall to test platform
- Thrust based surface adhesion tested on different surface conditions
- Platform can perform multiple orientation changes while maintaining surface contact

Testing of platform prototype 1 and 2 on concrete wall mock-up

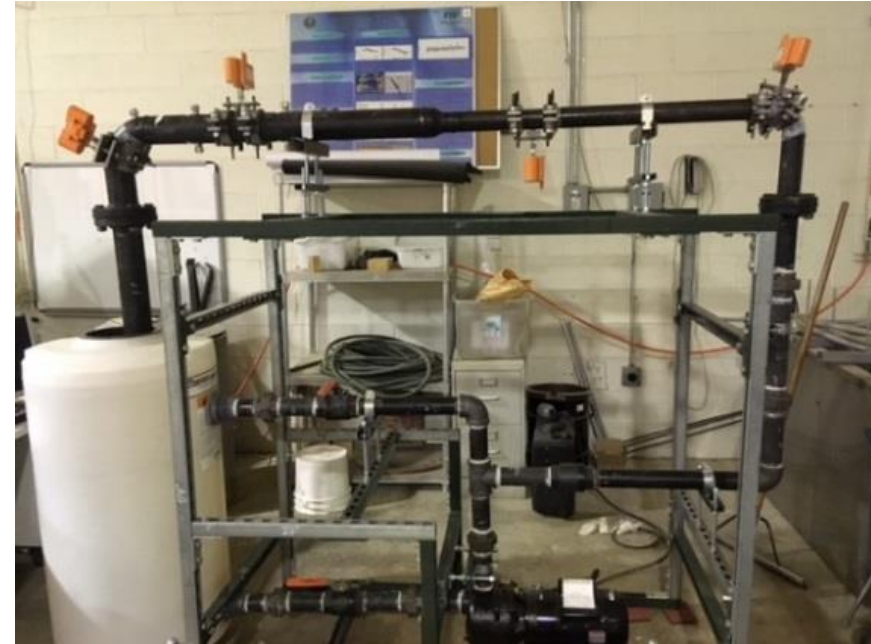
Test Loop

- 4 Permasense guided wave sensors
- 2 and 3 inch pipe sections (straight sections and elbows)
- Sand/water mixture
- 3 HP centrifugal pump - up to 2.5m/s and 110 gpm
- Sand particle sizes - 400 to 1600 microns
- By-pass system to control flow rates

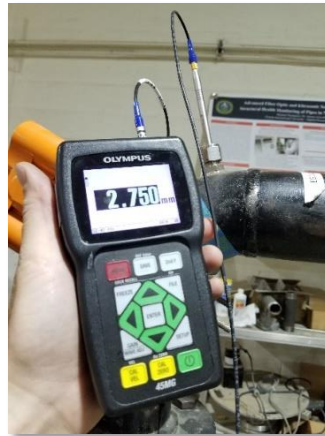
- Incorporate an additional method to measure sensitive wear rate
- Shorten the test durations
- Provide a correlation between UT sensor data and mass loss data

Thickness measurements using UT probe

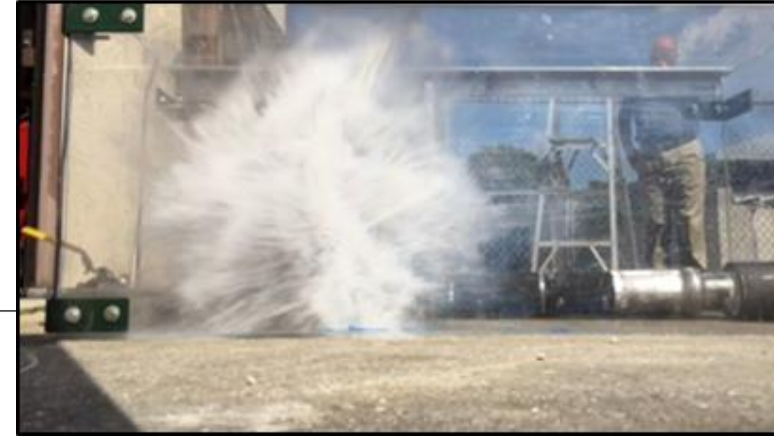
Water-Only HIHTL Pressure Testing

- Specimens were pressurized until rupture.
- Pressure profiles and initial and final lengths were measured.
- Rupture pressure was compared to baseline values.

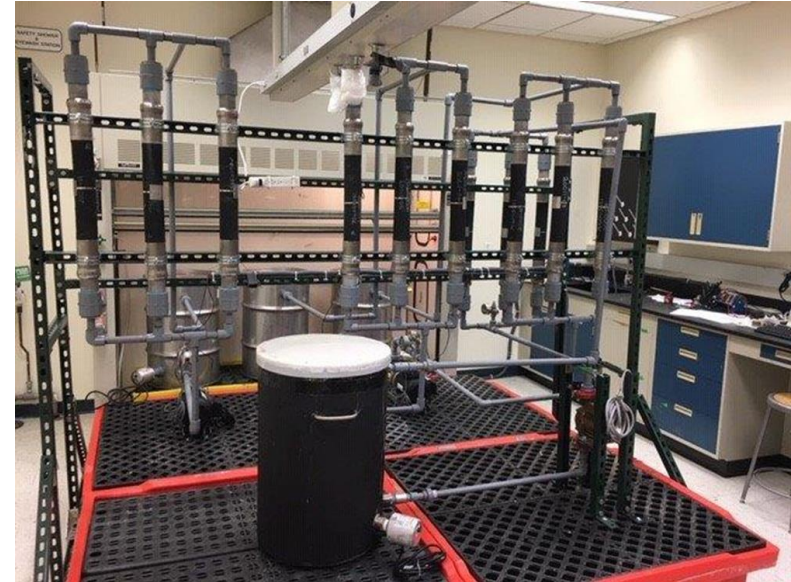
Phase III Aging Loop

- In order to determine the effect of the NaOH on the material degradation, aging experiments are being conducted with four loops of 6.25%, 12.5% and 25% NaOH and only water respectively running at 170°F.
- The setup consists of four pumping loops with three hose sections on each loop.
- The coupon aging consists of a coupon aging vessel submerged in the test loop's storage tank with each vessel containing six EPDM dog bone samples.
