DOE-FIU Cooperative Agreement Annual Research Review – FIU Year 2

Project 1 – Task 20

Study of Carboline Coating for the Protection of the HCAEX Tunnel's Concrete Walls at Savannah River Site

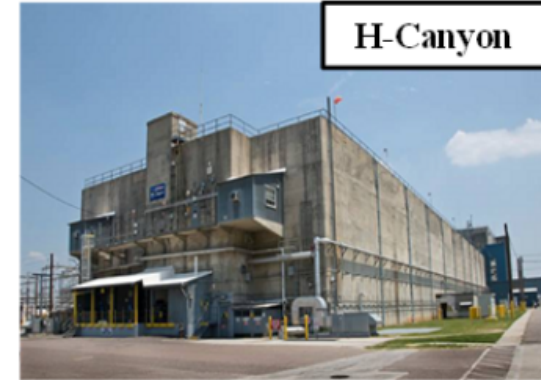
Schematic of the top view of the H-canyon and the tunnel.

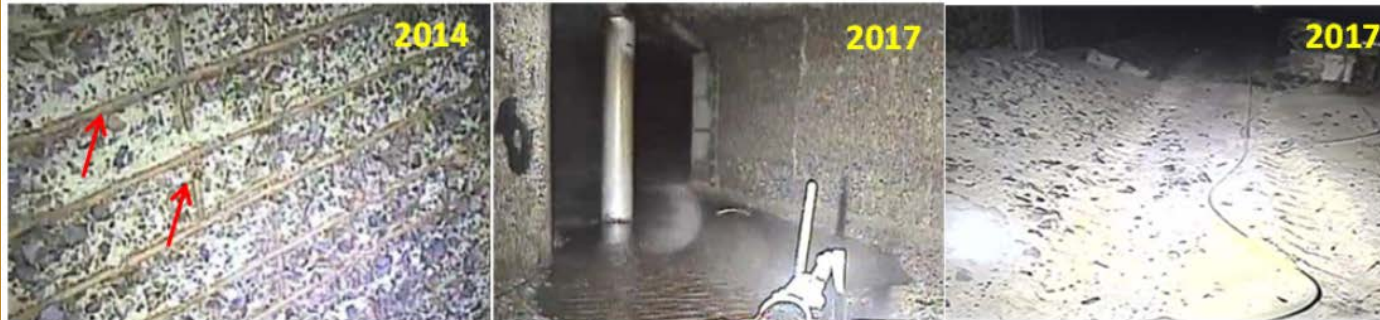
H-Canyon Exhaust Tunnel remote inspection revealed severe degradation

Steel (arrows) and coarse aggregates exposed

Water accumulation

Concrete degradation products (e.g. nitrate salts)

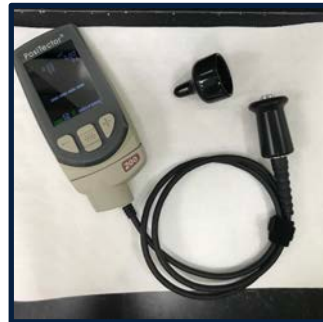
Positector-200 thickness Gauge

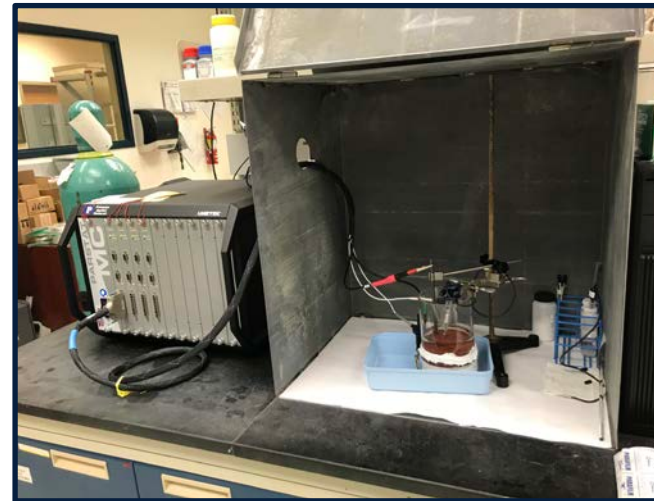
Potentiostat (left) and Faraday Cage (right) with test setup during impedance measurements

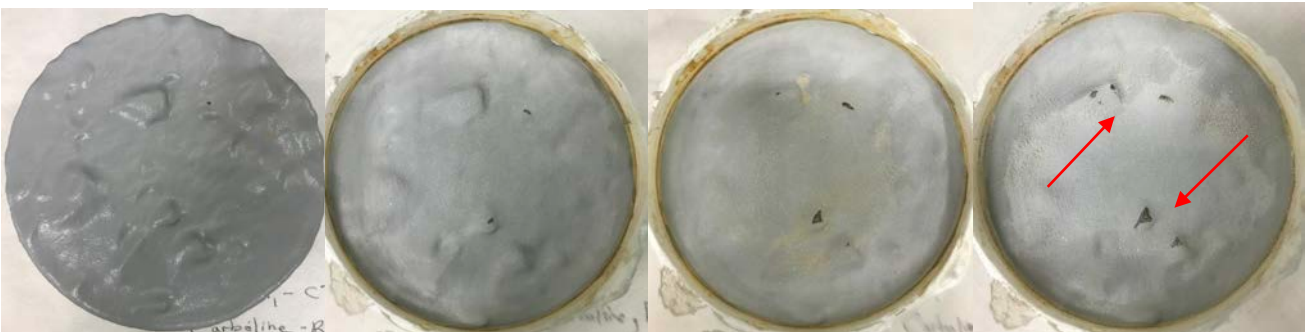
• Sample CT7-1 (Non-aged with Surface Preparation)

Average Coating Thickness Loss:
17 μm (19%)

- Degree of Erosion: #9

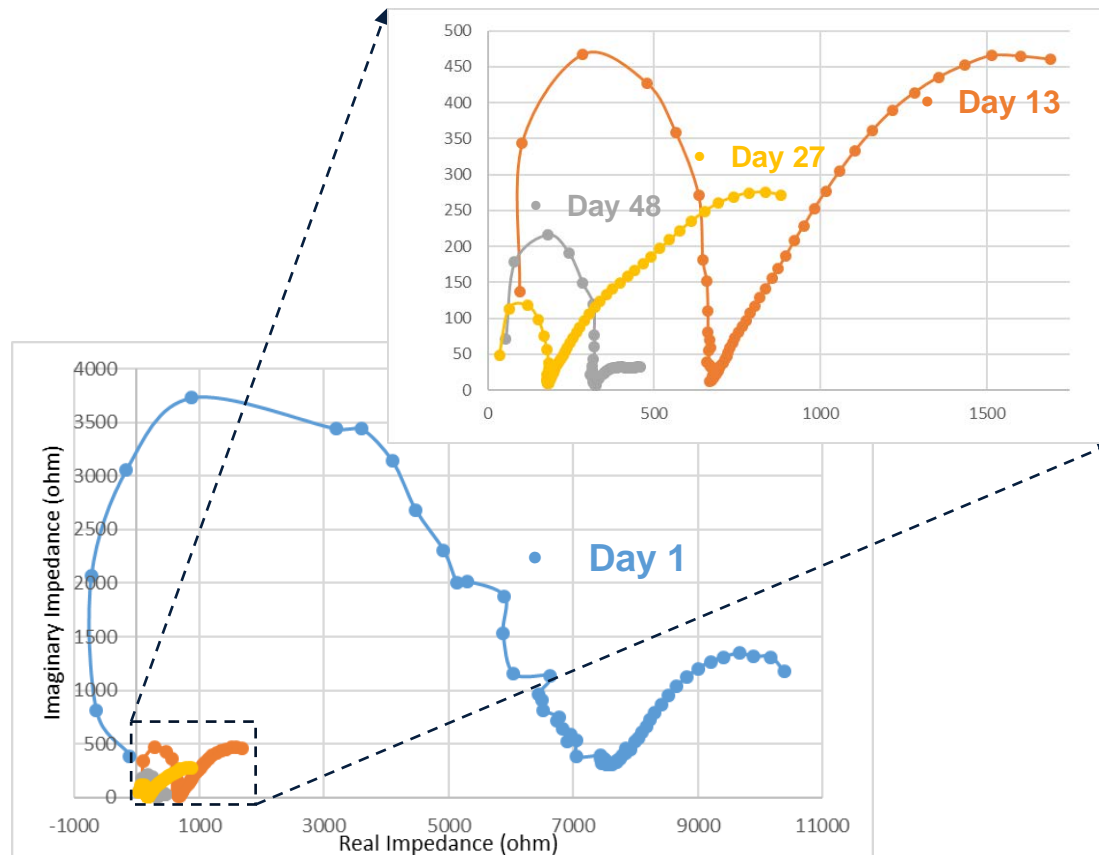
• Sample CT2-2 (With Surface Preparation)

- Taller, wider curves indicate less penetration of HNO_3 solution, better chemical resistance
- In both cases, a similar decrease of the impedance with time is observed, meaning the deterioration of the coating's protective properties
