Development of Inspection Tools for DST Primary Tanks & WRPS Internship Summer 2019

Patrick Uriarte (DOE Fellow)

DOE-FIU Science and Technology Workforce Development Program
Applied Research Center
Florida International University

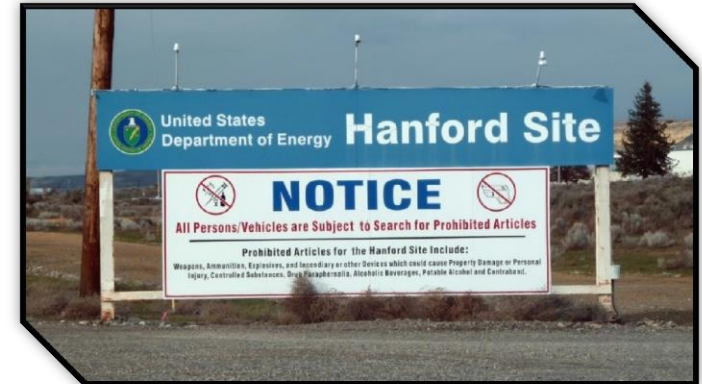
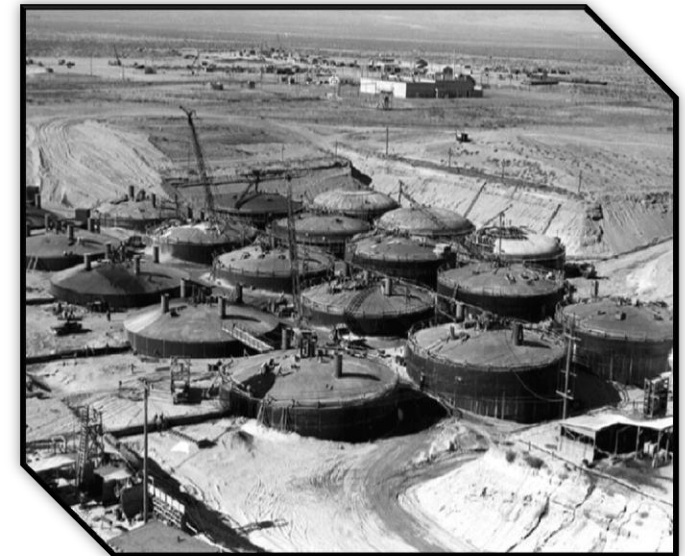
- Location of underground “Tank Farms” containing nuclear waste produced from nuclear material processing for bombs during WW2 and Cold War.
- Aged Tanks, most passed their expected usage date.
- Tank Leakage of nuclear material threaten local environment and health of interstitial Columbia River of the Northwest US.

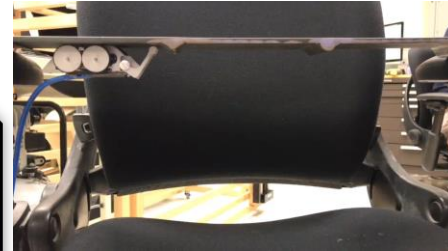
- Uni-Body + Arm Design:

- Utilizes stabilizer arm to maintain magnetic adhesion over weldments
 - Risky potential loss of magnetic adhesion during weld climbing maneuver
 - Large Rigid Body
 - Traverse 3/8 inch weld seam

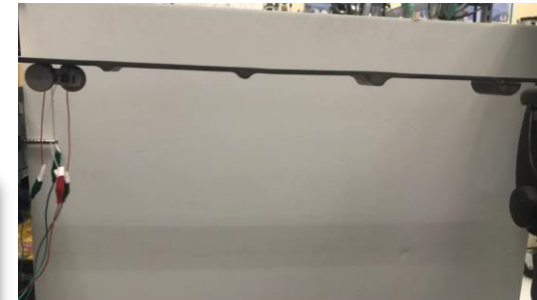
- Caterpillar Design

- Adaptable to overcome curved surfaces
 - Modular, each unit can be swapped
 - Traverse up to 1-inch weld seam
 - Increased moving part complexity

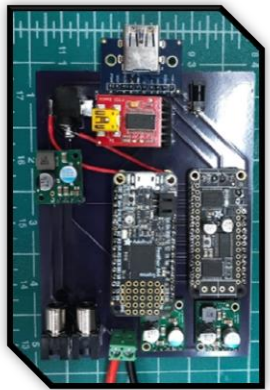
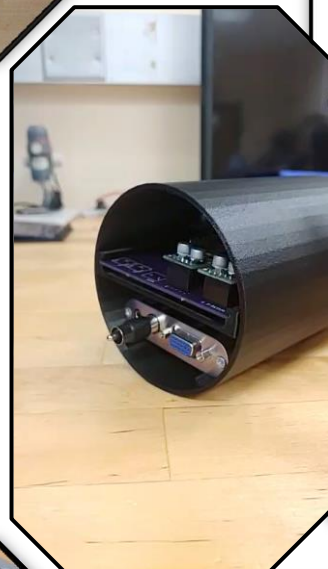
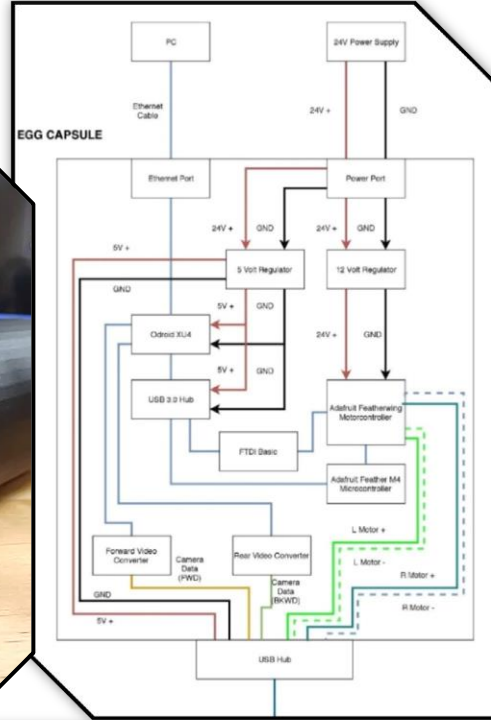
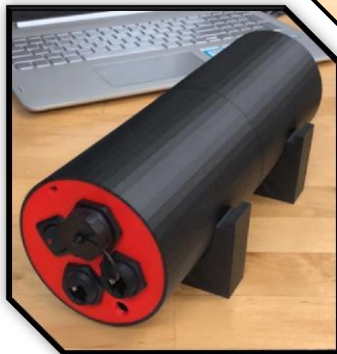
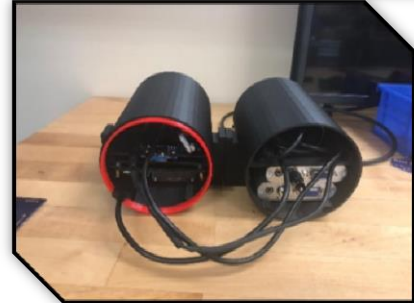
- Controller Capsule Design Purpose: Core of the Robotic System
 - Receives operator commands, relays commands to Mini Rover.
 - Receives Visual and sensor data, relays data to operator.
 - Acts as voltage regulator.
 - Solves voltage drop issue which occurs if the operational voltage line was directly connected to the rover over large cable length
 - Improves video signal transmission.
 - Analog camera signal converted to digital earlier, solving issue with camera feed quality. Analog camera feed suffers from voltage drop over long cable distances.
 - Onboard computer has wireless capabilities. Although not currently used, potential data transfer usage in the future.
