FIU
Applied Research
Center

FIU PROJECT 1

CHEMICAL PROCESS ALTERNATIVES FOR RADIOACTIVE WASTE

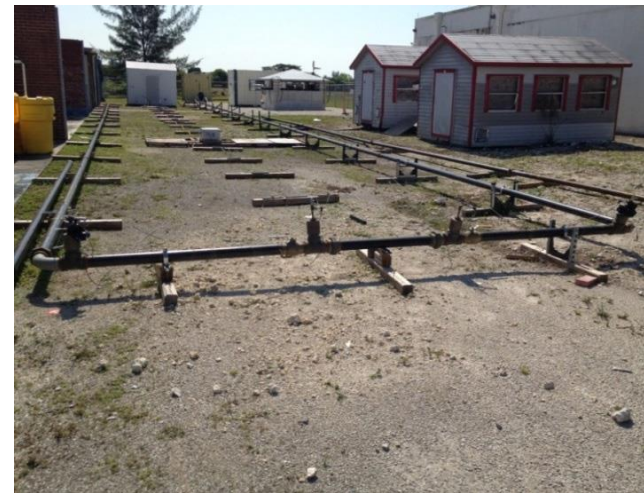
- variables in the initial test matrix (velocity mode, per-flush water volume, number of flushes)
- space and pipe line support mechanism for the test loop
- initial conditions modes to be tested (gravity drained versus fully-flooded)

Matrix for Flushing Test Using 165 ft Test Loop

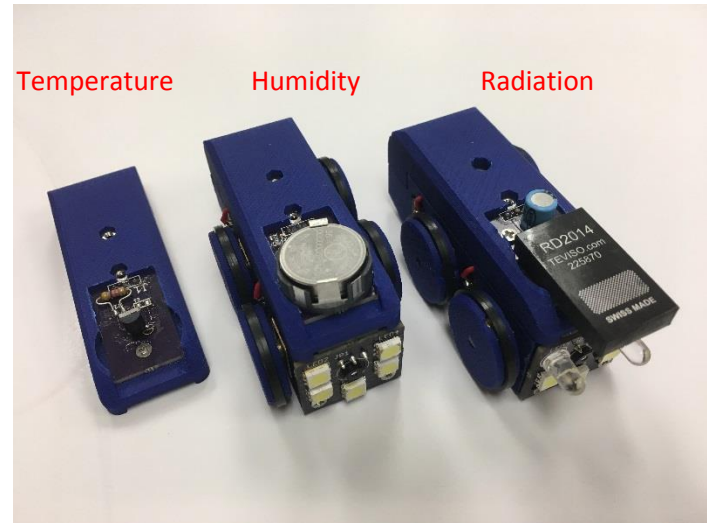
Modular Sensor Hoods

Temperature

Humidity

Radiation

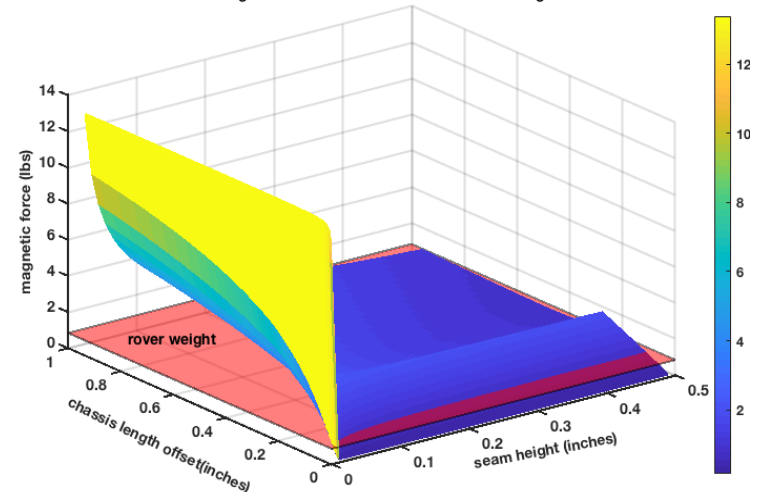
Magnetic Force vs. Weld Seam Height

Total magnetic force under different weld seam heights

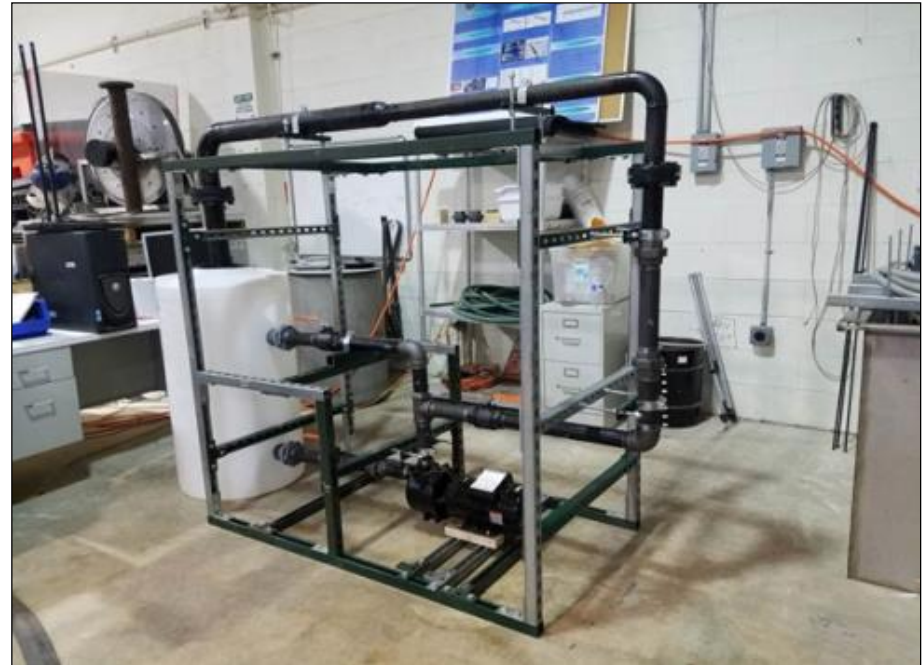
- 4 Permasense guided wave sensors
- 2 and 3 inch pipe sections (straight sections and elbows)
- Sand/water mixture
- 3 HP centrifugal pump - up to 2.5m/s and 110 gpm
- Sand particle sizes - 400 to 1600 microns
- By-pass system to control flow rates

Pipe loop assembly

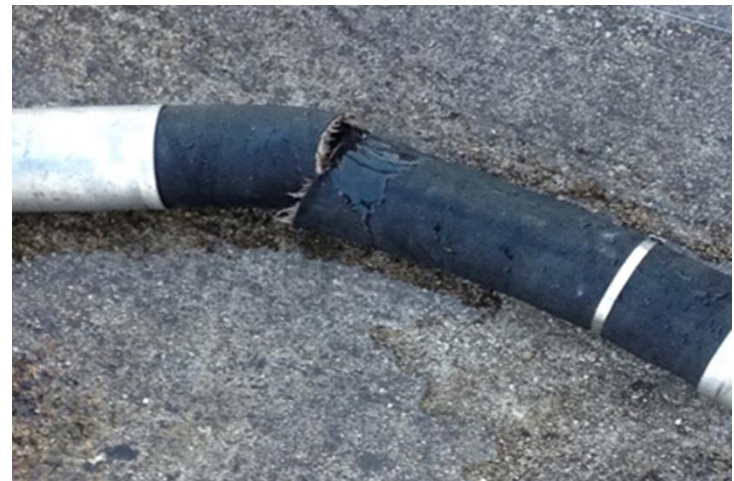
Pressure Test Results

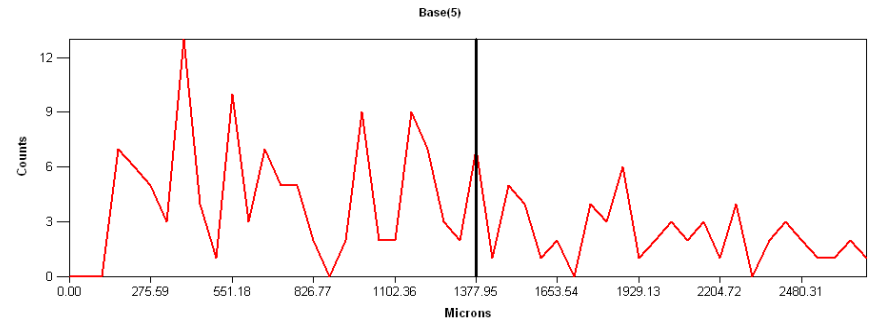
SEM – EDX Results

170°F Sample

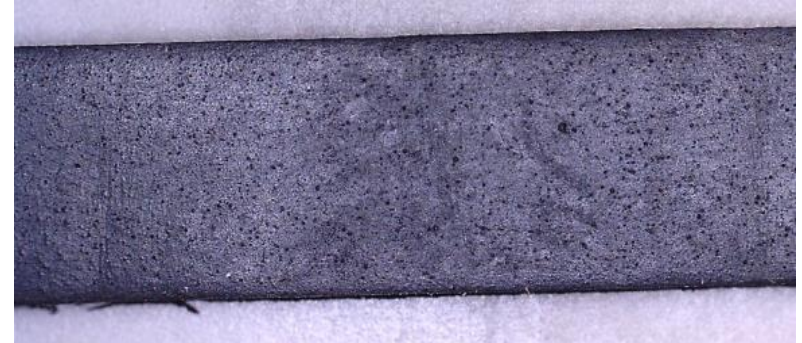
6-Month 100°F

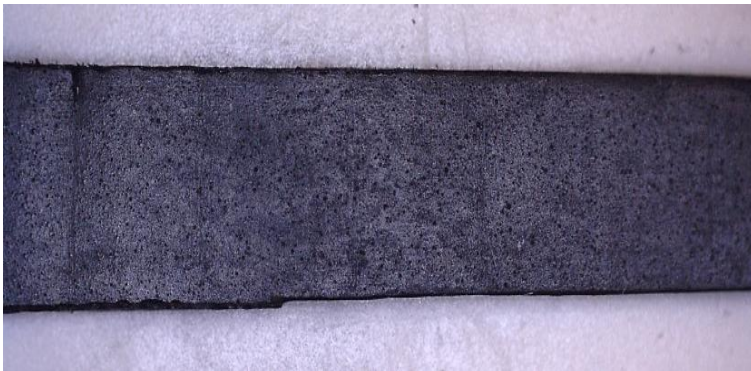
6-Month 130°F

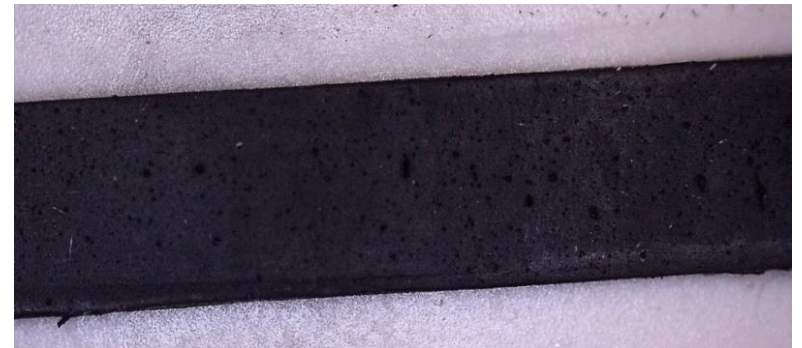
6-Month 170°F

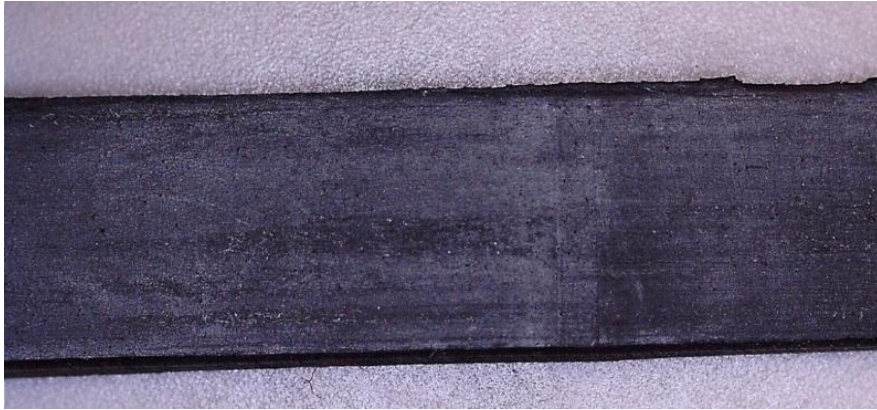
Baseline Specimen

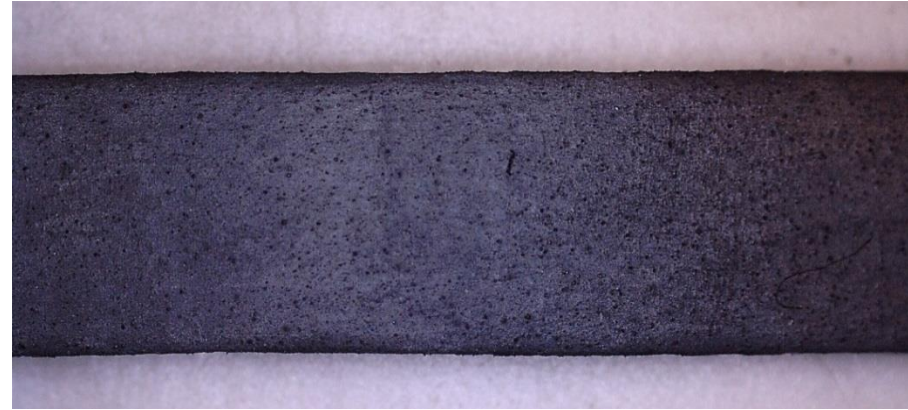
12-Month 100°F

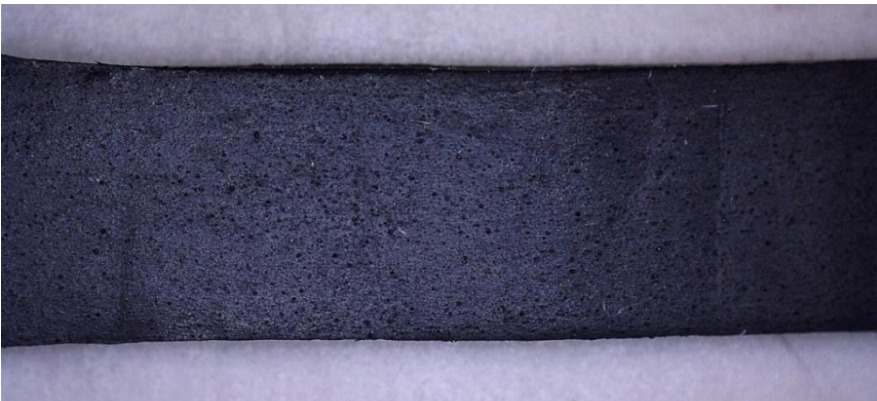
12-Month 130°F

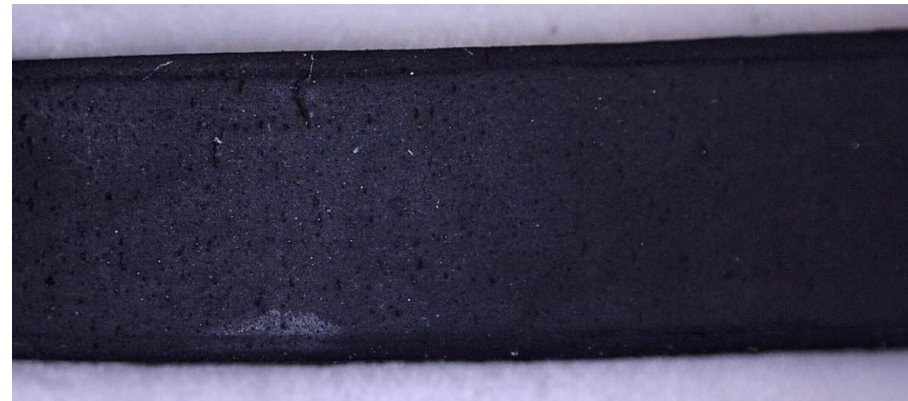
12-Month 170°F

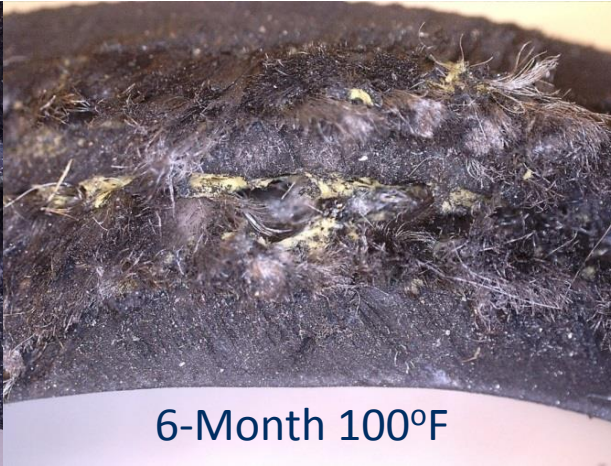
6-Month 100°F

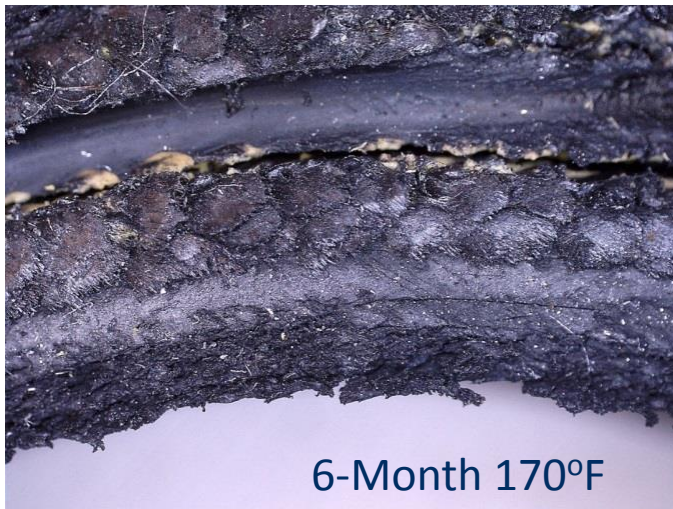
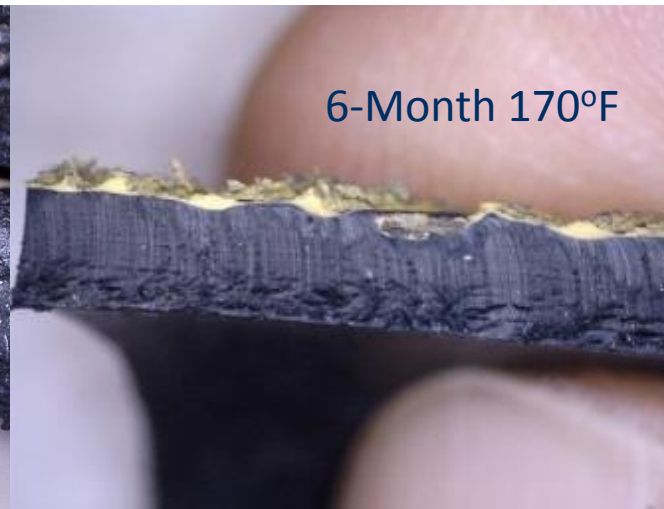
6-Month 170°F

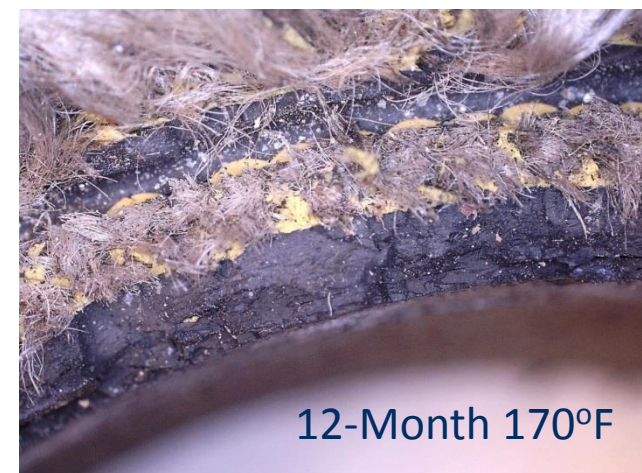
12-Month Hose Visual Inspections
