YEAR END TECHNICAL REPORT

September 29, 2019 to September 28, 2020

Chemical Process Alternatives for Radioactive Waste

Applied Research Center

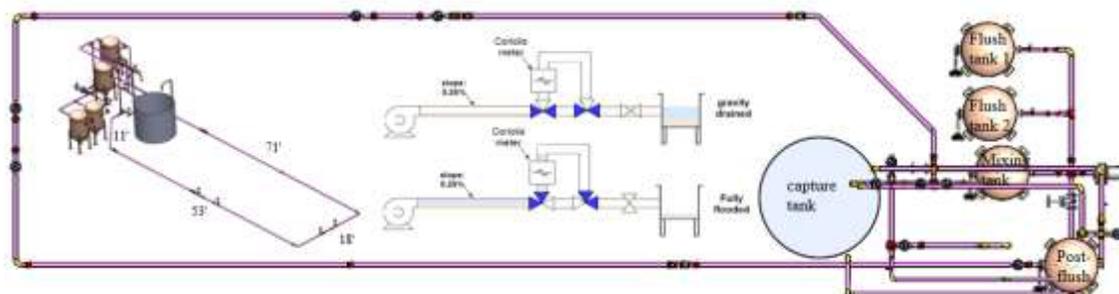
Figure 1. Schematic of a pipeline for flushing experiments.

To conduct these investigations, a 165-foot (50.3m) test loop made of 3-inch schedule 40 carbon steel pipes and fittings was completed (Figure 1 and Figure 2) in the previous period of performance year. This experimental loop can perform various functions such as slurry circulation, pump cleaning, flushing, sediment and water retrieval, filtration, and post-flush circulation. The pipeline was sloped at the rate of 0.15% (3-inch height difference 100 feet of pipe length) to emulate conditions at Hanford site and facilitate gravity draining.

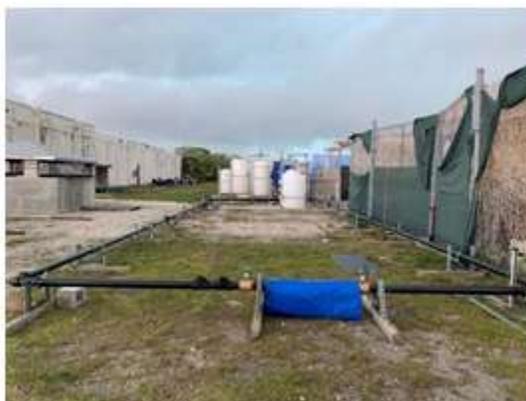
Figure 2. Pipeline constructed for flushing experiments.

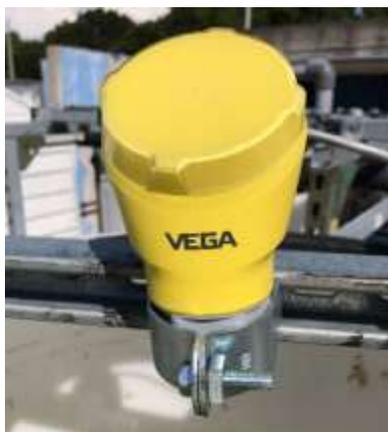
Figure 3. Water level measurement sensor attached to the tank.

The first improvement to the existing loop was the addition of a level sensor capable of automating the process to determine the flush-line volume by measuring the height of the water within the water flush tanks. A water level sensor was down selected from the three options considered. Of three potential sensors, the radar sensor was selected as a suitable level sensor for continuous measurement of the flushing tank. The sensor will allow automated shut-off of the pump after a designated volume has been achieved. VEGAPULS 11 is a radar sensor for non-contact, continuous level measurement and is suitable for both liquids and solids. The instrument emits a continuous, frequency-modulated radar signal through its antenna. The emitted signal is reflected by the medium and received by the antenna as an echo with modified frequency. The frequency change is proportional to the distance and is converted into the level. This sensor was procured, and initial testing was conducted which produced accurate reading of the water level.

To evaluate the performance of the VEGAPULS11, the radar sensor was attached to the top of the main water flush tank during both fully flooded and gravity-drained flush operations. Before commencing the operations, the initial height was captured manually. During the operation, the VEGAPULS11's 4-20 mA output was captured by both the Bluetooth function on the VEGA mobile app and the data acquisition device (DAQ). As the operation was completed, the final level was captured. Then, linear interpolation graphs were created to convert the 4-20mA output to a fluid level output. On the gravity-drain condition, the fluid level was also measured. During this process, a random intermediate value was selected to determine how accurately the level sensor matches to this value. The result is a total of three curves: one curve with the intermediate value,

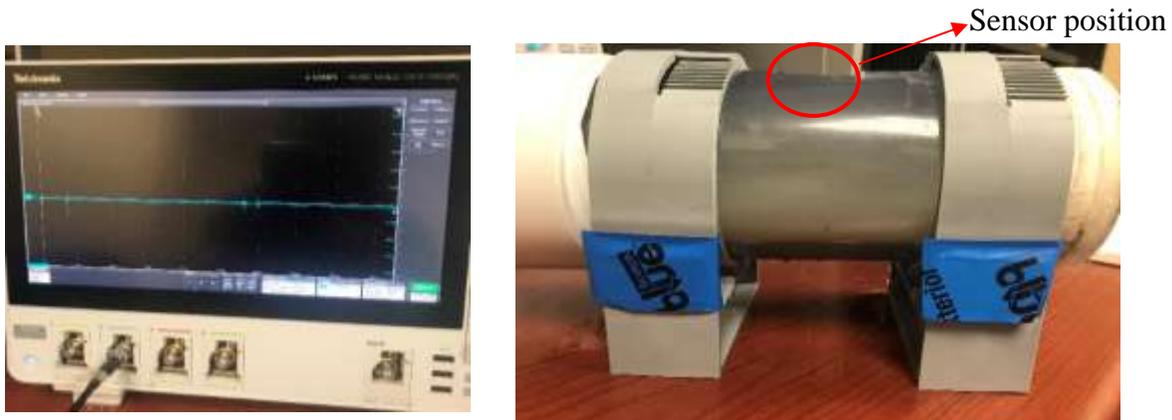
Figure 5. (Left) Tektronix MSO44 Mixed-Signal Oscilloscope (Right) Experimental Setup of settled kaolin in a mock 3-inch PVC pipe for fully-flooded conditions.

Lastly, ultrasonic investigations using a UT sensor and Tektronix Oscilloscope MSO44 were done to determine the bed height of the sediment within the pipe. Figure 5 shows the experimental setup for a fully flooded system with the oscilloscope waveforms. The data was captured by placing the sensor at the top of the pipe (empty condition) as shown in Figure 6. The first echo appeared at 18 microseconds, which indicates the time of travel through the pipe wall thickness. The experiment was then repeated for the pipe filled with water and sediment at the bottom. As can be seen in Figure 6, new peaks appeared at about 115 microseconds indicating the signal travel through the liquid followed by the sediment. The changes in the thickness of the sediment can be estimated by using the velocity of the wave travel through the different media.

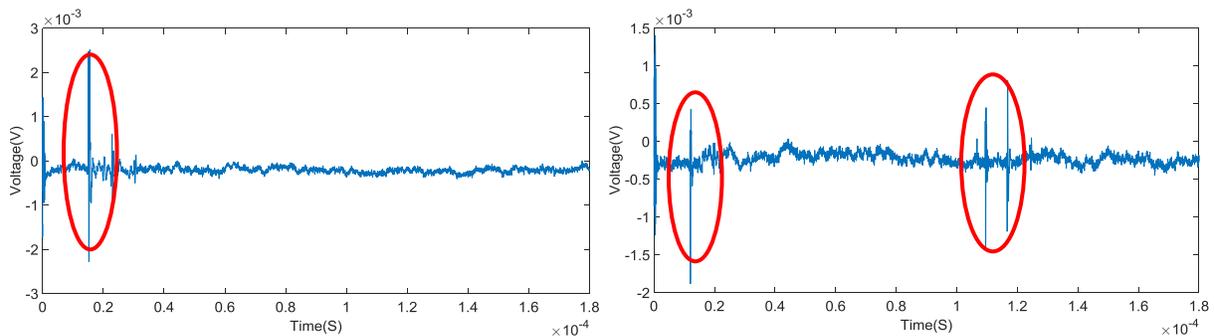
Figure 6. Oscilloscope waveforms that show (left) echoes in an empty PVC pipe and (right) fully flooded pipe with sediment.

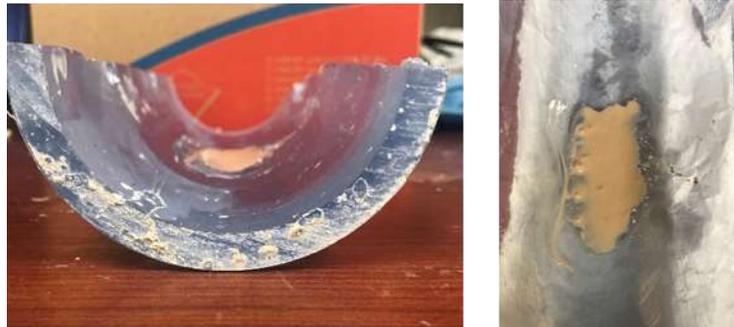
Figure 7. Experimental setup of settled kaolin in a mock PVC pipe cut in half to simulate gravity-drained conditions.

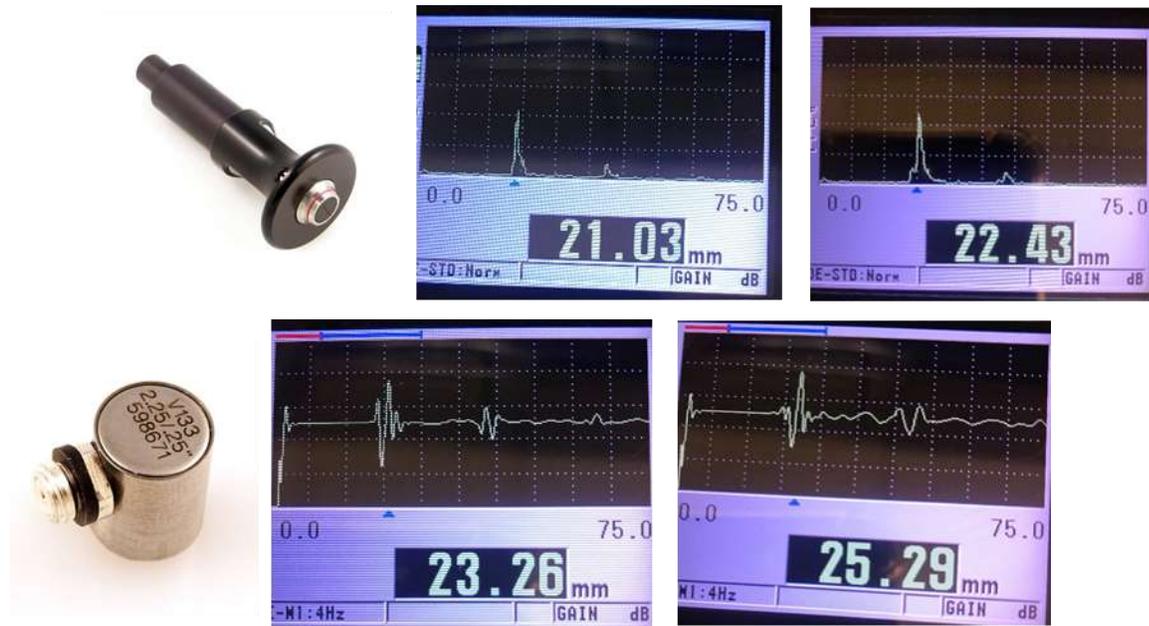
Figure 8. (Top) Oscilloscope waveform using a 5 MHz dual element transducer (bottom) and using a 2.25 MHz single element transducer.

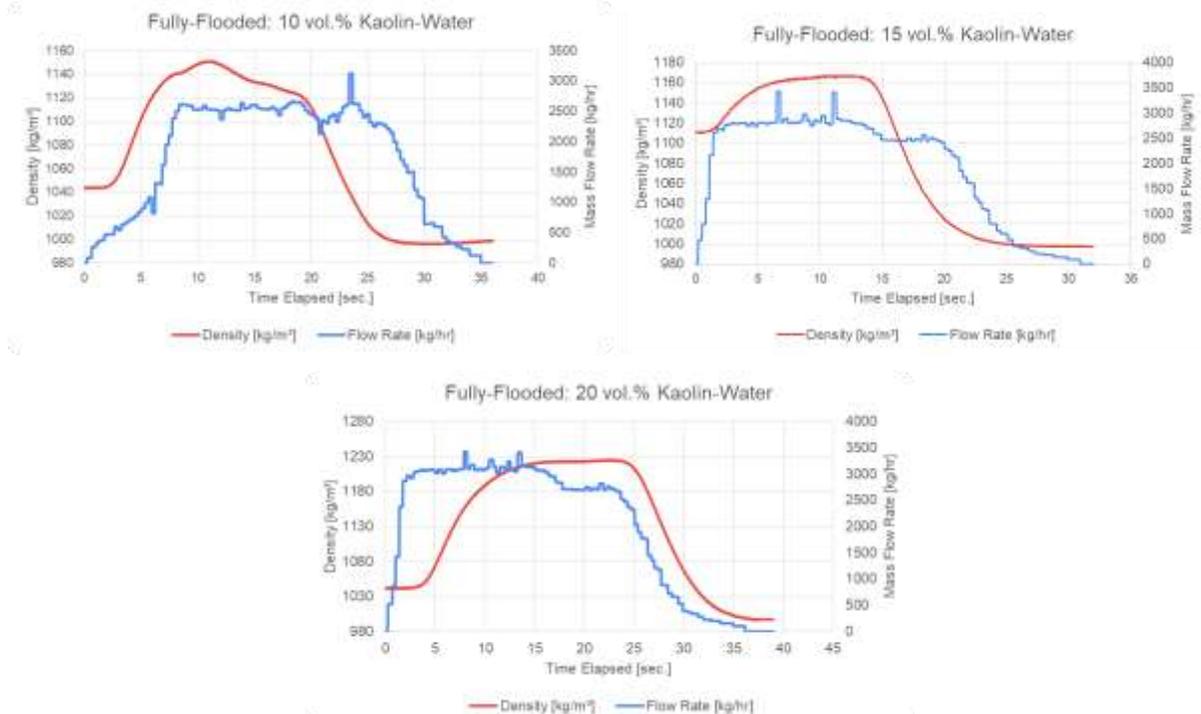
Figure 9. Density-Mass Flow Plots for 10 vol.%, 15 vol.%, and 20 vol.% kaolin-water simulants in the fully-flooded test condition.

Figures 9 and 10 show data from the Coriolis meter during flushing of both the fully-flooded and gravity-drained pipes. It can be seen during the flow, for the fully flooded condition, density begins at a value of 990 kg/m³. Data sets that show this value elevated above 990 kg/m³ is likely due to suspended solids. For the gravity drained conditions, it can be seen that this value begins at approximately 1 kg/m³ (the density of air), as the contents within the vertical section of the loop (where the Coriolis meter is located) was drained prior to flushing. At the moment the slurry pump is activated, a sudden rise of fluid flow can be noticed as water flushes through the system; in the fully flooded case, an increase in density to the approximate expected density for the solid concentration as the slurry is agitated by the flush operation. This can also be similarly stated for the gravity drain condition, with the notable exception that density rises to the expected density value from near-zero. As the slurry is flushed, it can be seen that the fluid eventually plateaus to the density of water, indicating a fully cleaned pipe loop. At this moment, the slurry pump is stopped.

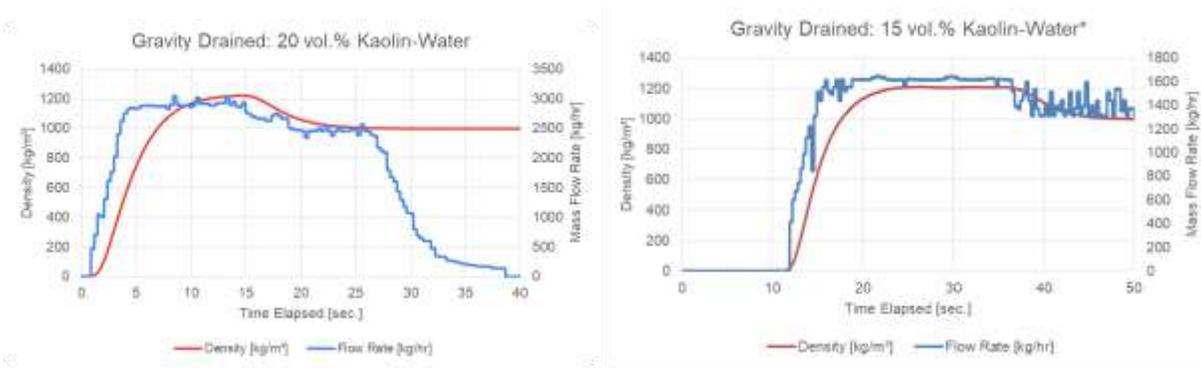
Figure 10. Density-Mass Flow Plots for 15 vol.% and 20 vol.% kaolin-water simulants in the Gravity-Drained test condition.

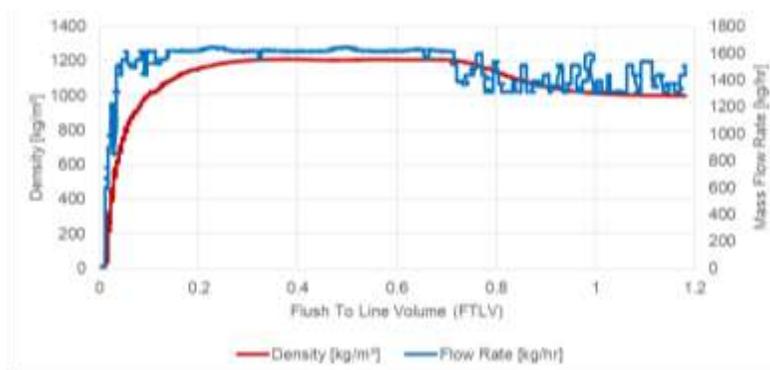
Figure 11. Density and Mass Flow Rate against FTLV of pipeline for 15 vol.% kaolin-water in the gravity-drained test condition.

For the fully flooded conditions, flush-to-line volume (FTLV) was calculated manually since intermediate fluid level data was not available at the time of testing. However, for the gravity drain condition at 15 vol %, the density-mass flow plot was compared to fluid level data obtained by the level sensor during the flush operation to determine the FTLV. As can be seen, the mixture plateaus at ~0.3 FTLV until 0.75 FTLV, where the fluid density gradually decreases to water, indicating that the sediment has been fully flushed. This occurs at approximately 1 FTLV. Exact values can be determined based on specific values for the acceptable density level defined by site engineers.

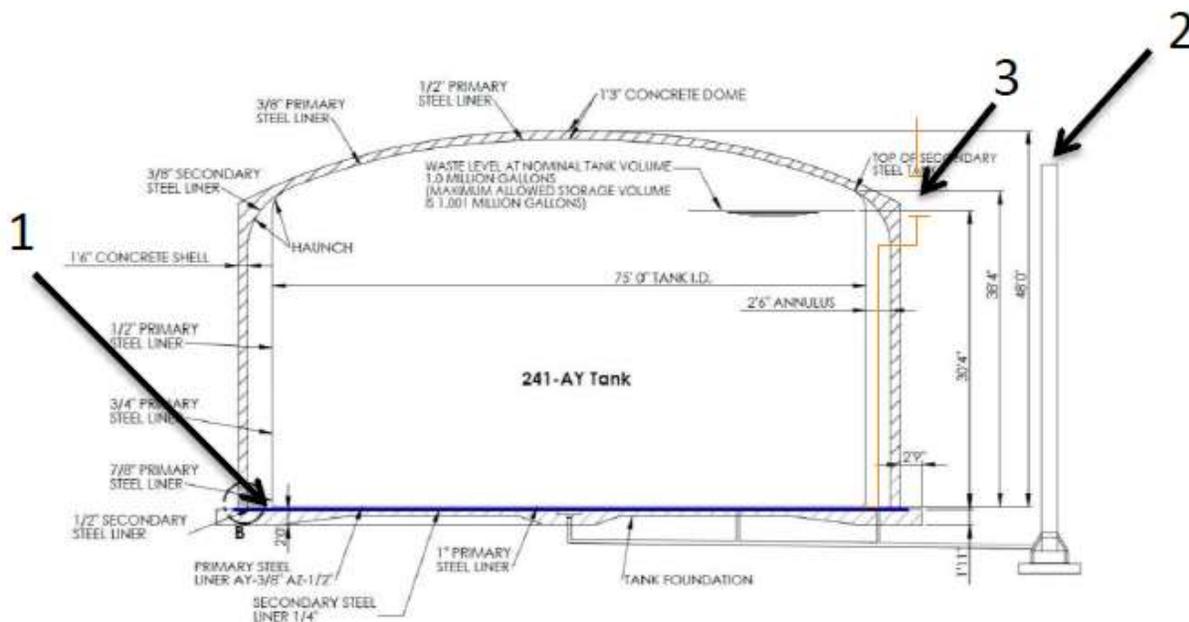
Figure 12. Inspection entry points of the AY-102 double-shell tank.

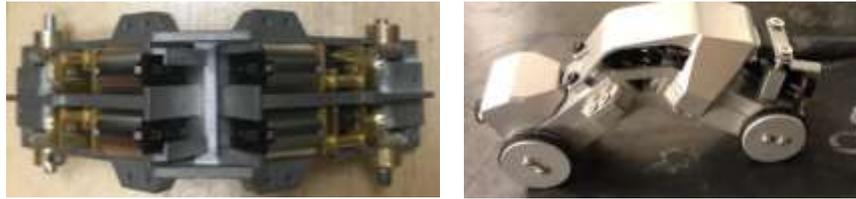
Figure 13. Current miniature rover design.

One of the primary challenges in the development of the mini rover was its ability to traverse over surfaces with weld seams. Some of the initial design concepts for the rover led to systems that had difficulty traversing the seams. After numerous tests, design changes and modifications, the current version of the rover was developed. The concept with the final design was to give the unit clearance in its middle, which provided the means for one end of the system to go over the seam while the other end was firmly attached to the plate. With this concept in place, a bevel gear design was incorporated to allow for the use of right-angle motors. This position change made it possible to utilize micro motors with higher stall torques (140 oz.in).

This rover uses 1/2" x 1/4" x 1/10" magnets to keep it attached to the metal plate. The number of the required magnets and size of the wheels were calculated based on the torque of the motors, required pull force (5 lb.) and the distance of the rover from the surface. The relations between the number of the required magnets, size of the wheels and the distance of the rover from the surface are shown in Figure 14 and was used to finalize the design.

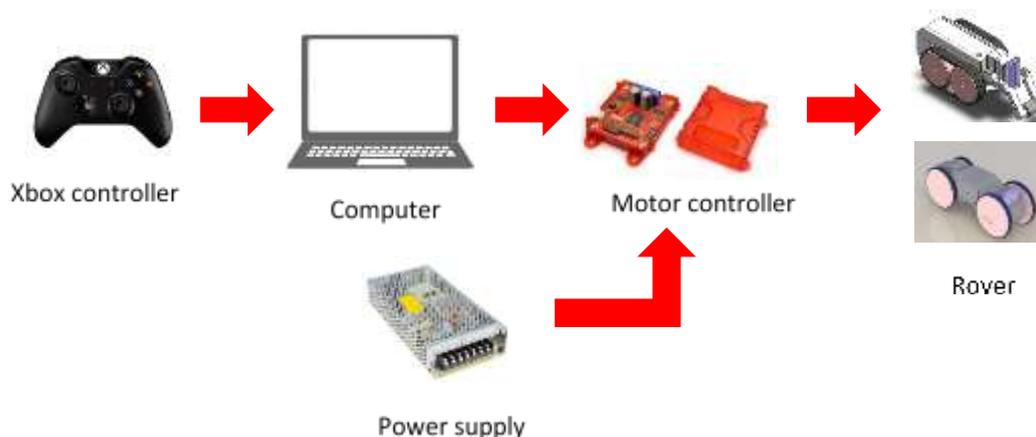
Figure 15. Control process.

With the long tether requirement, power was lost due to the voltage drop and video quality was also reduced for similar reasons. In order to address this issue, the current control box for the mini rover was designed to utilize stronger DC motors and a longer tether. The new control box includes a RoboClaw 2X7A as a digital controller and is controlled through serial communication using a python library. The computer receives the commands from the Xbox controller and sends the commands to the motor controller through the serial communication. The RoboClaw also receives its power from the power supply, which can go up to 34V and generate a 34V PWM signal to control the DC motors.

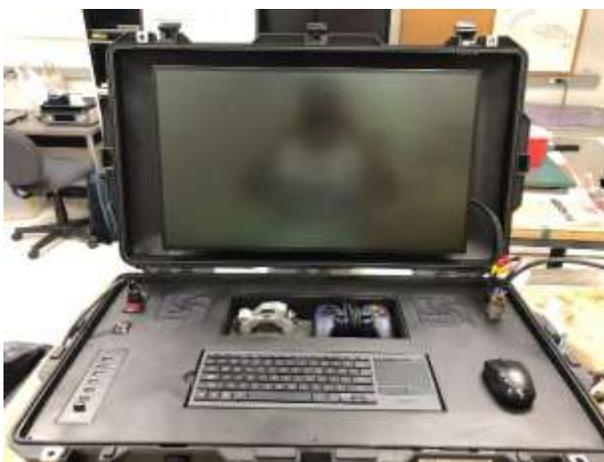
Figure 16. Final control box design.

To be able to deploy the miniature rover system at DOE facilities, an electrical safety inspection is required for the control box. After the control box design was finalized and fabricated, it was subjected to an electrical safety check and received the required certification to be considered for use at Hanford. The inspection validated the capabilities of the control box and ensured safe operating conditions.

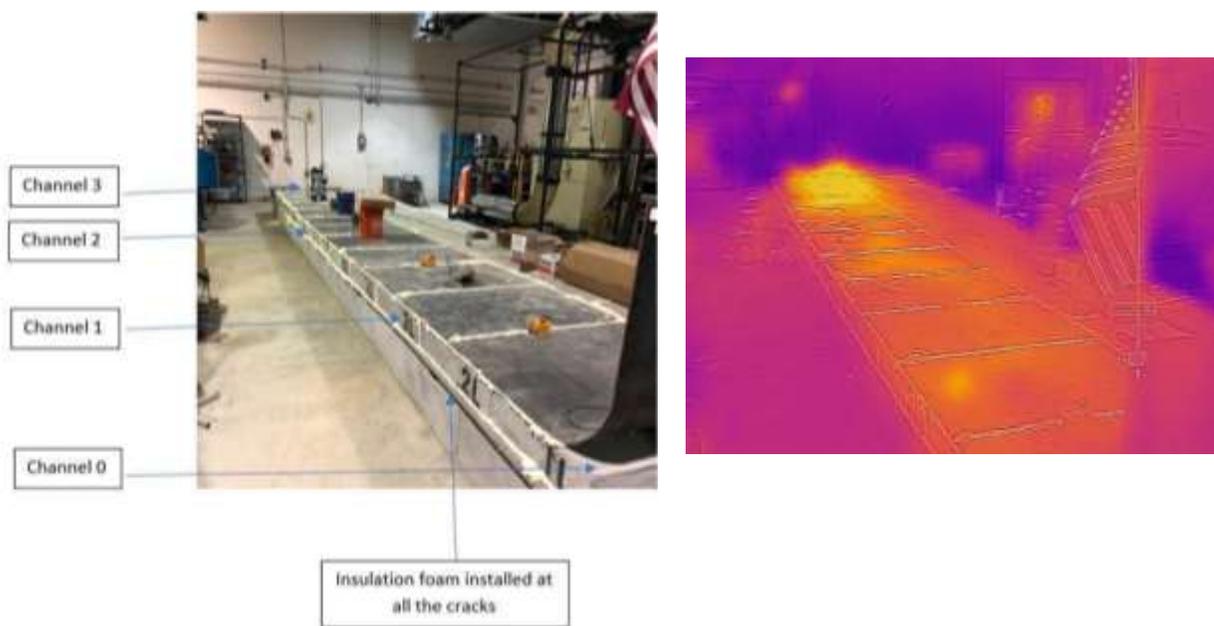
Figure 17. Durability test mockup.

The process of heating will include blowing hot air into the channel using two heating fans placed at the central plenum and annulus (Channel 0 & 3 in Figure 17). The blower’s temperature and flow rate will be adjusted to attempt to maintain roughly 130°F in the channel. Side channels (branches) will be blocked using a thermal insulation foam and filler material. The gaps between the primary liner plates and the space between the plates and the concrete sections along the air slot channel, will be sealed using insulation foam. Thermocouple probes will be inserted into the channel via the side channel gaps and insulation at four points (C0, C1, C2 and C3 in Figure 17). These four points will be used to obtain real-time temperature measurements. K-type thermocouples with 4 feet bendable metal probes connected to a USB-UTC 8-channel data acquisition system will be used for temperature monitoring.

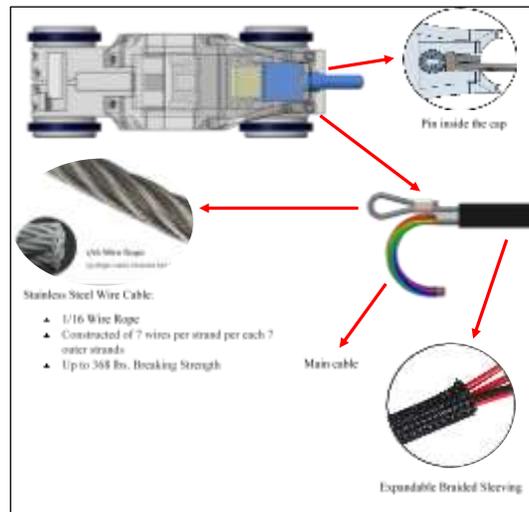
Figure 18. Tether details.

The emergency retrieval test will assess if the rover is capable of being withdrawn from within the channel in the event of a unit failure, or if the unit falls from the tank. To assist with emergency retrieval, the rover is equipped with a tether that is secured with a locking cap. The tether consists of the main cable, a stainless steel wire cable for strength support and expandable braided sleeve (Figure 18). The stainless-steel wire cable has up to 368 lbs of load before failing. The tether may be pulled manually from grade through the riser, annulus, and refractory to retrieve the unit. The test will evaluate whether the tether and locking cap can withstand the loads applied to the crawler during the retrieval process.

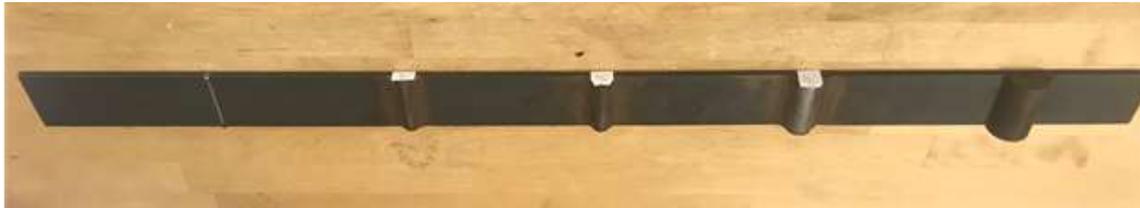
Figure 19. Half-round weld seams with different heights.

The weld seam test will assess the mini rover's ability to traverse weld seams on the primary liner of the tank. Two mockups of weld seam variations will be utilized. Figure 19 shows a steel plate with 5 weld seams ranging from 1/8th to 1 inch in height that will be used to represent semi-circular weld seams. The weld seam plates will be placed near the central plenum. The rover will be required to traverse the weld seams while pulling the tether, extending the entire length of the mockup.

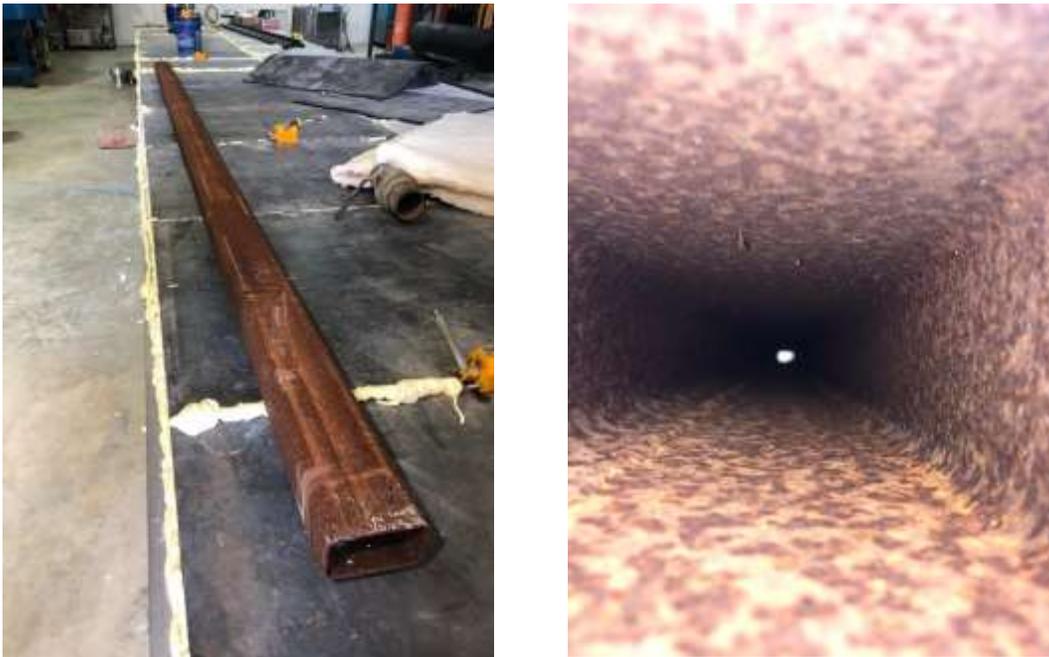
Figure 20. Corroded surface setup.

The corroded surface test will assess the rover's ability to traverse corroded surfaces (Figure 20) without change in the unit's performance. A critical issue will be the observation of corroded material accumulation on the magnets and its effect on performance.

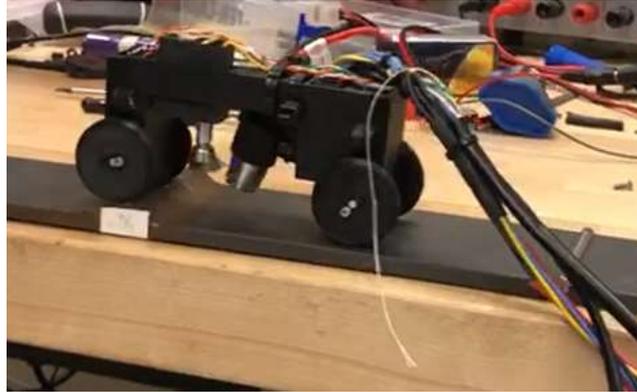
Figure 22. Weld seam testing.

In order to evaluate the new systems ability to traverse weld seams, the unit was tested on weld seams ranging from 1/8th to 1 inch in height. As shown in Figure 22, the system was capable of traversing seams up to 0.5 inches in height, which is above the maximum height expectation based on conversations with engineers at WRPS.

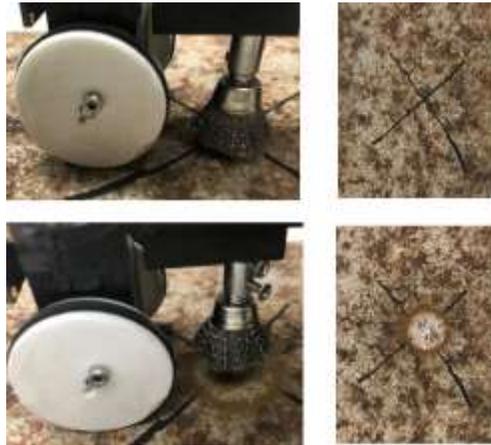
Figure 23. Surface preparation demonstration.

As noted previously, the surfaces on the tank may require some level of cleaning prior to thickness measurements. A wire brush has been incorporated into the rover and was evaluated for its functionality. The figure below shows a surface with debris and scaling both before and after the prepping process.

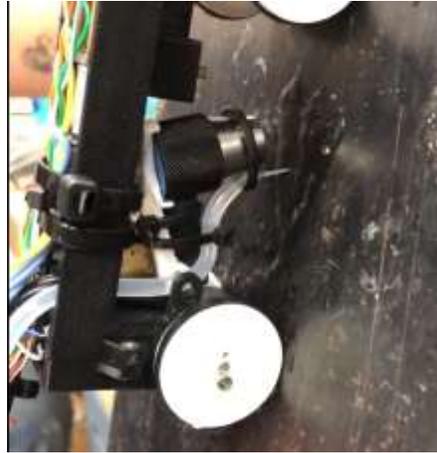
Figure 24. Water pumped as a couplant.

In order to evaluate the UT sensor, a means for applying a couplant is required. Rather than incorporating a reservoir pump into the unit, taking up valuable space, it was decided to include a tube in the tether and utilize a water pump external to the unit. The pump supplies the couplant, in this case water, through the tube that is attached to the rover and places a small amount of water on the surface to be examined as shown in Figure 24. For this testing, a tube of 150 ft in length was used.

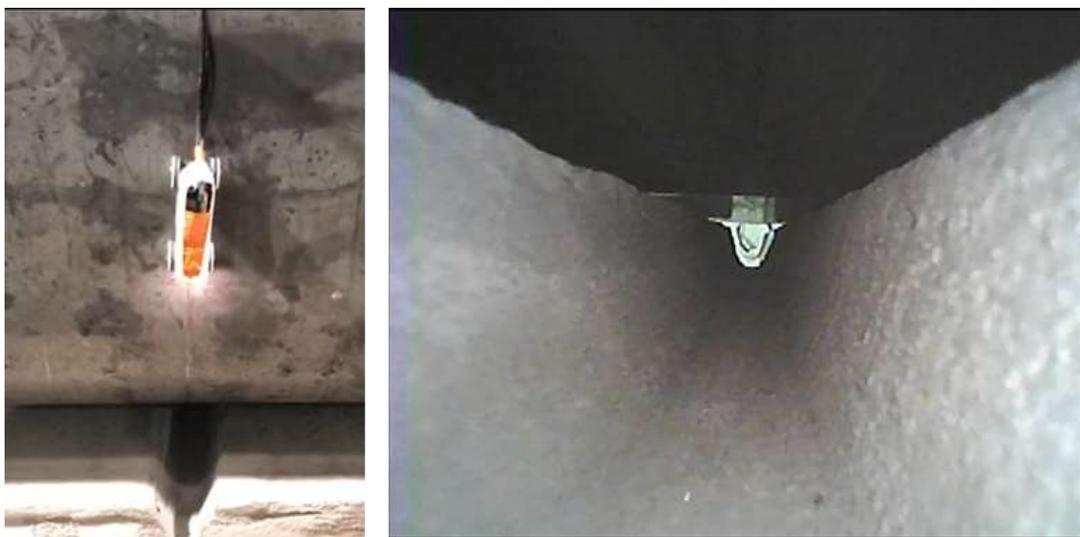
Figure 27. UT rover entering and exiting mockup.

In order to navigate the UT sensor unit within the channels, the UT rover was configured with the same controller that was utilized for the original mini rover. The controller includes a RoboClaw 2X7A, power supply, voltage adapters, analog to digital video converters and a computer. The UT sensor rover was placed on the side wall above the tank knuckle and driven into a refractory slot from the annulus. The system was easily able to navigate from the annulus to the central plenum. Figure 27 shows the entrance location and a picture taken from the video feed from the rover near the central plenum.

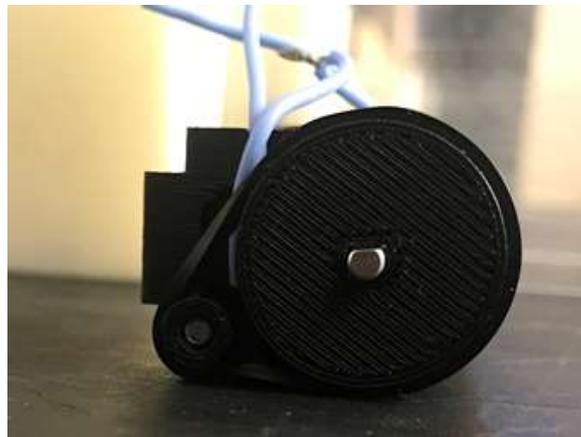
Figure 29. 3D printed 90° rover.

After the modifications were completed, a prototype of the rover was printed and assembled and is shown in Figure 29.

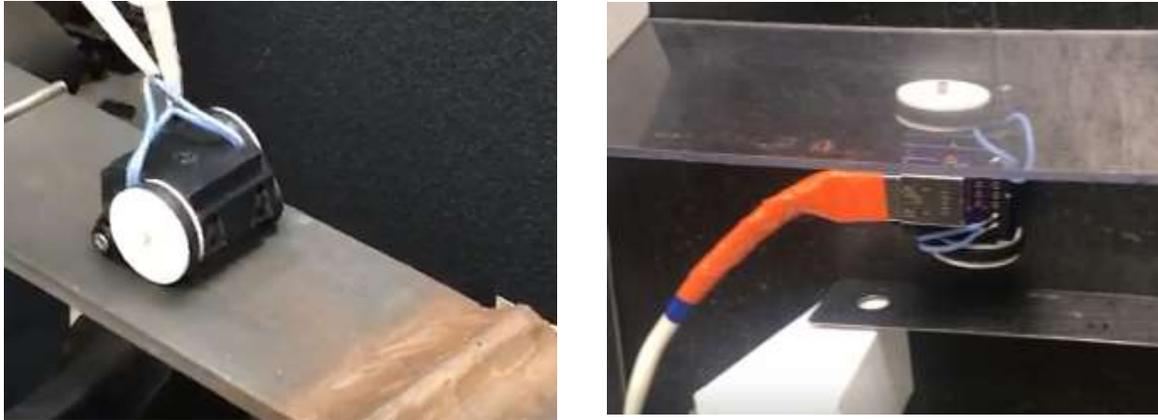
Figure 30. Testing of the 90° rover over weld seams and through sharp turns.

The new prototype of the rover was successfully tested for its ability to navigate around 90° turns and over weld seams. The maximum pull force of the unit was also measured and found to be 3.7lbs. Additional tests will be conducted to ensure functionality of the rover and optimize its pull force. Testing of the rover over weld seams and through turns are shown in Figure 30.

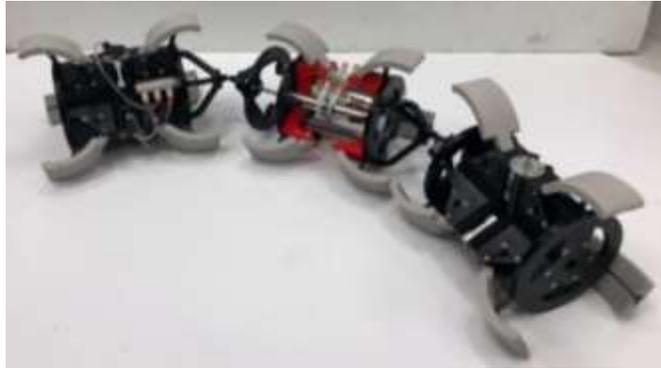
Figure 32. Mother pipe crawler prototype.

The crawler operates using pneumatic actuators on the same peristaltic principles of other inspection tools previously developed at FIU. The crawler, which was developed in the Year 9 period of performance, is shown in the figure below.

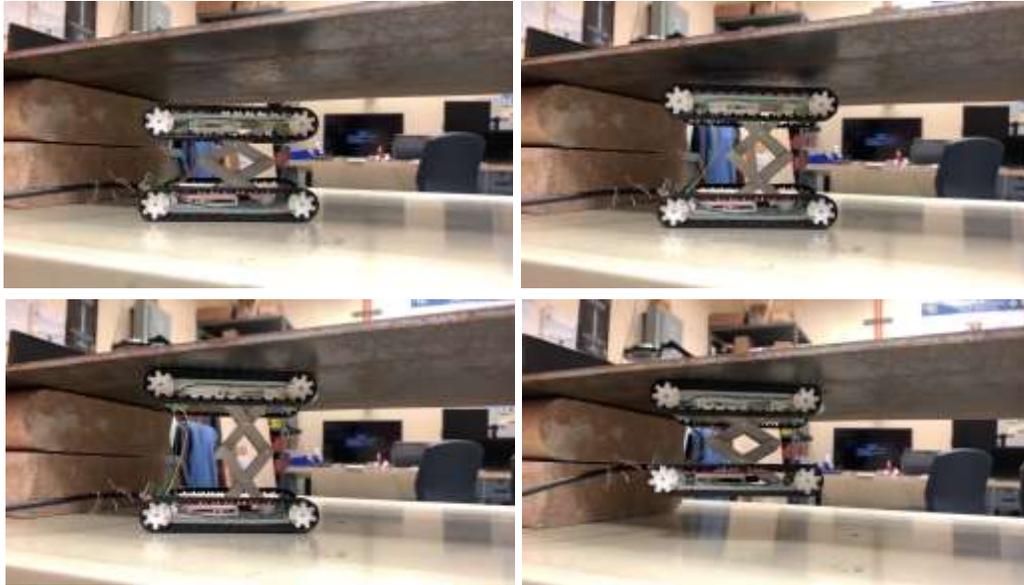
Figure 33. Original miniature inspection tool.

This lifting concept was exhaustively explored during the past performance period, and a functional prototype was successfully tested. Figure 33 shows this original version of the rover that successfully extended the mechanism, magnetically attached to an overhead metal surface, retracted, lifted the unit, and drove on the surface.

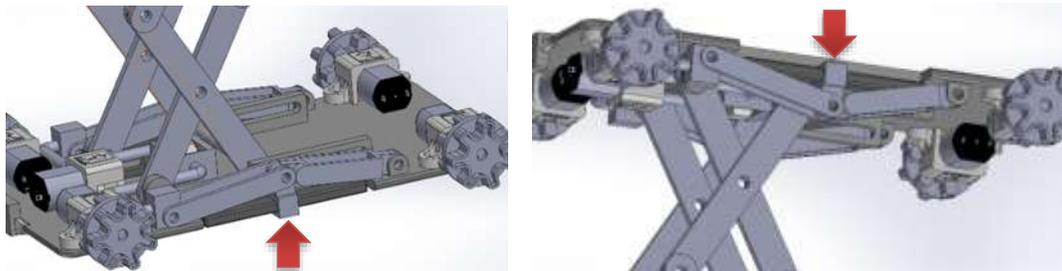
Figure 34. Magnet displacement mechanism engaged (left) and disengaged (right).

This original version of the miniature inspection tool also uses additional lateral scissor mechanisms to control the gap between the magnets and the secondary liner, allowing the unit's eventual disengagement during retrieval, as illustrated in Figure 34.

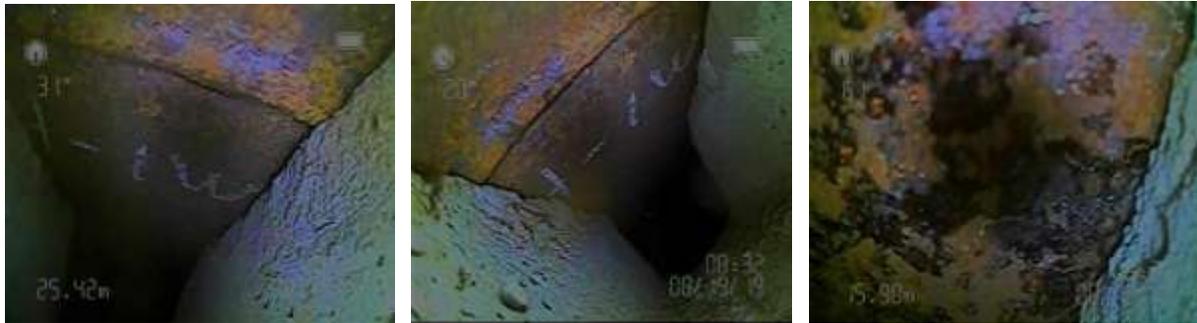
Figure 35. Primary liner weld seams (left and center) and flakey corrosion spot (right).

Figure 35 shows images from previous inspections of the DST's primary tank liner, presenting challenging conditions to navigate magnetically attached. Conditions could potentially be worse in the secondary tank liner, with a lack of humidity control in the ventilation system.

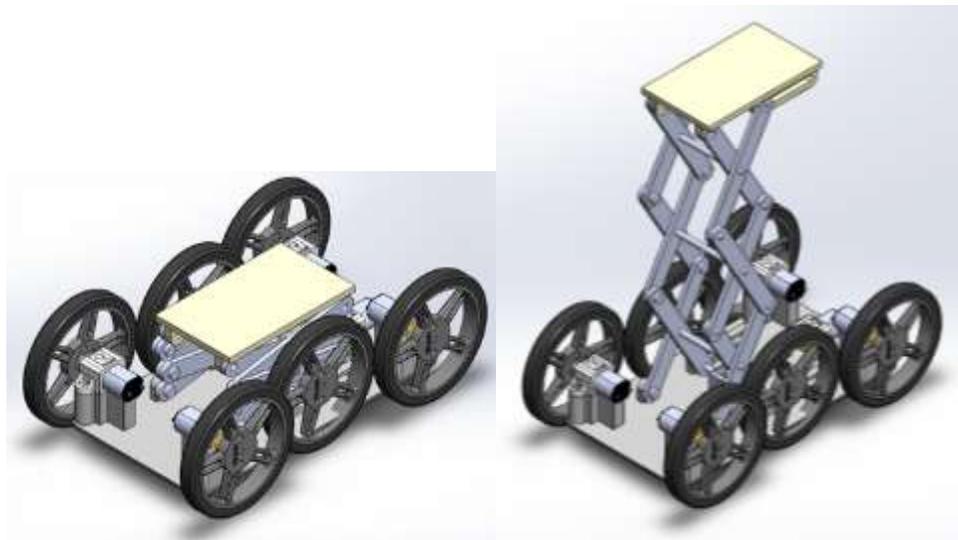
Figure 36. Alternate design using large wheels.

Figure 36 shows a design that uses large wheels, approximately 2" in diameter, replacing the original bottom and top tracks. Larger wheels have the ability to overcome unexpected obstacles than the current small tank treads.

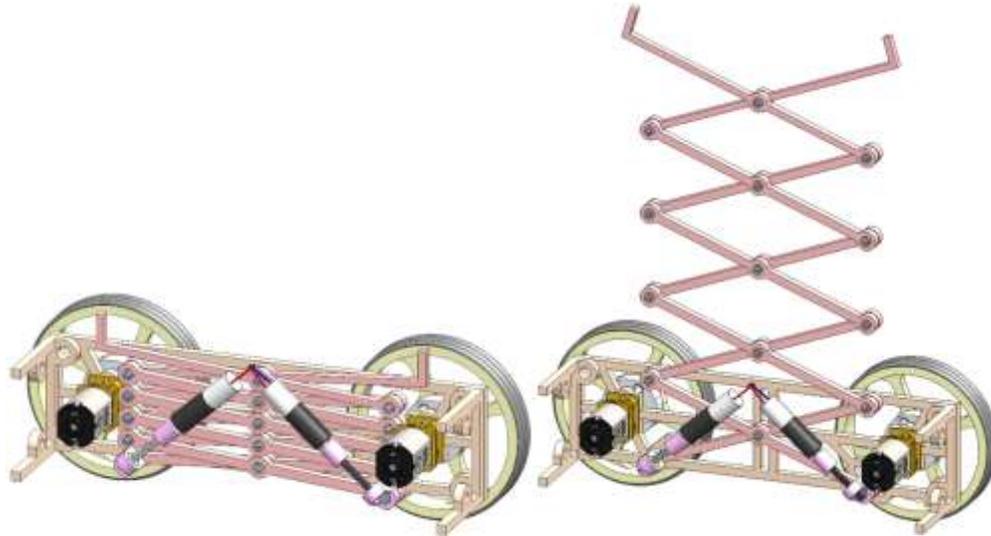
Figure 39. Rover's scissor lift mechanism.

Figure 39, the rover uses micro gear motors that diagonally open the scissor lift mechanism allowing the extended floor clearance. The current reach of the arrangement is approximately 9".

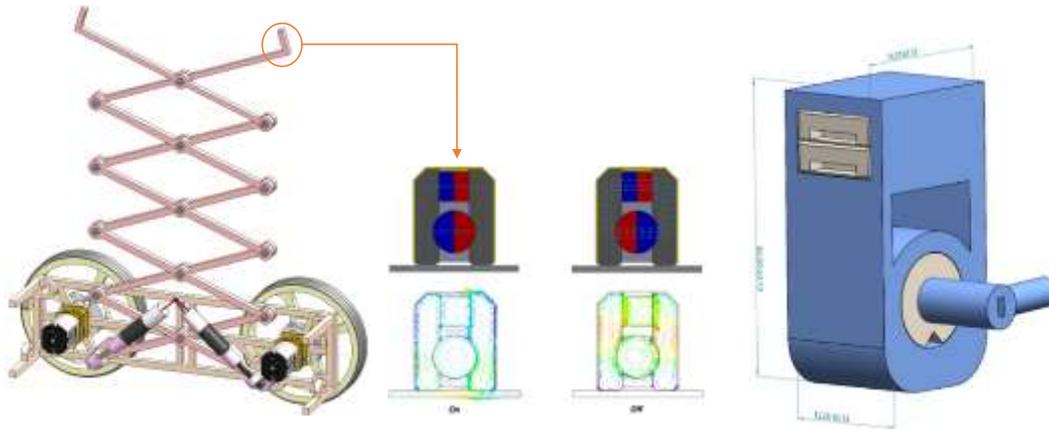
Figure 40. Rover's scissor lift mechanism (left) and magnetic attachment (right).

Based on permanent magnet lifters, a switching magnetic attachment was also designed to control the inspection tool magnetic engagement to the secondary liner, illustrated in Figure 40. In the magnetic attachment system located at the scissor lift ends, the relative movement between the permanent magnets inside the lifter adds and cancels the magnetic field strength on the working surface, switching between loading and unloading conditions. However, finding small, powerful motors capable of dealing with neodymium magnets' strong repulsion was challenging to implement in such a small device.

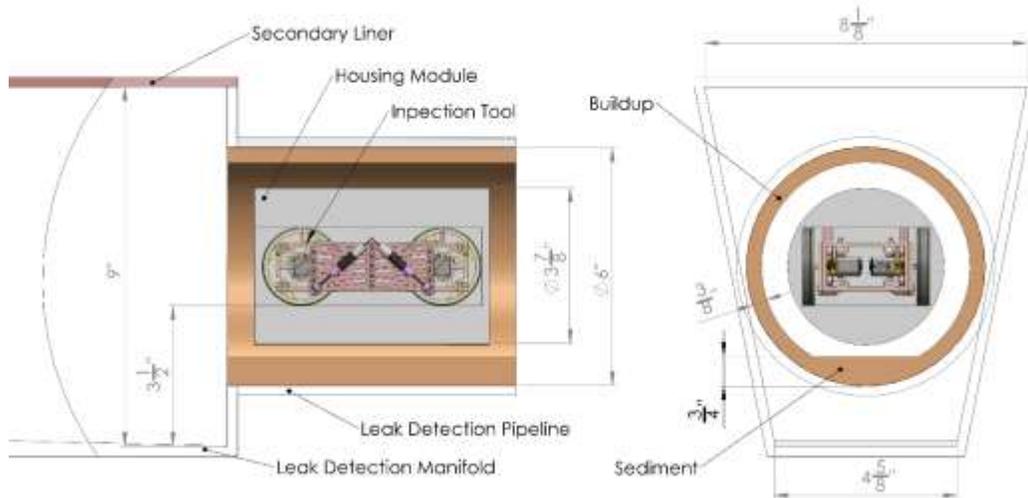
Figure 49. Housing module.

As shown in Figure 49, the distance between the rover and the floor is about 3.5", which requires a deployment apparatus to deliver the inspection rover from the housing module to the floor of the leak detection manifold.

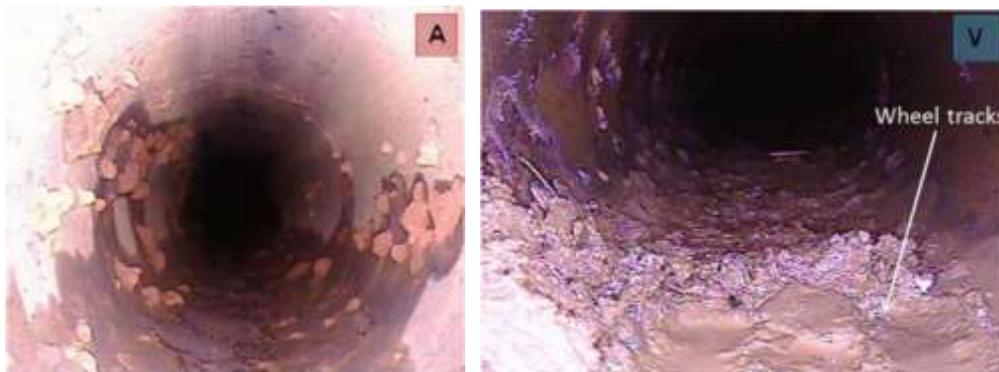
Figure 50. Existing sediments and buildup in the leak detection pipeline.

The pipe crawler modules are approximately 4" in diameter and centered by guides to avoid existing sediment and build up in the leak detection pipeline. Figure 50 shows the drain lines' current conditions from previous inspections at Hanford.

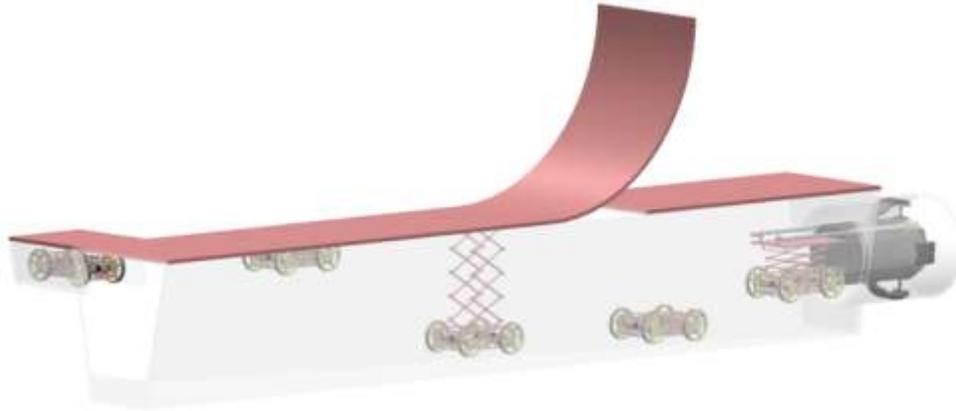
Figure 51. Overhead deployment ramp.

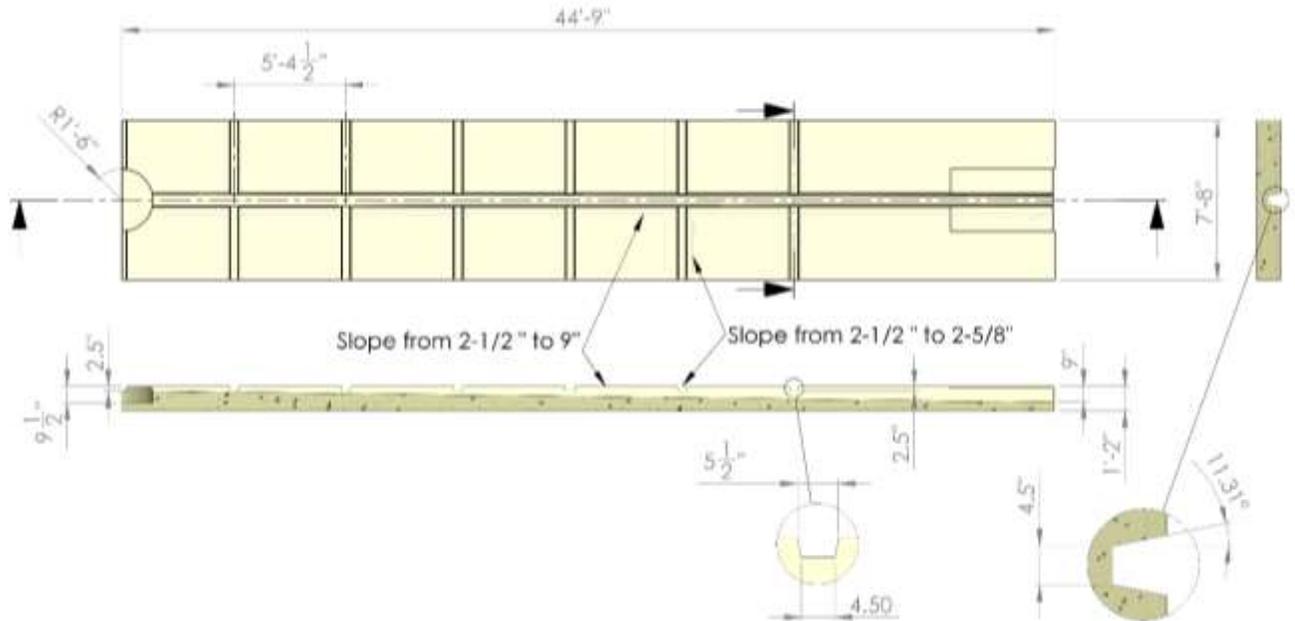
Figure 54. Concrete foundation with drain slots.

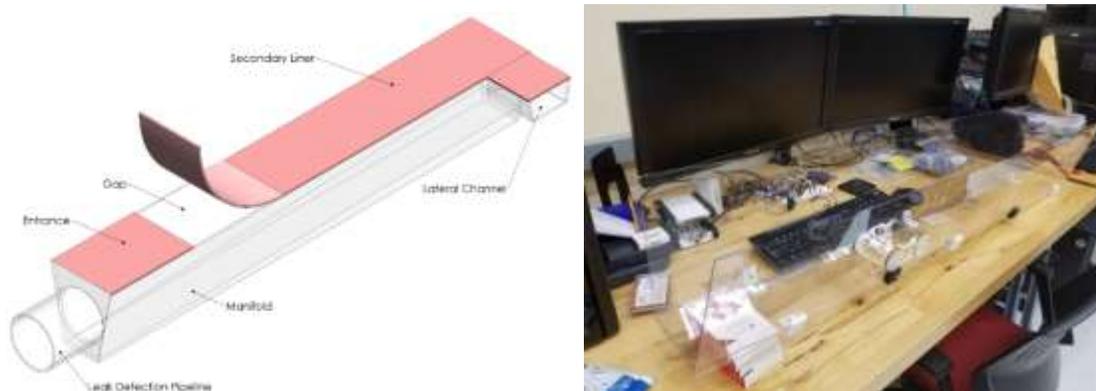
Figure 55. Bench-scale mockup.

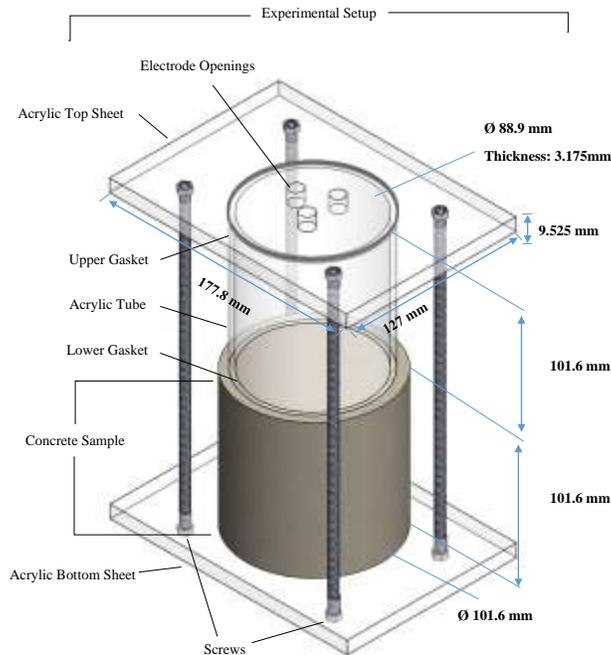
Figure 56. Schematic of new test setup for immersion-type test in acid solutions.

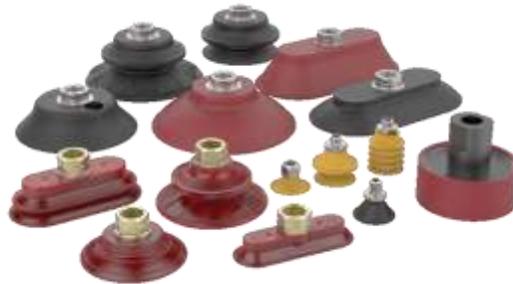
Figure 59. Vacuum cups with different geometries [15].

Different types of vacuum cups may be selected based on the geometry of the surface to which the system needs to adhere. Several types of designs are available depending on the condition and surface variations the unit will be dealing with. There are vacuum cups designed to work with smooth and even surfaces, surfaces with small and large variations. In regards to the large surface variation, the EPDM foal seal suction cups would be selected due to the amount of suction force needed to compensate for the large area and low flow rate. Regardless of the cup chosen, the method by which the vacuum is created will remain the same as described above.

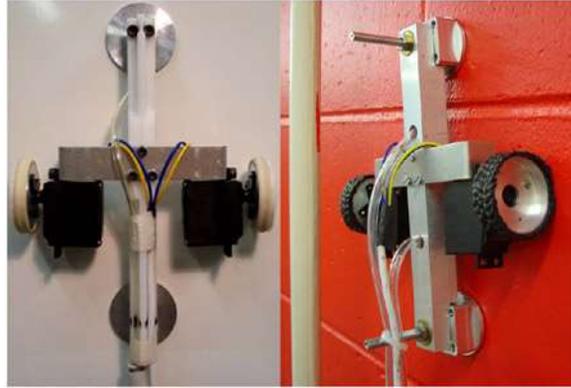
Figure 61. NCAP robot equipped with non-contact grippers [21].

Although these types of grippers are widely used to handle sensitive products within various industries, wall-climbing robots that use non-contact adhesion are very limited. An example of wall-climbing robot utilizing these types of non-contact grippers is the NCAP robot unit pictured in Figure 61, or the wall-climber that is able to traverse varying surfaces including brick walls and a gap between a wall and door [20].

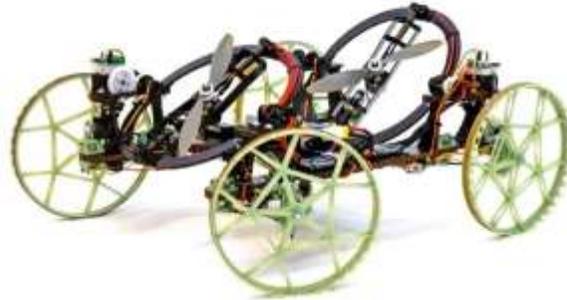
Figure 62. ETH Zurich and Disney collaboration robot: Vertigo [22].

A very popular example of a fan-based wall-climbing system is the Vertigo robot pictured in Figure 62, which was co-developed by Disney and ETH Zurich. Some of the design factors that were considered when developing this unit were high mobility, horizontal to vertical surface transition capabilities and maximized thrust output to weight ratio. In order to minimize the weight of the unit, the Vertigo unit does not have motorized wheels, but is able to move along a surface by utilizing the fans to produce forward movement and a tandem servo setup to turn the wheels. The platform also takes advantage of low weight and high strength carbon fiber for the chassis construction.

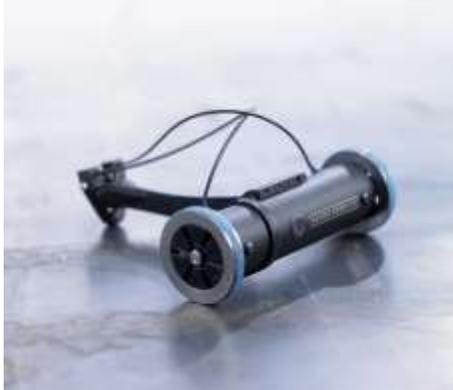
Figure 67. ReconRobotics Recon Scout magnetic ship climber [38].

Applications that utilize this adhesion mechanism are centered on the inspection of metallic surfaces such as those found on tanks and ships. Examples of robotic platforms utilizing this adhesion method are the ReconRobotics Recon Scout ship climber, Figure 67, which is used for ship hull inspections and the mini rover being developed at the ARC robotics lab, Figure 68. The mini rover uses magnets to cling to metallic tank floors for inspection in nuclear waste tanks [37].

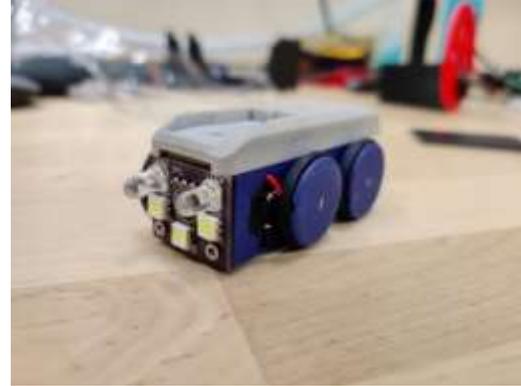
Figure 68. FIU Applied Research Center's Mini Rover.

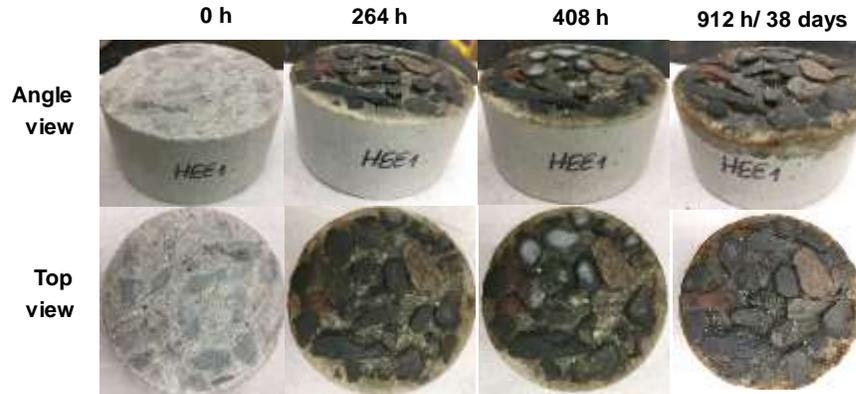
Figure 70. Images of a concrete specimen before and after enhanced aging conditions of Test 7. HEE1 was selected as representative of the 6 replicates tested. (Surface was wet at the time the pictures were taken, except for the initial images).
