YEAR END TECHNICAL REPORT

September 29, 2019 to September 28, 2020

Chemical Process Alternatives for Radioactive Waste

Applied Research Center

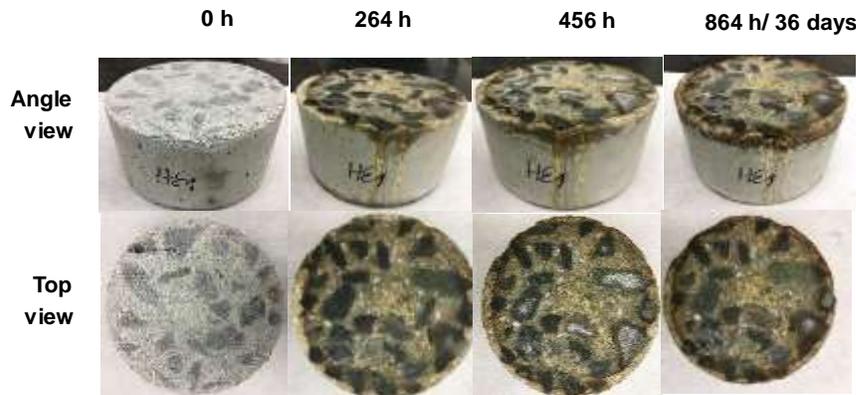
Figure 71. Images of a concrete specimen before and after enhanced aging conditions of Test 8, immersion in 0.5M nitric acid solution, over time. Surface was wet at the time the picture was taken, except for the images at initial time. HE1 was selected as representative of the 6 replicates tested.

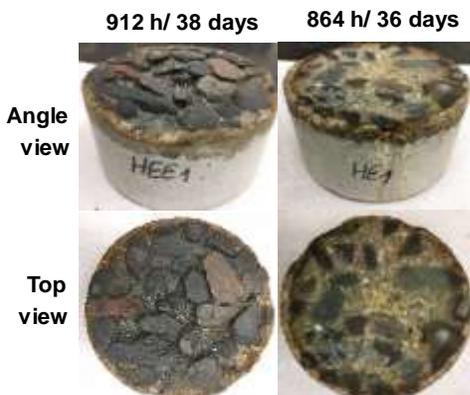
Figure 72. Comparison of Images of a selected concrete specimen HE1 exposed to immersion in 0.5M nitric acid solution without erosion.

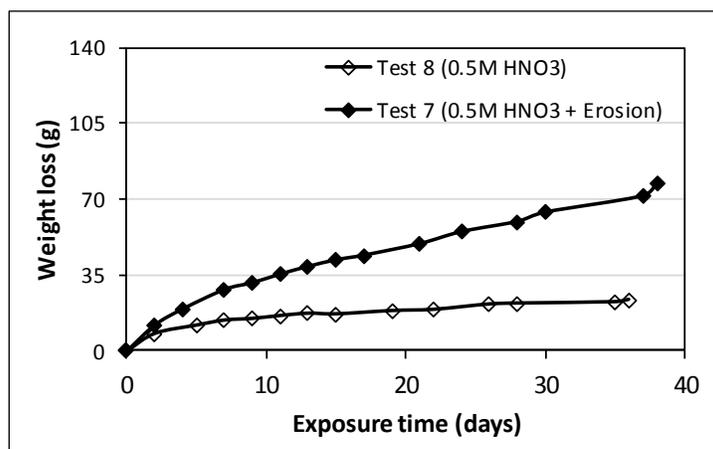
Figure 73. Average weight loss with time of concrete specimens exposed to Test 7, 0.5M HNO3 solution and erosion, and Test 8, 0.5M HNO3 solution, enhanced aging conditions.

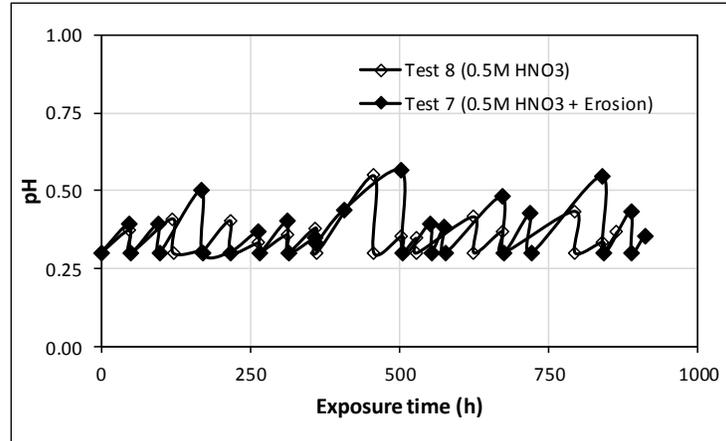
Figure 74. pH changes of the 0.5m nitric acid solutions used for Test 7 and Test 8.

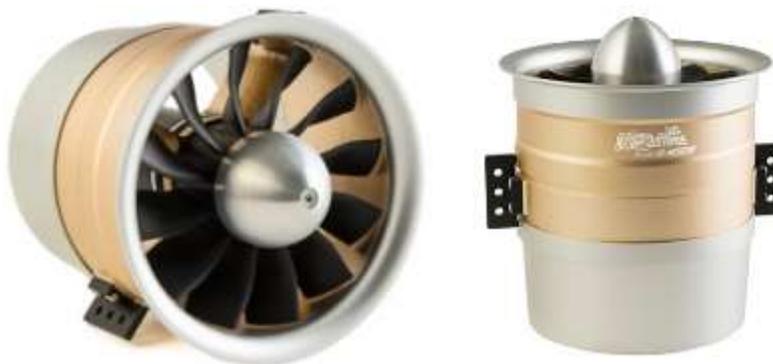
Figure 75. Dr. Mad Thrust 90mm EDF unit (blade and side view).

The platform design chosen to test the selected adhesion mechanism is a wheel-based platform. The adhesion mechanism selected is a thrust approach, which was chosen based on the environmental conditions inside of the HCAEX tunnel along with the type of payload necessary to accomplish the task of coating the concrete walls without further damaging the walls. The fan unit used to create the thrust to provide contact with the target surface is the Dr. Mad Thrust 90mm EDF unit, Figure 75. This fan is capable of generating 3.8kg of thrust.

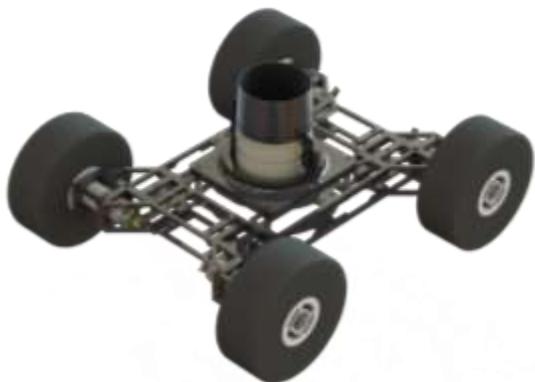
Figure 76. CAD design of thrust based prototype.

The design for the wheeled based platform was generated in Solidworks, Figure 76, and 3D printed using PLA, Figure 77. The platform utilizes four motors that work independently to create the movement necessary to reach a desired location. The prototype is designed to operate on power supplied through either an on board LiPo battery or connected to a dedicated power line via a tether. The platform is also equipped with an inertial measurement unit (IMU) which is used to detect the orientation of the system and a camera for visual based navigation via teleoperation.

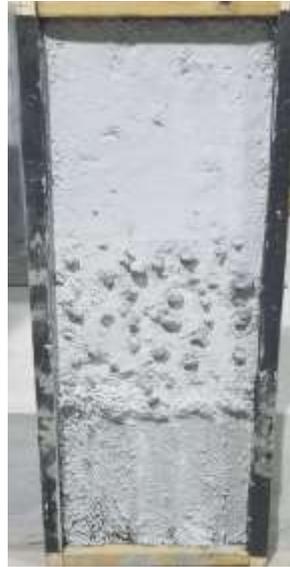
Figure 78. Varying surface condition of small-scale concrete wall.

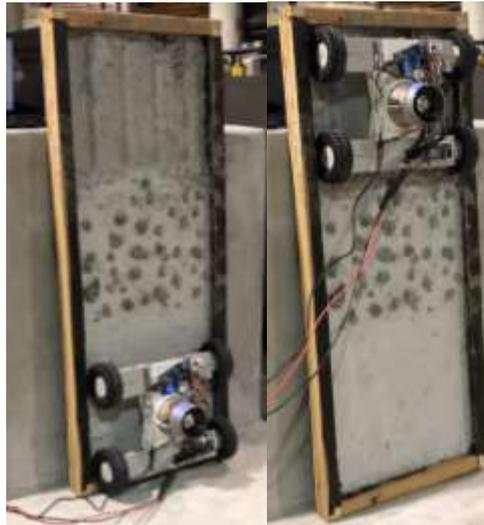
Figure 79. Prototype completing horizontal to vertical transition (left) and completing test over varying surface conditions along a vertical wall (right).

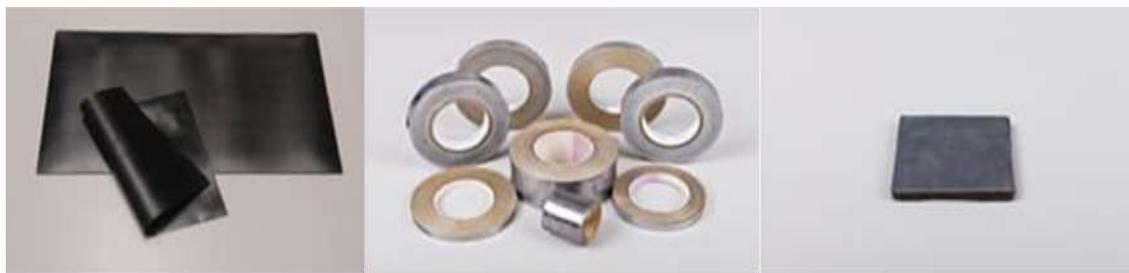
Figure 81. Lead Vinyl Sheeting (left), lead foil tape (center), lead lined foam (right) [16].

Initial research on radiation hardness testing resulted in compiling a list of different radiation hardness tests and a generic test plan for evaluating off the shelf commercial electronics for low-level radiation environments. The methods for shielding commercial grade electronics were investigated with a focus on ease of implementation and not requiring any disassembly of the original device. Several solutions were found that could significantly increase the durability of off-the-shelf electronics to low levels of ionizing radiation without adding significant weight or costs. Lead as an element has proven to be one of the most effective means of absorbing radiation and shielding both electronics and organic matter from the harmful effects of ionizing radiation. Unfortunately, it is toxic and risks leaching into the environment if deployed in its raw state. Newer technologies have emerged, though, that solve this issue by combining lead with other materials to make it easier to apply and reduces the risk of it contaminating the environment. Lead vinyl sheeting is available from a company called RayBar, it is available in thickness from 1/32” to 1/8” and is extremely flexible [16]. Other solutions for shielding include lead paint, and conformal coatings that use heavy element particles. Some of the options of the lead-based materials that can be used for radiation shielding are shown in Figure 81 and Figure 82. Evident from the figures are the sheeting, foil tape, gamma and neutron absorbent foams. Depending on the application, any of these could be easily applied as a shield against radiation for the sensors and electronic devices.

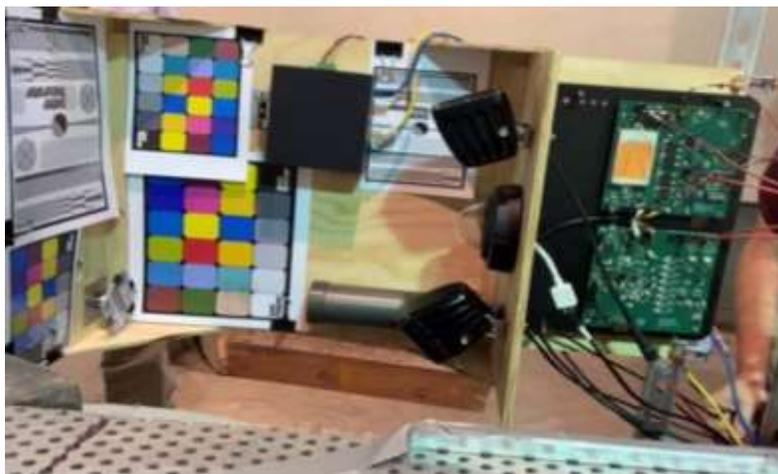
Figure 83. Cameras and sensor system electronic component set up board for radiation chamber testing SWRI [20].

The test plan was submitted to WRPS and DOE as a deliverable with only minor comments, after which confirmation was received from WRPS to proceed with the radiation testing. The scientists also assessed FIU's test plan with similar testing conducted by SWRI. The difference in both test plans was compared. As shown in Figure 83, SWRI used a test set up with electronic components attached to a plywood board and the entire set up was placed in a hot-cell facility for radiation exposure using cobalt-60 sources. FIU proposed a similar process except for the sensors to be tested at the McClellan Nuclear Research Center at UC Davis using their radiation chambers.

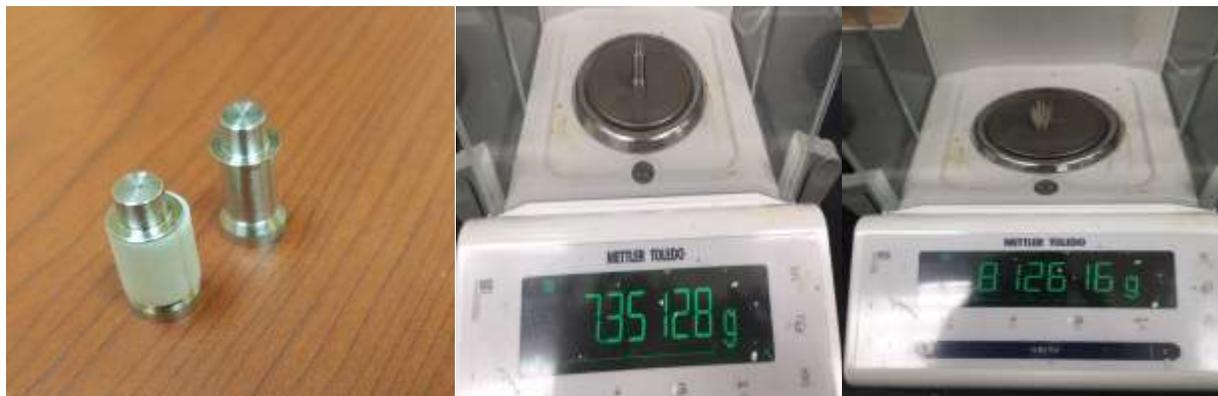
Figure 84. a) SRNL coupon b) coupon weight (without sleeve) and c) with sleeve.

Collaboration with SRNL scientists during the previous year led to the initial testing of SRNL coupons for erosion in pipe sections. The process included use of small coupons of steel (Figure 84

Figure 84) made of the same material as used in pipelines across DOE nuclear waste sites. The intention was to measure the changes in thickness using UT sensors and to measure the mass loss on a minute level to detect and quantify pipeline wear. By measuring the minute erosion of the coupon, the life expectancy of sections of pipelines in the field may be calculated. The coupon is inserted into a coupling welded to the pipe surface and the head of the coupon is made flush with the inside of the pipe. By being subjected to the same abrasive forces as the pipe walls, the coupon represents a fully observable model of the pipe section. The advantage of the coupon is that it is easily removable. Mass measurements of the coupon before and after testing were taken to provide insights into the degradation of that particular pipeline, or a pipeline made of similar material.

To quantify the erosion taking place in the pipe, the coupons were weighed and measured using a balance (Figure 84) and caliper before being inserted. The surface of the coupon head was also viewed under a microscope and photographed for later comparison after erosion had occurred. During the test, measurements were taken in situ using an Olympus V260-SM UT pencil sensor [18] that was modified to fit specifically in the provided channel within the coupon. Thickness measurements were collected every 30 minutes from both a handheld UT pencil sensor and the permanently mounted UT sensors on the loop. After testing, the coupons were removed from the pipe loop and measurements were taken again in order to quantify mass and height loss, and validate the measurements taken by the pencil sensor.

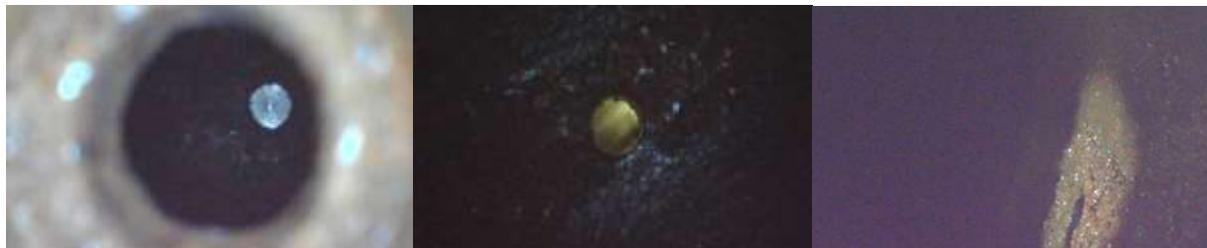
Figure 85. Borescope images of the coupons in the pipe loop.

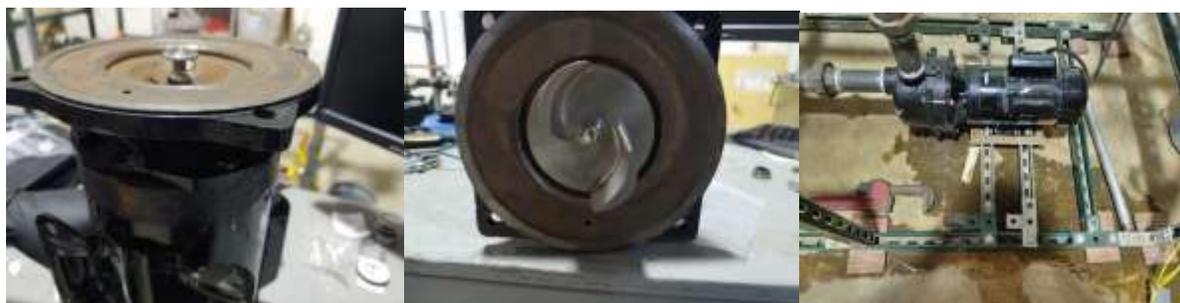
Figure 86. a) Pump assembly stages (left and center) and b) assembled pump - leakage after testing (right).

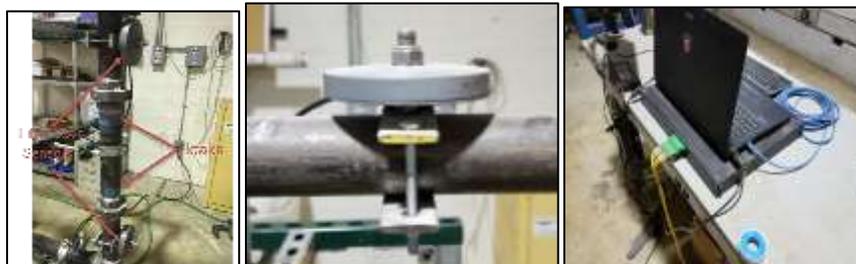
Figure 88. a) Fiber optic sensors on the loop; b) single transducer (LCM-500); c) LCM-2500 Interrogator and user control station.

The FIU loop previously described was used to install the fiber optic sensors as shown in Figure 88. In this set up, both straight and 90° elbow sections were used and joined by a reducer. The pipe sections were welded and the sensors were installed per the manufacturer's instructions. A threaded boss is attached to the exterior of the pipe. Typically, it is physically attached to the pipe by clamping it with an industrial rated strap or clamp. The transducer shown in Figure 88b is attached to the threaded boss using a supplied nut and washer.

Figure 88b shows the installation of one of the three LCM-500 acoustic transducers mounted on a 2 in. section of pipe. Once installed, each sensor must have their pigtail fiber cables fusion-spliced into the fiber optic backbone cable that travels the length of the pipeline to the interrogator. Figure 88c shows the monitoring station placed several feet away from the scale pipeline with a laptop sitting on top of the LCM-2500 interrogator.

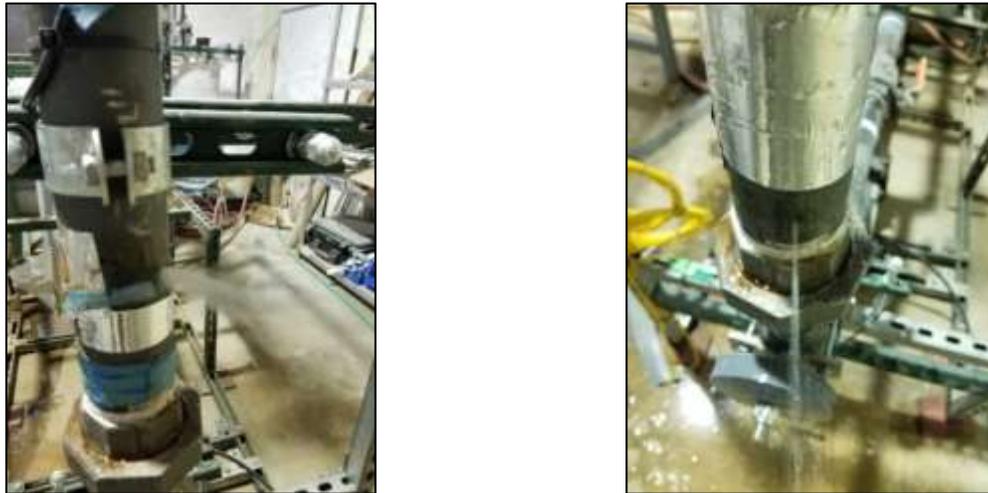
Figure 89. Leaks in the pipe loop a) ¼ inch hole b) 1/8 inch hole

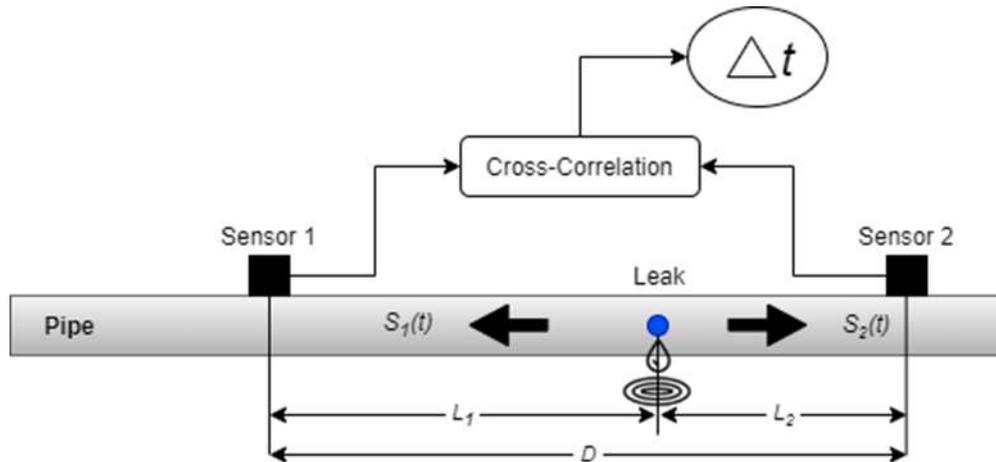
Figure 92. Pipe leak location detection using cross correlation.

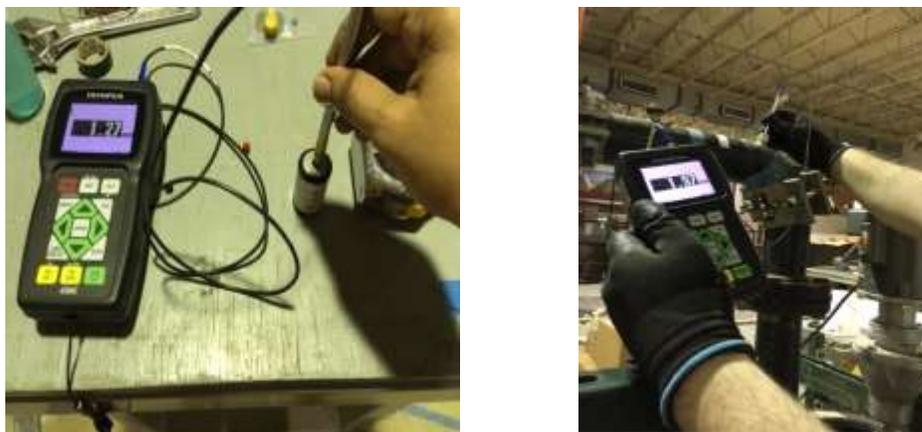
Figure 93. a) UT sensor (V260 SM) calibration and b) real-time coupon thickness measurement.

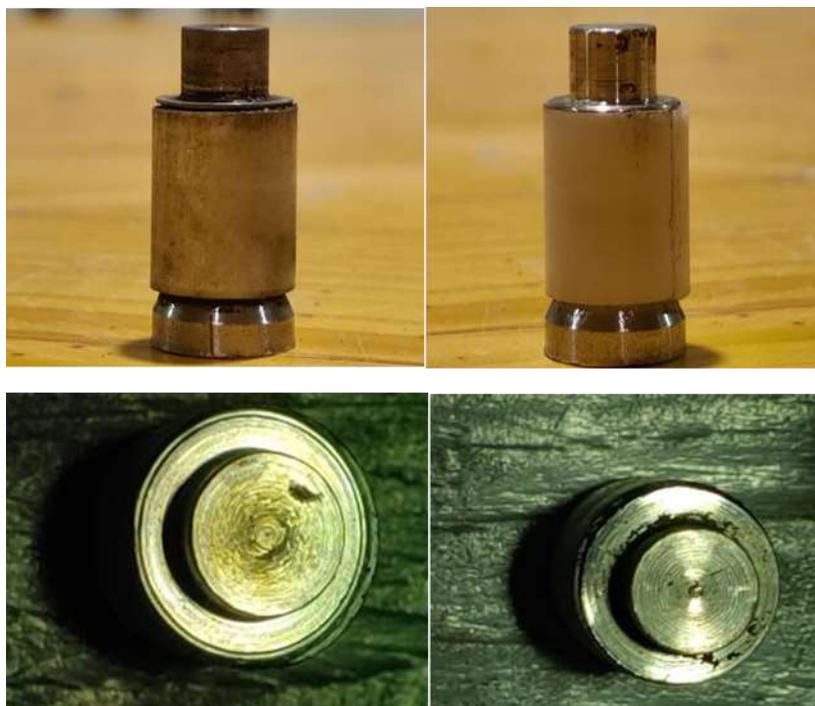
Figure 94. Eroded Coupon surfaces removed from the elbow and bottom sections of the pipe.

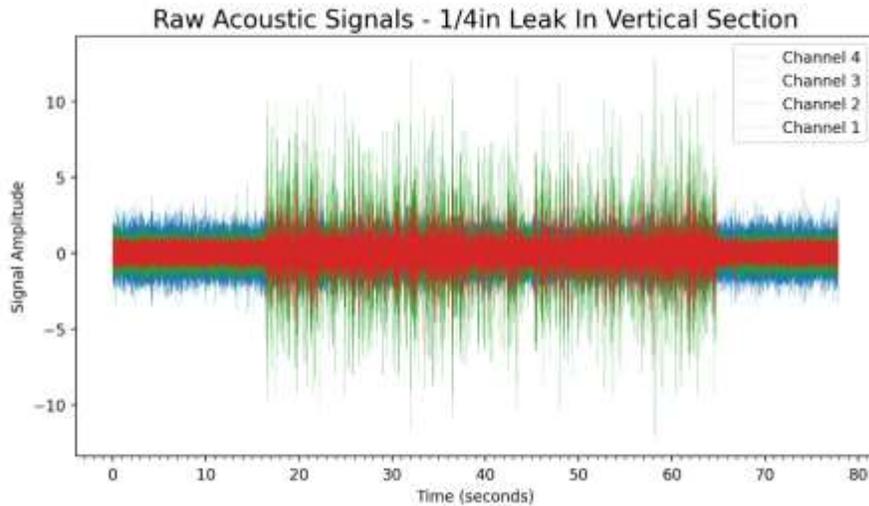
Figure 98. Raw acoustic data from all sensors during 1/4” hole leak.

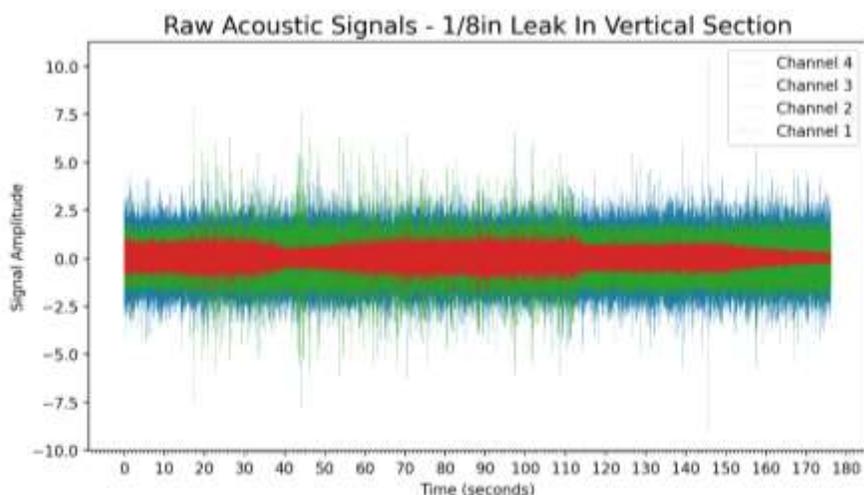
Figure 99. Raw acoustic data from all sensors during 1/8” hole leak.

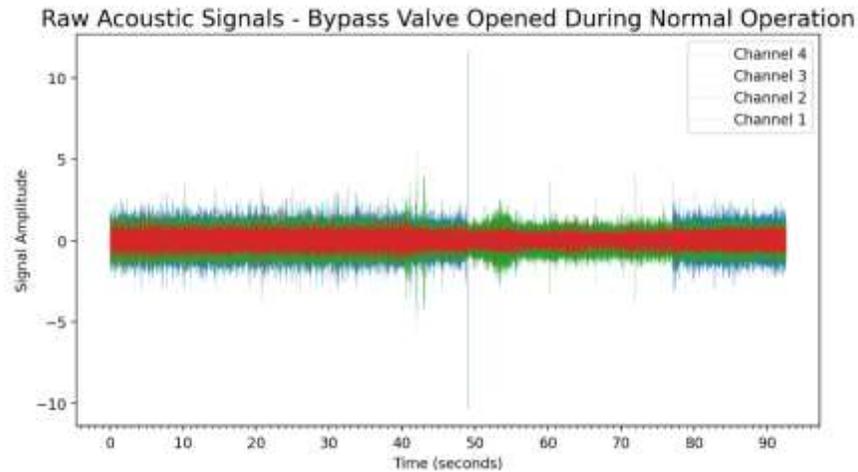
Figure 100. Raw acoustic data from all sensors during bypass valve opening and closing.

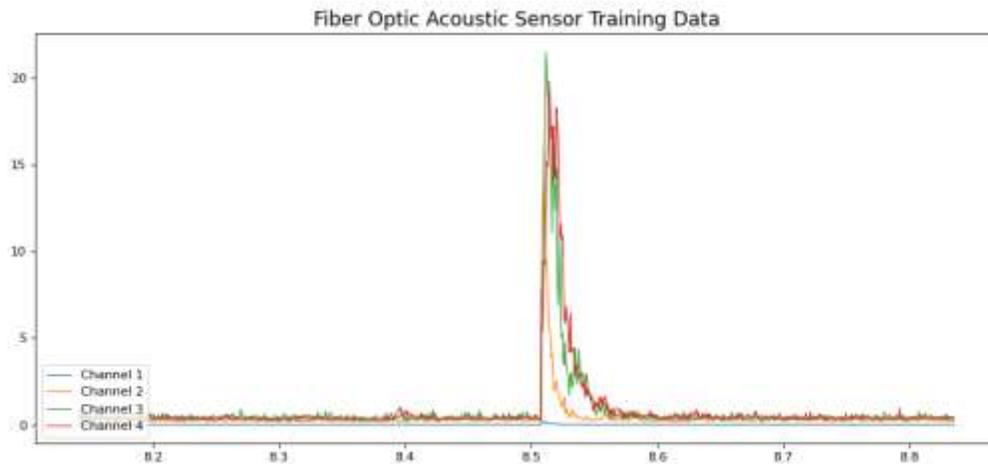
Figure 101. Raw acoustic data from all sensors during hammer strike.

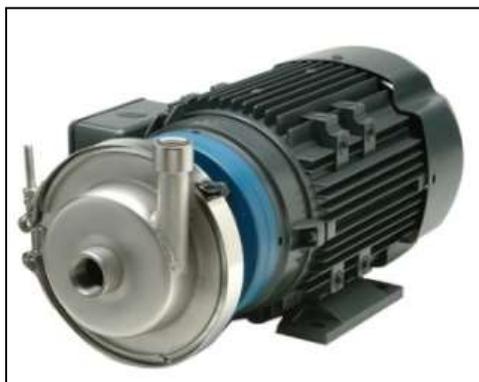
Figure 103. Finish Thompson AC4 stainless steel pump.

During the previous phase of testing, magnetic-drive centrifugal pumps were used that had a chemical resistant plastic body. The plastic body did not withstand the synergetic effects of NaOH at high temperature. This resulted in numerous pump failures during the aging phase. During this phase of testing, FIU decided not to use the same type of pumps and wanted to use a stainless-steel magnetic-drive pump, however it was cost prohibitive. A Finish Thompson AC4 stainless steel pump with a mechanical seal (Figure 103) was then selected for the next phase of testing.

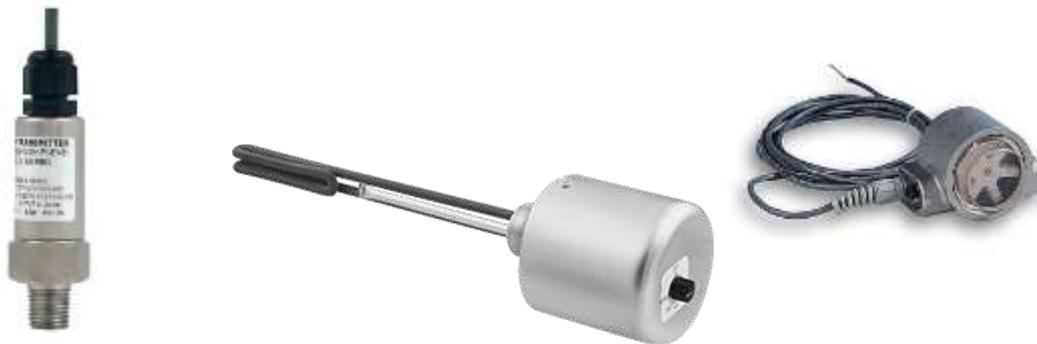
Figure 104. Dwyer pressure transducer, thermostatically controlled immersion heater and flow meter.

Some of the instrumentation elements included a Dwyer model 628CR-08-GH-P1-E1-S1-NIST pressure transducer, which has been proven to withstand the anticipated harsh conditions. In order to maintain the solution temperature at 170°F, a thermostatically controlled immersion heater is installed in each tank. A 1500-watt 120-volt immersion heater with an Incoloy heating element was chosen for the testing. To measure and record the solution flow rate, a model FPR207-PC from Omega Engineering was selected. It has a stainless-steel body that can withstand temperatures up to 225°F with an accuracy of ± 1 GPM.

The solution temperature is monitored via a thermocouple. Thermocouple model number KQIN-18U-12 from Omega Engineering was selected for the testing. It is a K type thermocouple with an Inconel® 600 sheath. Finally, a 30-gallon 304 stainless-steel drum was selected as the storage tank in order to withstand the hot caustic solution.

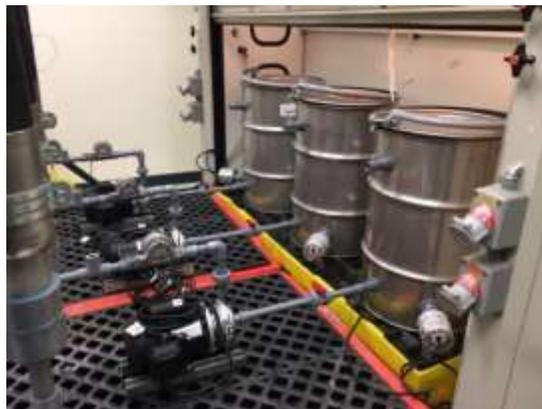
Figure 105. Three of the system's four pumps and tanks with heaters installed.

After receipt of all the components, loop fabrication commenced. Figure 105 shows three of the system's four pumps and tanks with the heaters installed.

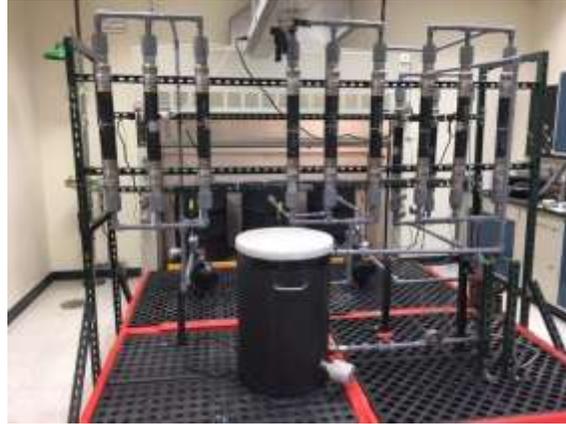
Figure 106. The four ageing loops, three in the front and one in right rear.

Figure 106 shows the four test loops. Each loop is fabricated from schedule 80 CPVC pipe and contains a set of three hose specimens. There are three sets in the front and one in the right rear. The tank in the front is for the water-only ageing loop. Figure 107 shows the three tanks that will contain the sodium hydroxide solution which are located in the fume hood.

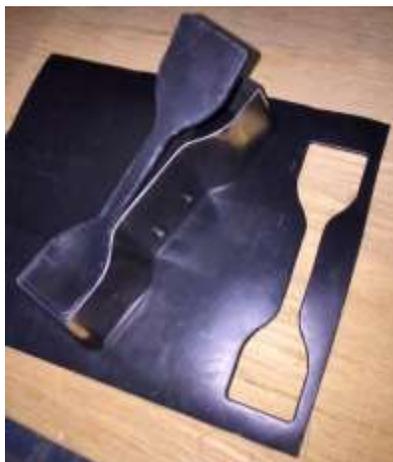
Figure 108. Dog bone cut from a sheet of EPDM.

In addition to the HIHTL coupons, a total of 24 dog bone specimens were cut out of a sheet of EPDM material (Figure 108). Six specimens were placed in each of the four ageing vessels (Figure 109). An ageing vessel was placed in each loop's storage tank and aged for the same one-year duration as the hose specimens in the same fluid used to age the hose specimens.

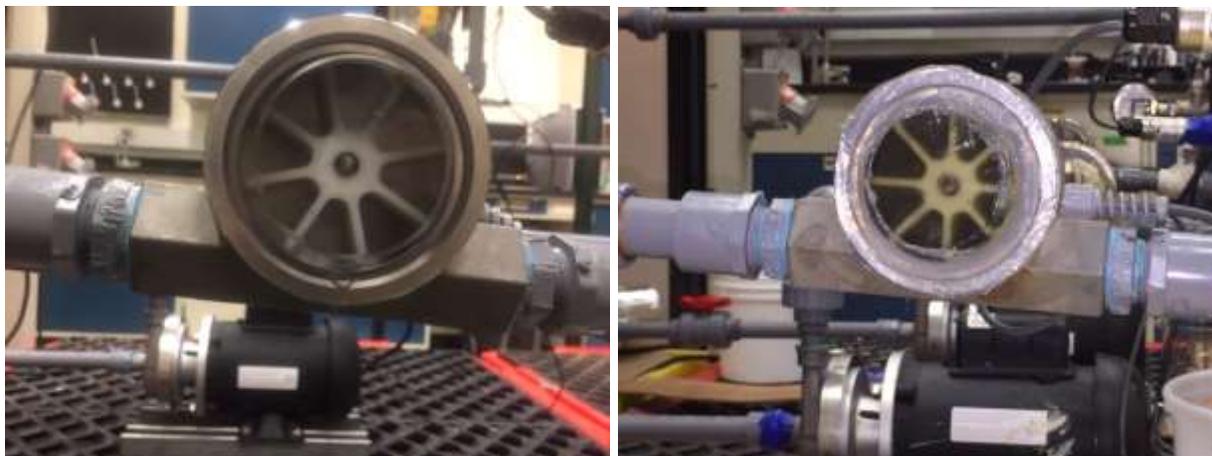
Figure 111. Leaking flowmeter (left), repaired flow meter with silicone sealant.

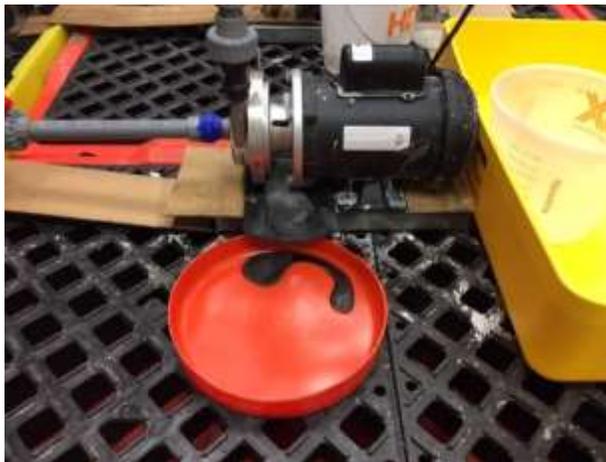
Figure 113. Pump leaking from seal.

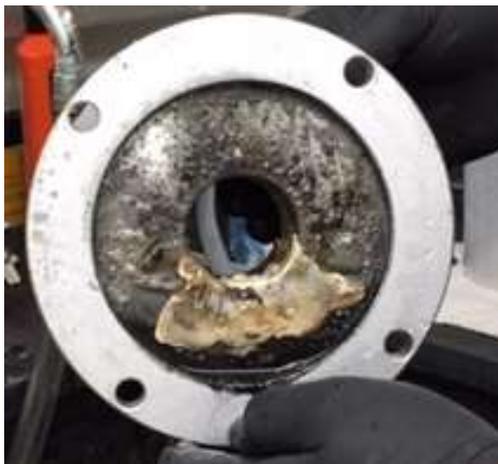
Figure 114. Pump #2 backplate showing leakage from mechanical seal location (Seal removed).

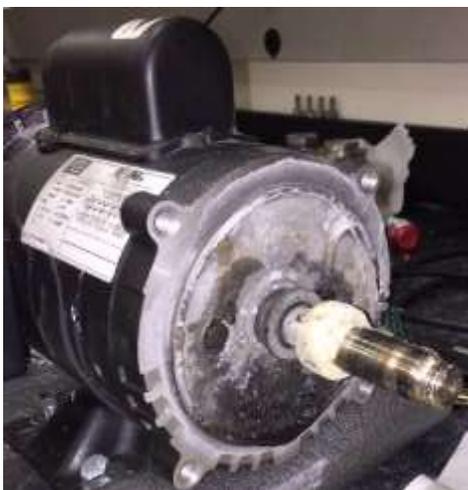
Figure 115. Pump #2 motor.

FIU repaired the remaining two pumps with the failed mechanical seals. The remaining pumps included pump #1 and pump #2 that circulate 25% and 12.5% NaOH solutions, respectively. Figure 114 shows the backplate of pump #2 where crystalized NaOH can be seen from the location where the mechanical seal resides and where the pump mates up to the motor. In Figure 115, the motor of pump #2 can be seen with its faceplate covered with the crystalized NaOH residue.

After cleaning the motor, it was observed the NaOH solution had eroded the face of the motor and entered into the motor winding (Figure 116). The motor was bench tested and determined that it was damaged beyond repair. A new motor was ordered to replace the damaged one.

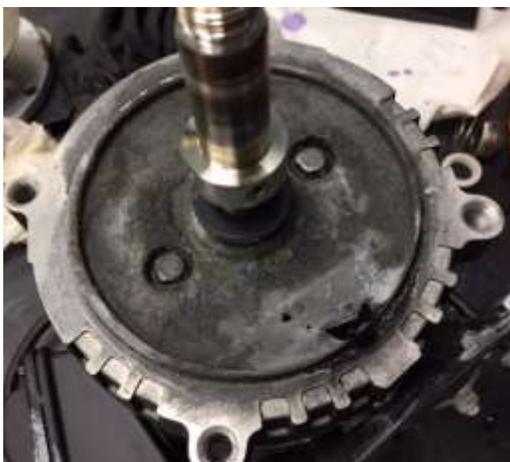
Figure 116. Motor face with eroded hole.

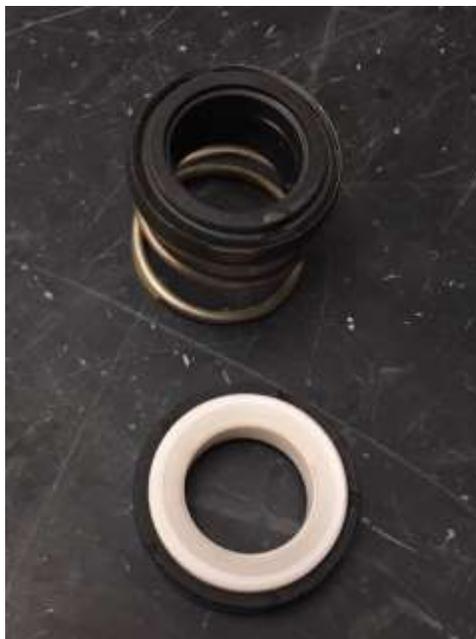
Figure 117. Mechanical seal from pump #2.
