FIU
Applied Research
Center

FIU PROJECT 1

CHEMICAL PROCESS ALTERNATIVES FOR RADIOACTIVE WASTE

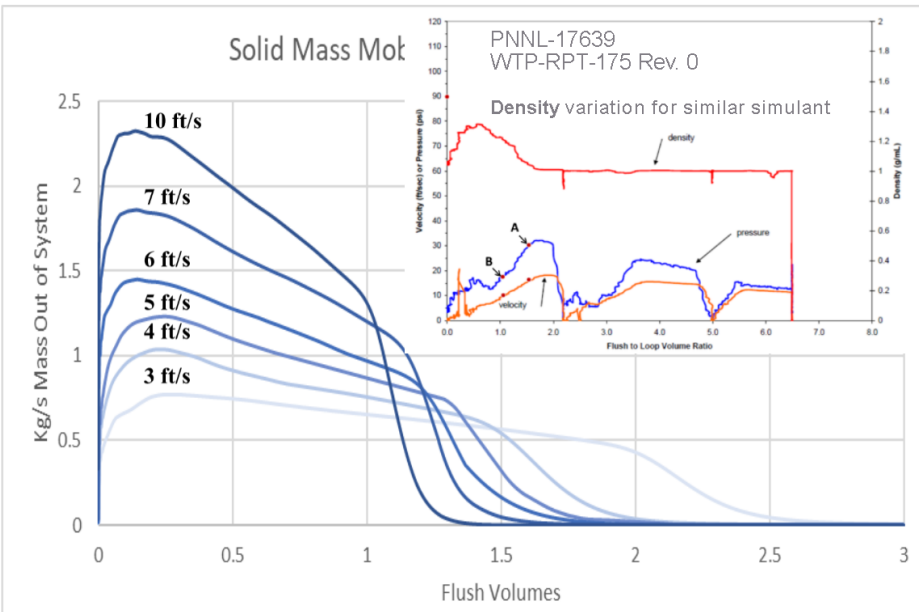
- TFM multiphase, k- ω turbulence, various V_{in} (3 to 10 ft/s), a typical fixed-length pipe line, monitoring of \dot{m}_{solid} at exit, stop at zero \dot{m}_{solid} , and measure/compare the used water volumes.
- A linear correlation between V_{in} and flush-to-line-volume (FTLV) was found ($FTLV_{min}=1.5$ @ 10 ft/s)

Contour of solid volume fraction

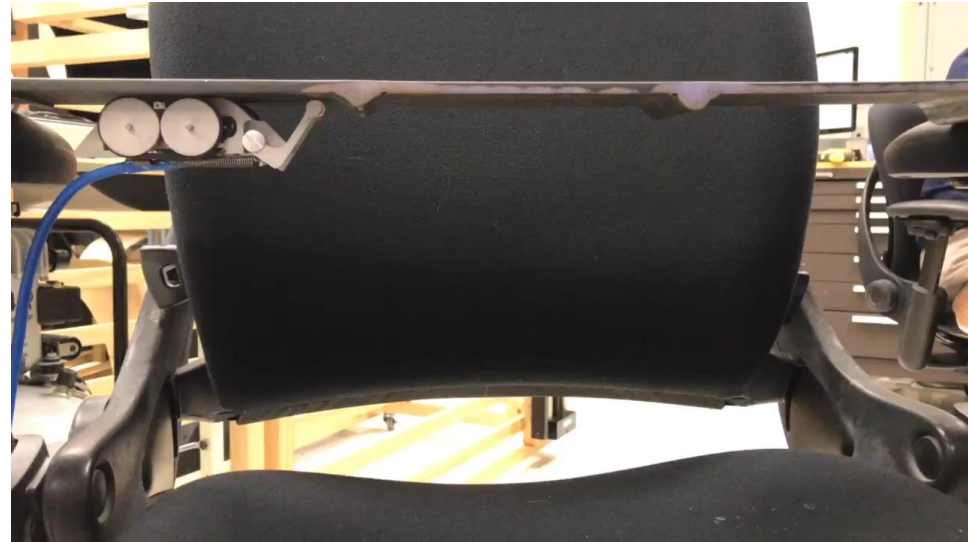
Magnetic Arm Design

- Traverses up to $\frac{3}{8}$ th of an inch weld seam

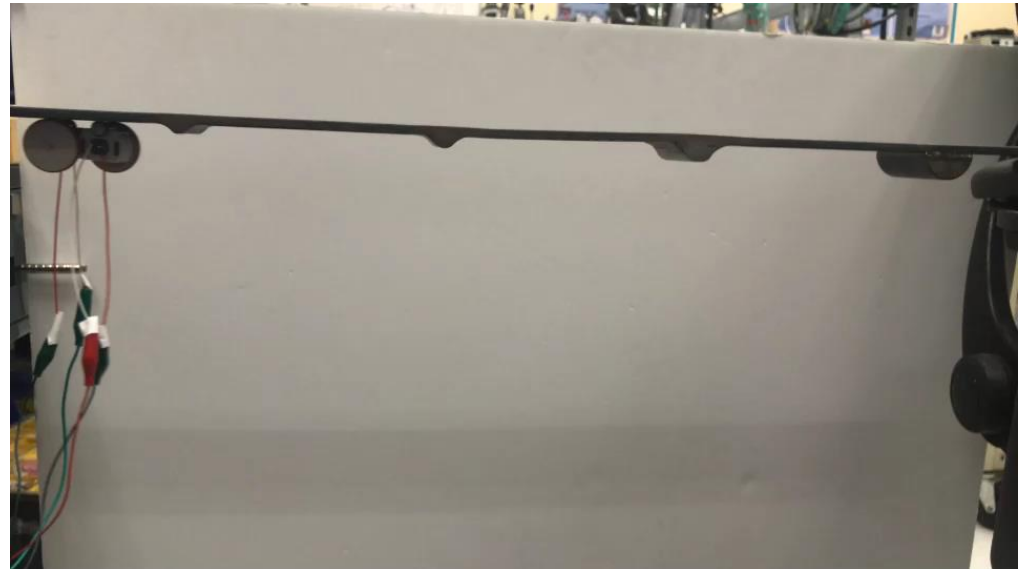
Caterpillar Design

- Traverses up to one inch weld seam
- Initially designed for 90 degree turn

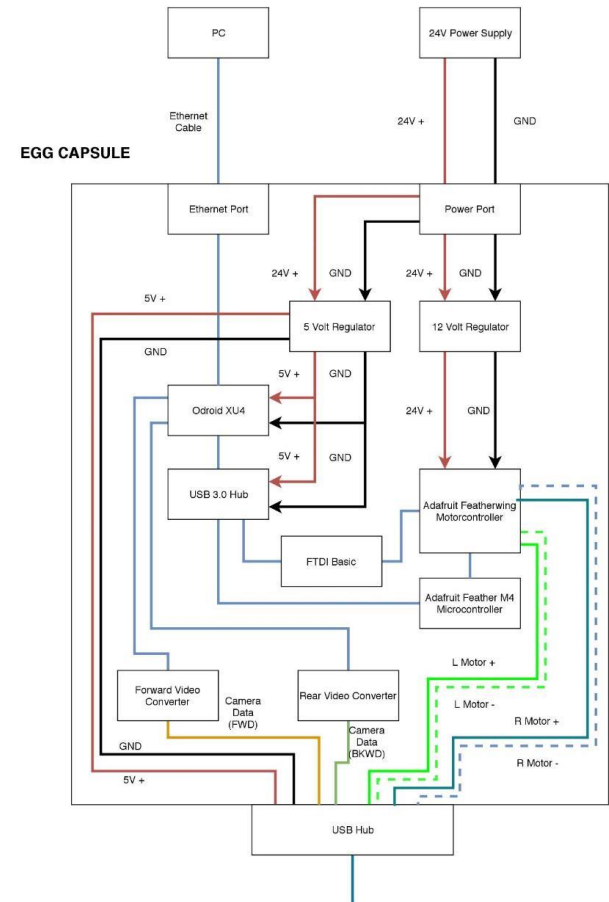
Controller Design

To address the problems of significant voltage drop and video signal transmission over long cable lengths, a control capsule was designed that will stay within the tank annulus.

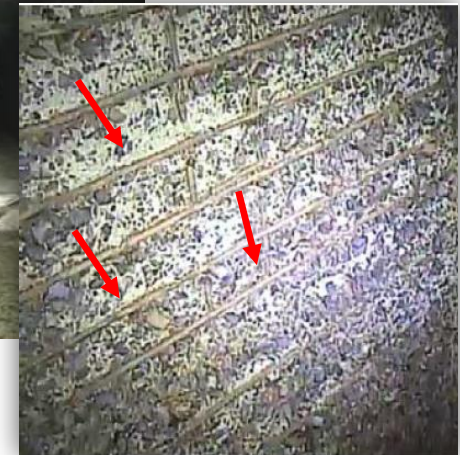
Degraded concrete exposing the steel rebar (red arrows).¹

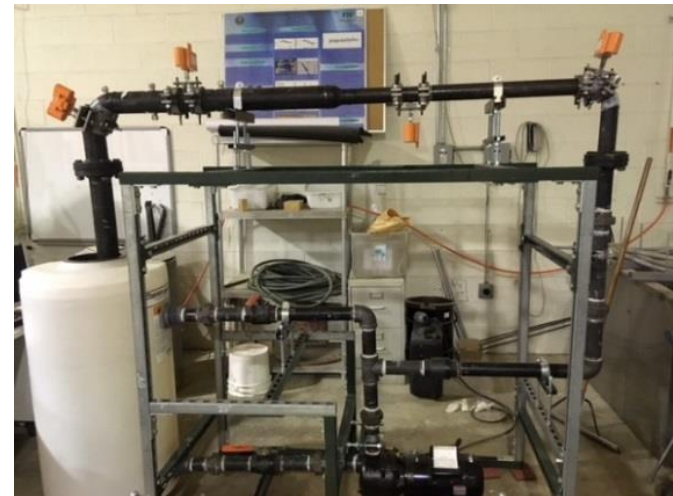
Engineering scale testing

- 4 Permasense guided wave sensors
- 2 and 3 inch pipe sections (straight sections and elbows)
- Sand/water mixture
- 3 HP centrifugal pump - up to 2.5m/s and 110 gpm
- Sand particle sizes - 400 to 1600 microns
- By-pass system to control flow rates

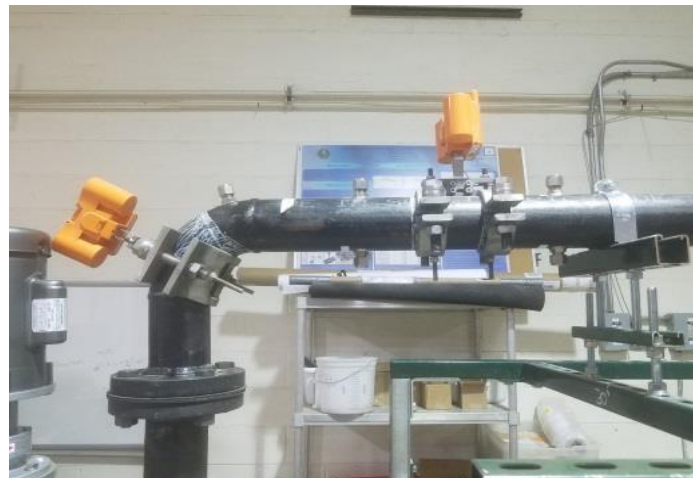
Coupons on the pipe loop

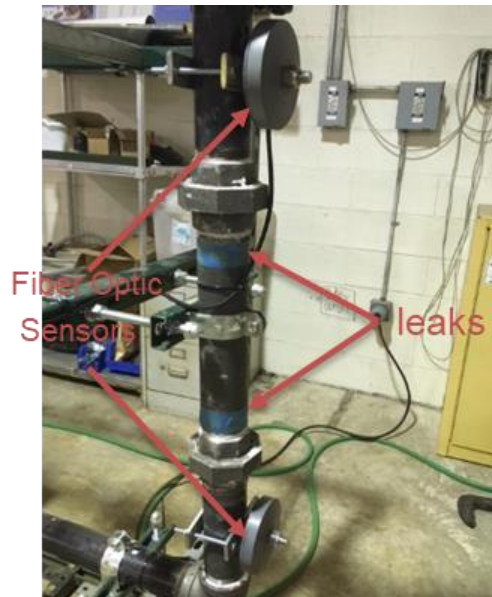
Fiber optic sensors

installed on the pipe loop

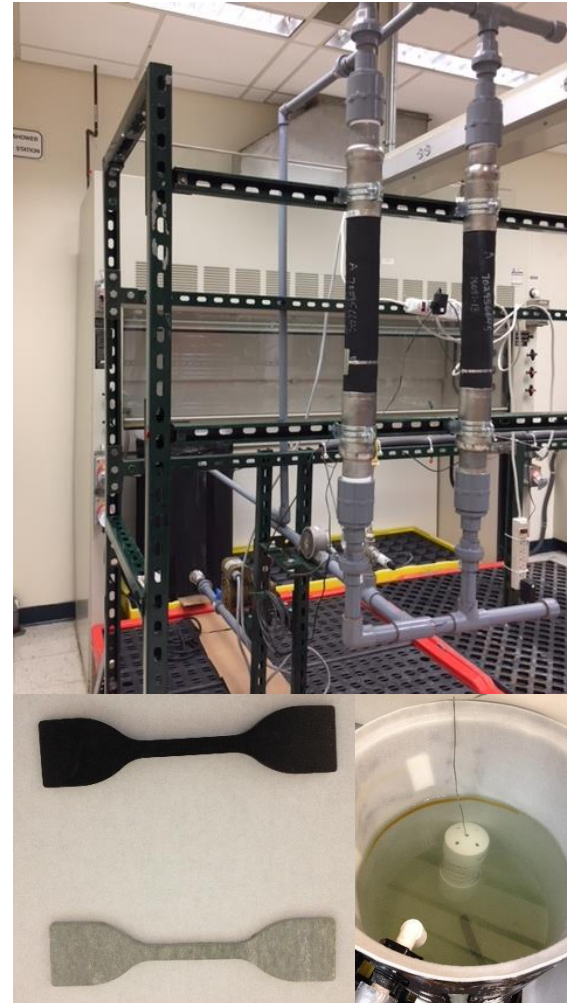
Water Only Aging Loop

- In order to determine the effect of the NaOH on the material degradation, the experiments were repeated with only water.
- The setup consisted of a pumping loop with two hose sections. Water at 170°F was circulated through the loop.
- The coupon aging consisted of a coupon aging vessel submerged in the test loop's storage tank.
- Each vessel contained three EPDM and three Garlock® Dog bone samples.
