FIU
Applied Research
Center

FIU PROJECT 1: CHEMICAL PROCESS ALTERNATIVES FOR RADIOACTIVE WASTE

FLORIDA INTERNATIONAL UNIVERSITY

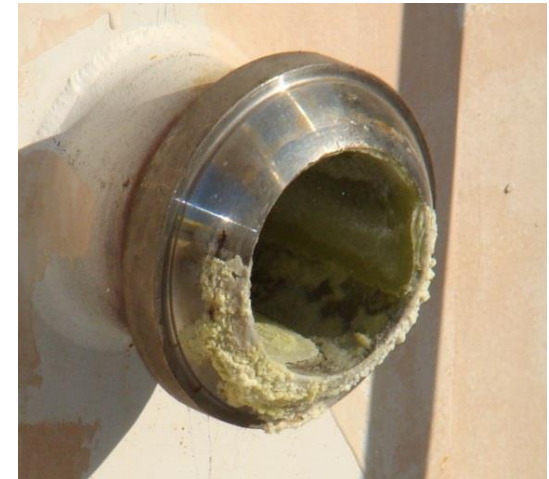
Supernatant Dried on Nozzle
18 in AP Valve Pit.

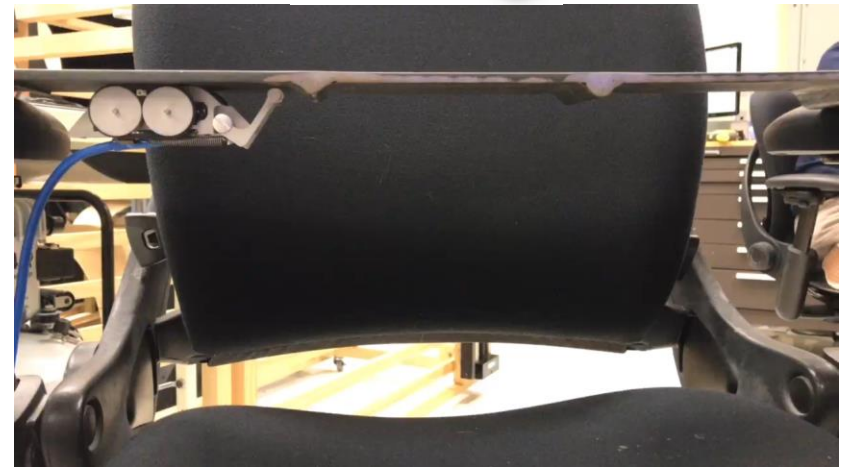
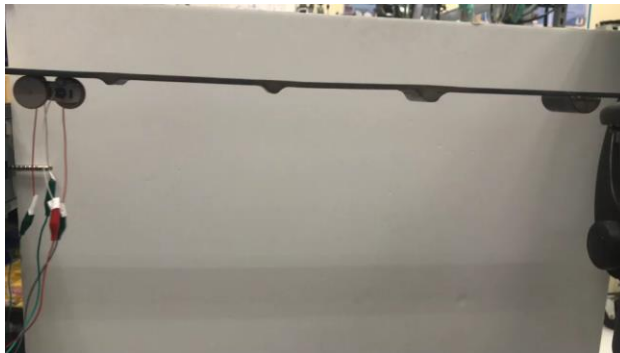
- Added a magnetic arm to be able to navigate over large weld seams.
- Began developing a caterpillar crawler to navigate around 90 degree turns.
- Developed control capsule to address voltage drop and video signal transmission over long cable lengths.
- Investigated and developed electronic boards, to move electronics onto unit and improve signal options.
- Conducted analysis of UT systems for testing and integration.

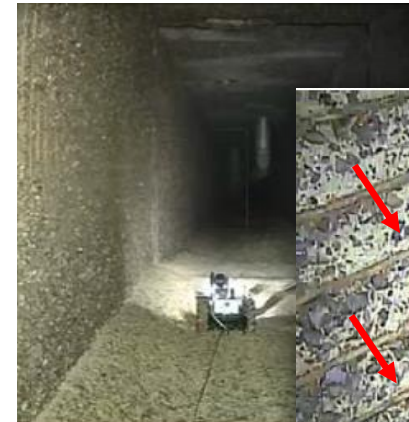
Tunnel view

Visual inspections of the H-Canyon exhaust (HCAEX) tunnel showed degradation of the concrete walls. Also, a recent tunnel fragility analysis identified safety issues of the affected concrete regarding their strength [1].

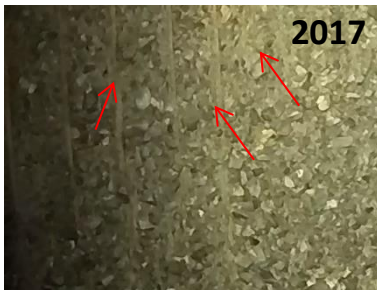
Coarse aggregates and steel rebar exposed (arrows)

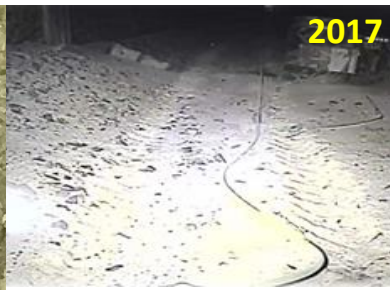
Accumulation of concrete products (e.g. CaCO_3)

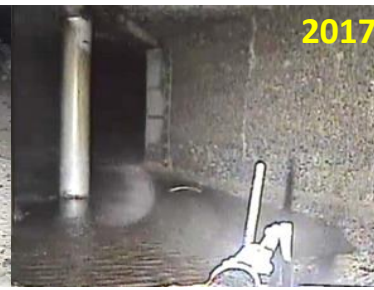
Water accumulation

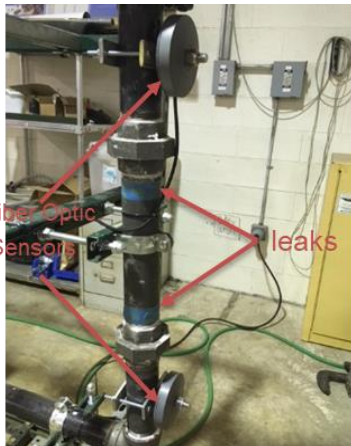
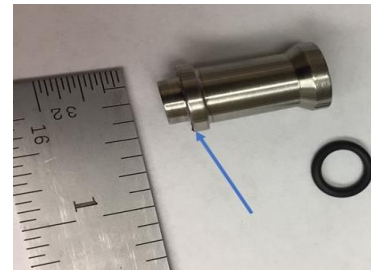
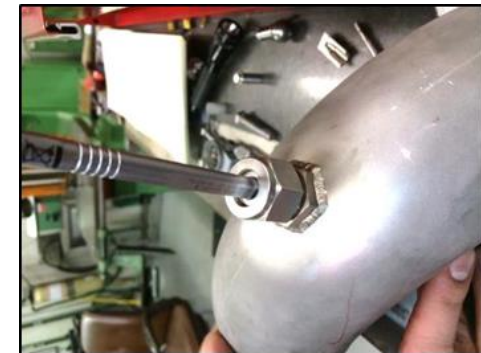
- Completed engineering scale testing and demonstrated the capability of the Permasense sensors.
- Constructed an environmental chamber and tested the sensors at elevated temperature and humidity.
- Continued to evaluate the SRNL erosion coupons and evaluated surface contours via SEM.
- Installed fiber optic/electroacoustic sensors from Cleveland Electric Laboratories to identify pipeline leaks or cracks.
