YEAR END TECHNICAL REPORT

September 29, 2017 to September 28, 2018

Chemical Process Alternatives for Radioactive Waste

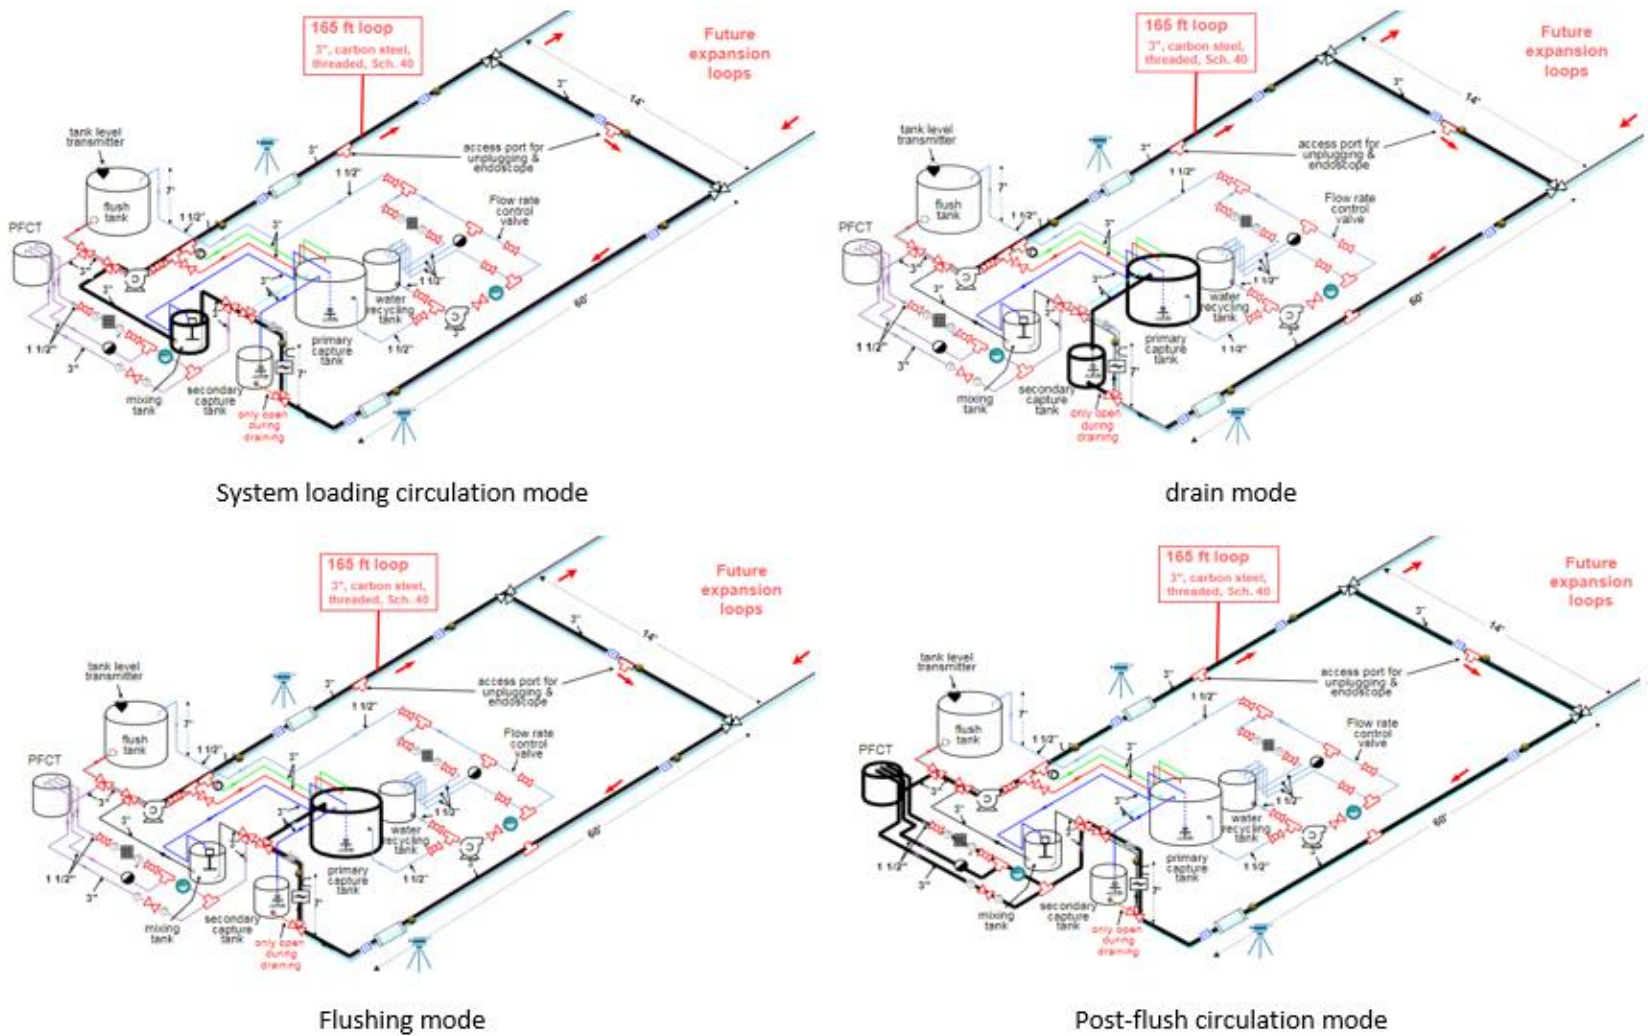
Figure 2. Different modes of the test loop operation.

An experimental loop with the capability of operating in different operational modes has been designed (Figure 1). Operational modes include slurry circulation (to load the system), draining, flushing, and post-flush circulation and are shown in Figure 2. A detailed schematic design of the pipe loop is shown in Figure 3 and the different initial conditions considered (gravity drained versus fully flooded systems) are shown in Figure 4.

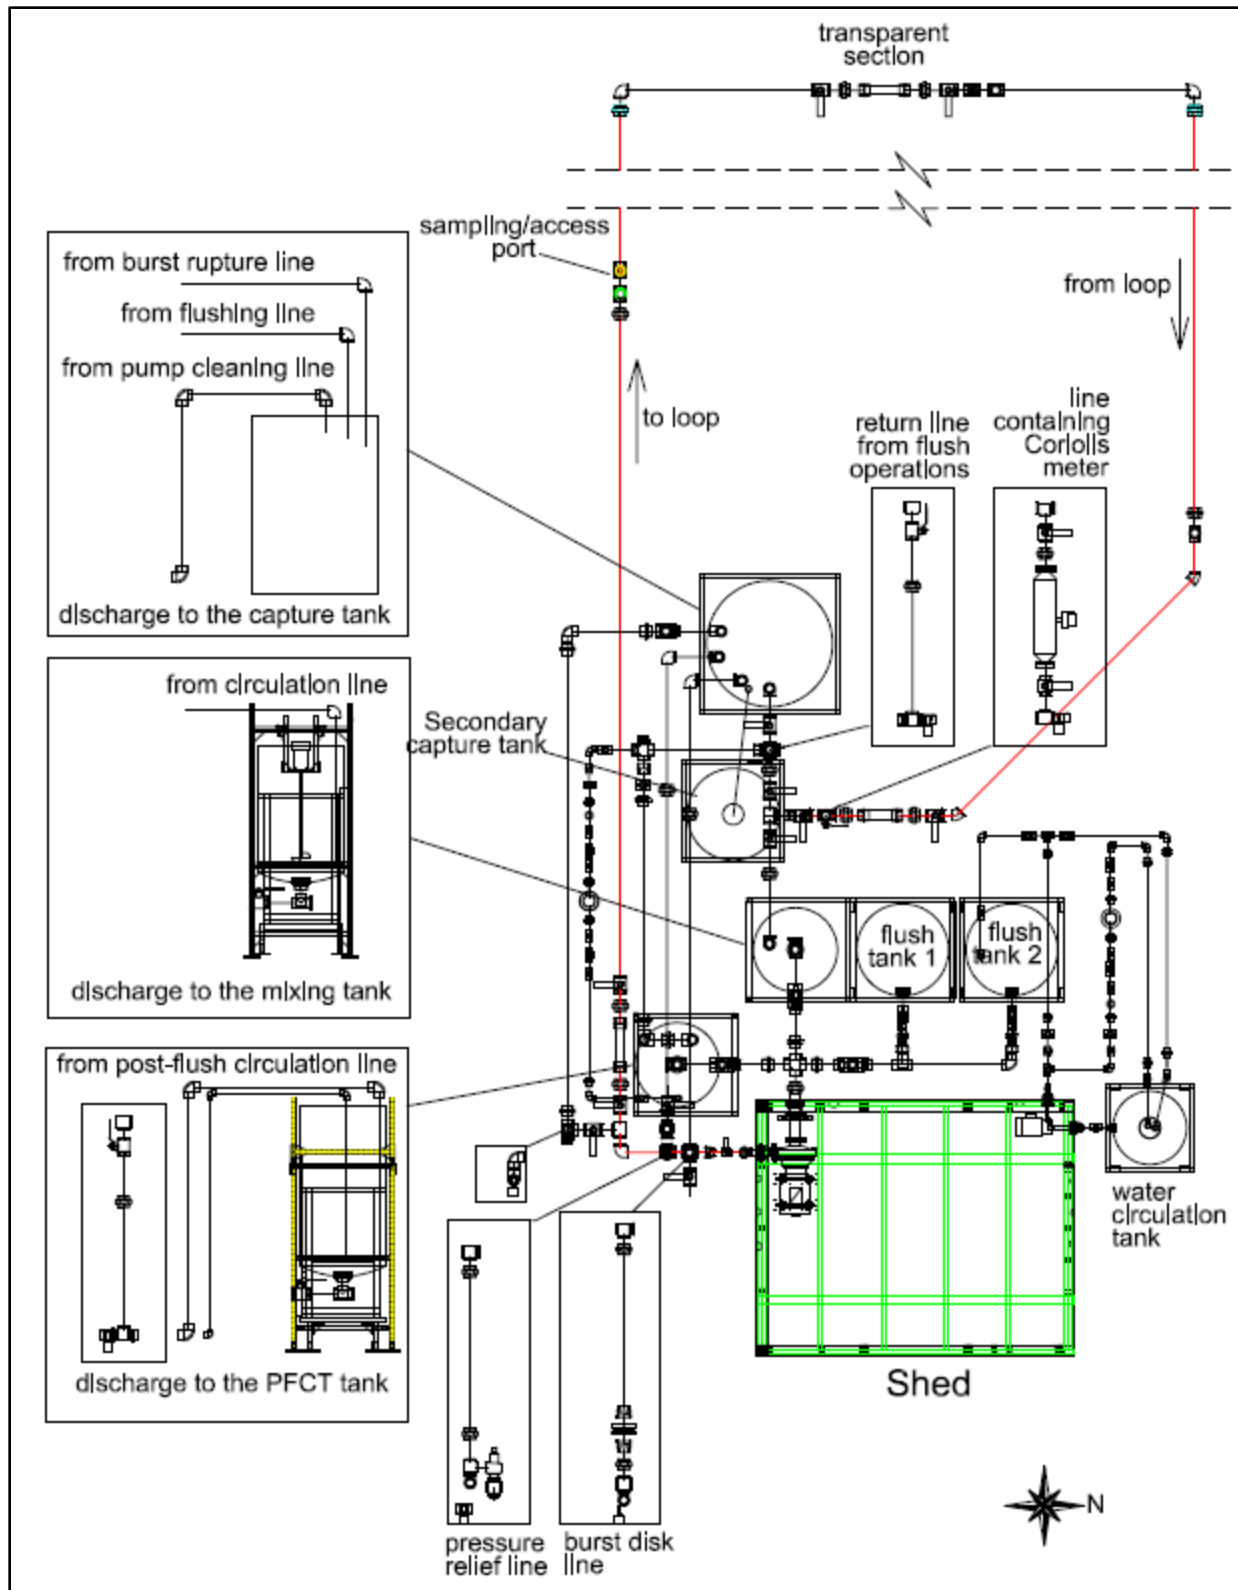
Figure 3. Schematic design of the flushing test loop.

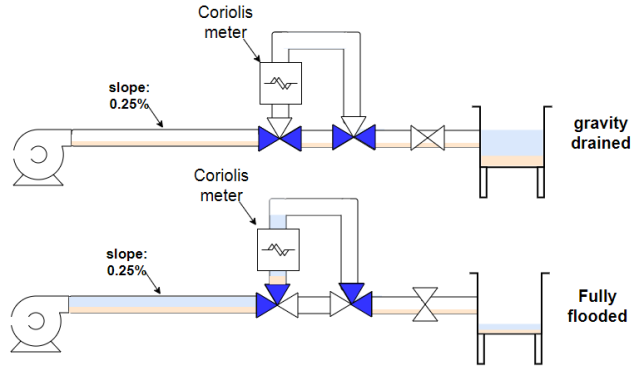
Figure 4. Two initial condition modes for the flushing studies.

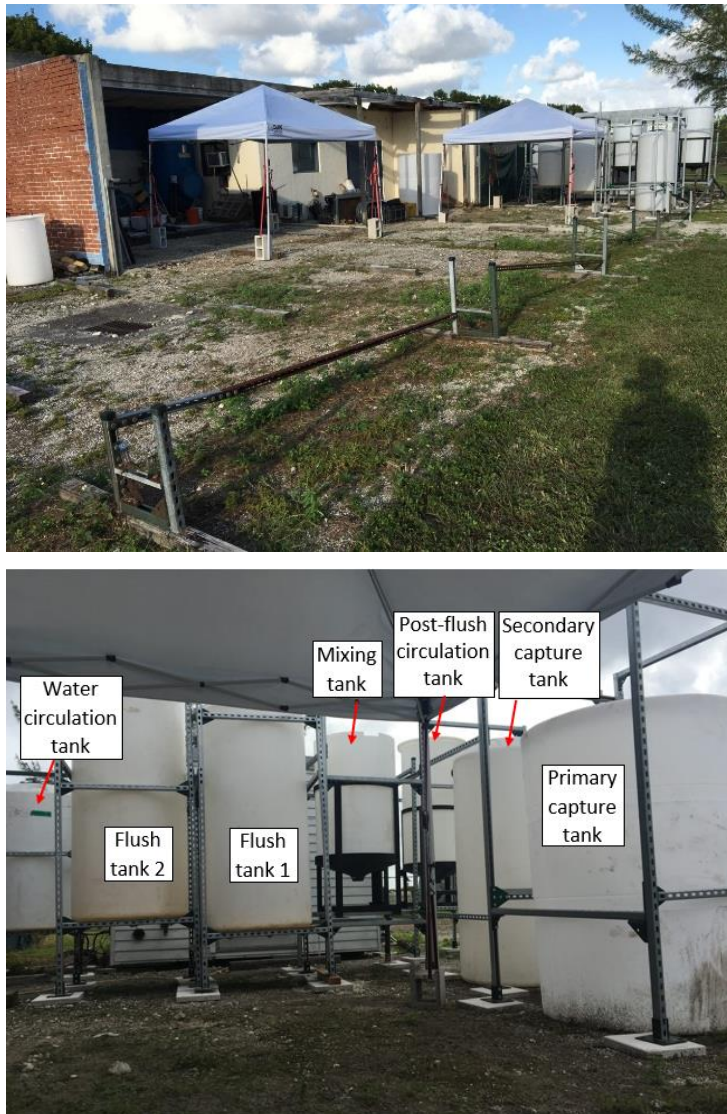
This loop is currently under construction at FIU as shown in Figure 5. This figure shows several posts and tank frames constructed for support of elevated tanks and pipelines.

Figure 5. Construction of the flushing test loop.

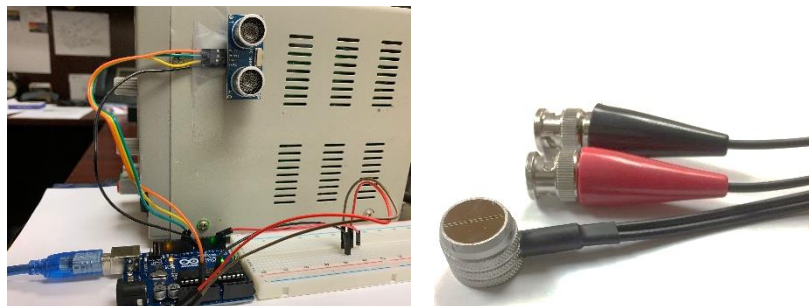
Figure 11. Ultrasonic transducers for tank level (left) and sediment thickness measurement (right).

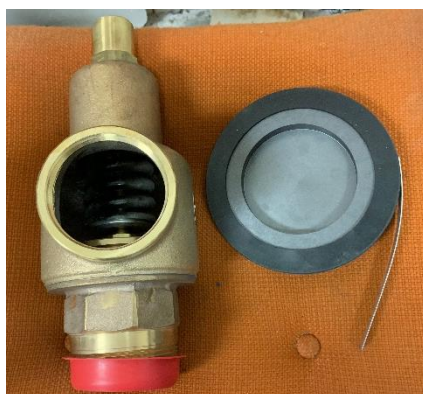
The loop will be equipped with safety components to protect the system elements, particularly the slurry pump. Figure 12 shows the pressure relief valve and burst disk which were purchased to avoid over pressurization of the lines and to provide quick venting. The relief valve (Aquatrol Inc., Series 69) was selected for its ability to vent 230 gpm at a set pressure of 85 psig (set pressure is adjustable from 76 to 110 psi, corresponding to 214 to 259 gpm). Selection of the 4-inch burst disk (Graphilor, Series 3) was based on its 180 gpm capacity at the burst pressure of 100 psig.

Figure 12. Pressure relief valves (left) and burst disk (right).

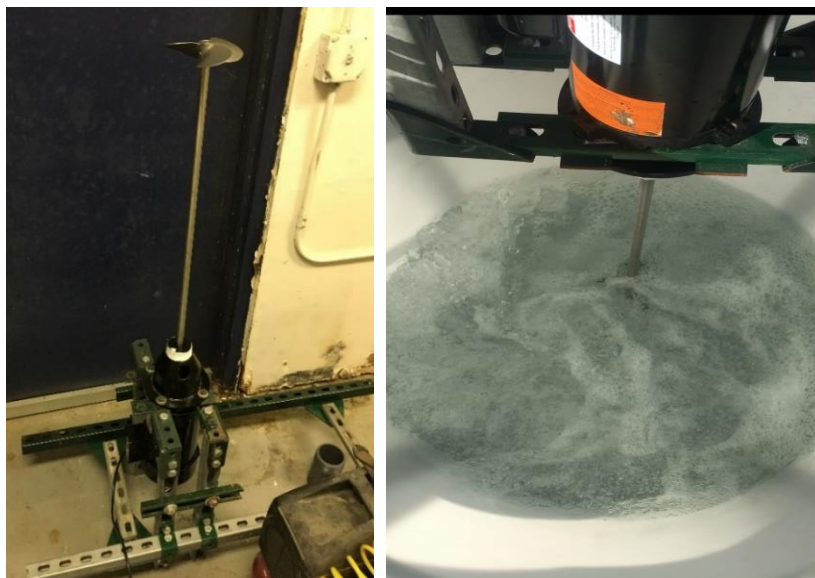
The utilization of an existing 0.5 hp 32V136 Dayton mixer was also demonstrated. This mixer was integrated into an overhead mounting frame (as shown in Figure 13) over a 28-inch diameter cone bottom baffleless tank. This assembly allows for $D/2$ vertical offset (D represents tank diameter) from center of the tank to enhance mixing in the absence of baffles. The original 3.5-inch foldable propeller of this mixer was replaced with a 6-inch right-pitched propeller for upward pumping of material inside the tank. Selection of the propeller was based on the need to achieve sufficient agitation for sediment re-suspension from the tank bottom.

Figure 13. Mixer for the flushing studies.

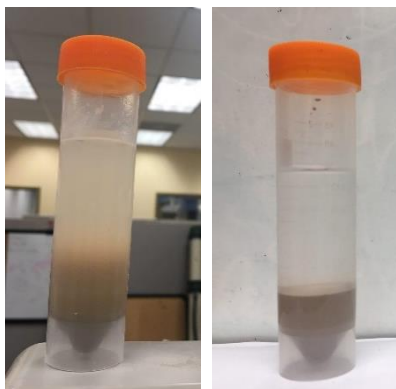
Results of testing a settling suspension of 22% by volume kaolin in water is shown in Figure 14. Testing was conducted to extract information about the upper (dilute) and lower (concentrated) sediment layers after 2 hours of settling time. Calculated concentrations for the upper and lower layers were 3.6 and 30 vol %, respectively. After 48 hours, a completely clear layer was observed above the concentrated layer. At this point, tilting the tube to large angles did not disturb the kaolin layer, showing a strong cohesion (Figure 15). At the horizontal level, particles started to shear off and mix with the water as soon as the edge of air-water interface reached the packed kaolin-water layer. Testing showed that the concentration in this thick layer was as high as 45 vol %.

Figure 14. Kaolin suspension testing - sample after 2 hours (left) and 48 hours (right).

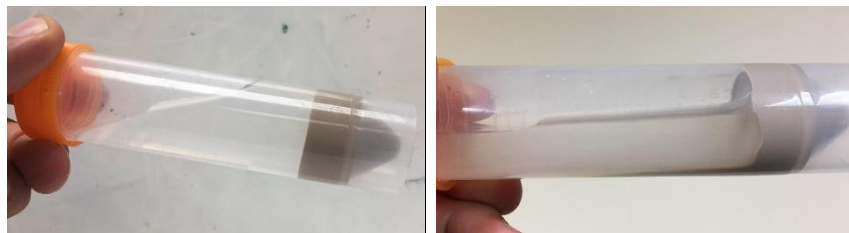
Figure 15. Test of cohesiveness of a fully settled kaolin bed in water.

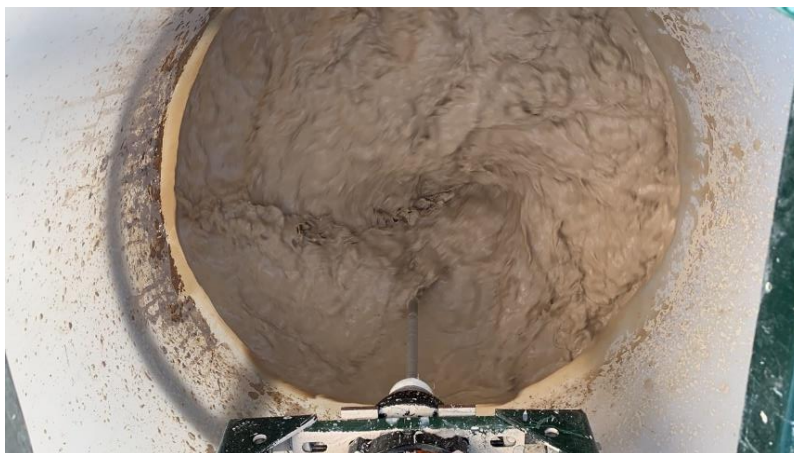
Performance testing of the mixer was conducted by extracting one sample from the top and one sample from the bottom (through a valve) of the mixing tank while the mixer was in operation (Figure 16). The densities of the extracted samples were analyzed (indicative of percent solids) for the tank filled with 30 and 60 gallons of 17 wt% kaolin-water. FIU found no significant differences between the density samples for each tank loading. In addition, results at different loadings were almost identical (less than 1 percent difference), validating the performance of the mixer.

Figure 16. Performance testing of the mixer with 60 gallons of material in the tank.

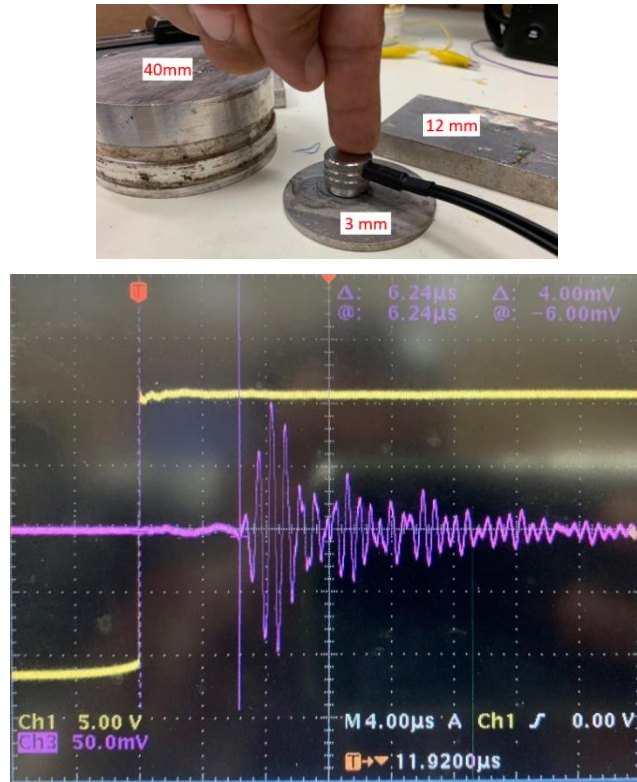
Bench-scale ultrasonic PulseEcho testing was conducted using a dual element 0.5 fingertip NDT transducer with center frequency of 1 MHz and Tektronix oscilloscopes (THS720A and TDS3034). The goal was to measure the time-of-flight of sound waves in the absence and presence of various kaolin-water mixtures. These tests were intended to demonstrate the accuracy of the transducers in measuring the sediment height inside a test spool. Initial testing was conducted for calibration purpose using aluminum pieces of different thickness (3, 12, and 40 mm). Initial results showed that a 6.2 μs time gap existed between the start of the excitation signal and the start of the first echo. This time delay is a typical representative of material thickness by a factor of two, as it shows the time of flight measurement of waves traveling to and back from the end of the material. This time distance was approximately 9.2 μs and 18 μs for the 12 mm and 40 mm pieces, respectively. These results failed to show a proportionality between the time delays and the thickness of the pieces.

Figure 17. Test of PulseEcho Transducer for Thickness Measurement.

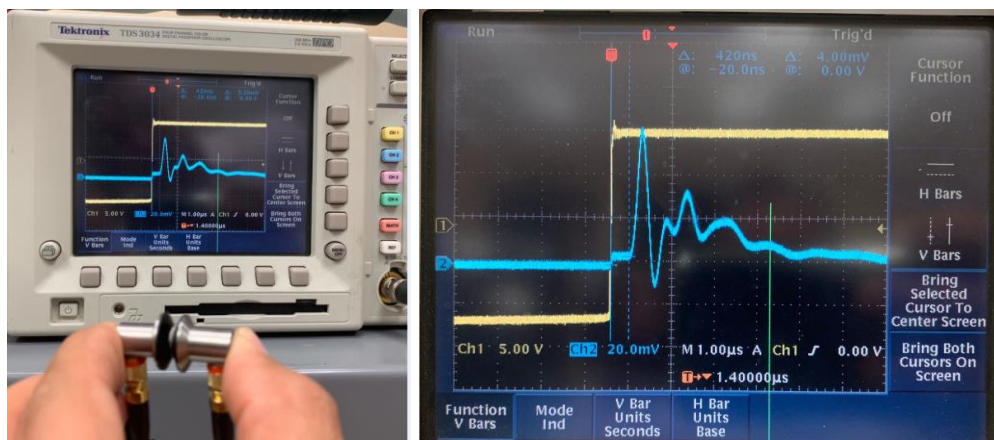
Therefore, FIU tested the time delay of the transducer to respond to the excitation wave (square wave generated by the signal generator) and echoed sound waves. The test was performed to measure how fast the transducer reacted to voltage signals (to create sound waves) and vibrations (to create voltage signal). FIU first tested a pair of fast-response single element Ultran transducers (Figure 18) and found a total of 490 ns time delay. As the transducers were identical, half of the delay time (~0.25 μs) was assumed to be created during reaction to the voltage signal and the same amount during reaction to the sound echoes.

Figure 18. Test of Ultran transducer for response delay measurement.

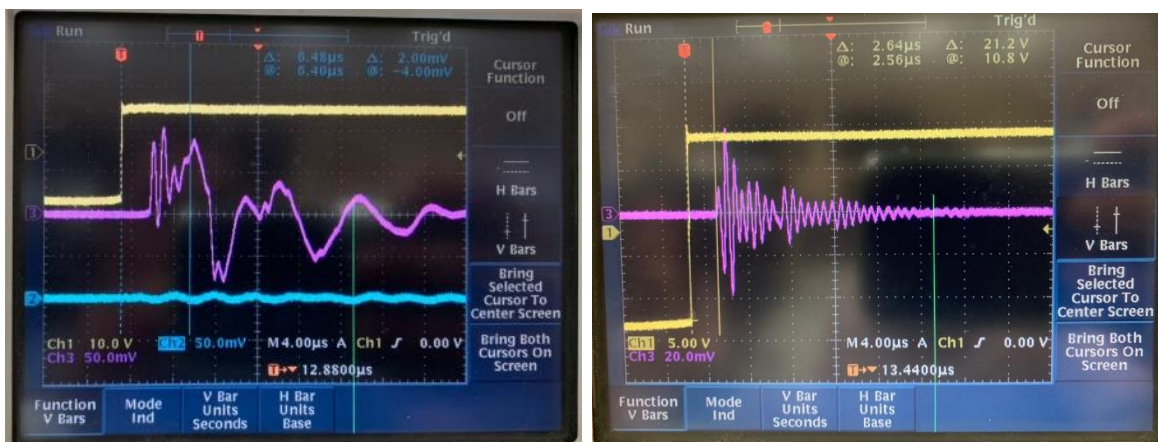
transducer was excited by the signal generator and the Ultrason transducer showed the waveform and time delay generated by NDT transducer (left image in Figure 19). In another test, the Ultrason transducer was excited by the signal generator and the NDT transducer showed the waveform and time delay generated by NDT transducer (right image in Figure 19). In both cases, a delay time of about $2.8 \mu\text{s}$ was observed. By considering a $0.25 \mu\text{s}$ delay time of the Ultrason transducer, a $2.55 \mu\text{s}$ time delay was considered for the NDT transducer in its pulse and received modes. Therefore, time delay values will be modified to 1.14, 4.4, and $12.9 \mu\text{s}$. The updated ratios correlate strongly with the material thickness. Slight deviations can be related to variations in material density between the aluminum pieces ($\rho_{3\text{mm}}=2.85 \text{ gr/cm}^3$, $\rho_{12\text{mm}}=2.66 \text{ gr/cm}^3$, $\rho_{40\text{mm}}=2.67 \text{ gr/cm}^3$).

Figure 19. Test of PulseEcho for thickness measurement.

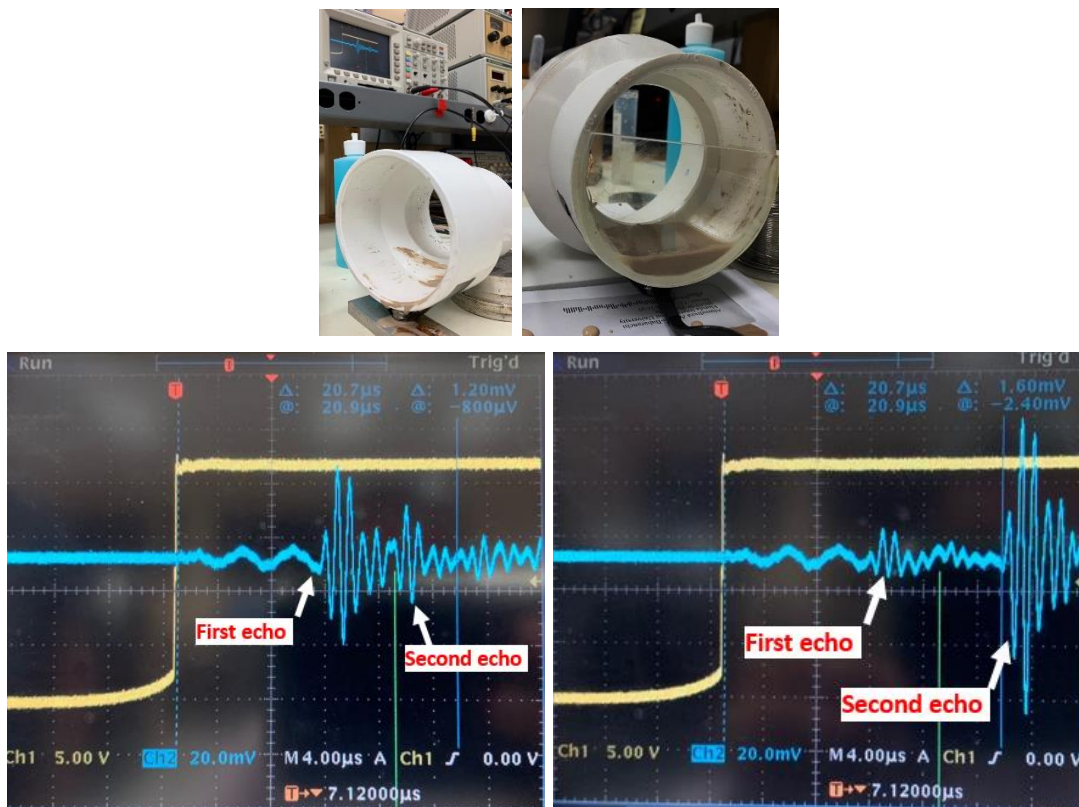
Next, ultrasonic testing was performed to measure sediment thickness, as shown in Figure 20. FIU used PVC pipe (schedule 40) for its stronger acoustic match with the sediment. Tests were conducted with and without the presence of sediment (10 mm layer of uniform kaolin in water with 17 wt % concentration) in the pipe. Blue curves in Figure 20 show the echoes received by the transducer. The time difference between the first and second echoes significantly increased ($7.2 \mu\text{s}$) with the addition of the sediment. This time shift was $4.8 \mu\text{s}$ for a 7-mm thick layer, demonstrating the proportionality between the increase of sediment thickness and the increase of time between the first and second echoes. Thus, this time difference may be used to determine the sediment thickness in fixed concentrations of mixture. Another observation was a significant increase of strength of the second echo with the addition of sediment layers. This effect can be explained by considering the close acoustic match between PVC and sediment (allowing sound energy to mostly transmit through the PVC-sediment interface instead of reflecting) and strong acoustic mismatch between PVC and air (causing a major energy reflection from the PVC-air interface). This finding was in accordance with results published by Lee (2010).

Figure 20. Test of PulseEcho with (right) and without (left) sediment.

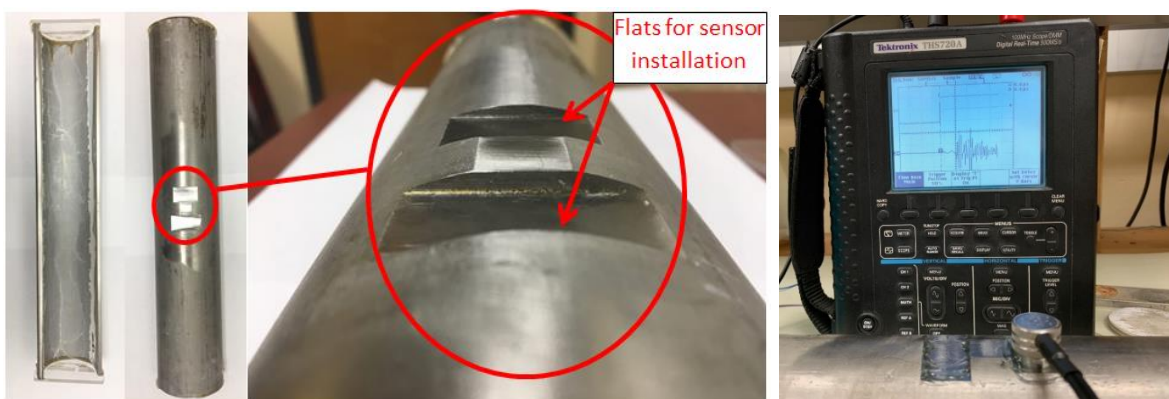
Testing was also performed on a spool piece that was provided to FIU for initial bench-scale testing. This spool was previously used in PNNL’s ultrasonic tests and, as shown in Figure 21, has two flattened sections with thicknesses of 2 to 3 mm. Results of this test are shown in Figure 22 and indicate distinctive echoes for the thicker flat section. However, for the thinner section, FIU only observed small modulations in the noise signal (the signal generated by the receiver part of the transducer when it is not connected to any surfaces). This dampening effect was probably caused by destructive effects in the near-field-zone of the transducer (entire pipe wall thickness was in the near-field-zone).

Figure 21. Spool piece considered for ultrasonic tests at FIU.

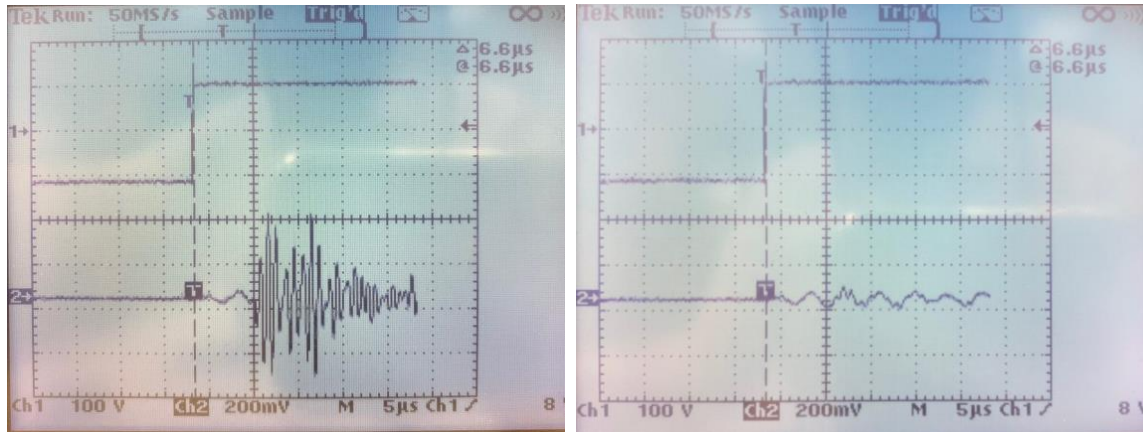
Figure 22. Sound echoes detected by the ultrasonic sensor on the ticker (left) and thinner (right) flats.

Ultrasonic testing was also performed in the presence and absence of sediment placed inside the stainless-steel spool piece. For this pipe material, the same results in Figure 22 were reproduced, showing no differences in time and amplitude of the echoed waves. This lack of difference can be related to the inability of waves to travel into the sediment due to the large acoustic impedance difference between the pipe and sediment material. Use of higher amplitude sound waves (increasing peak-to-peak voltage) can increase the amount of energy transmitted to the sediment and potentially increase the strength of detectable echoes sound waves.

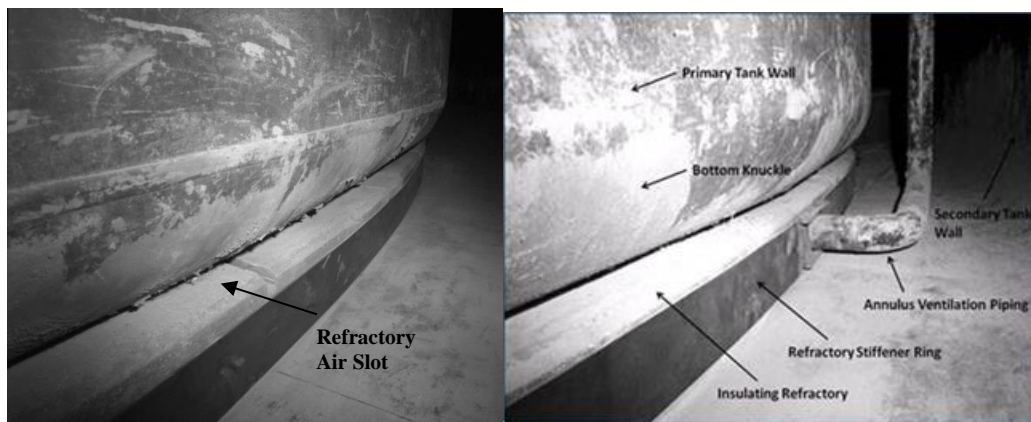
FIU is developing a technology that will access the primary tank floor of DSTs at Hanford through the annulus and refractory air slots (Figure 24) and provide visual feedback of the conditions within the air slots. The refractory air slots range from 1 inch to 3 inches in width and provide a complex maze to navigate through, including four 90° turns to reach the center of the tank (Figure 25). Pictured is documentation on AY-102, a tank possessing one of the more difficult inspection paths due to the layout of the refractory cooling channels; other double-shell tanks contain channels with layouts that resemble a web structure with much larger angles at the turns rather than sharp 90° turns (Figure 26).

Figure 24. Side view of primary tank and refractory air slot.

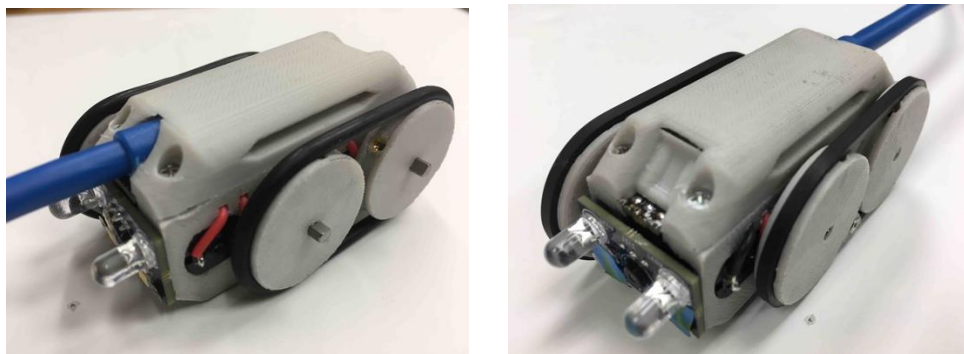
The fully assembled, modified version of the mini inspection tool is shown in Figure 35. The major difference from the previous version of the mini inspection tool is the backward-looking camera, as well as moving the tether connector to the top of the inspection tool, to provide space for the second camera. The tool is fully functional and is currently being tested in the full-scale mockup facility at ARC as well as with traversing weld seams.

Figure 35. Fully assembled mini inspection tool with dual cameras.

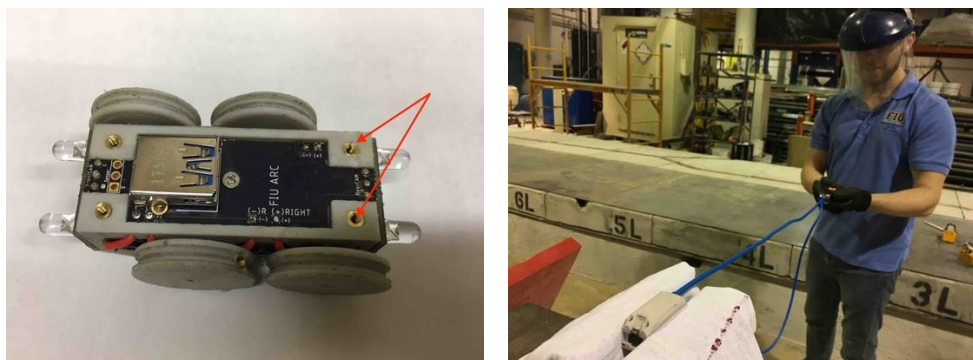
One of the concerns expressed by the site engineers was the strength of the tether connection since the inspection tool must be capable of being pulled out in case of system failure. This critical fail-safe measure will ensure that no external objects are left behind, which could potentially obstruct the air flow that is used to maintain the tank temperature. The modified mini inspection tool has the connector located at the top of the tool, and the connection is tightly secured with two supporting screws and the hoop. Figure 36 shows the screw holders that are used for the screws to secure the hoop and the tether connector to the inspection tool. Tests were conducted to ensure the strength of the tether when it is pulled (Figure 36). The tether and the connector were able to withstand a pull-force of about 65 lbs. without breaking. FIU is also considering incorporating a bus drop grip on the tether to increase the safety buffer.

Figure 36. Screw holders at red arrows (left) for securing the hoop and the connectors to the inspection tool and performing a pull test for tether strength (right).

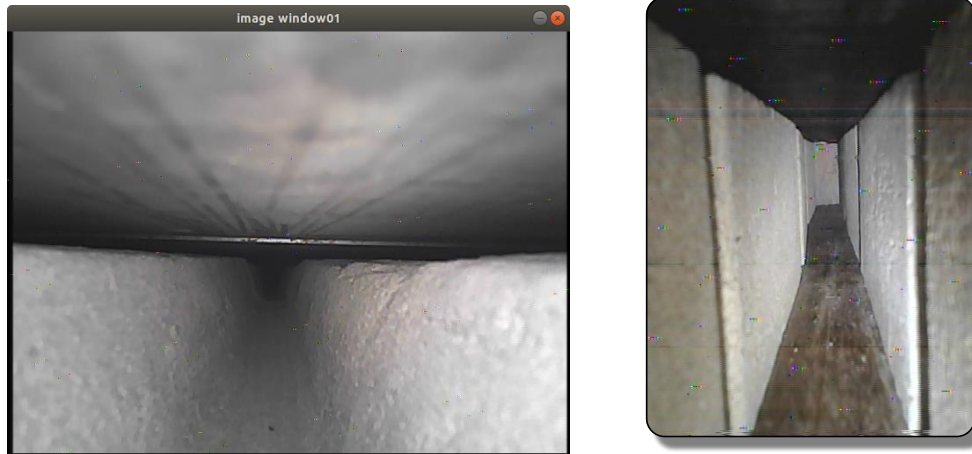
FIU reviewed the video footage from the deployment of the inspection tool at the sectional full-scale mockup facility and noted that due to the close proximity of the inspection tools' camera to the tank bottom, and wider refractory slots of AZ/SY/AW/AN/AP tank configuration, the previous approach of using image segmentation to identify navigable region is no longer suitable. Figure 37 shows the camera views in the slot mockup that mimics the narrower top surface the slot for the AY tank configuration as well as the wider top surface of the slot for other tank configurations. The narrower slot configuration poses a challenge to determining a clear navigable path for semi-autonomous control of the technology.

Figure 37. Narrower top surface of the slot mockup based on the AY tank configuration (right) and the wider top surface of the slot mockup based on other tank configurations (left).

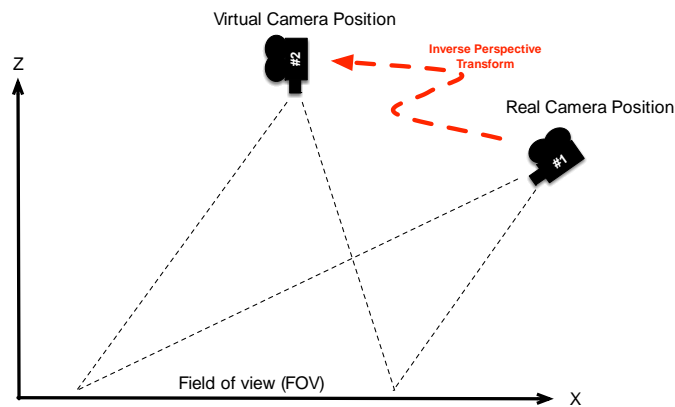
Instead of segmenting the top surface of the tank, FIU took advantage of the channel’s geometry and the lighting conditions on the refractory slots when illuminated by the inspection tool’s lighting source as another alternative for navigable path identification. The approach employed the inverse perspective transformation of the camera’s image to identify the central location of the slot. Figure 38 illustrates the idea of using the inverse perspective transformation. It transforms the camera’s image, taken at the real camera’s position, to an image that appears as if it was taken from a top view camera. The results from the transformation of the video footage taken at the sectional full-scale mockup can be seen in Figure 39. The approach managed to identify the center location of the slot and the inspection tools’ current heading (blue and red circles shown in Figure 39). The horizontal difference between these two circles can be used to control the mini inspection tool to perform lane-keeping during semi-autonomous operation.

Figure 38. Inverse perspective transformation to transform the camera’s image, taken at the real camera’s position, to an image as if it was taken at the virtual camera position.

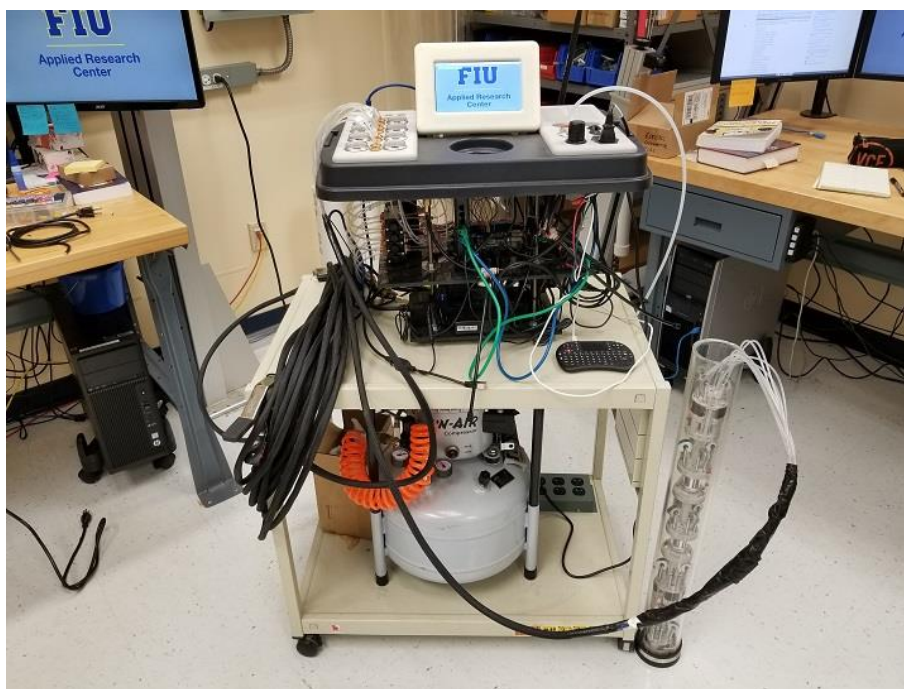
The current design for the pneumatic pipe crawler is a worm-type robot with a modular design, composed of interchangeable cylindrical modules connected with flexible links. Figure 42 shows of one of the more recent designs of the system.

Figure 42. FIU's pneumatic pipe crawler.

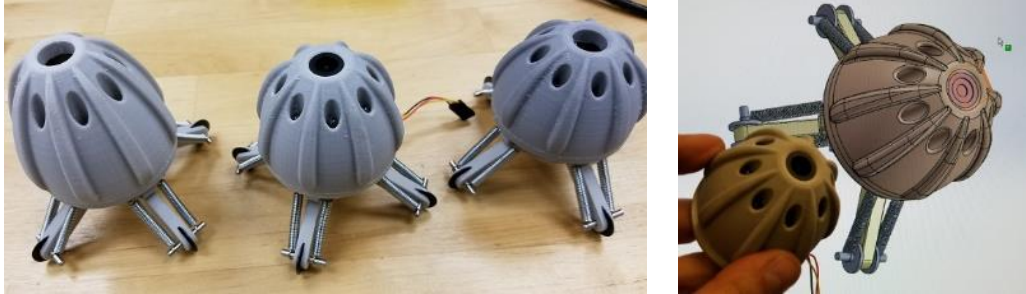
Minor changes were implemented in the pneumatic crawler design, including a streamlined camera module, and extension modules with a larger stroke. The following figure shows the new streamlined camera module, redesigned to better handle obstacles and geometrical changes in pipes and fittings.

Figure 43. Redesigned camera module.

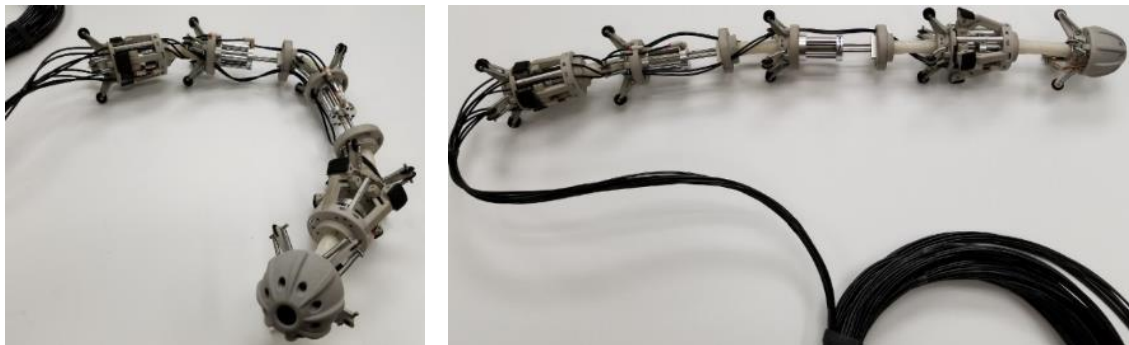
The 3/4" stroke pneumatic cylinders of the extension modules were also replaced by equivalent actuators with 1-1/2" stroke each, which significantly improved the device speed and navigation thru elbows. The figure below shows the current crawler with the minor design modifications.

Figure 44. Current design of the crawler.

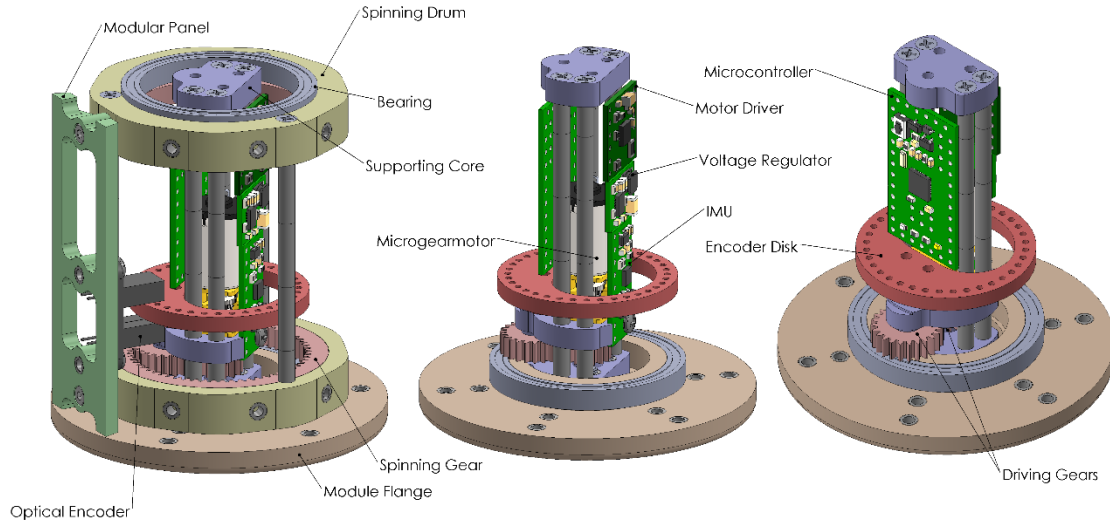
- a) a set of spur gears, similar to a planetary gearbox, to provide the spinning movement,
- b) an optical encoder to track the rotational position and the speed of the drum, and
- c) an inertia measurement unit (IMU) to provide an estimation of the position and the orientation of the module.

Figure 49. Module’s basic components.

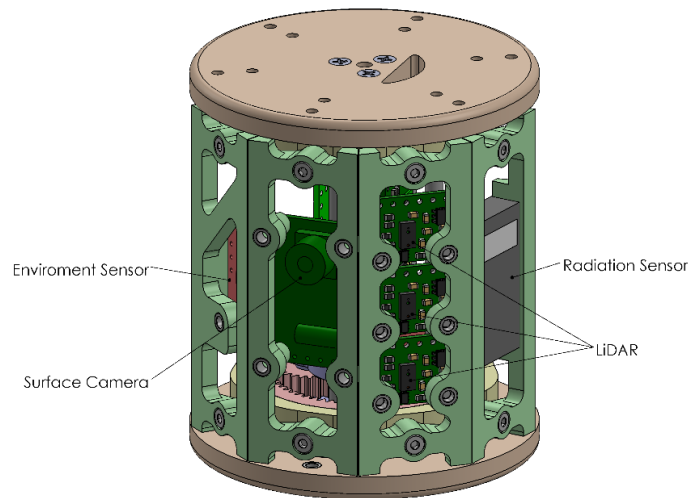
- a BME280 atmospheric sensor to measure barometric pressure, humidity, and temperature,
- a LSM6DS33 inertial measurement unit (IMU) to measure position and orientation,
- three VL6180X proximity (LiDAR) and ambient light sensors to measure pipeline circumference,
- a generic miniature NTSC video camera to stream surface images, and
- a RD2014 radiation sensor.

Figure 50. Instrumentation module.

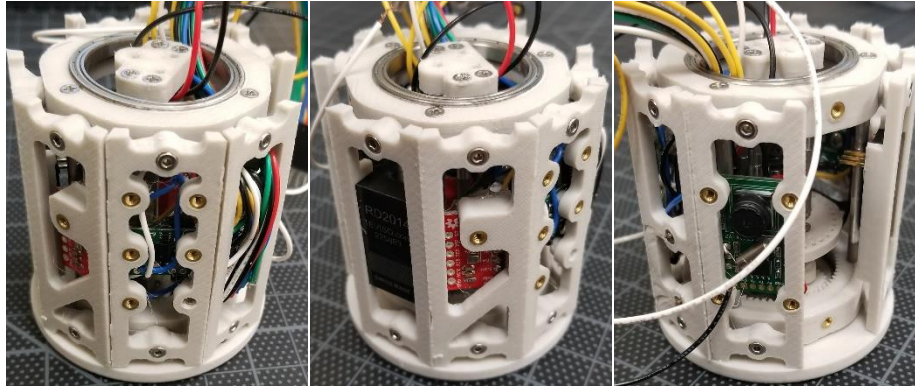
The module with the sensors installed is shown in Figure 51. The left picture shows the LiDAR sensor, the middle shows both the radiation sensor and the environmental sensor which includes temperature, humidity and pressure and the right picture shows the camera.

Figure 51. Installed sensors: LiDAR (left), radiation and environmental sensor (center) and camera (left).

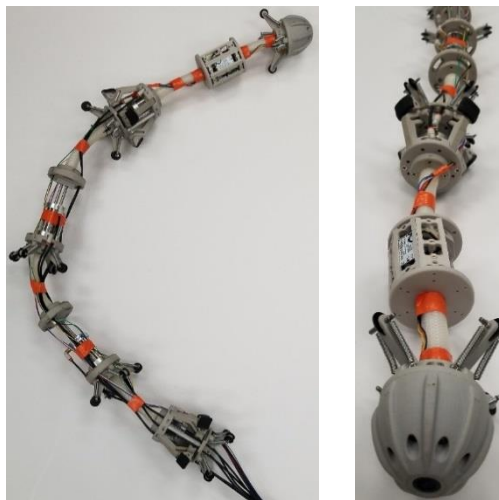
The sensor module is shown in Figure 52 and depicts how it fits within the pneumatic crawler. As noted previously, the sensor module is placed behind the front camera and before the forward gripper module. This eliminates the requirement of having to pass the pneumatic lines through the sensor module.

Figure 52. Crawler with sensor module.

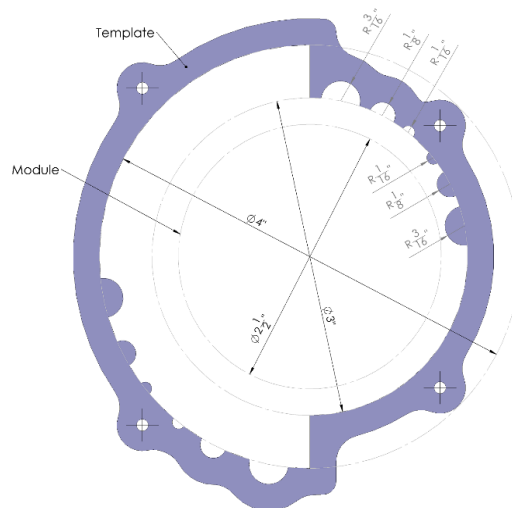
To evaluate the ability of the LiDAR to scan the internal surfaces of pipes, a template representing a pipe was designed and is shown in Figure 53. The 3D printed template simulates sections of 3- and 4-inch diameter pipes with measurable irregularities.

Figure 53. Scanning template.

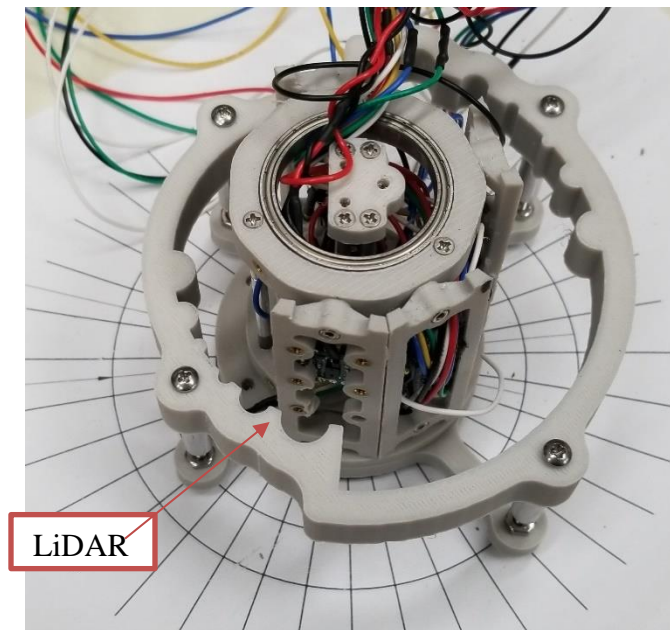
Figure 55. LiDAR testbed.

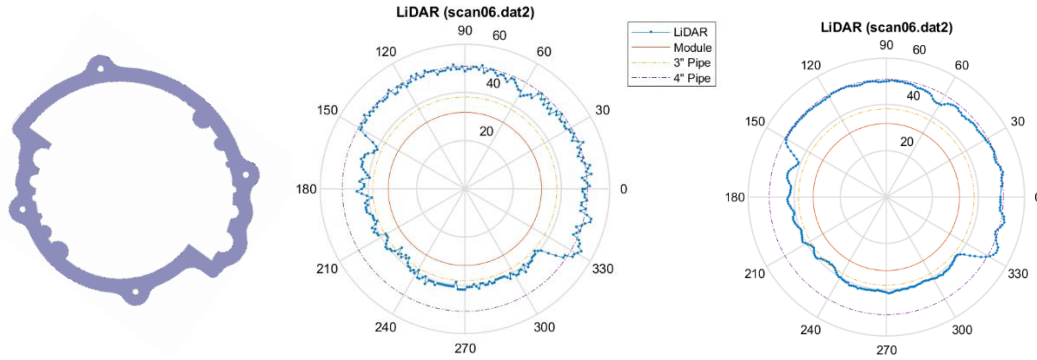
Figure 56. Preliminary circumferential scanning, raw data (left) and filtered data (right).

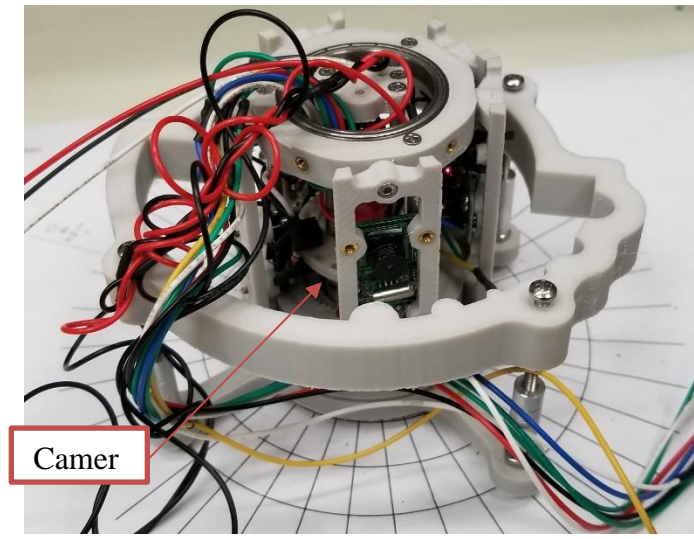
Figure 57. Circumferential camera.

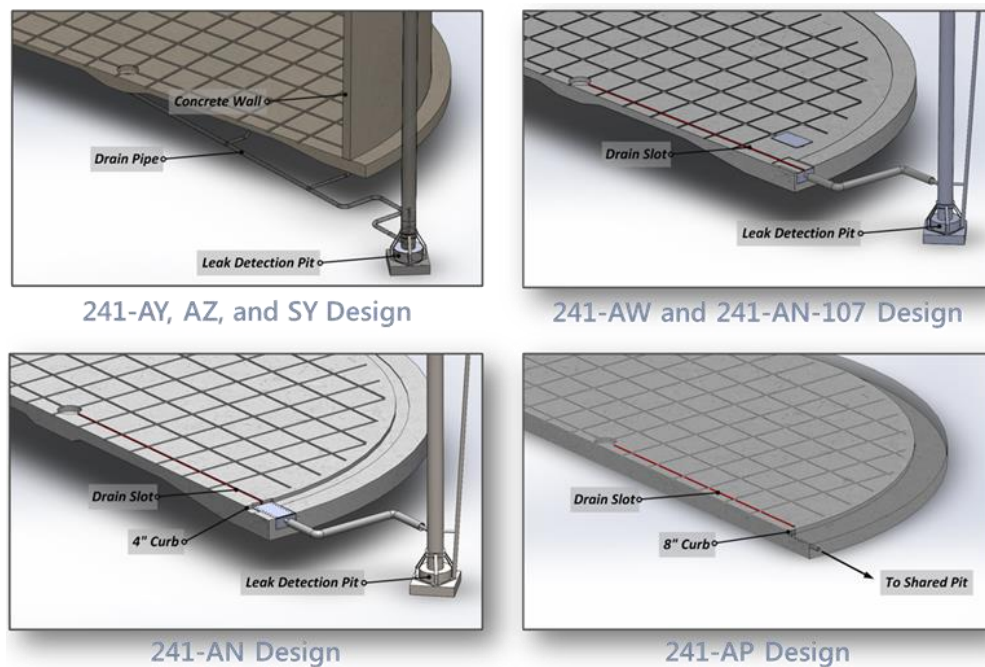
Figure 60. Leak detection systems at Hanford’ DSTs.

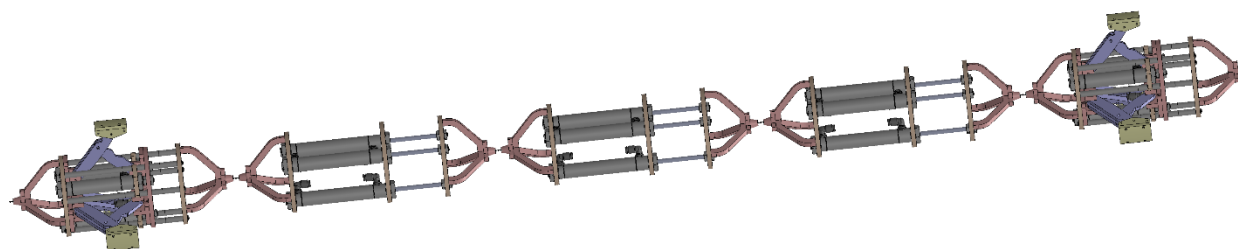
Figure 61. FIU’s 6-in peristaltic crawler.

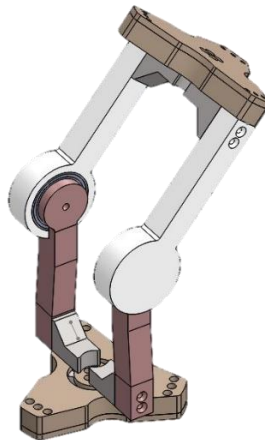
Figure 67. Bistable joint.

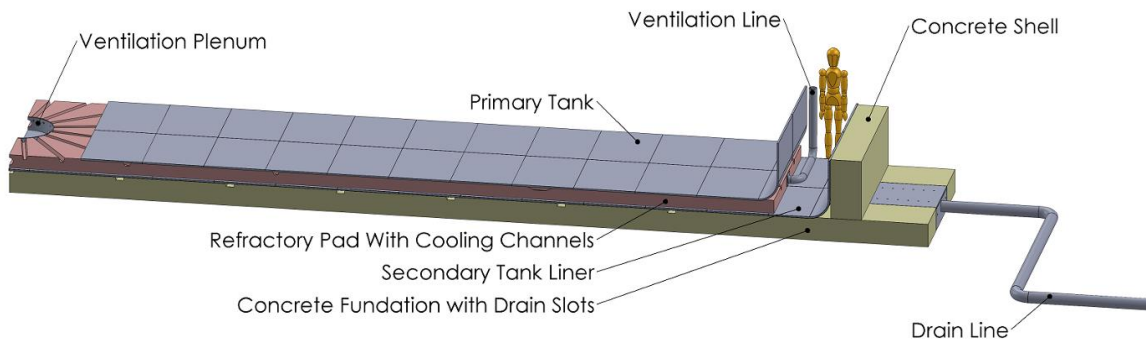
Figure 68. Current mockup design.

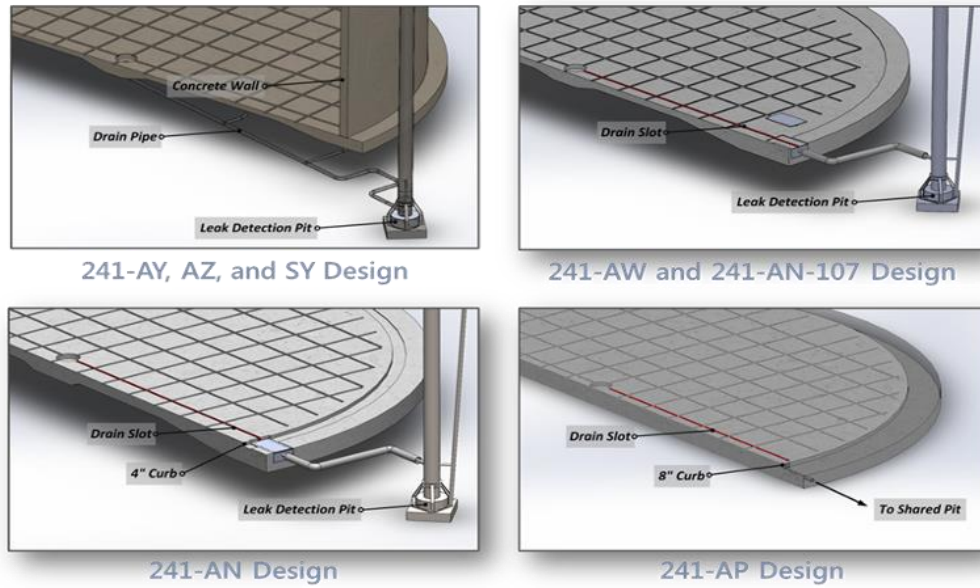
Figure 69. Existing configuration of the DST’s leak detection system.
