YEAR END TECHNICAL REPORT

September 29, 2017 to September 28, 2018

Chemical Process Alternatives for Radioactive Waste

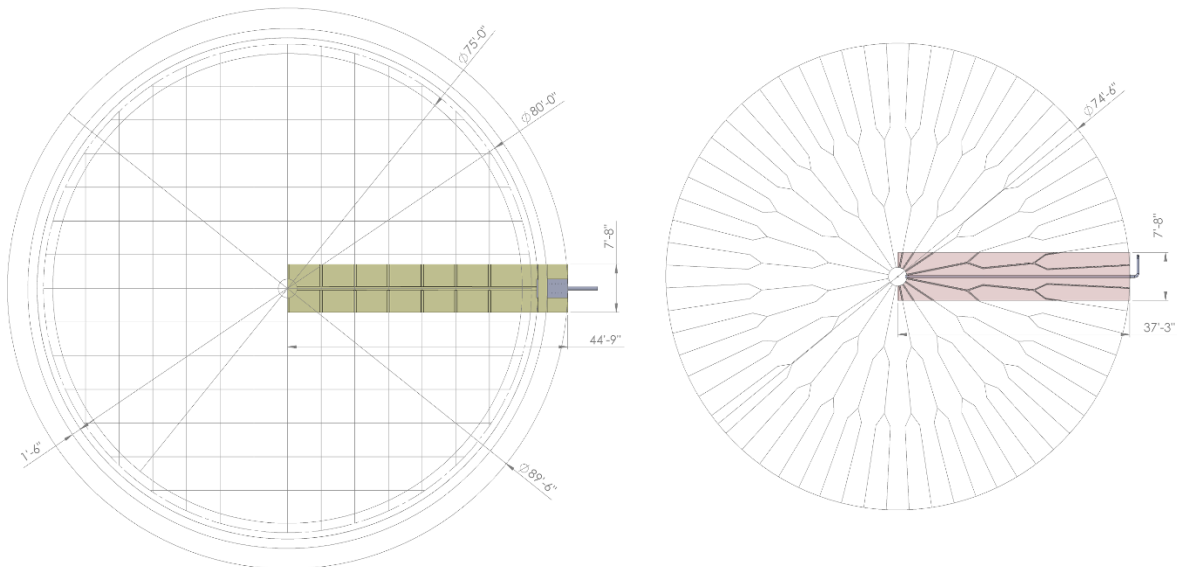
Figure 70. Layout of the tank foundation drains (left) and cooling channels (right).

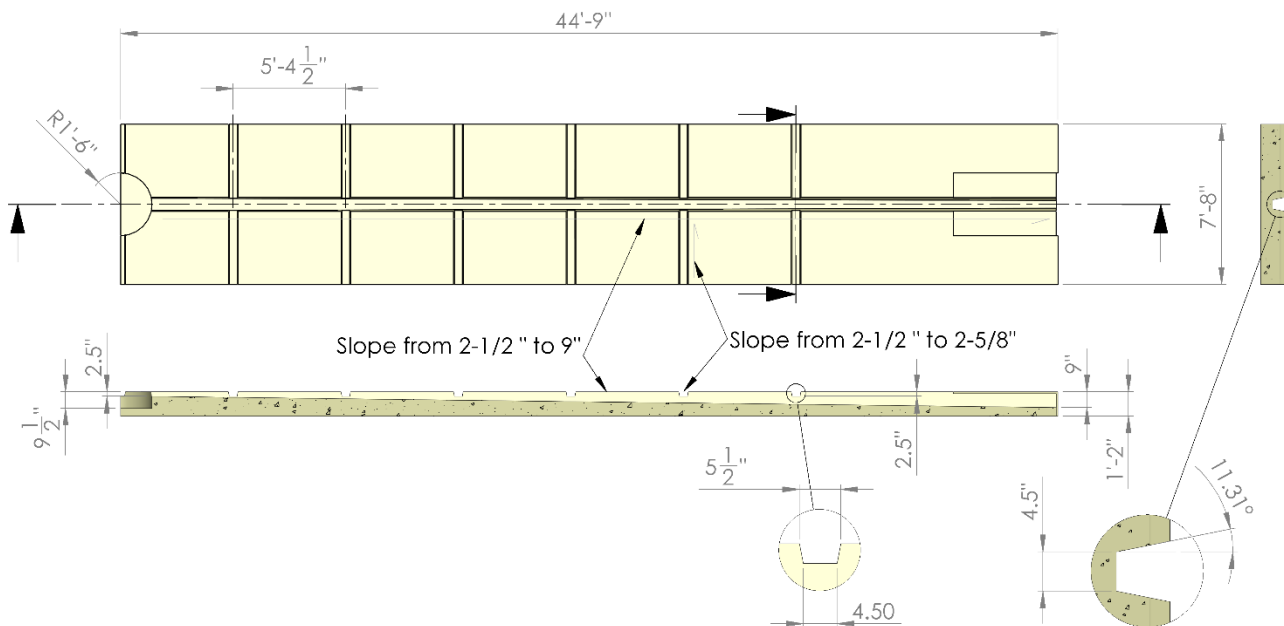
Figure 71. Concrete foundation with drain slots.

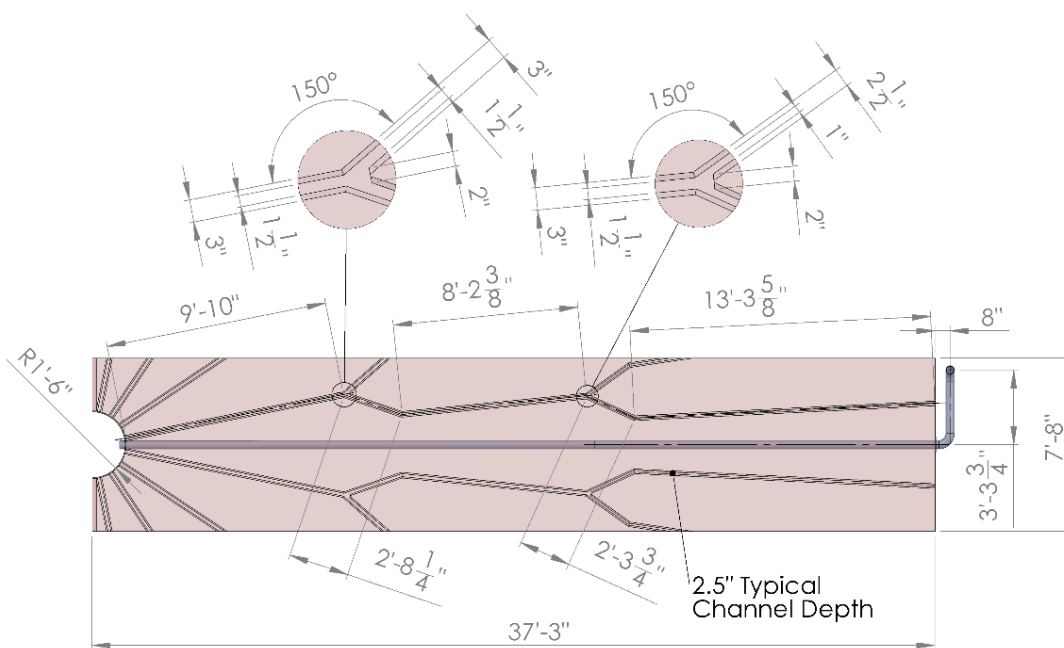
Figure 72. Refractory pad with cooling channels.

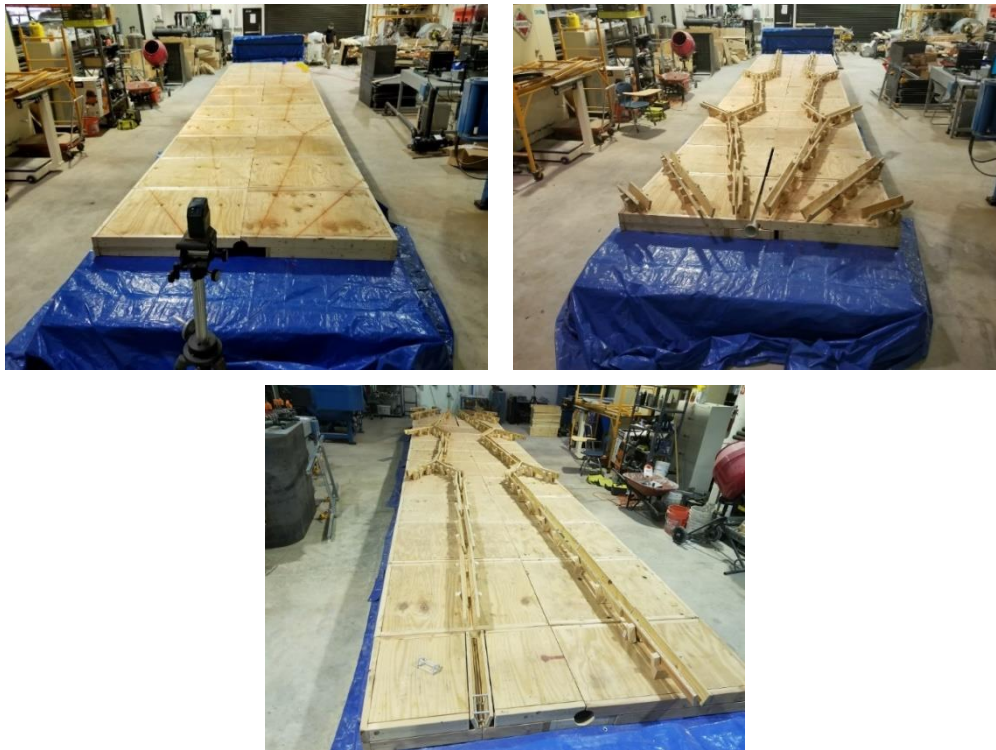
Figure 74. Progression of refractor channels.

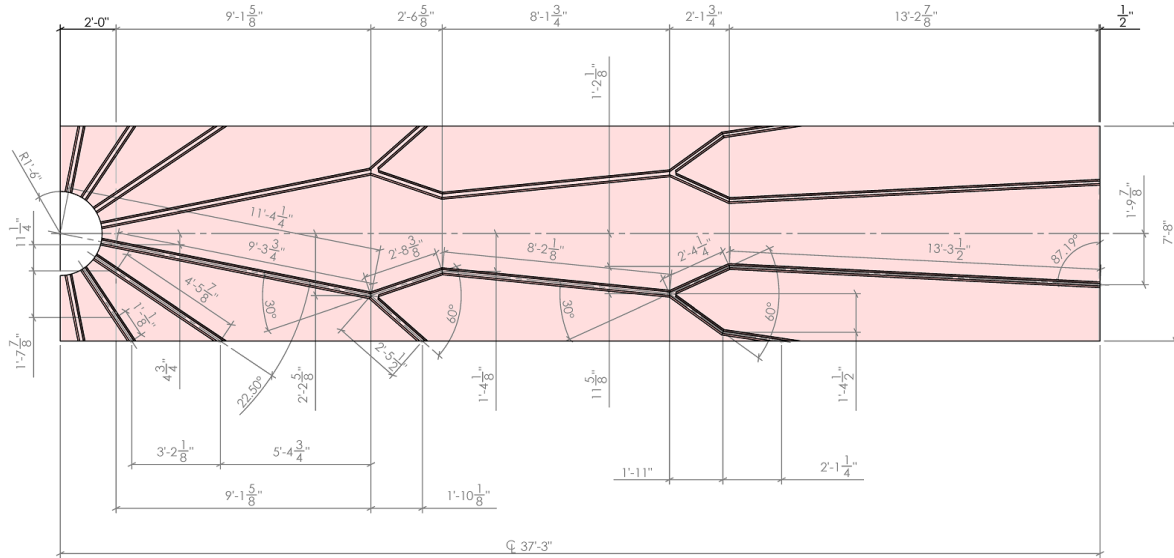
Figure 75. Refractory channel layout.

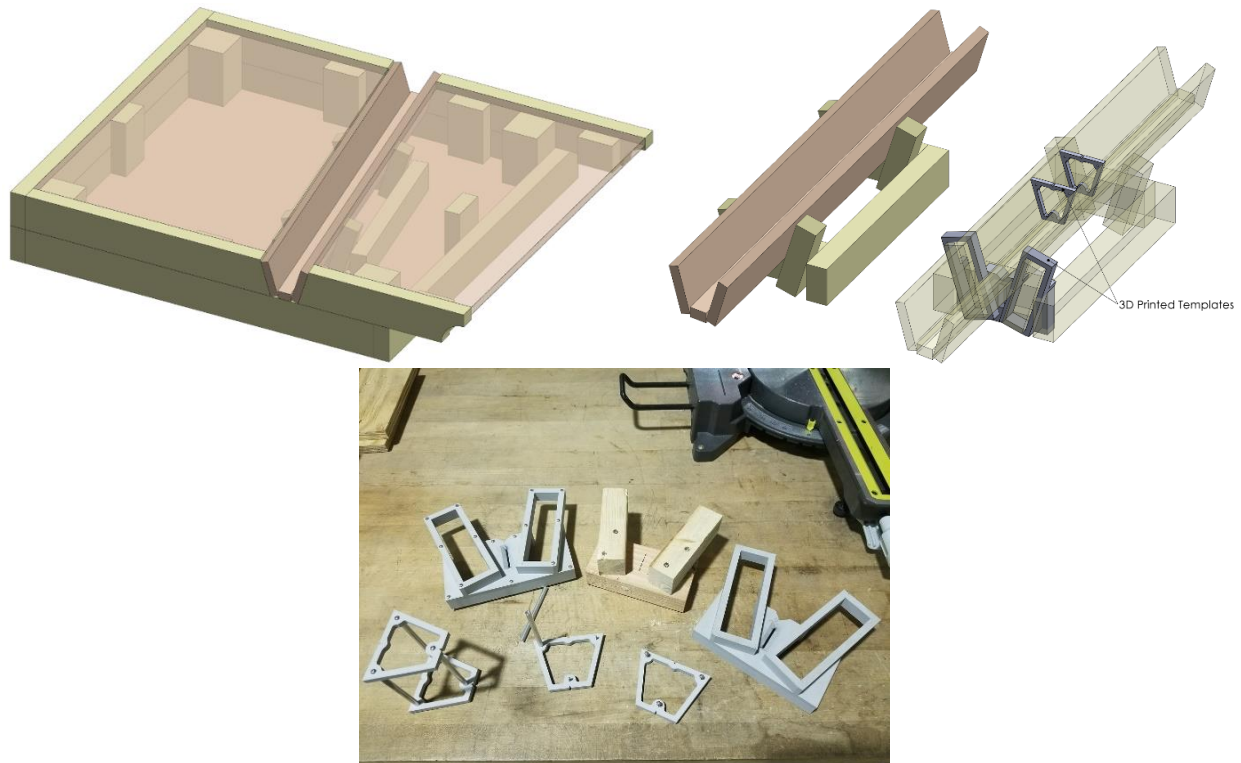
Figure 76. Refractory channel supporting structure.

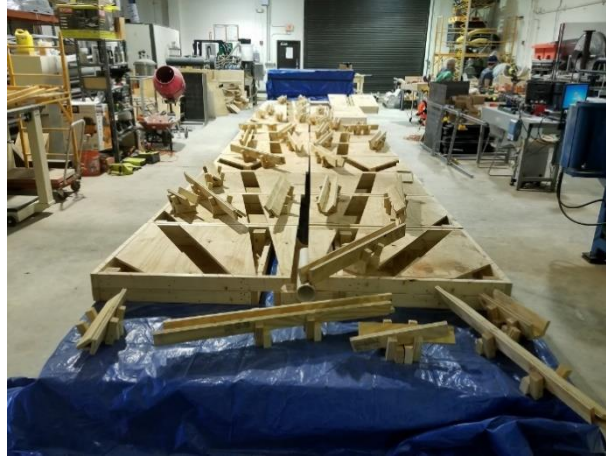
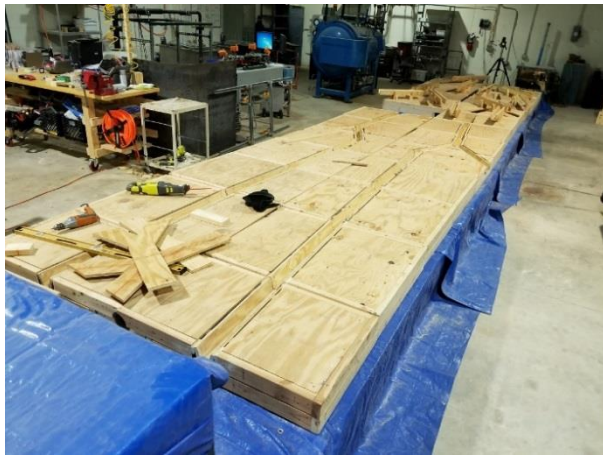
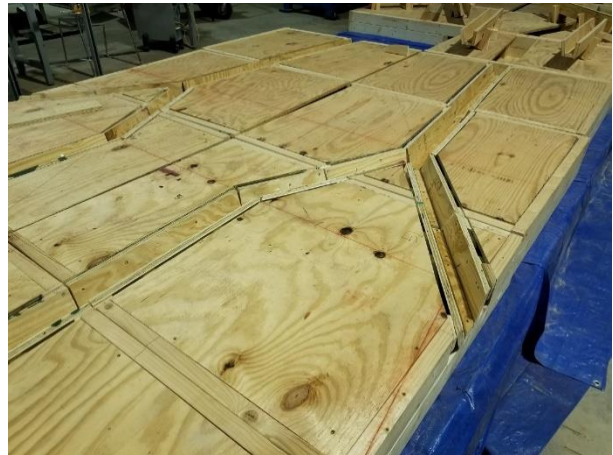
Figure 77. Framing for the refractory slots.

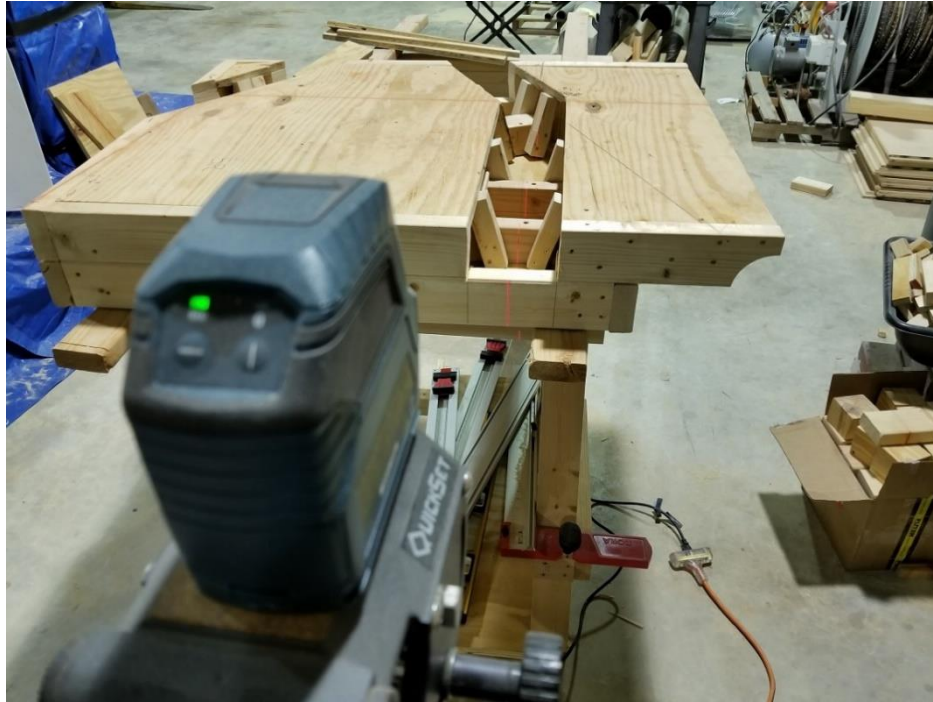
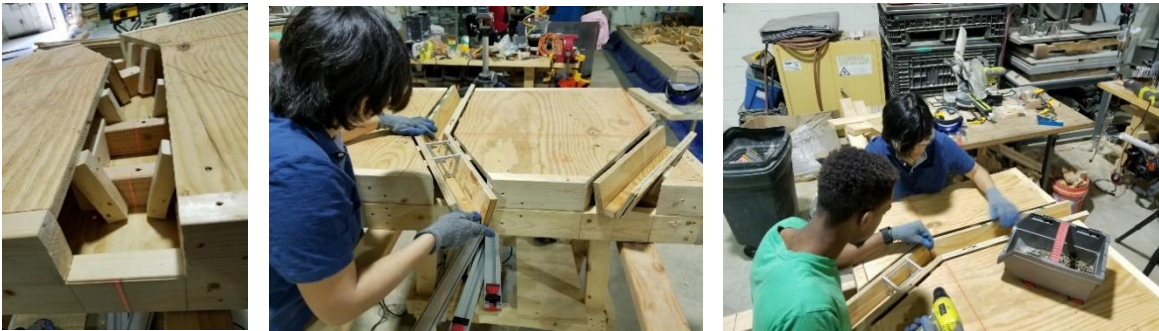
Figure 78. Refractory channel construction.

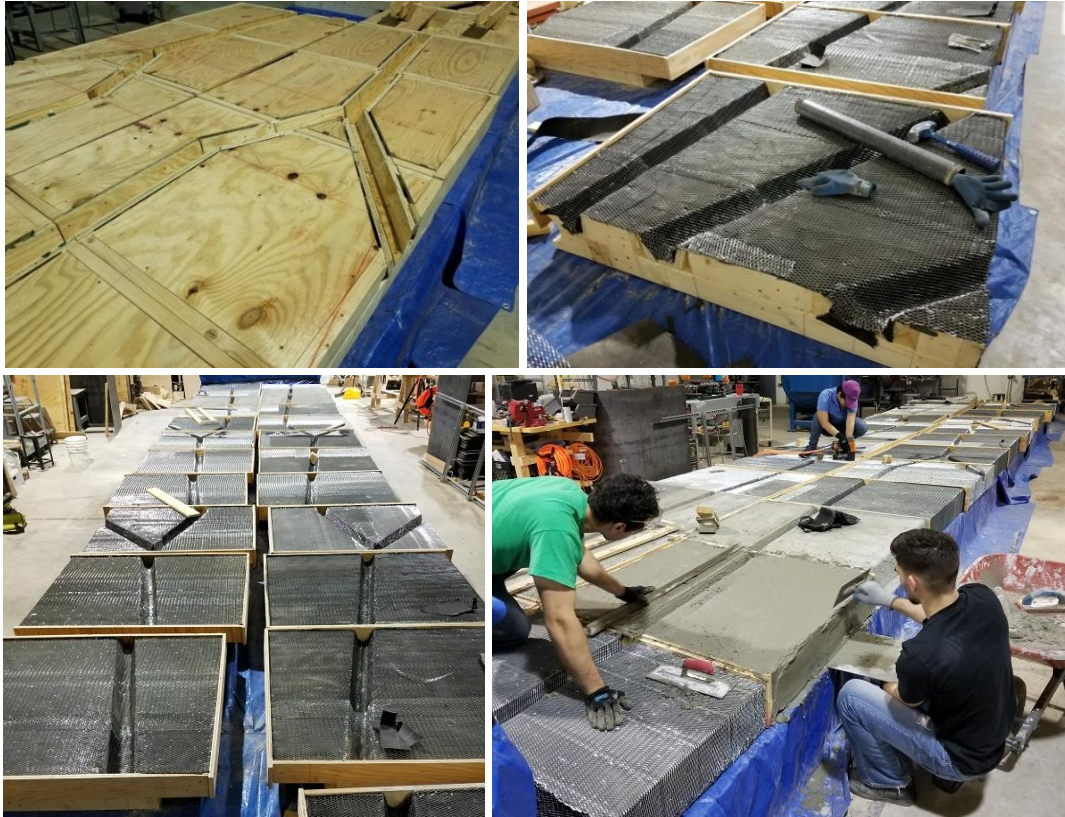
Figure 79. Refractory channel construction.

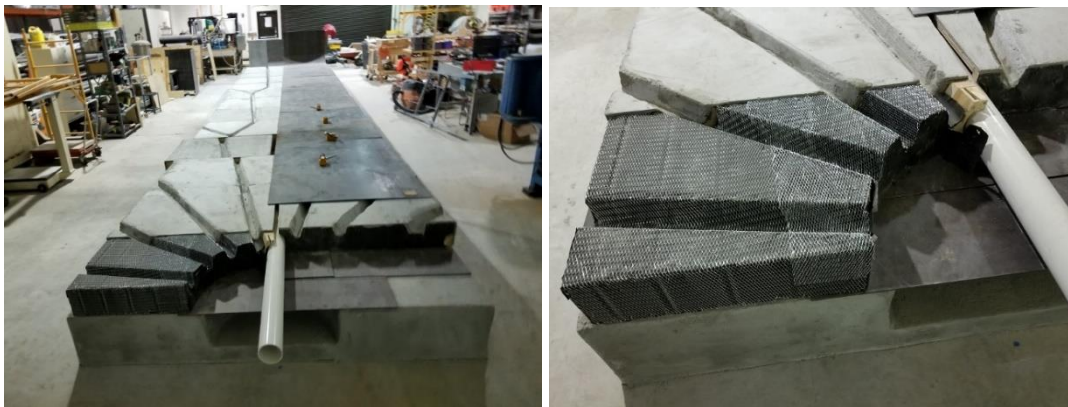
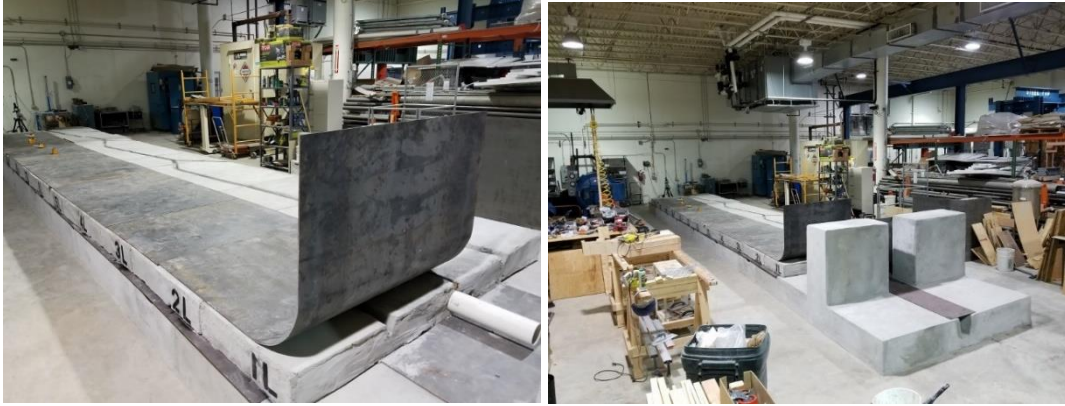
Figure 80. Construction of the full-scale HLW DST test bed.

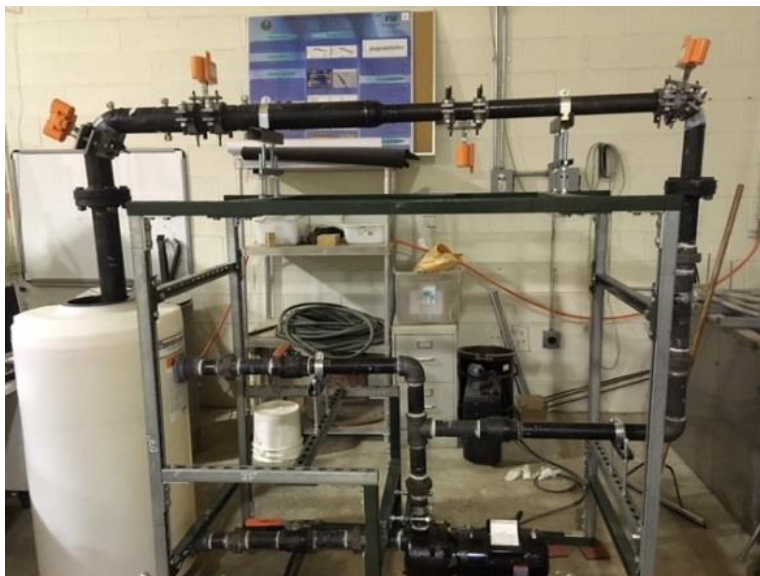
Figure 81. Erosion Pipe loop with sensors.

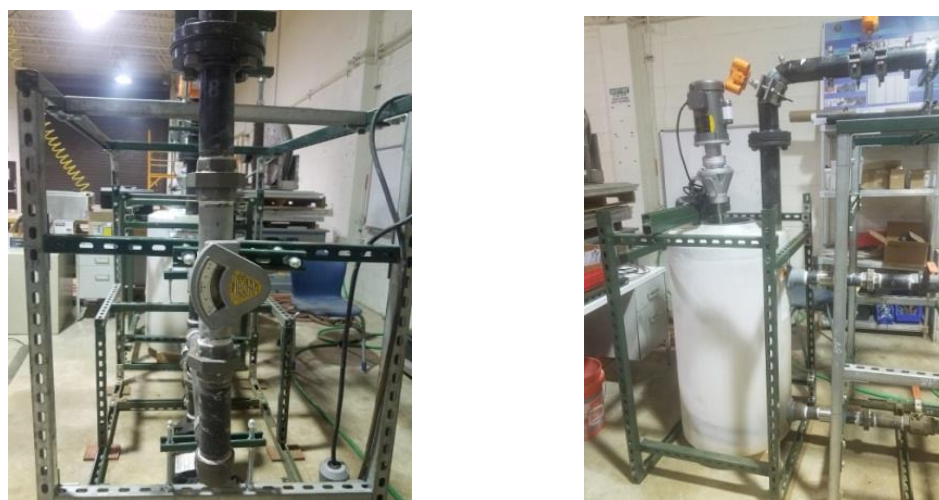
Figure 82. Flow meter [4] (left) and mixer and supporting stand (right).

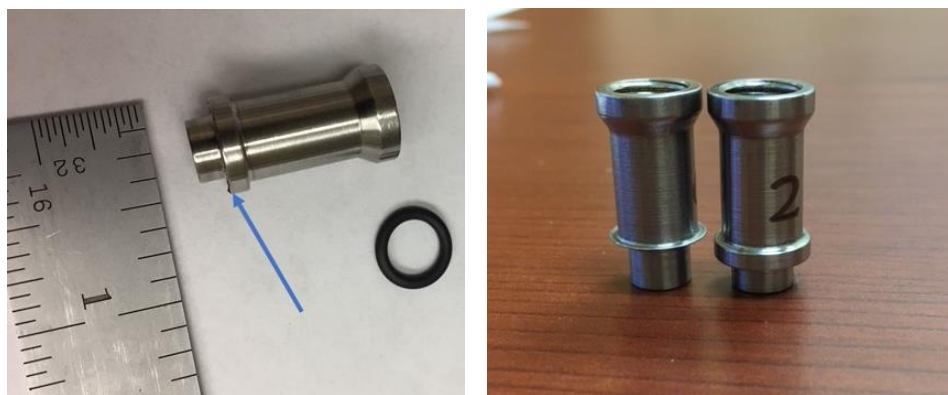
Figure 84. Coupon surface to be milled (left) and coupons before and after machining (right).

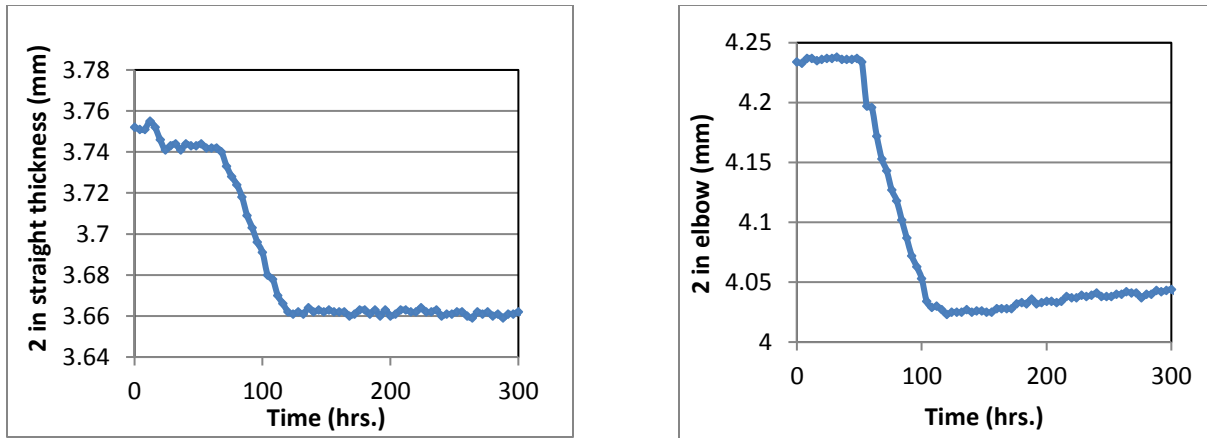
Figure 87. UT thickness change: 2-inch straight section (left) and 2-inch elbow section (right).

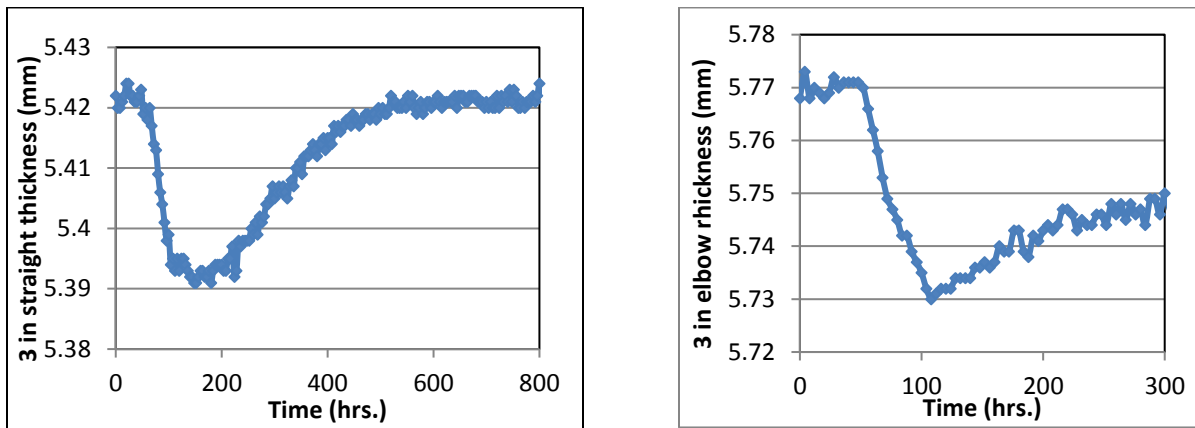
Figure 88 . UT thickness change: 3-inch straight section (left) and 2-inch elbow section (right).

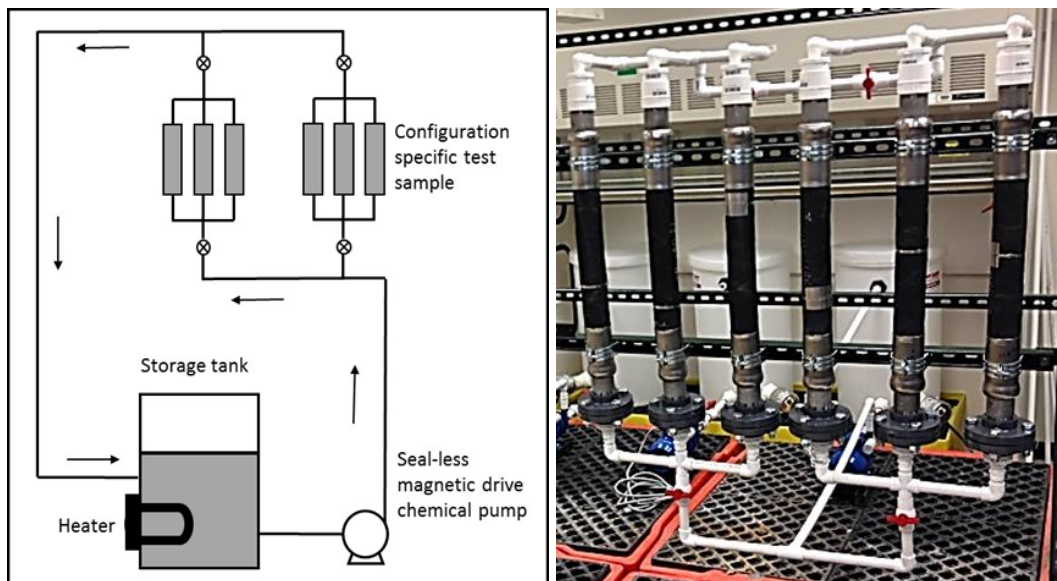
Figure 89. In-service component aging loop.

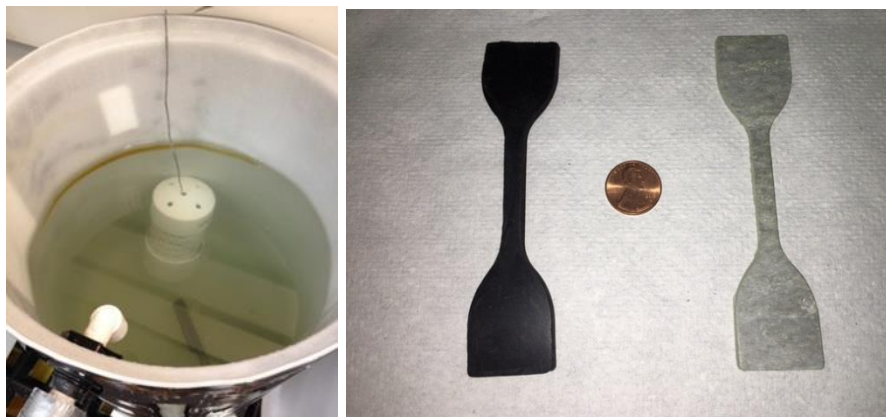
Figure 90. Coupon aging vessel (left) and EPDM & Garlock® coupons (right).

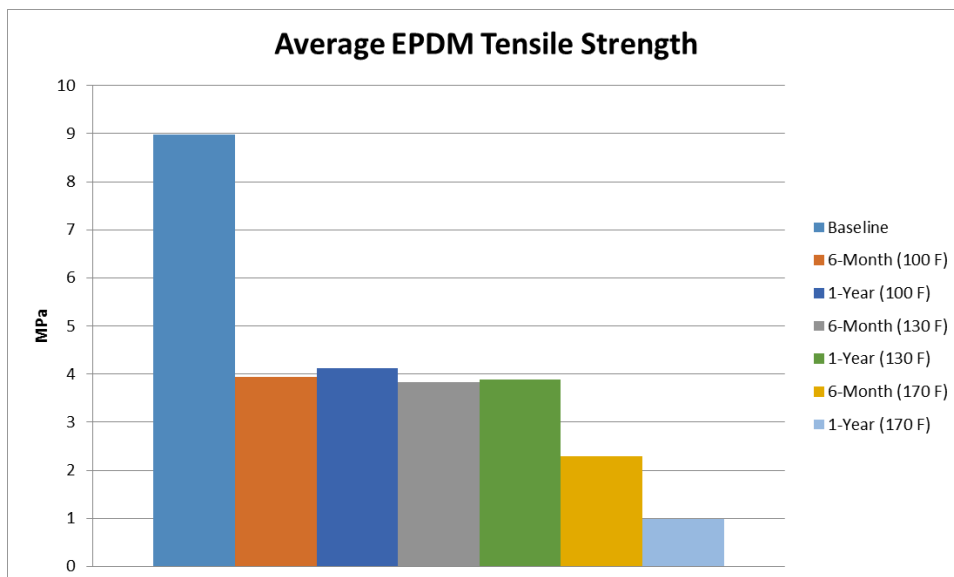
Figure 93. EPDM coupon tensile strength.

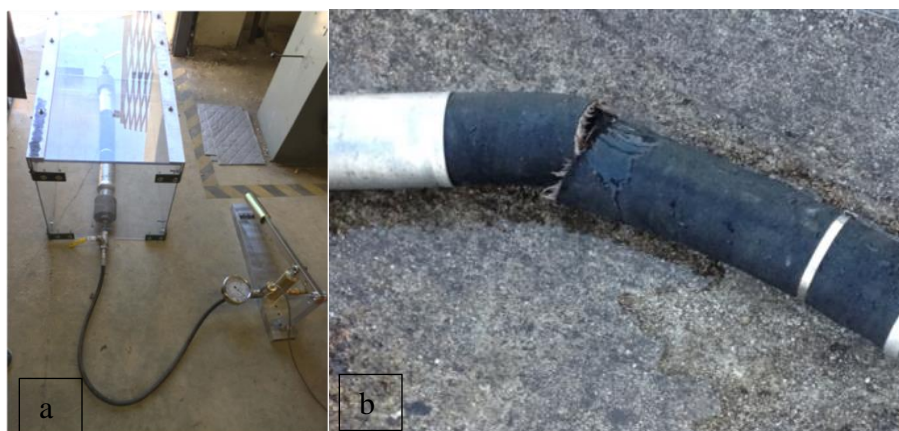
Figure. 94. Hose burst testing: burst pressure test apparatus (left) and ruptured hose section (right).

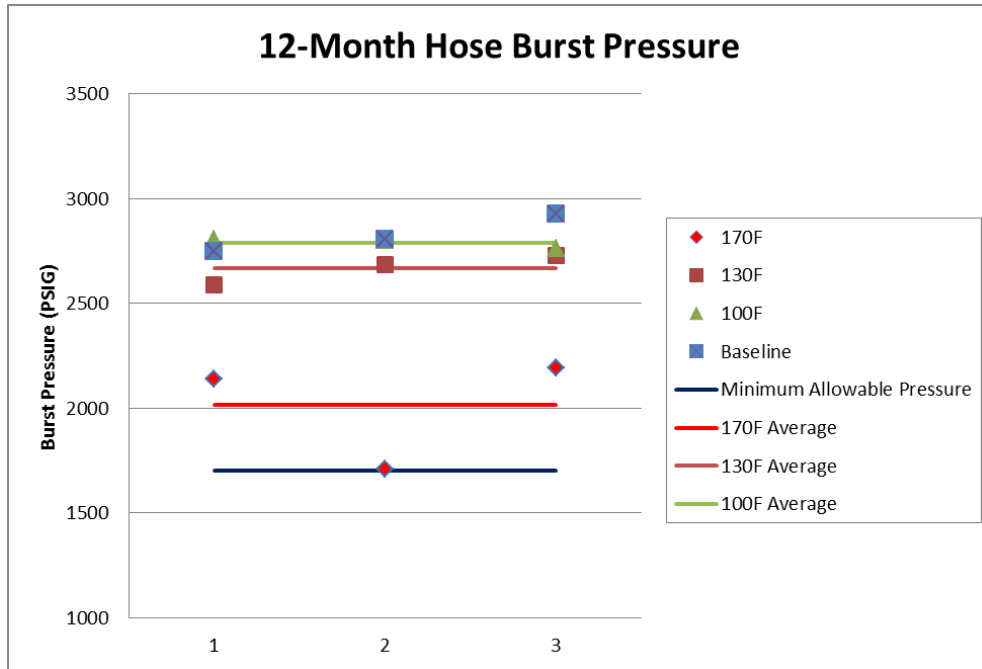
Figure 95. 12-month hose burst pressure results.

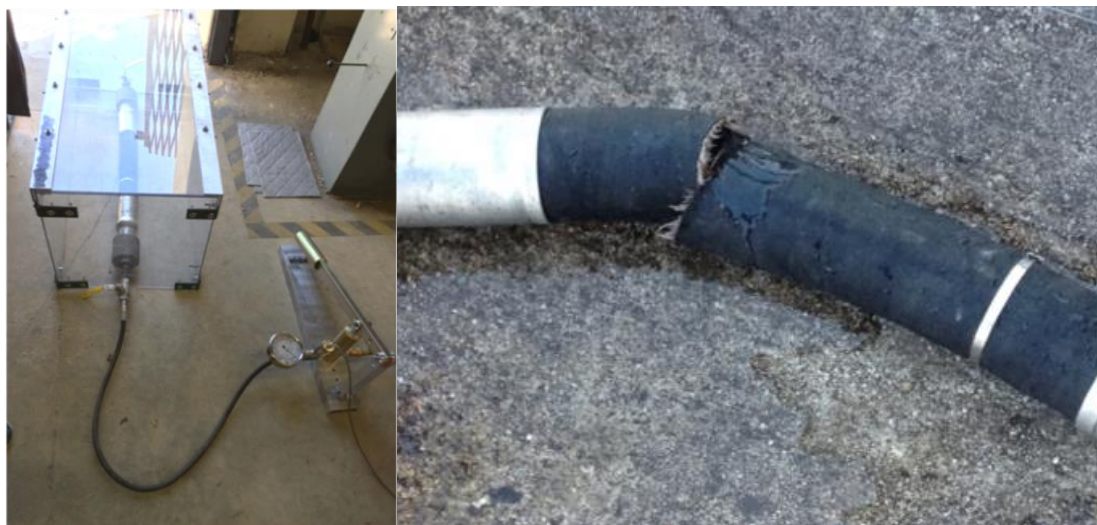
Figure 96. Hose rupture test apparatus (left) and ruptured hose section (right).

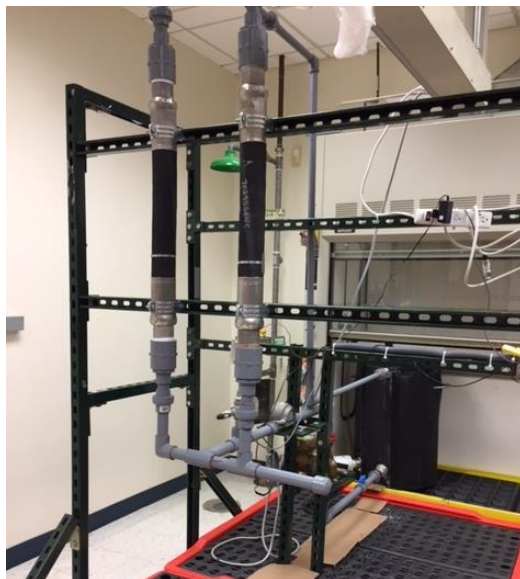
Figure 100. Second phase for testing using only water.
