## **YEAR END TECHNICAL REPORT**

September 29, 2018 to September 28, 2019

# **Chemical Process Alternatives for Radioactive Waste**

U.S. Department of Energy

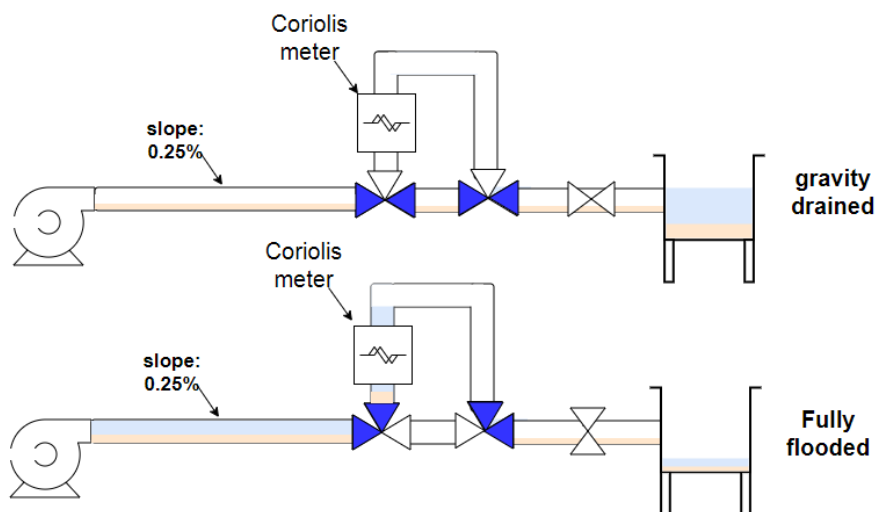
**Figure 1. Two initial condition modes for the flushing studies.**

This effort is intended to determine effective flushing operations using a minimal amount of water usage and provide additional guidelines in support of recently developed flushing standards (TFC-ENG-STD-26). Successful execution requires creation and characterization of sediment beds, flushing in different modes, and evaluation of operation effectiveness through measurement of post-flush pipeline residues. To extend previous flushing studies, our strategy will be creating different case studies targeting different materials and pipe lengths. In addition, existing ultrasonic and visualization methods inspired by the work conducted at PNNL, PNNL-20350 FINAL (Denslow et al., 2011) and PNNL-19441 Rev. 0 (Bontha et al., 2010), will be used in the collection and assessment of data. In each round of testing, focus will be on influential parameters set for one simulant in a fixed pipe length. These parameters are flush velocity mode (continuous one-step, continuous two-step, and pulsing) and initial conditions (gravity drained versus fully flooded systems, as shown in Figure 1). These initial conditions can be simply created before start of flushing operations by directing the flow in different directions using two ball valves.

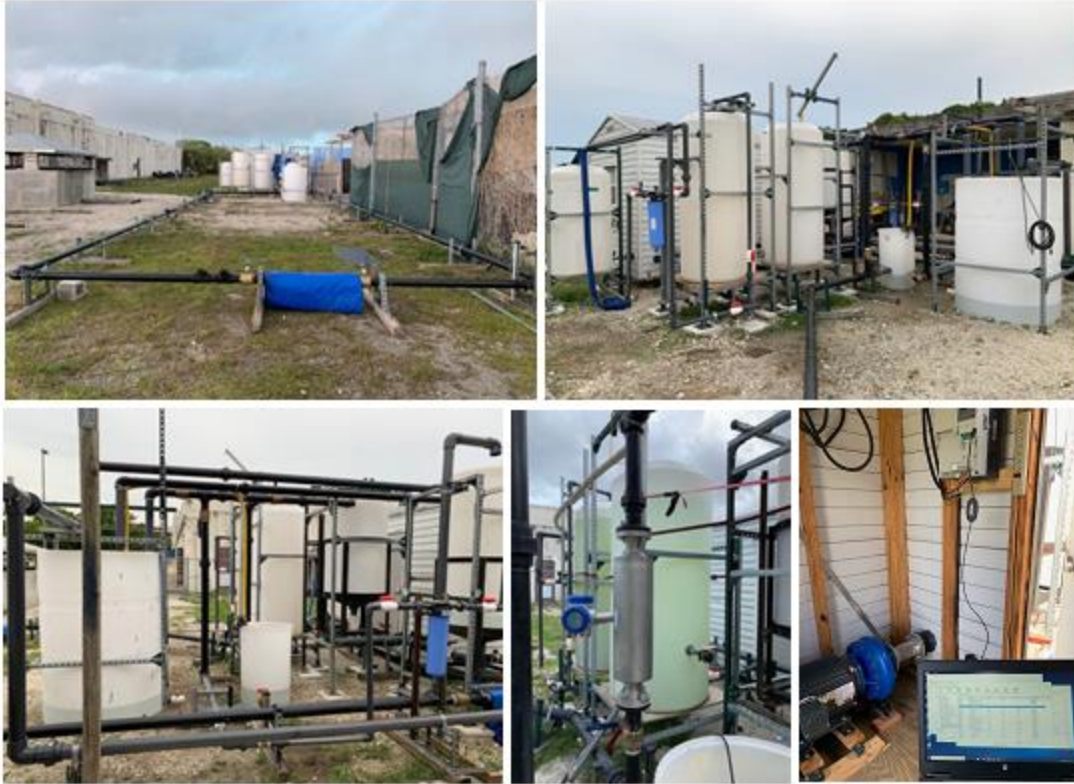
**Figure 3. Pipeline constructed for flushing experiments.**

To achieve the objectives of this study, a 50.3 m (165 ft) test loop made of 3 inch schedule 40 carbon steel pipes and fittings was constructed (Figure 2 and Figure 3). The pipeline was sloped at the rate of 0.15% (3 inch drop in 100 ft) to emulate conditions at Hanford site and facilitate gravity draining. This experimental loop can perform various functions such as slurry circulation (to load the system), draining (to create gravity-drained initial condition and to empty the system), pump cleaning, flushing, sediment and water retrieval, filtration, and post-flush circulation.

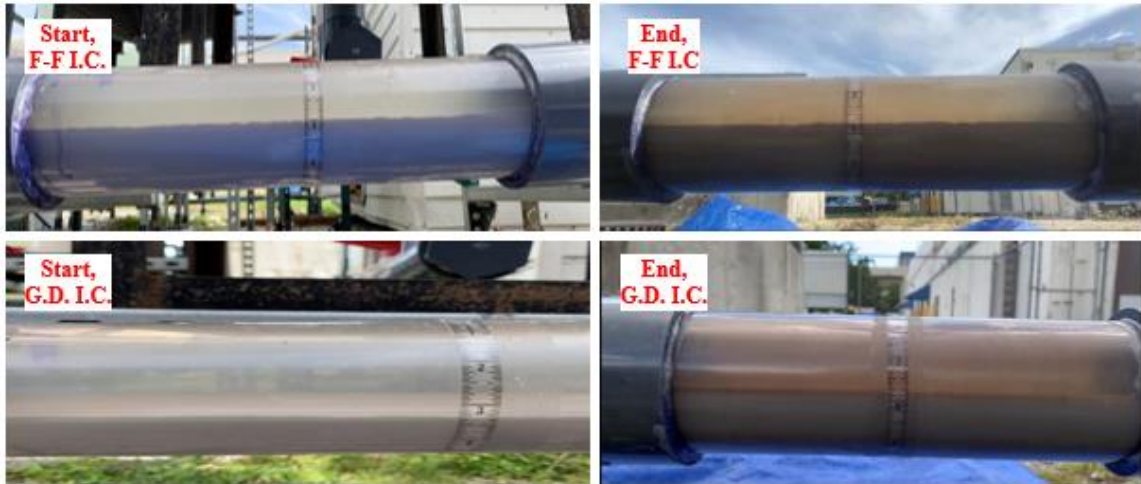
**Figure 4. Fully-flooded (top) and gravity-drained (bottom) initial conditions created in the pipeline.**

conditions. The fully-flooded condition was created by allowing kaolin to settle for one day in the loop after stopping the slurry pump and without changing any valve configurations. The gravity drained condition was created by opening a drain valve after full settlement. Sediment bed height was observed in the clear sections at the beginning and end of the loop for quantification of initial conditions (Figure 4) in both modes. This figure shows the presence of a consistent bed at both clear sections in the case of the fully-flooded initial condition. However, different bed heights were observed across the loop for the drained initial conditions. Presence of a thicker bed at the end of the pipe loop can be associated with accumulative settling of particles toward the end of the pipeline during drainage process.

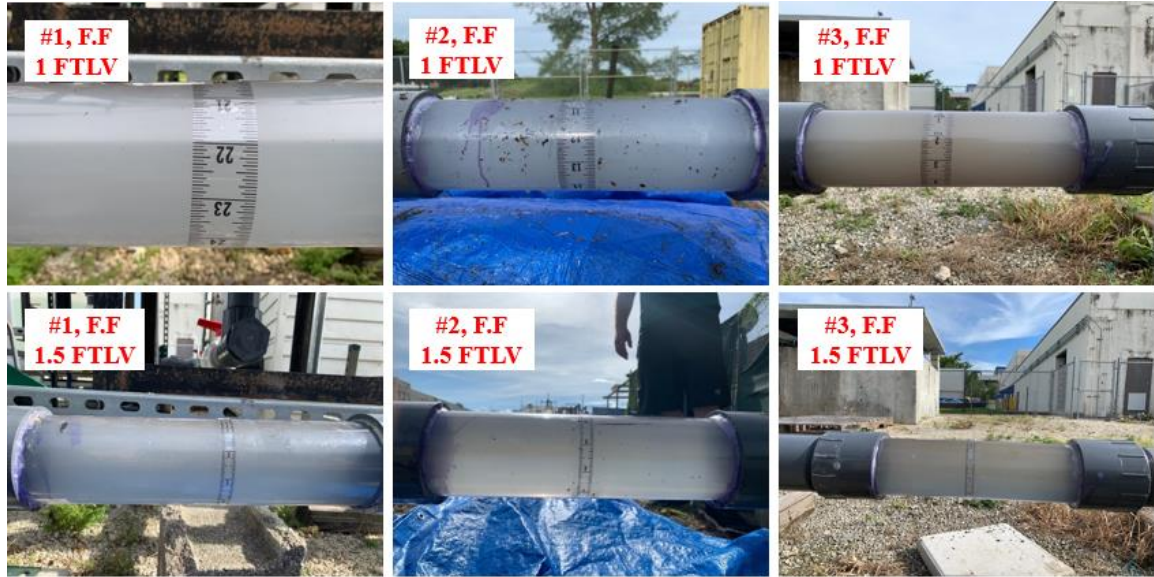
**Figure 5. Pipeline condition after flushing with 1 (up) and 1.5 (bottom) line volume of water from fully-flooded (F.F) initial conditions; sections #1, 2, and 3 are start, middle, and end of loop, respectively.**

Flushing tests were started with the system loaded with 10 vol. % (19 wt. %) kaolin-water and in the fully-flooded condition. In the flush operations, the slurry pump was stopped at target flush-to-line-volume (FTLV) values of 1 and 1.5 (corresponding to 65 and 97.5 gallons, respectively). Condition of the pipeline in three points immediately after flushing is shown in Figure 5. This figure shows a cloudy condition inside the third clear section (post-flush residues), indicative of insufficient cleaning with use of 1 line of flush water. Clean conditions were obtained by use of 1.5 line volume of water in all three clear sections.

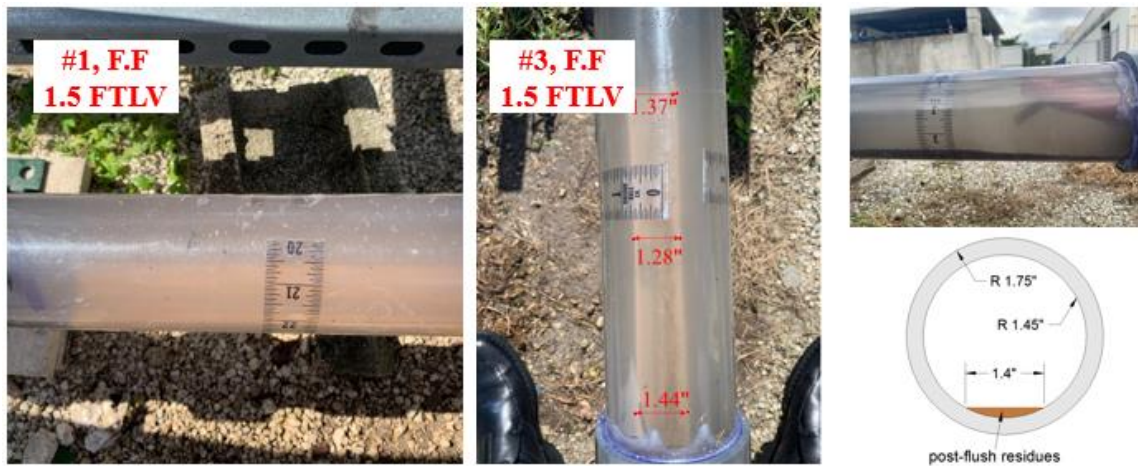
**Figure 6. Post-flush conditions of loop at start and end point clear sections one-day after flushing.**

Further, loop content was circulated in the post-flush circulation initially filled with 50 gallons of fresh water and allowed to settle for two days. After this period, a strip of kaolin was observed in the pipe invert. Solids concentration of this bed was found to be 1.6 vol. % through sampling from the loop (density measurements) and matched with a value obtained from geometric reconstruction. No post-flush residues (strips of kaolin) were found in the case of the target 1.5 FTLV. Similarly, no difference was found between density values of fresh water and recirculated post-flush streams displayed by the Coriolis meter.

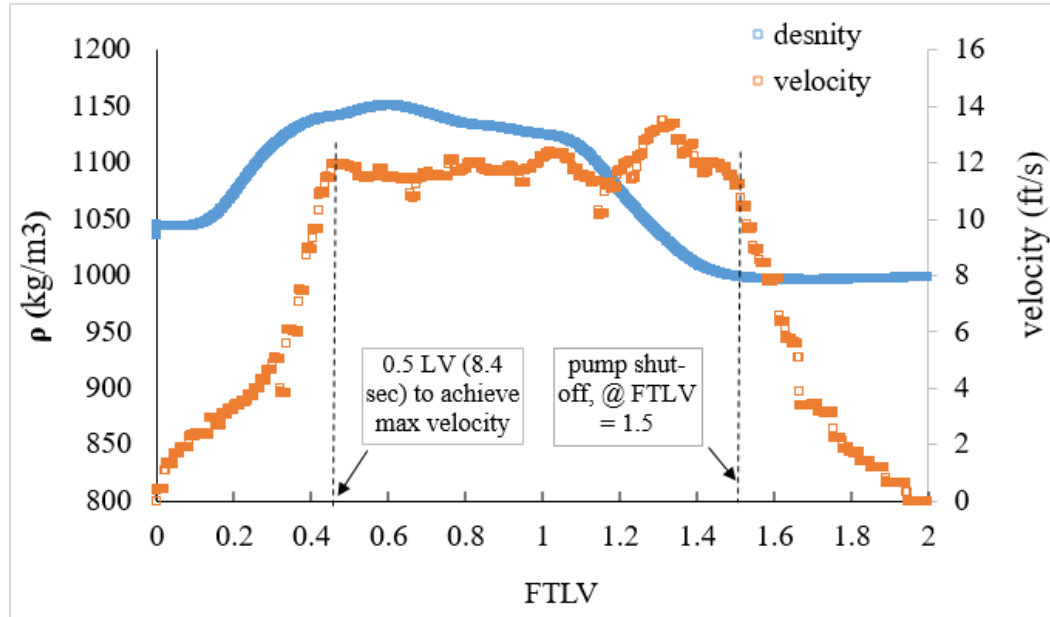
**Figure 7. Flow quantities during flushing of fully flooded pipeline with target FTLV of 1.5.**

system loss (solids leaving the pipeline). Density data reached a plateau at FTLV=1.5 which suggested a sufficient cleaning of the system at this FTLV. Further, content of the loop was circulated in the post-flush loop where constant density of  $996 \text{ kg/m}^3$  was observed at the Coriolis meter.

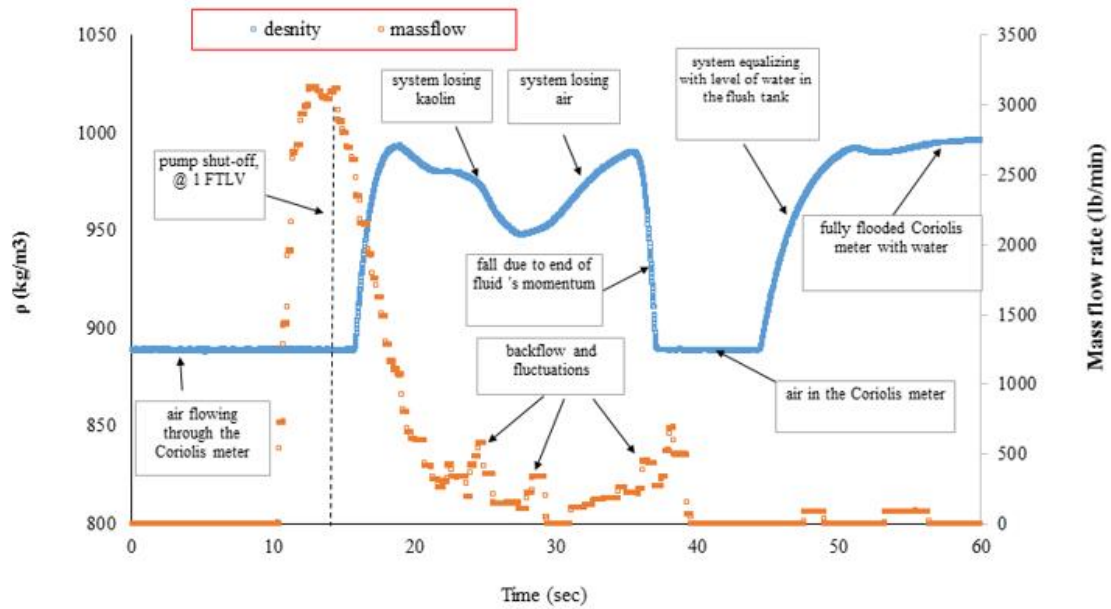
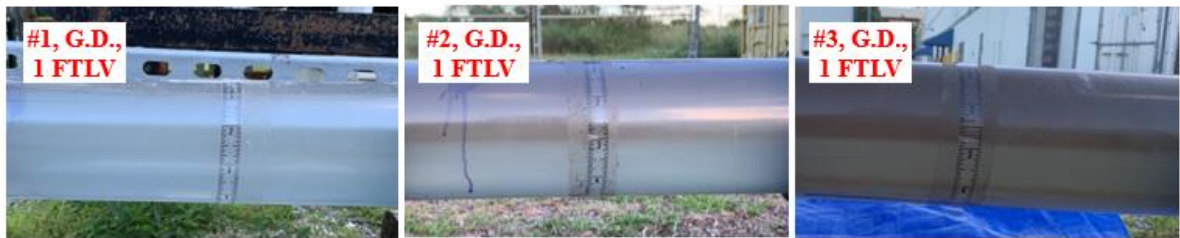
Figure 8. During-flush (up) and post-flush (bottom) assessments gravity-drained pipeline with target FTLV of 1.

Figure 8 shows data from the Coriolis meter during flushing of the gravity drained pipe. Density data shows small perturbations due to air being pushed through the Coriolis meter. Field observations (video recording) discovered a 10 second travel time for flush water to reach the end of pipeline at the location of the meter. This observation matched with the delay in the rise of mass flow curve. However, delay in the rise of density can only be explained by presence of air in the meter meaning that meter was not fully flooded. Full removal of air from vertical pipes inside the meter took about 4 seconds. Interestingly, the start of the density rise occurred after the pump was shut off and successive processes occurred due to system inertia as explained in the figure. Figure 8 also shows the condition of the clear sections immediately after the flush operation. All clear sections were found completely empty of kaolin and  $997 \text{ kg/m}^3$  was reported by the Coriolis meter.

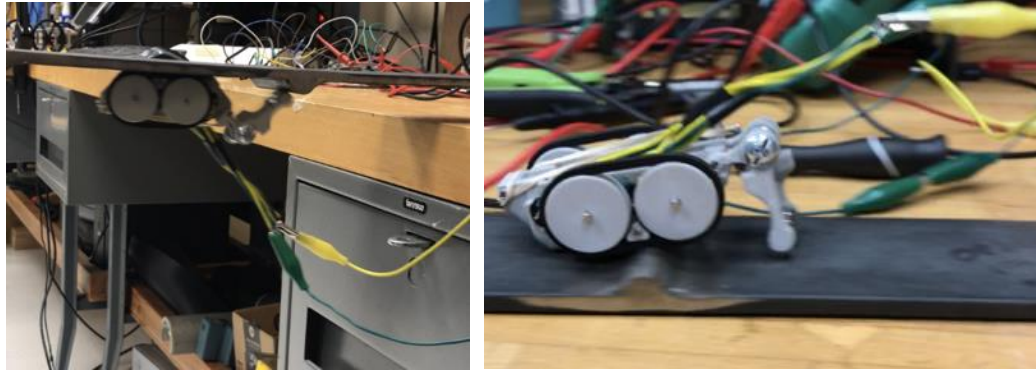
**Figure 11. Miniature inspection tool equipped with magnetic, free-rotating arm traversing over weld seams.**

Initial bench tests using the simulated weld seams with different heights showed that the modified version managed to traverse weld seams of 0.375 inches. This satisfies the minimum requirement specified by WRPS engineers. The figure below shows snapshots of the bench tests performed in the lab.

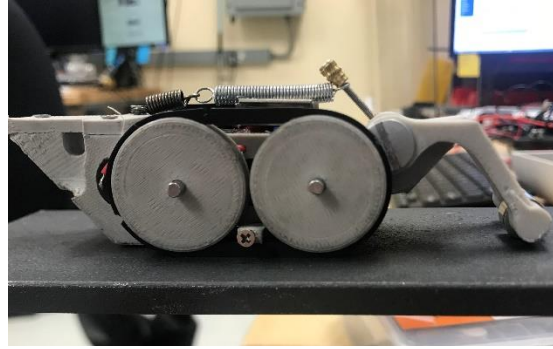
**Figure 13. Assembly of adjusted arms.**

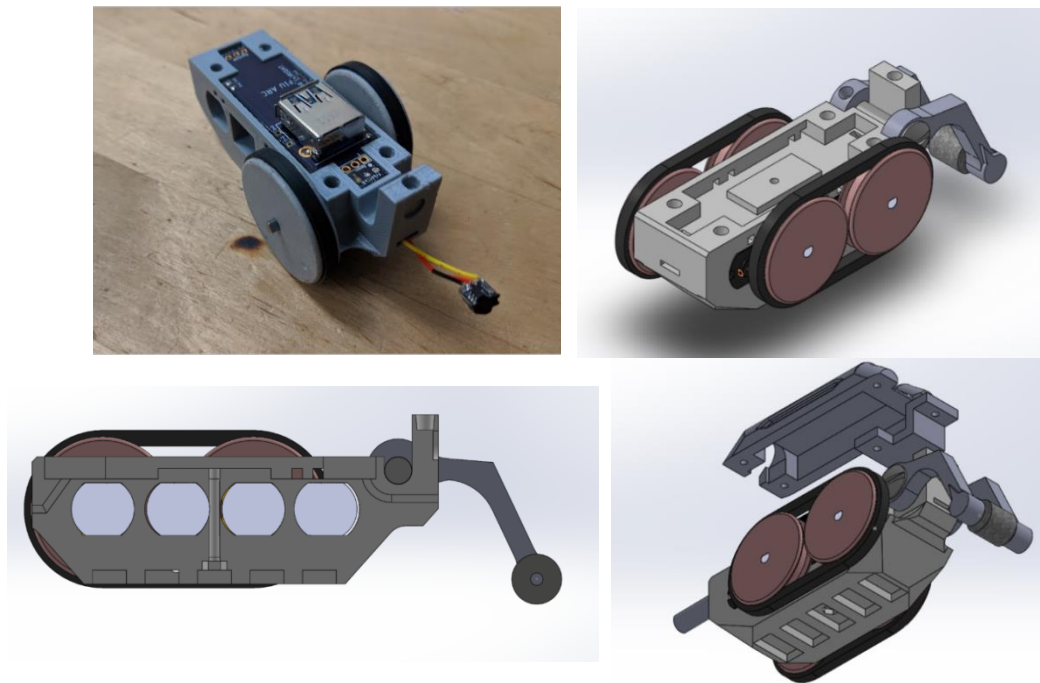
**Figure 14. Modified design of the magnetic arm mini rover.**

In preparation for testing of the miniature rover for the full-scale mock-up test, a few minor modifications were made. This included a dedicated holder and cable channels for the LEDs and camera. While testing the unit’s ability to traverse weld seams, it was observed that the unit would slightly yaw as it traversed over the seam since one track would reach the seam before the other. To account for this, a free rotating wheel was added to provide the stability needed. Some of these modifications are shown in the figures below.

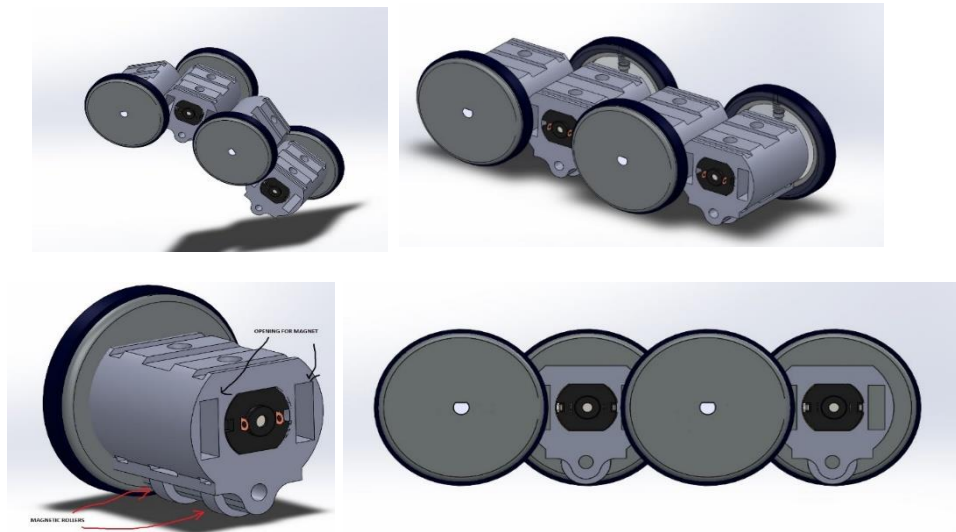
**Figure 18. Alternate rover design with the motor controls.**

To address challenges of inspecting the AY-101 primary liner, an alternate design is being developed for the rover to navigate around the 90 degree turns in the AY-101 refractory pad. The rover was split into separate sections, with each section housing a motor and a series of magnets. The segments are held together through a combination of stringers and magnets. Magnets are placed in the rectangular openings (referenced in the diagram below) in order to help maintain the natural, horizontal position between each motor segment. Magnetic rollers are used to maintain contact with the ferrous surface. The two holes on the top of each segment serve the purpose of securing a PCB and holding the motor in place. Each segment has a separate PCB, linked together using ribbon wire or flex PCB.

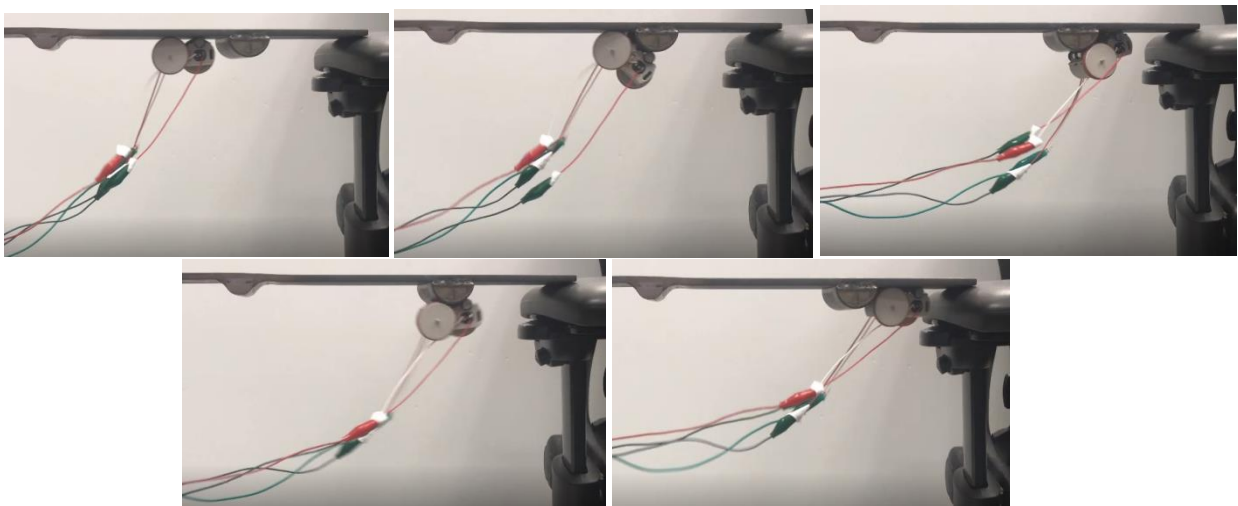
**Figure 19. Images showing rover traveling over 1.5” diameter weld seam.**

This new design of the rover was subjected to initial testing shown below. This multi-segmented version can not only address the weld seam challenge, but it can also navigate through 90° turns.

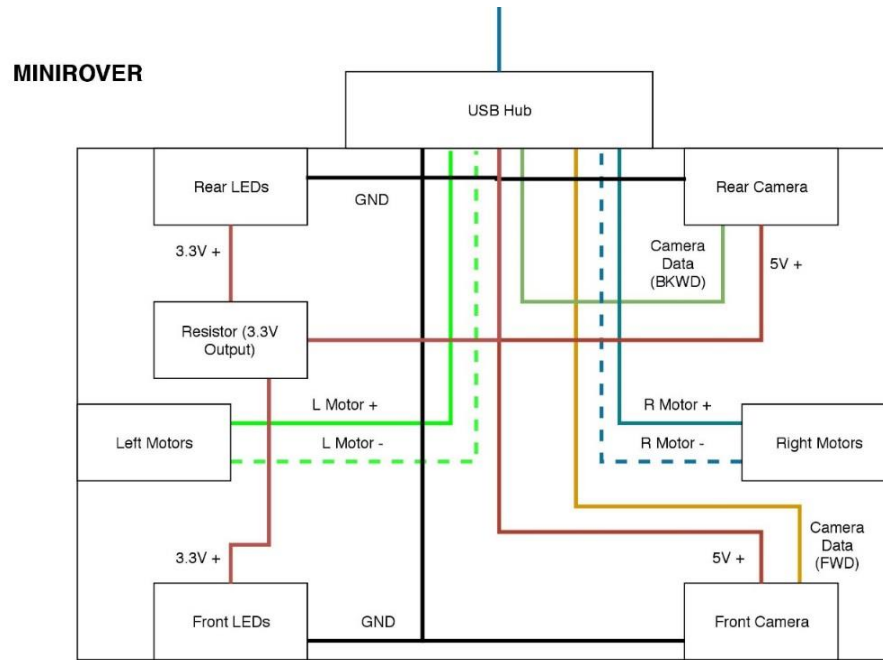
**Figure 23. Schematic of the control for mini rover.**

Schematics of the controls are shown for both the mini rover and the control capsule in the figures below.

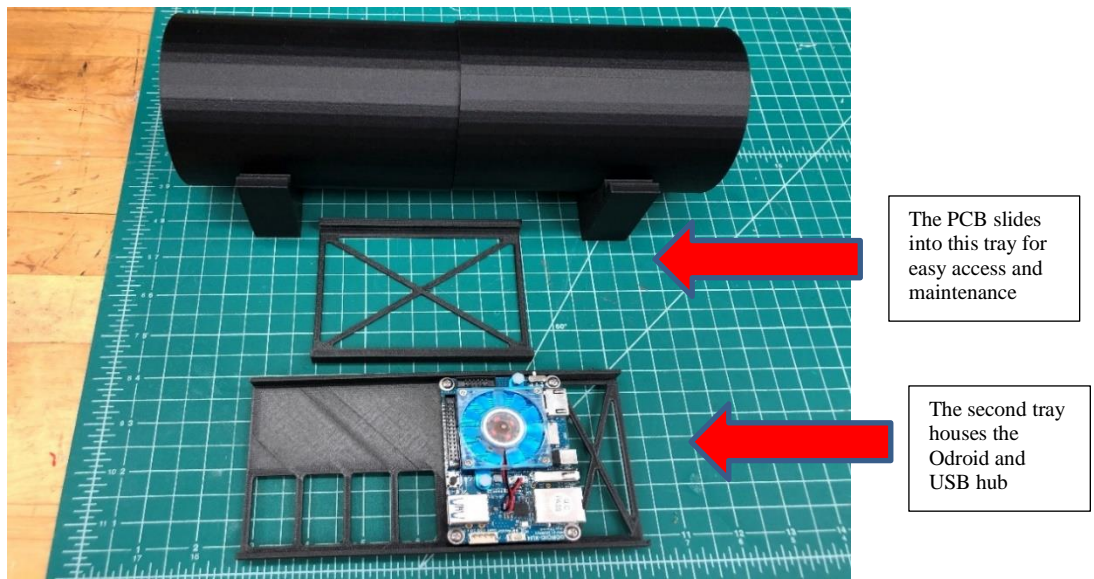
**Figure 27. New design for the capsule.**

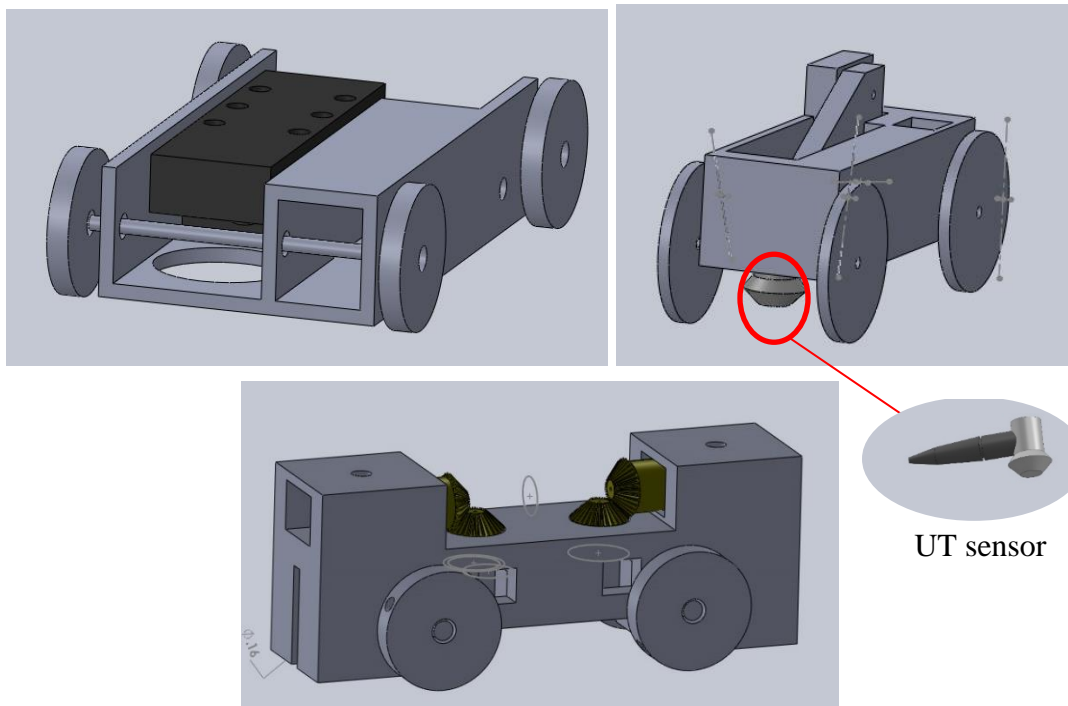
Figure 29. Secondary unit designs that include a UT sensor.

To improve the functionality of the rover, an additional module is being developed to house a UT sensor that can obtain thickness measurements of the liner. Renderings of the initial design concepts are shown in the figure below. Significant considerations include UT contact force required to obtain quality measurements and surface preparation required.

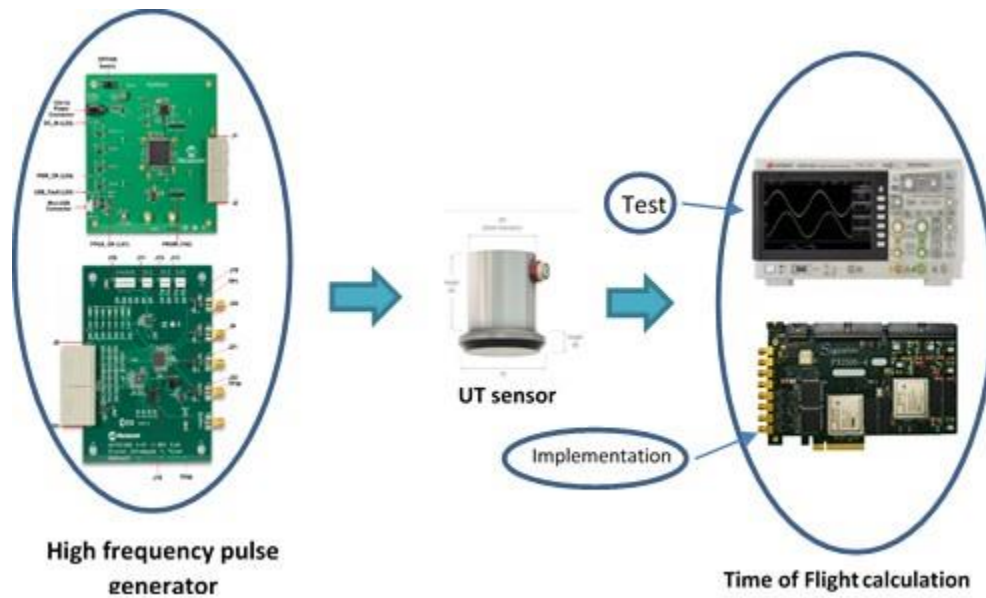
**Figure 31. UT sensor deployment process.**

In addition, the designs of the signal processing board of the UT sensor were evaluated. The evaluation utilized a high frequency pulse generator, an Ultrasound TX Pulsar Evaluation Board and a Microchip Ultrasound Platform Board (MUPB001). These components will be utilized to generate a high frequency pulse to actuate the UT sensor. An oscilloscope with a minimum 500MHz BW and two high-impedance probes will be used for the calculation of the time of flight. In the future, we plan to use an FPGA board for this function.

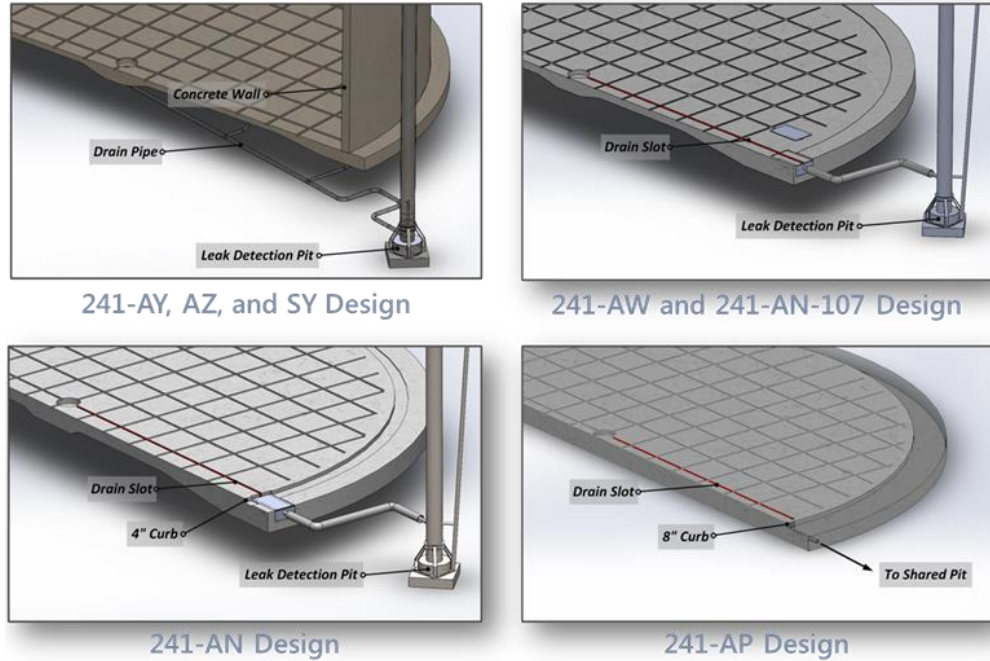
Figure 32. Leak detection systems at Hanford’ DSTs.

The only access to the secondary liner under the tank refractory is through the leak detection systems in the foundation of the DSTs. Figure 32 shows 4 different configurations for the leak detection systems with all having a DN 150 (NPS 6) drain pipeline providing access to the drains slots under the tank. Figure 33 illustrates a typical configuration of the drain slots in the foundation of the Hanford's DSTs. The system consists of a maze of channels about 115 mm (4.5 inches) with 65 mm (2.5 inches) high. Most of the configurations use an entry manifold that slopes up from the drain pipeline to the plenum at the middle of the tank.

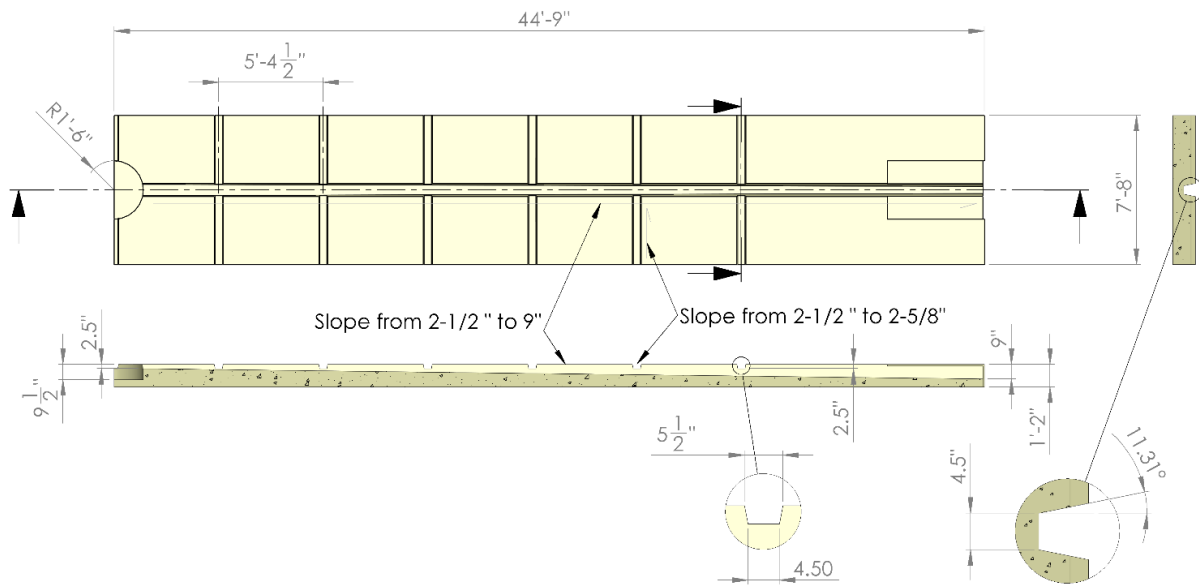
Figure 33. Typical DST’s drain slots foundation.

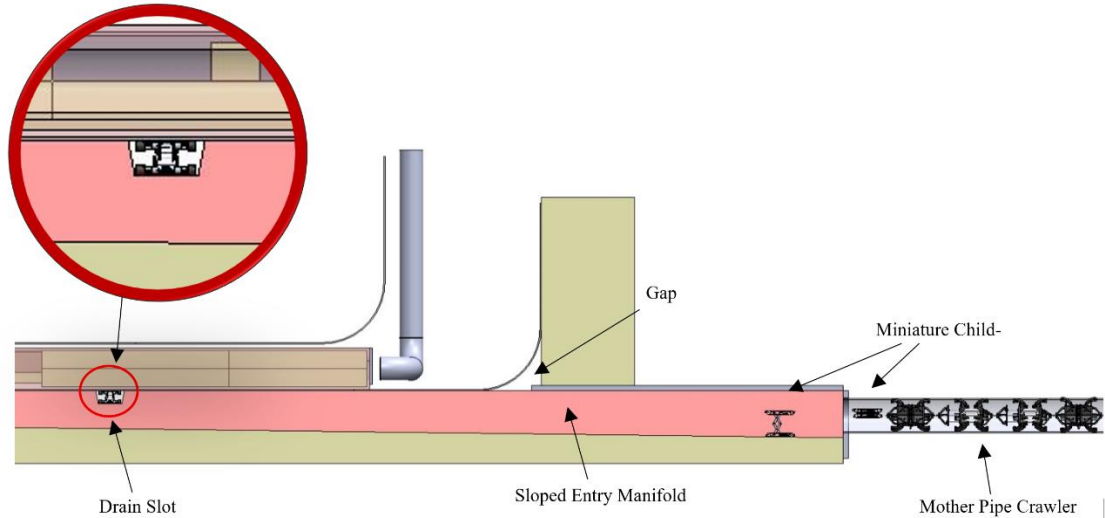
**Figure 34. FIU’s inspection system.**

The tool FIU has been developing is a robotic marsupial system that uses a mother pipe crawler to navigate through the ND 150 (6”) drain pipeline and deploys a miniature child-rover into the drain slots. Figure 34 shows a rendering of the conceptual design and approach.

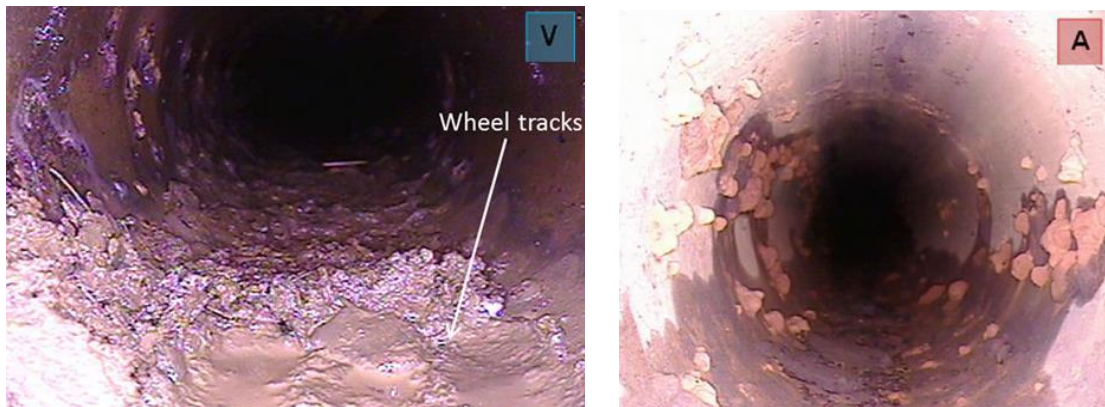
**Figure 35. Existing condition of DST’s drain lines (WRPS).**

The crawler operates using pneumatic actuators on the same peristaltic principles of other inspection tools previously developed at FIU [1-3]. This configuration provides a high payload to weight ratio, and should be suitable for tough environments found in the existing DST’s drain pipeline, as shown in Figure 35, and experienced in previous inspections attempted by WRPS. Previous efforts at the site have fallen short of reaching the central plenum due to debris and mud within the pipeline.

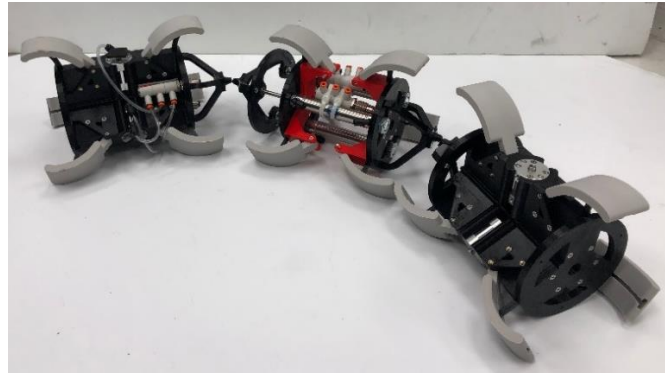
**Figure 36. Mother pipe crawler prototype.**

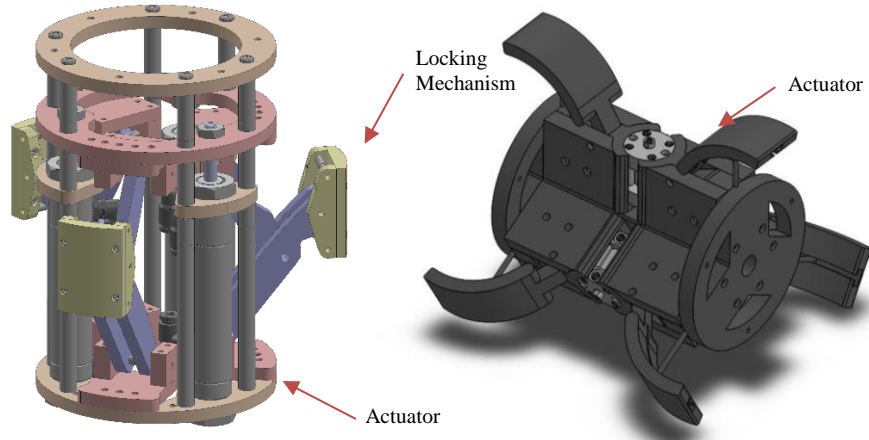
**Figure 38. Original (left) and redesigned (right) gripper.**

The grippers have been redesigned to incorporate less moving parts as illustrated in Figure 38. The new streamlined design takes advantage of the module large diameter (about 5”) and replaces the original locking mechanism with radially distributed pneumatic actuators acting directly to the pipe surface. A functional prototype of the redesigned grippers is as shown in Figure 39.

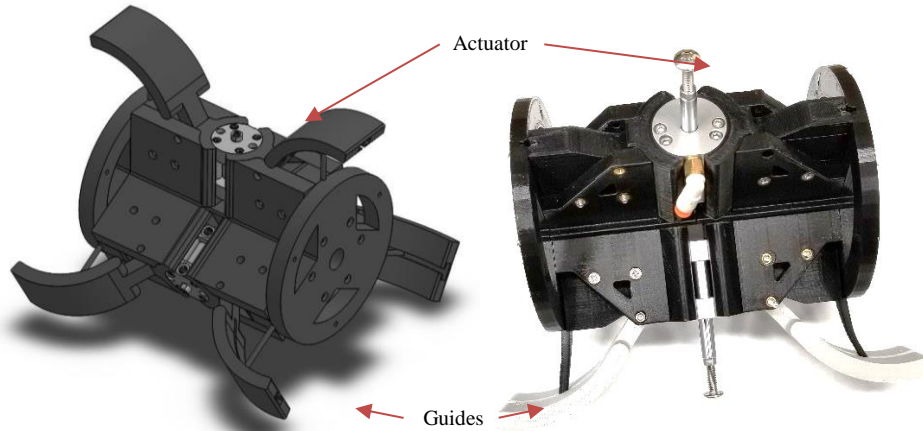
**Figure 39. Redesigned gripper model (left) and prototype (right).**

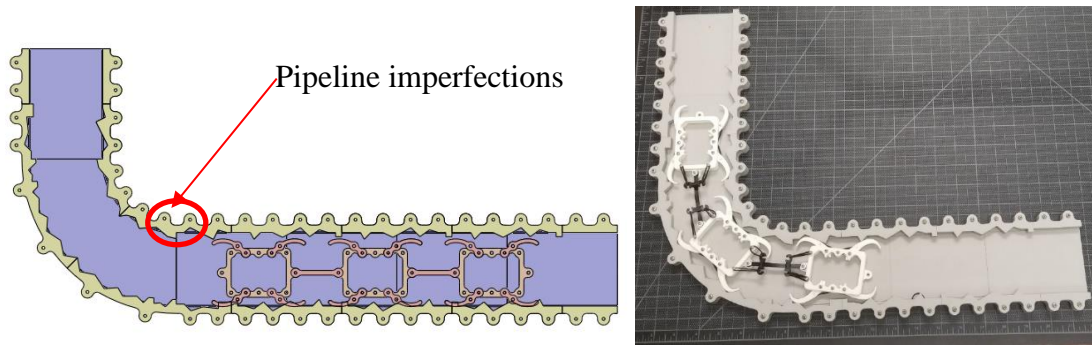
**Figure 40. Pipe cross-section mockup conceptual design.**

Figure 40 shows simplified two-dimensional cross-section tests that were used to optimize the curvature of the guides in each module and improve efficiency while minimizing potential sediment accumulation.

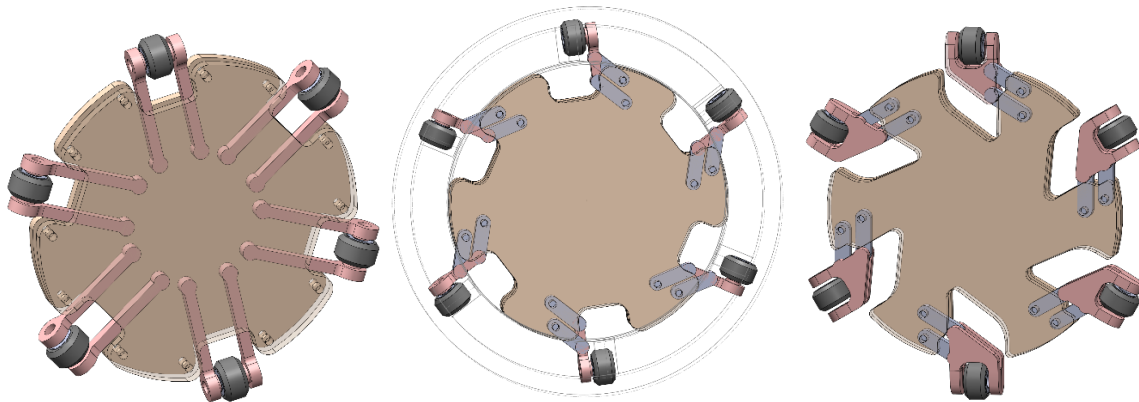
**Figure 41. Alternative guide designs.**

Other alternative guide mechanisms similar to the traditional suspension system are being investigated. Sample designs are illustrated in Figure 41. The use of radial springs and wheels has the potential to minimize friction to better handle the potential obstacles. However, they add extra complexity to the system.

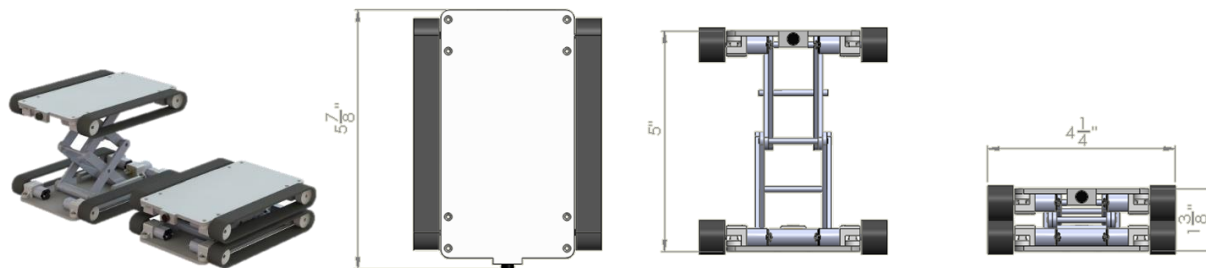
**Figure 42. Miniature child-rover conceptual design.**

The miniature child rover, shown in **Error! Reference source not found.**, is a modified version of the magnetic mini-rover developed to inspect the primary liner tank floor. The primary modification includes a scissor lift mechanism that allows the tool to travel at the bottom of the central slot and extend to magnetically attach to the bottom of the secondary liner. This approach is taken to provide a means to pass the gap in the cover of the drain line shown in **Error! Reference source not found.**

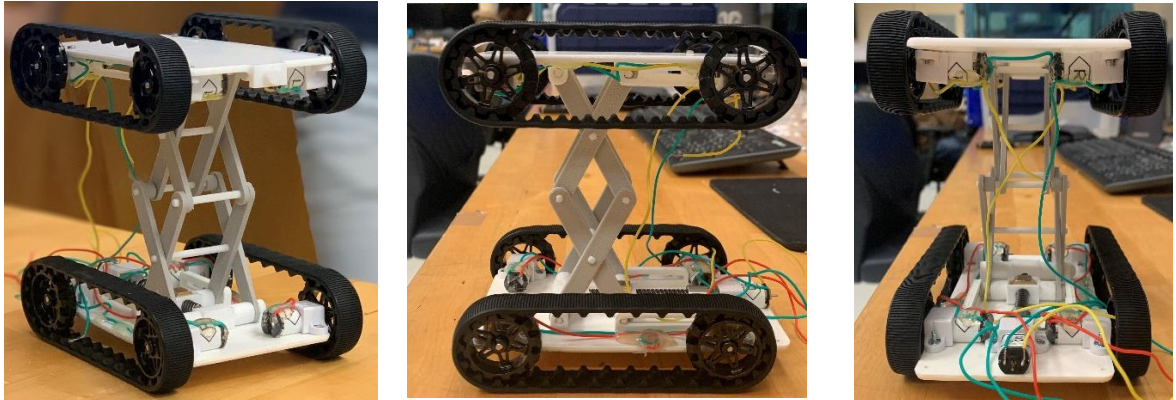
**Figure 43. Child inspection tool prototype.**

advanced sensors such as radiation, ultra-sound, LiDAR and surface camera. The integration will take advantage of the sensors and software framework being developed for other tasks at FIU.

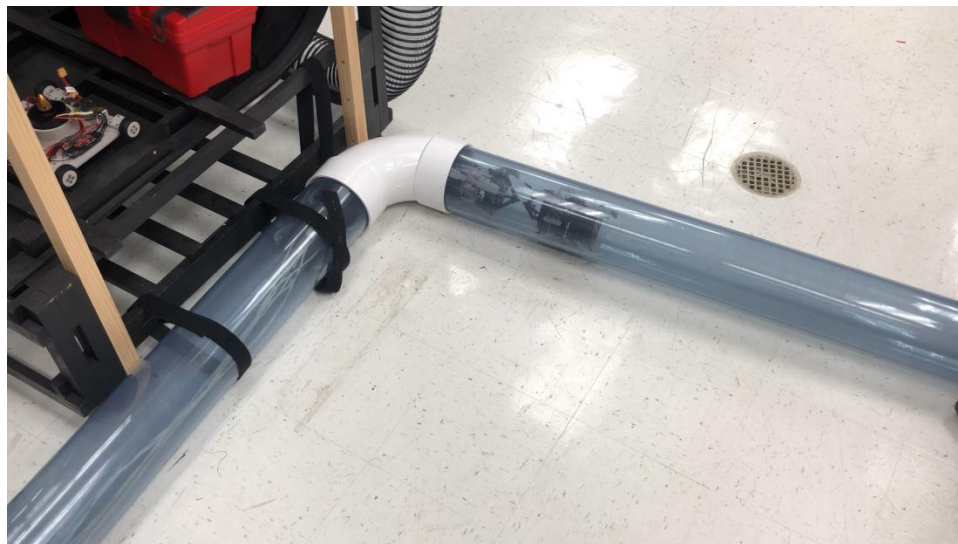
**Figure 44. Preliminary maneuverability tests.**

Several bench-scale tests have been conducted to evaluate the system performance and durability, including successful runs of the mother pipe crawler through pipelines with multiple fittings, as illustrated in Figure 45. The crawler is capable of pulling up to 445 N (100 lbs) before it stalls. The team plans to run additional testing considering mud deposit in the pipeline.

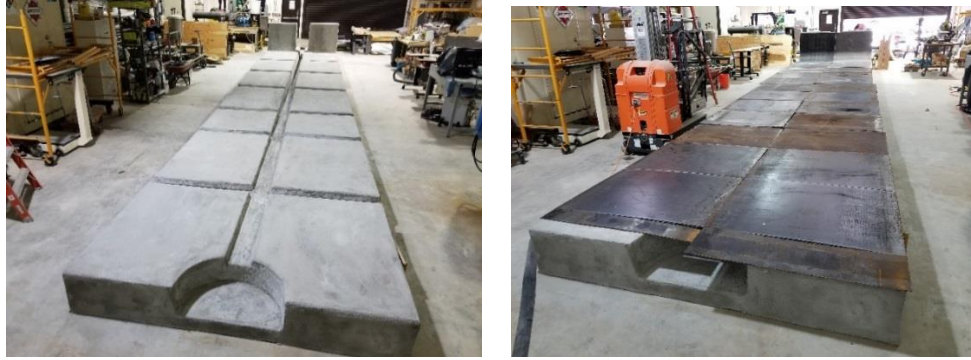
Figure 45. The full-scale mockup foundation.

After the integration of the child rover with the parent crawler, the system will be tested in the mockup of the DSTs at FIU. Figure 45 shows the 8 ft. wide sectional mock-up with the drain slots in the foundation.

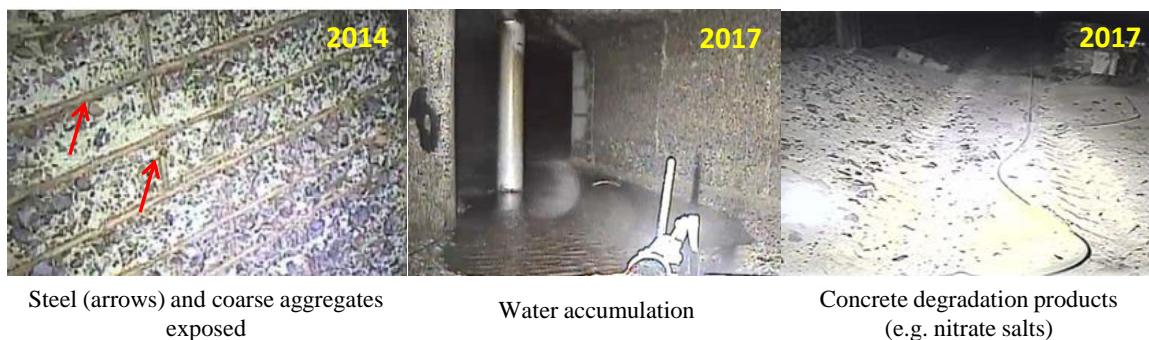
**Figure 46. Images of HCAEX tunnel degradation [2], [11].**

The HCAEX tunnel ventilation system mitigates the release of radioactive materials by pulling exhaust air from the H-Canyon chemical processing areas and the HB-line through the sand filter, where radioactive materials are removed [10]. Reinforced concrete was the material used for the construction of the tunnel, which was originally covered with a protective liner. The HCAEX tunnel has been visually inspected over the years by means of pole cameras and robotic crawlers, demonstrating the ongoing degradation of the concrete tunnel walls. Figure 46 shows images of the degradation observed of the tunnel interior walls at different times. The extent of the concrete tunnel degradation was characterized by: 1) exposure of steel rebar (large areas), 2) eroded surfaces exposing coarse aggregates (generalized), 3) formation of concrete degradation compounds (e.g. nitrates and carbonates) accumulated on the tunnel floor, and 4) water accumulation at some locations. Also, at multiple locations of the tunnel, the degradation is so severe that the two layers of steel rebar (vertical and horizontal) were completely exposed, indicating that more than 2 in. of concrete were lost [10].

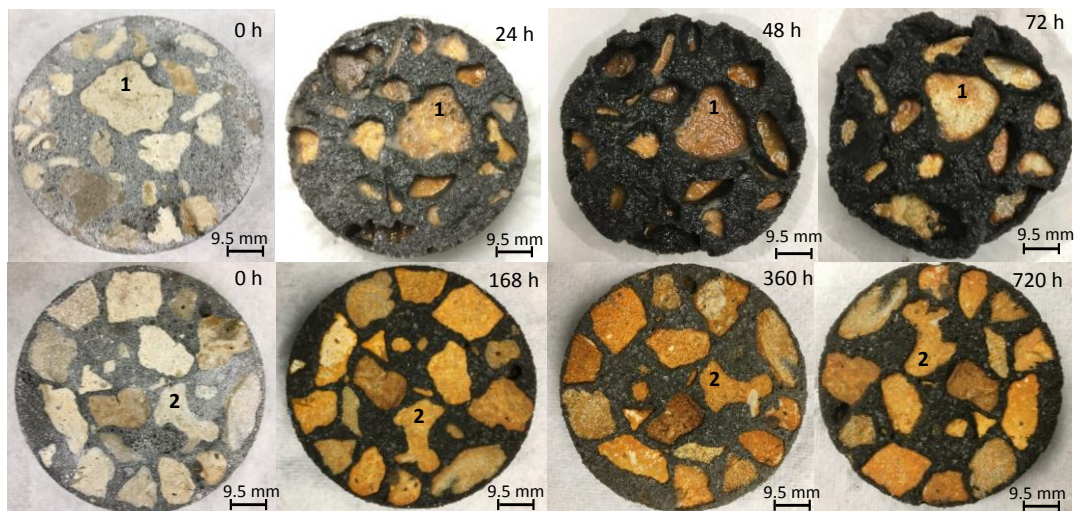
**Figure 48. Images of concrete specimens (sample 2) immersed in 0.025M (top) and 0.5 M (bottom) nitric acid solutions. (The numbers 1 and 2 identify the same coarse aggregate for the two tested specimens at different times. Samples were wet when the pictures were taken, except for the control sample).**

Figure 48 shows the progress of the concrete degradation with exposure time. In general, no matter the concentration of the acid solution, concrete samples experienced a fast and intense degradation with immersion time characterized by 1) loss of material (cement paste and sometimes coarse aggregates), 2) fragile and powdery surface (to the touch), 3) pores widening and 4) color change. The degradation of the concrete followed a heterogeneous pattern, more intense (hollowing) in the coarse aggregates than in the paste (Figure 48). It seems that the nature of the coarse aggregate used (limestone, with ~50% of calcium carbonate), determined the greater intensity of the attack. However, the HCAEX tunnel concrete surface showed significant erosion with protruded aggregate (see Figure 48), which may be related to the schist-type coarse aggregate used in the tunnel construction [12].

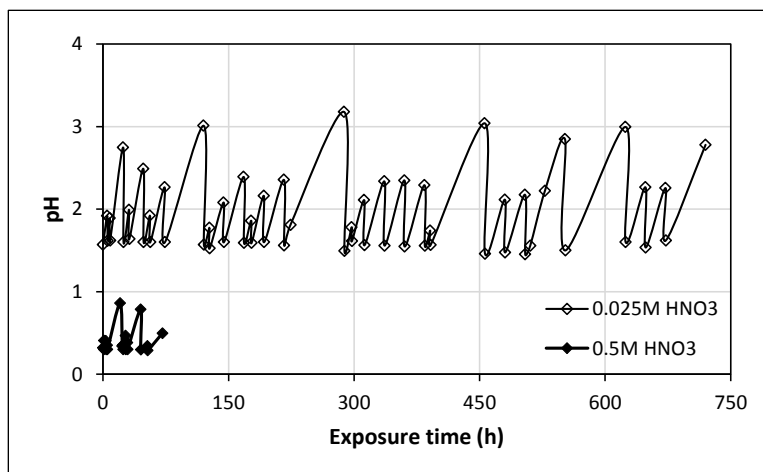
**Figure 50. pH Changes of the 0.025M and 0.5M Nitric acid solutions with time.**

The pH change of the acid solutions was also monitored with time, as shown in Figure 50. The pH change is an indicator of the occurrence of acid attack on the concrete surfaces due to an acid-base reaction (reaction 1) that will lead with time to a pH decrease of the solution. Consequently, the pH and alkalinity of the concrete samples will be affected leading to the material deterioration. The figure shows variation of the solution pH with time, which was faster at initial immersion times than after some days of testing. The pH variations are represented by peaks out of the expected pH values for the 0.025M solution (pH=1.6) and 0.5M solution (pH=0.3), indicating acid consumption. The concentrations of the acid solutions were adjusted by adding concentrated acid.

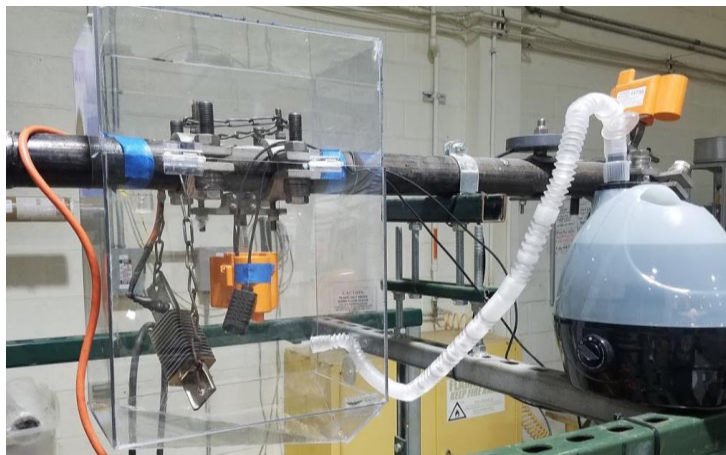
**Figure 51. Experimental set up with heater and sensors in the chamber.**

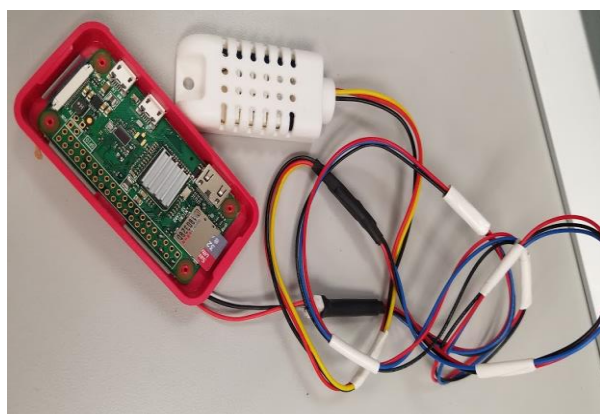
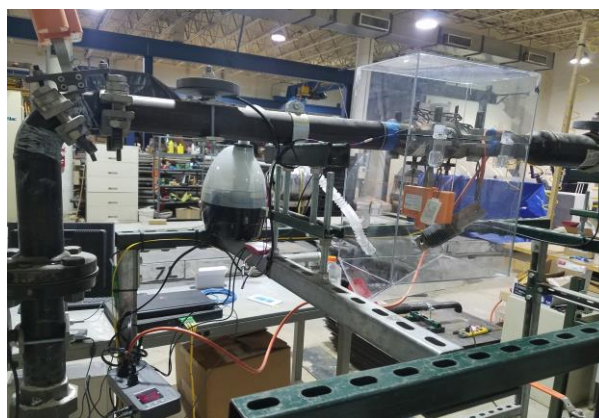
**Figure 52. Data acquisition system (left) and experimental set up (right).**

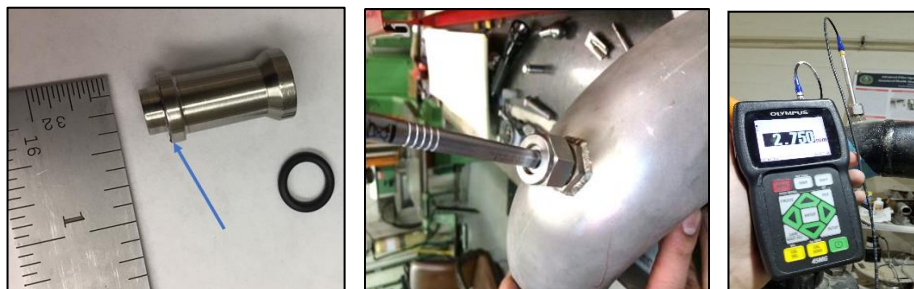
**Figure 53. a) Erosion Coupon b) UT sensor and coupon [4] c) UT pencil sensor on FIU's loop.**
