## **YEAR END TECHNICAL REPORT**

September 29, 2018 to September 28, 2019

# **Chemical Process Alternatives for Radioactive Waste**

U.S. Department of Energy

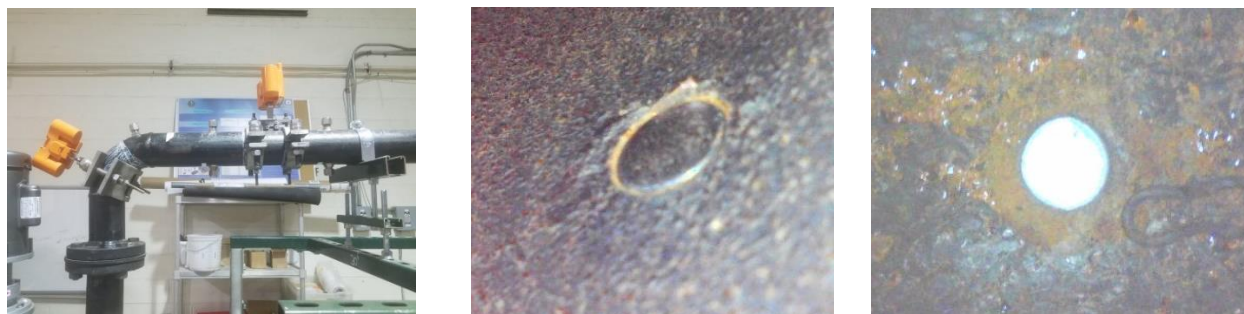
**Figure 54. SRNL Coupons on the pipe loop, endoscopic images of the pipe internal surface with the coupons.**

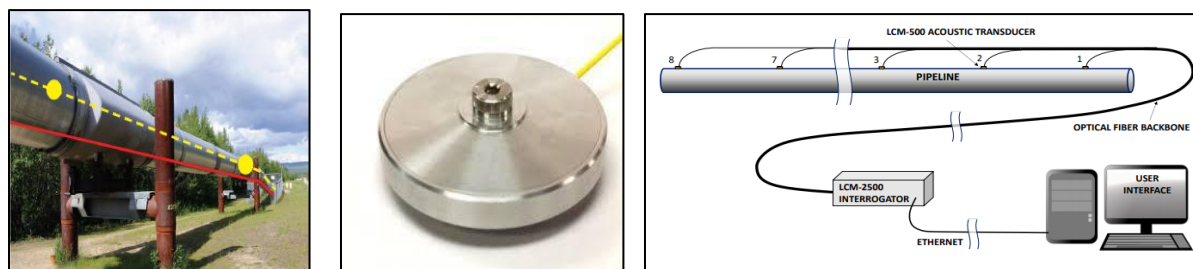
**Figure 55. Fiberstrike a) sensor system b) sensor [6] c) monitoring system layout [6].**

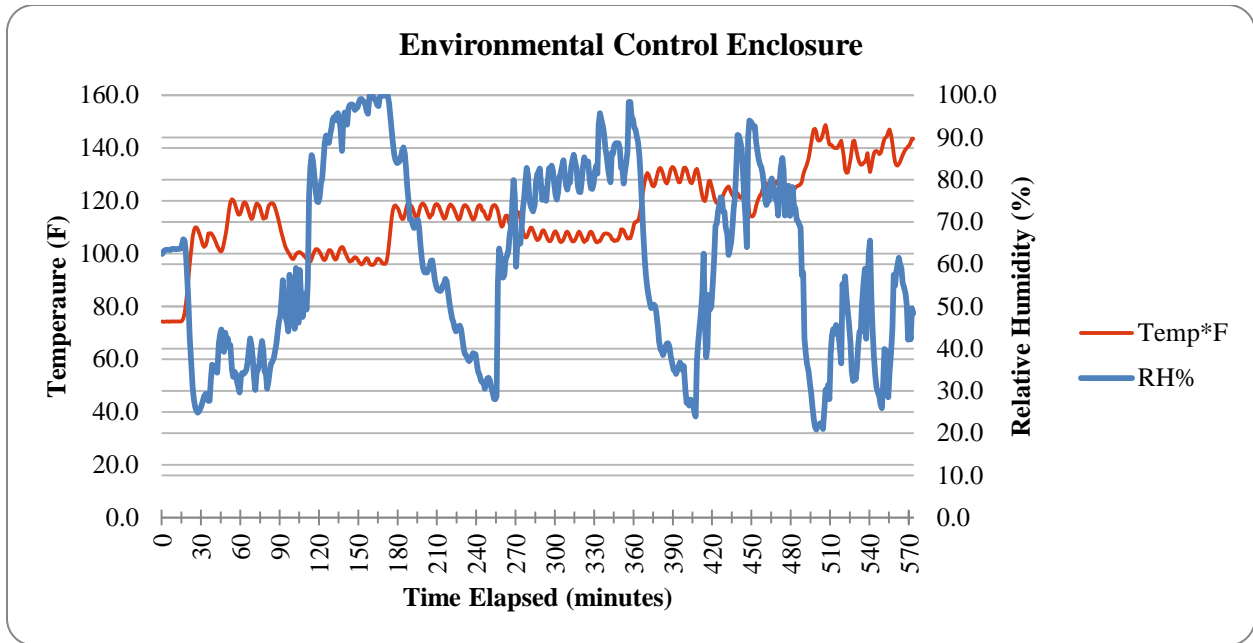
**Figure 58. Dynamic environmental conditions in the UT sensor’s testing chamber.**

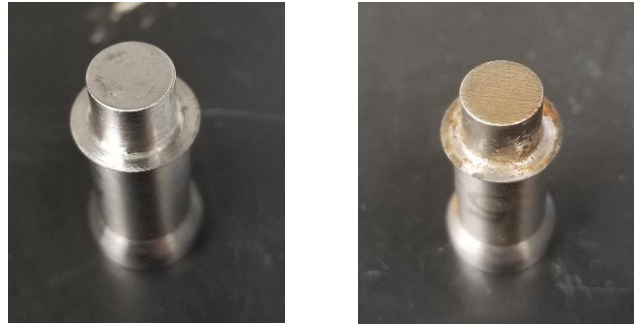
**Figure 60. SRNL coupon (new) a) before the test and b) after the test.**

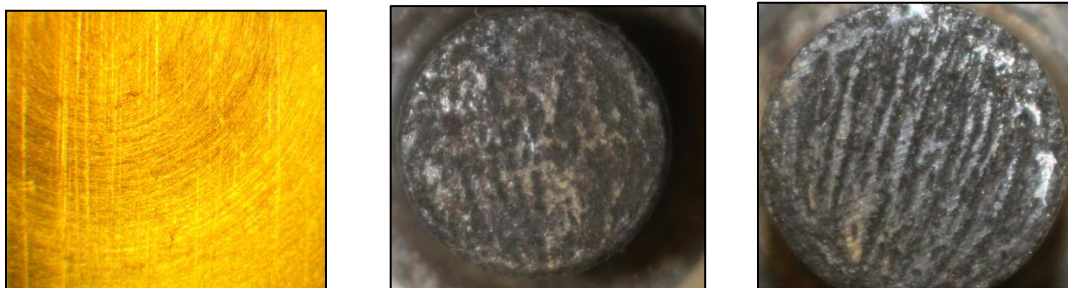
**Figure 61. a) New coupon surface; b) Coupon 1 (after testing); c) Coupon 2 (after testing).**

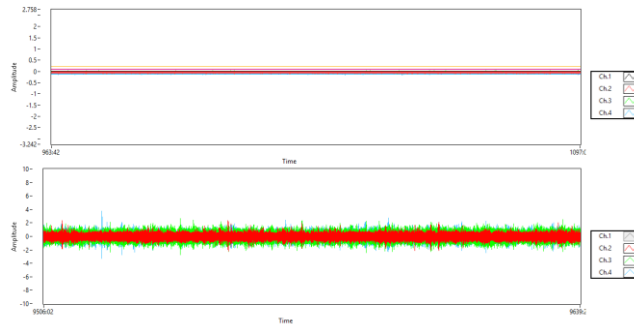
**Figure 65. Sensor baseline profile of pipe loop (no activity - top and pump operating - below).**

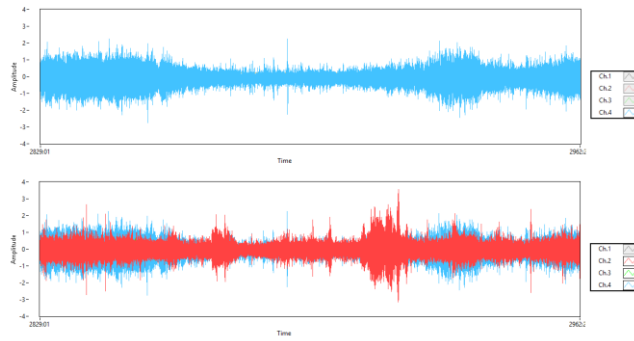
**Figure 67. Sensor profile (0.5” hole opened and closed).**

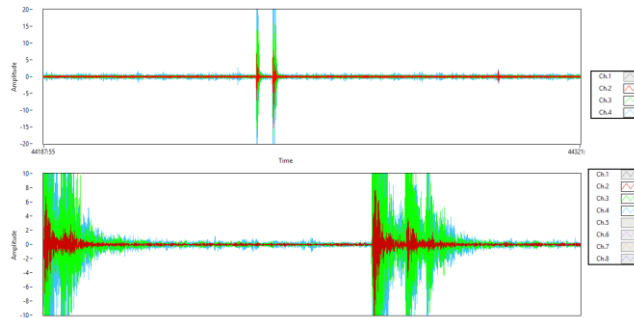
**Figure 68. Sensor profile (pipeline strike 13 sec - top and 2 sec magnified - below).**

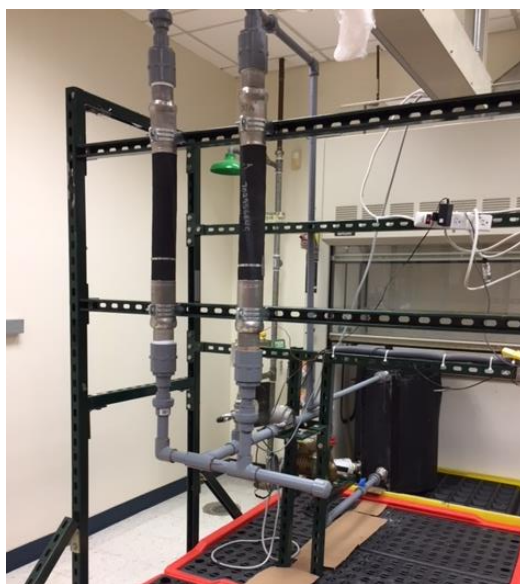
**Figure 69. Water only aging loop.**

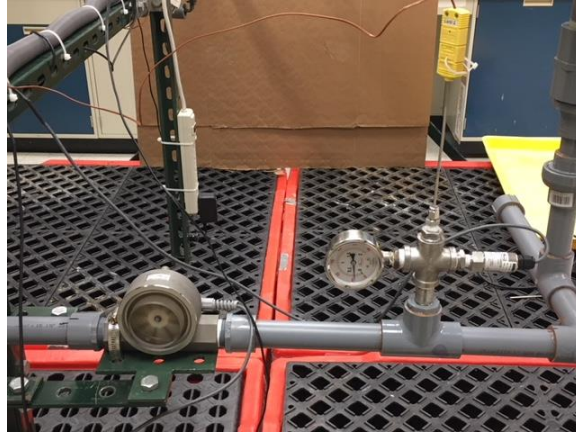
**Figure 70. Flow meter, pressure transducer and thermocouple.**

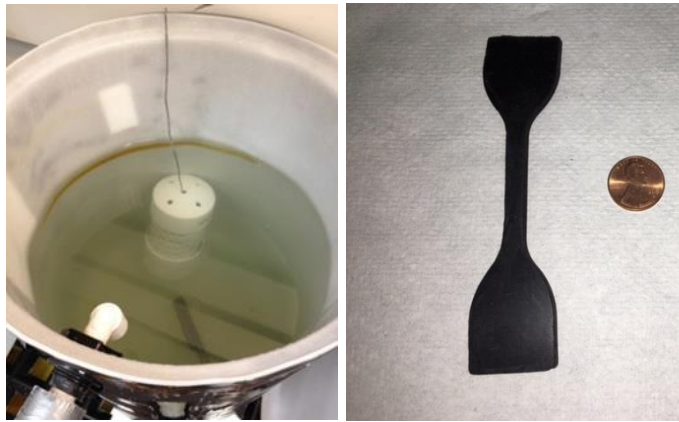
**Figure 71. Coupon aging vessel (left) and EPDM dog bone (right).**

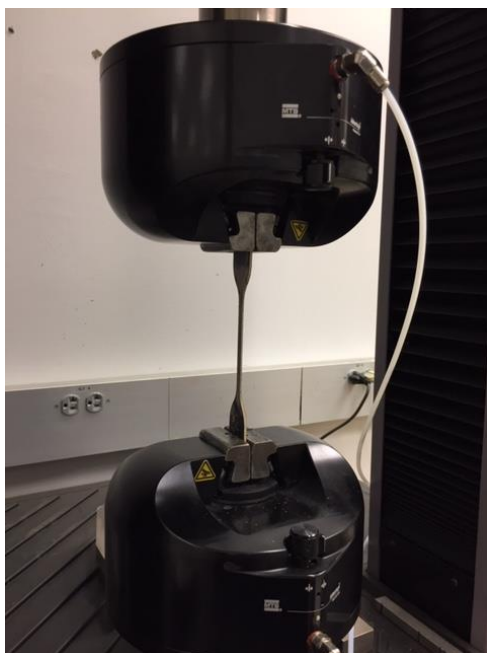
**Figure 72. Tensile strength testing of an EPDM dog bone.**

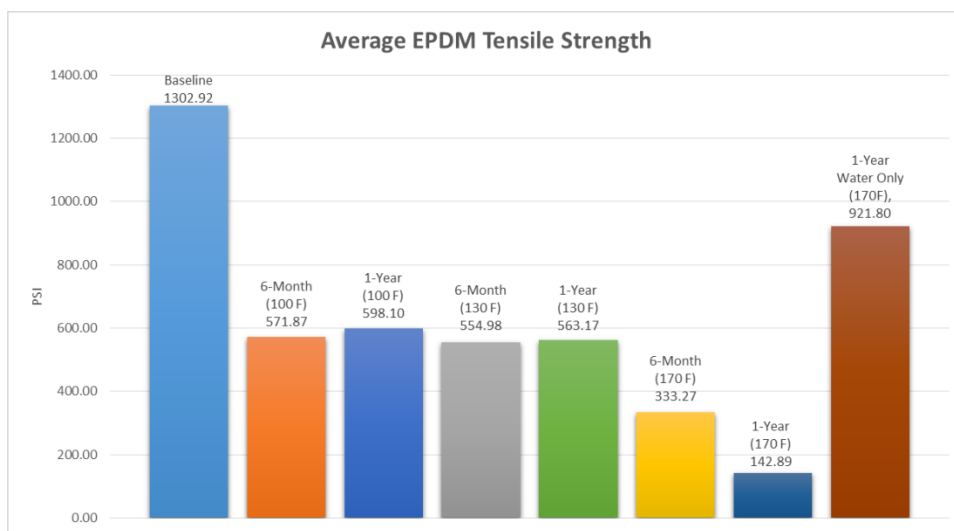
**Figure 73. EPDM dog bone tensile strength.**

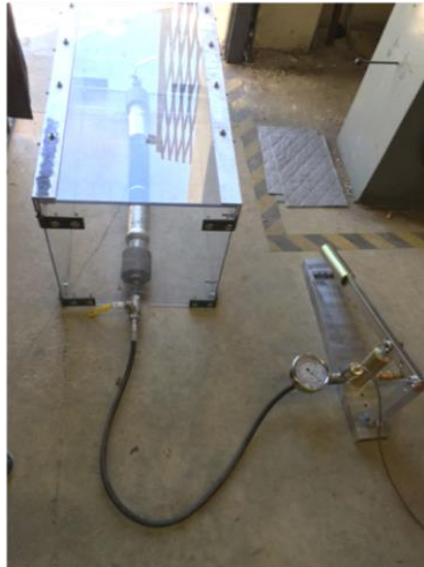
**Figure 74. Hose burst test apparatus.**

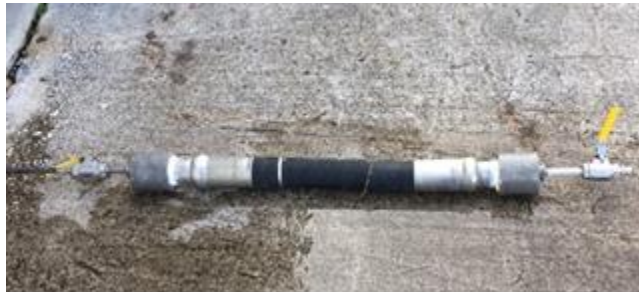
**Figure 75. Ruptured HIHTL specimen WO-01.**

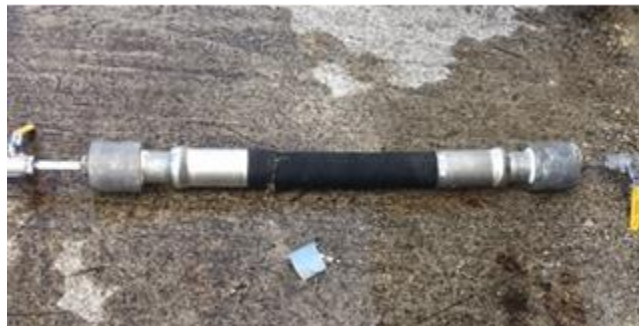
**Figure 76. Ruptured HIHTL specimens WO-02.**

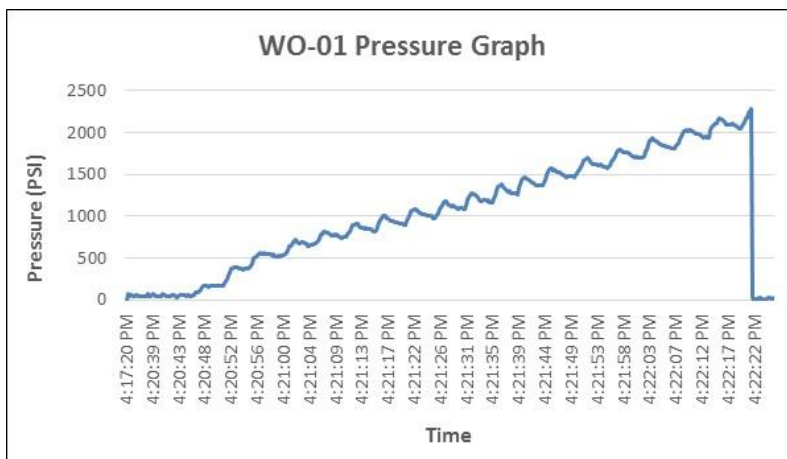
Figure 77. WO-01 burst pressure graph.

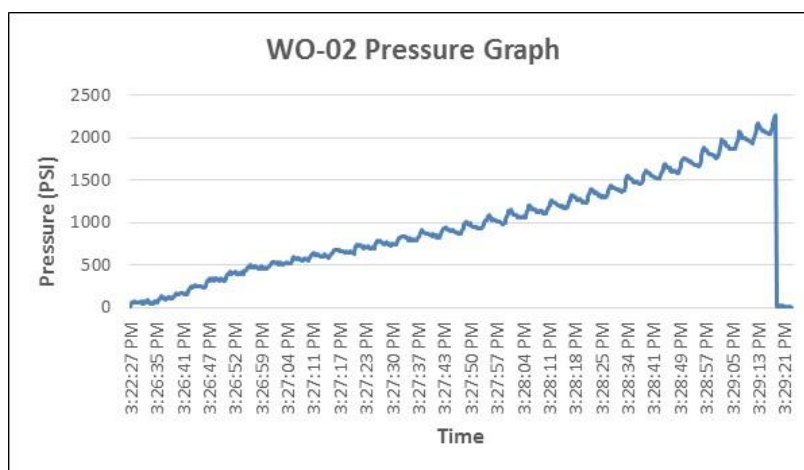
Figure 78. WO-02 burst pressure graph.

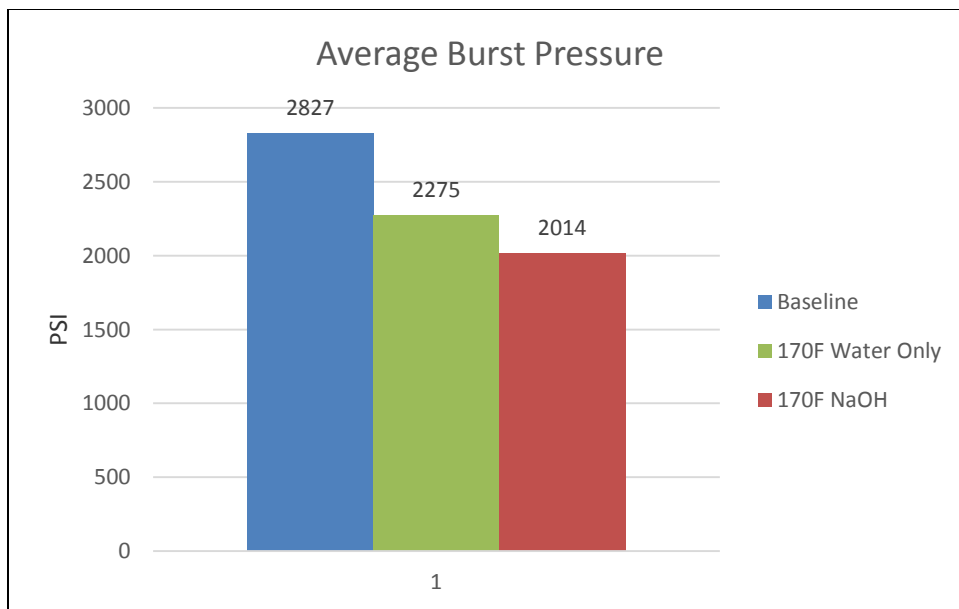
Figure 79. Average hose burst pressure comparison.

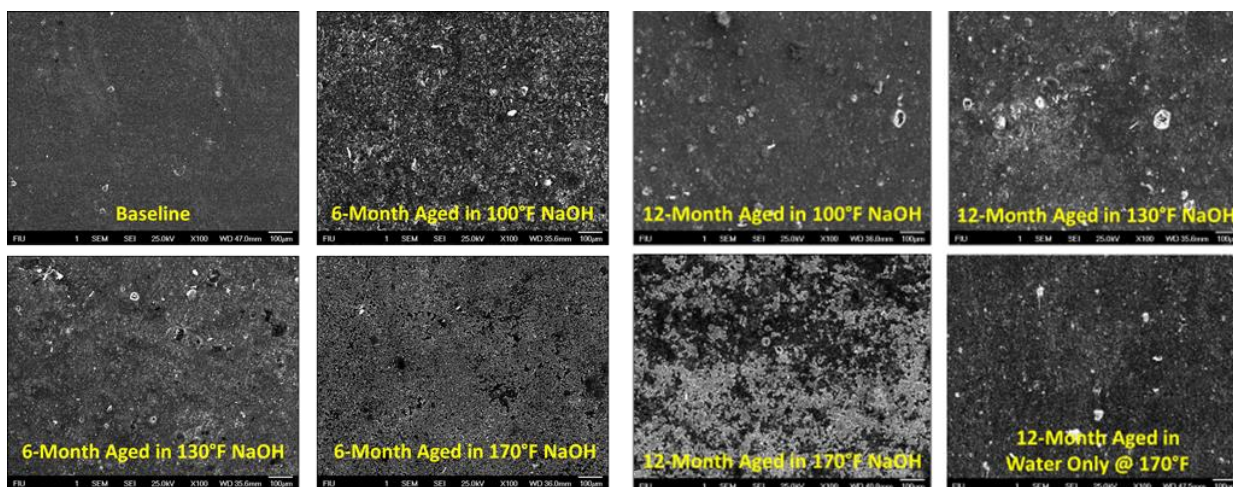
Figure 80. Visual characteristics of the surface of the EPDM (dog-bone) specimens before and after aging.

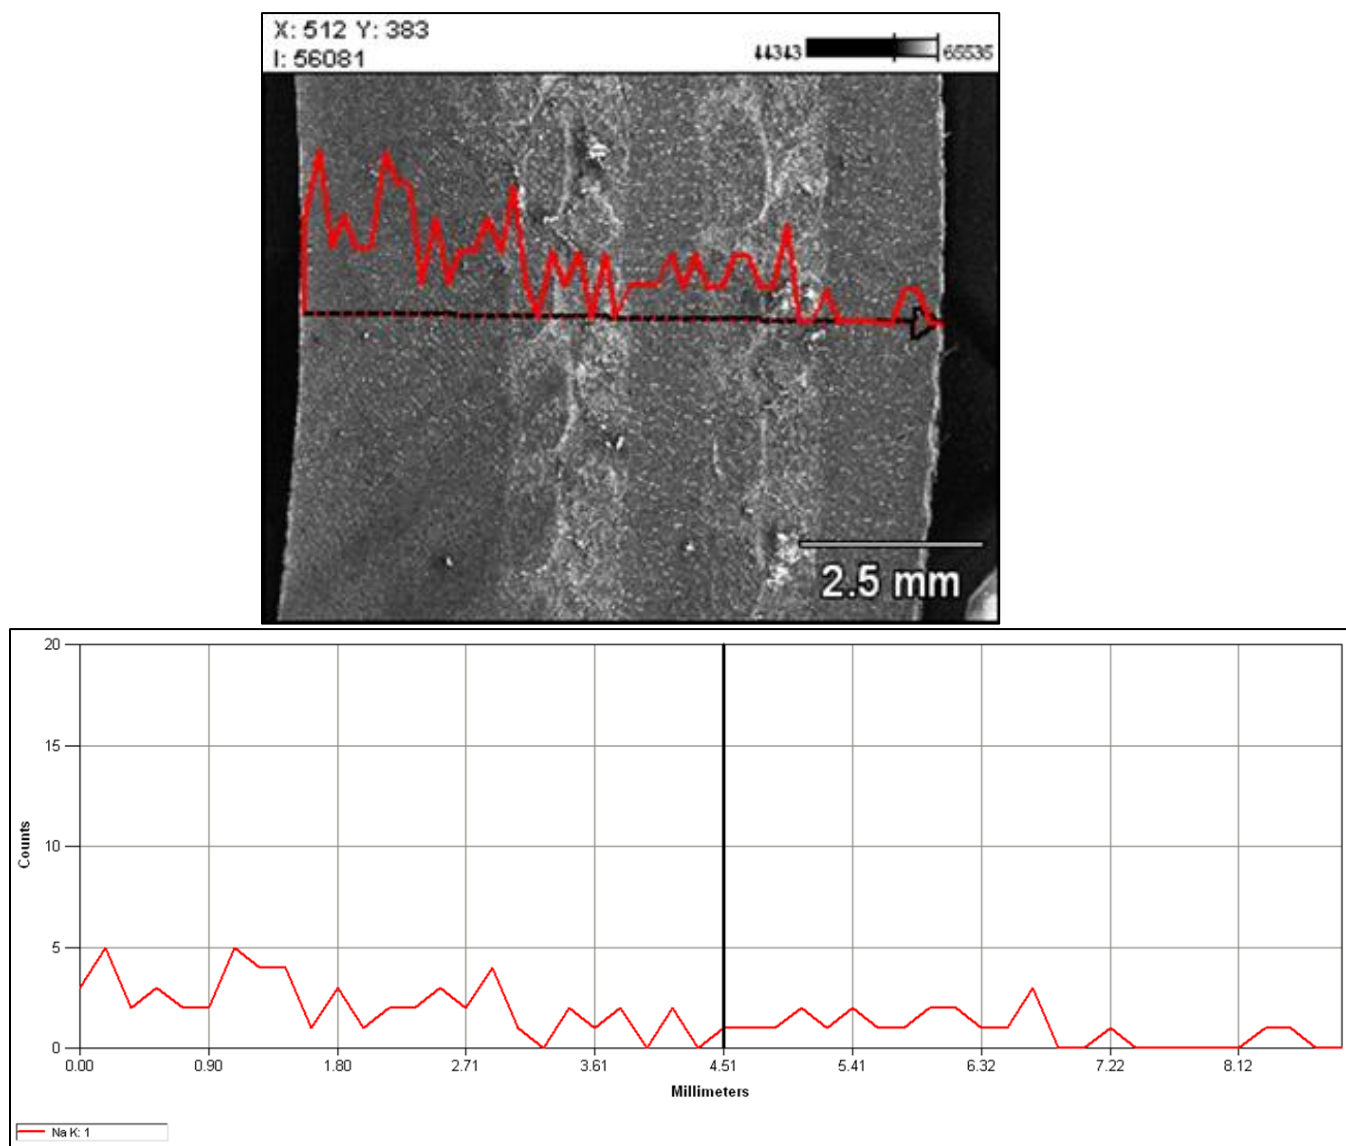
**Figure 81. SEM-EDS scan of baseline hose specimen.**

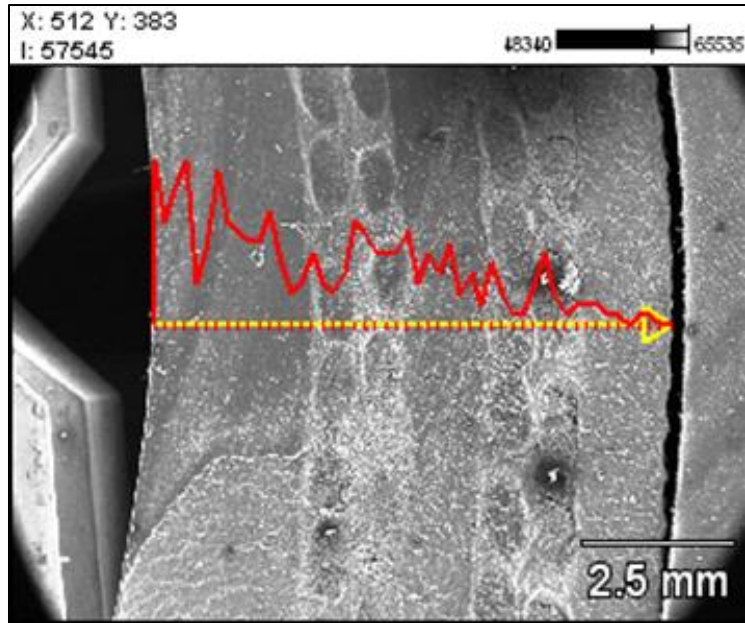
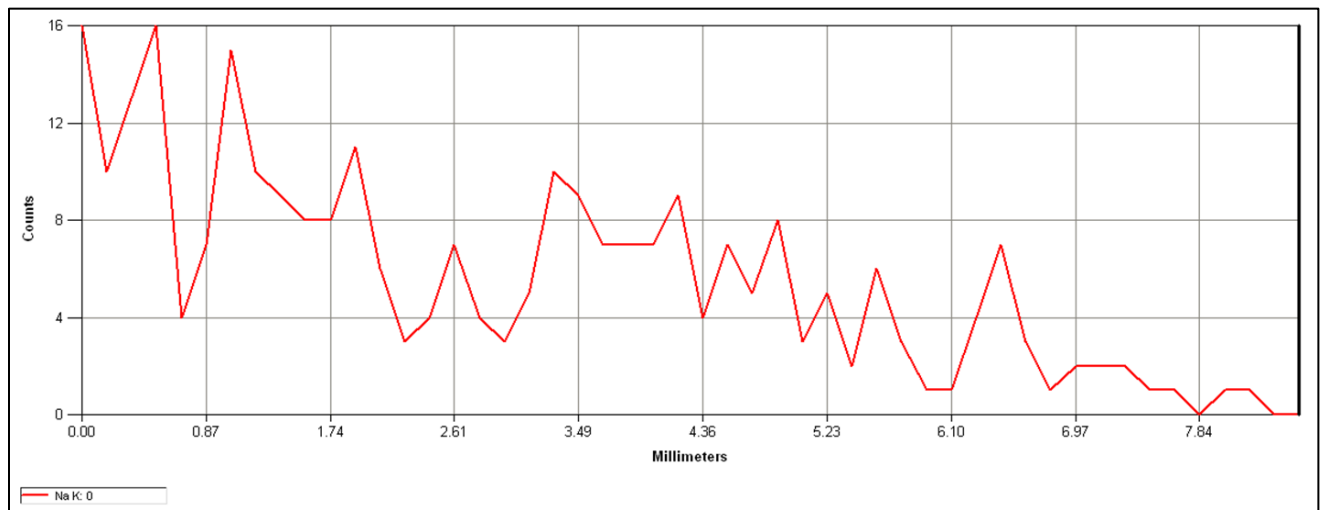
Figure 82. SEM-EDS scan of hose specimen aged for 6-months at 130°F.

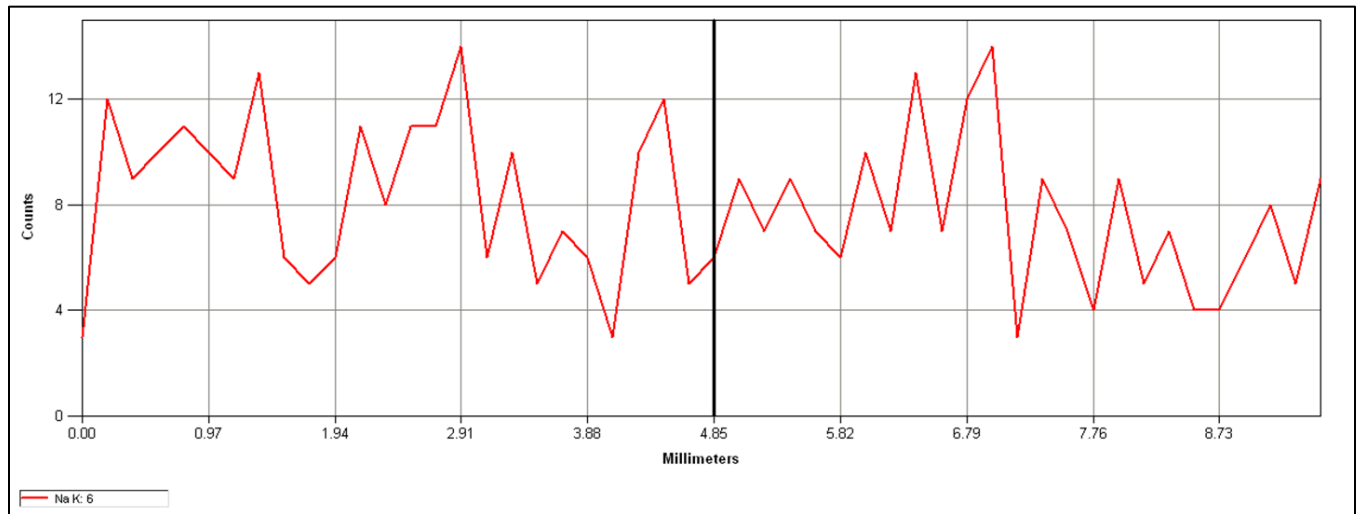
Figure 83. SEM-EDS scan of hose specimen aged for 12-months at 130°F.

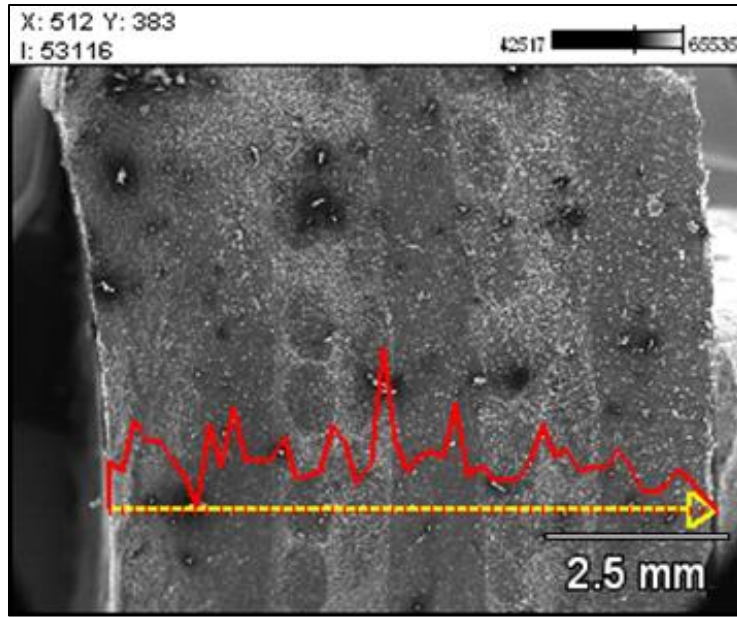
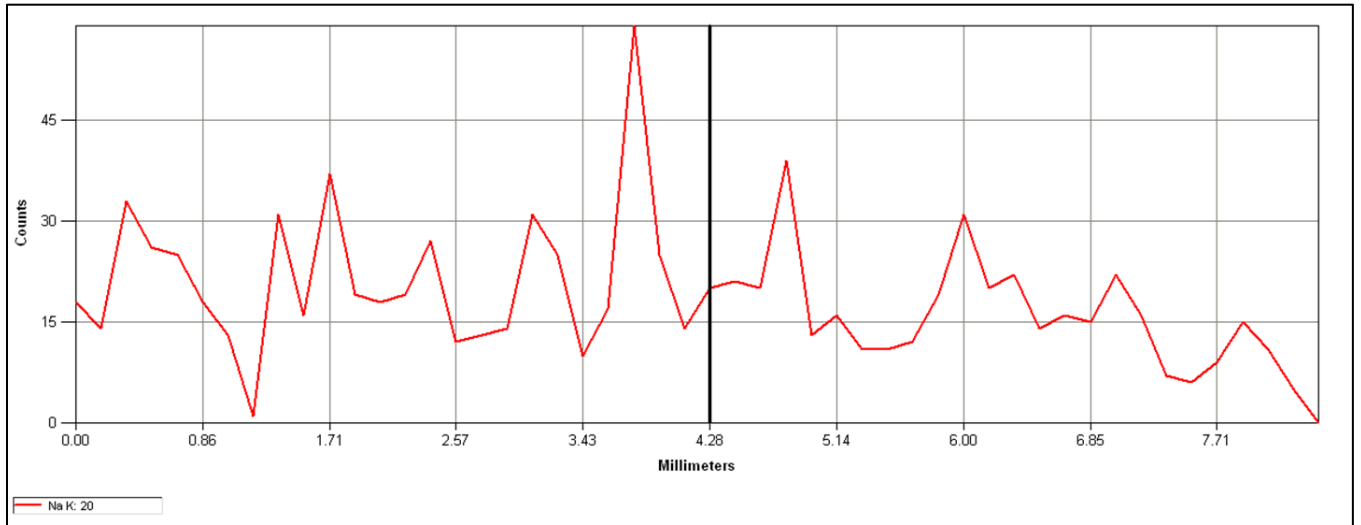
Figure 84. SEM-EDS scan of hose specimen aged for 6-months at 170°F.
