YEAR END TECHNICAL REPORT

September 29, 2020 to September 28, 2021

Chemical Process Alternatives for Radioactive Waste

U.S. Department of Energy

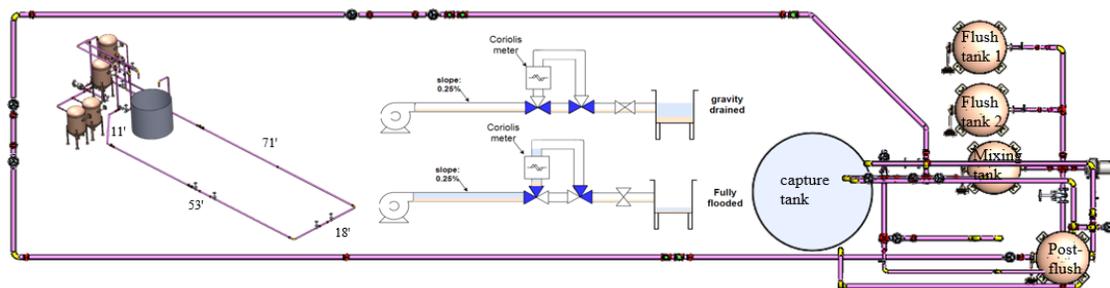
Test Loop

Figure 1. CAD Model of the 165-foot pipeline used for flushing experiments.

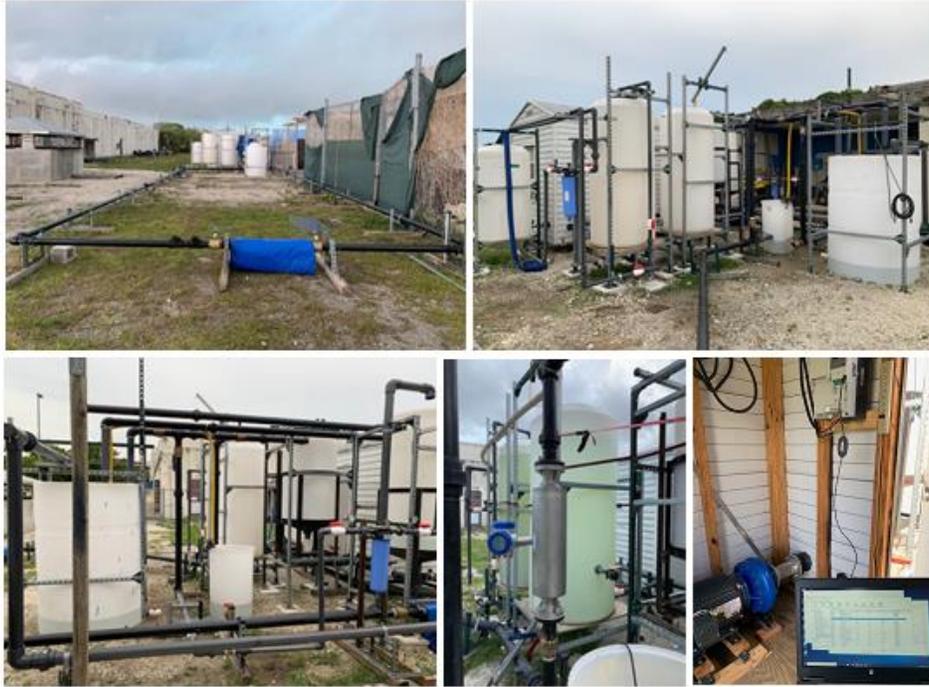
Figure 2. Constructed 165-foot pipeline used for flushing experiments.

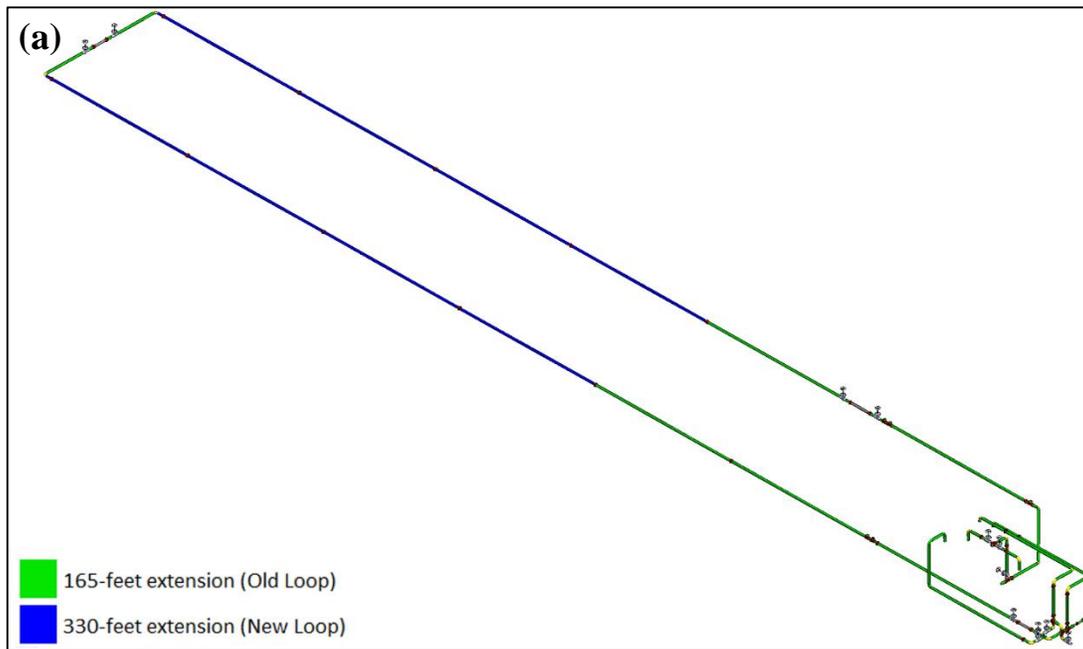
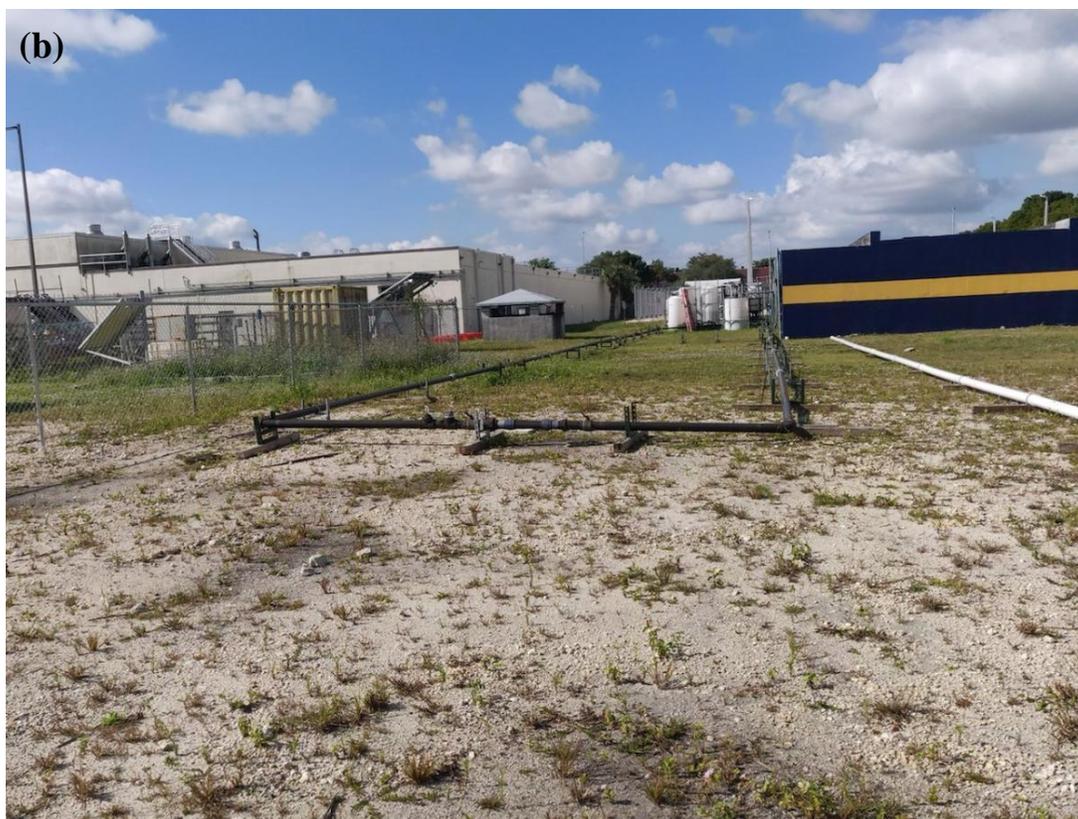
Figure 3. (a) CAD Model of 330-foot flushing loop used for second round of testing; (b) Assembled 330-foot flushing loop.

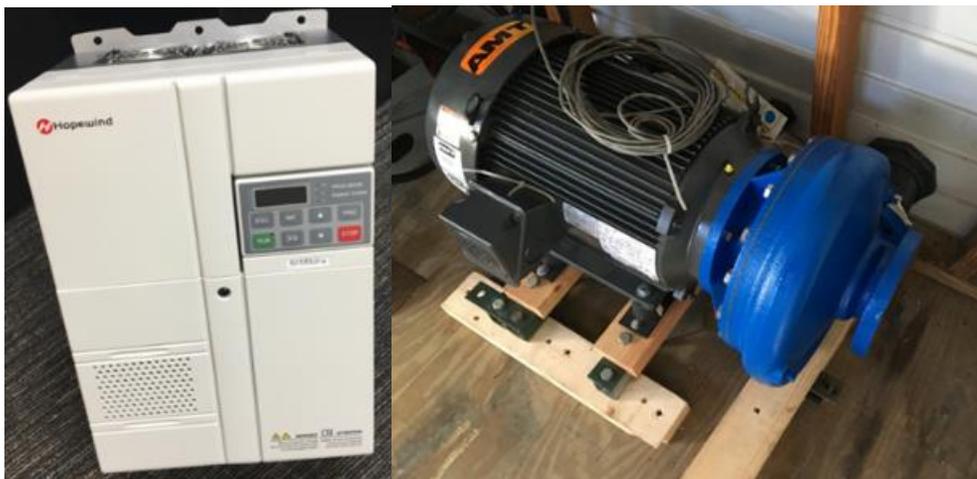
Figure 4. (Left) HopeWind VFD; (Right) AMT 427B-95 15 HP Slurry Pump.

To circulate, flush, and conduct post-flush analyses, a 15 HP slurry pump (AMT 427B-95) (Figure 4) capable of delivering up to 230 GPM of water at 93 feet of head was used. This pump was controlled through a HopeWind variable frequency drive (VFD) (Figure 4) to reduce ramp-up and ramp-down times to 0.5 seconds, which is the time to reach 1,750 RPM and vice-versa, such that the ramp-up and ramp-down times and fluid velocities could be set to the limits defined by the TFC-ENG-STD-26 and flushing recommendations outlined in the various studies from PNNL. Additionally, controlling the fluid velocity from the VFD increases the longevity of the system as solids travelling beyond 10 ft/s could potentially erode the pipe wall [2].

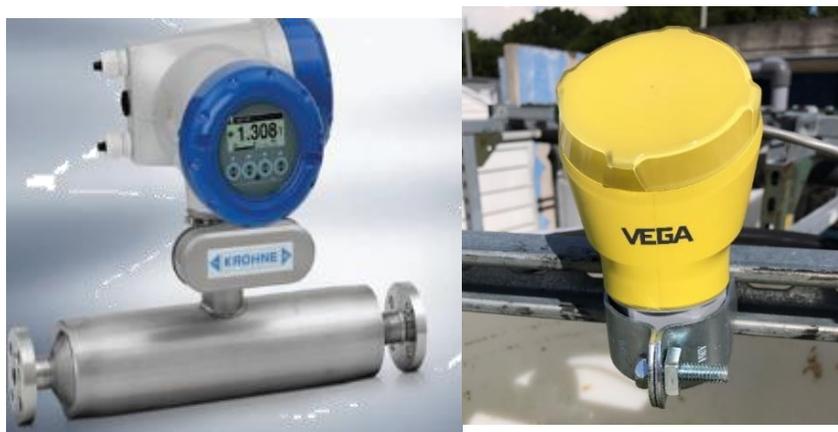
Figure 5. (Left) Krohne Optimass 1000 Coriolis Meter; (Right) VEGAPULS 11 level sensor.

Lastly, a fluid/water level sensor (VEGAPULS 11) (Figure 5) was used to determine the volume of water flushed through the pipeline. The level sensor works by emitting a continuous, frequency-modulated radar signal through its antenna. The emitted signal is reflected by the medium and

received by the antenna as an echo with modified frequency. The frequency change is proportional to the distance and is converted into the level. The radar sensor was attached to the top of the main water flush tank during both fully-flooded and gravity-drained flush operations. Before commencing the operations, the initial height was captured manually. During the operation, the sensor's output (4-20 mA range) was captured using Bluetooth function on the VEGA mobile app and a data acquisition device (DAQ). Upon completion of the test, the final level was captured. The linear interpolation graphs were then used to convert the output to a fluid level output.

The VEGAPULS 11 level sensor was installed on the supply tank and can be utilized to determine the volume of water used to flush by detecting a change of water level within the water tank. However, due to the limitations of hardware availability for some of the trial runs during the fully-flooded conditions and the gravity drain at 20%, a MATLAB script was generated to determine an approximate flush-to-line volume ratio. To determine when the system was “clean”, the condition of having the flow density achieve 99% of the density of water (~998 kg/m³) was arbitrarily used. The point at which the density reached this threshold was estimated using the flow rate and density curves generated for all trials using the MATLAB script. The FTLV can then be compared to the FTLV determined using the level-sensor data when applicable.

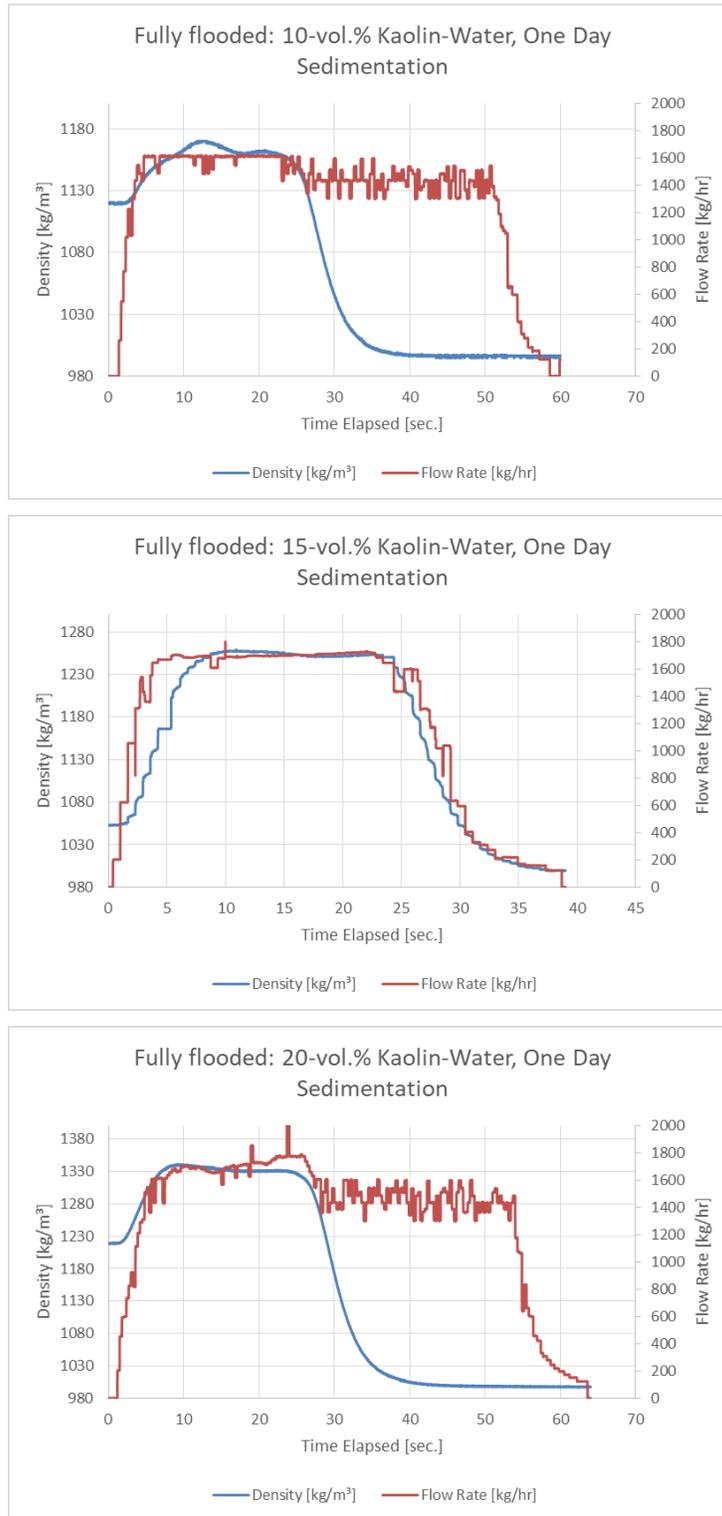
Figure 6. Density-mass flow plots for 10 % vol (top), 15 % vol (middle), and 20 % vol (bottom) kaolin-water simulants in the fully-flooded condition.

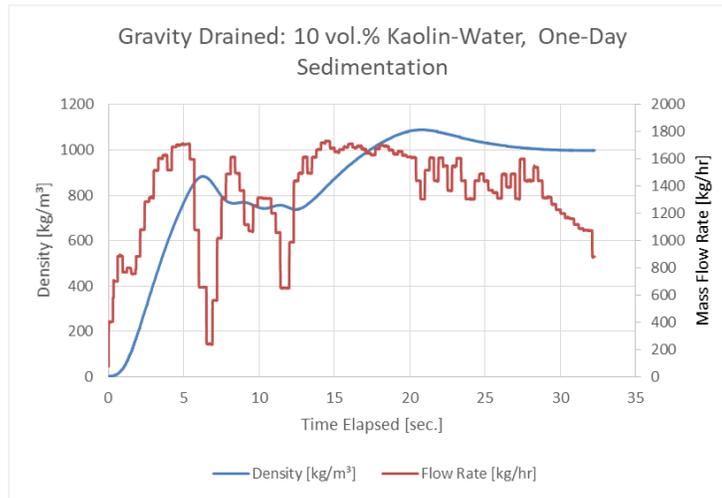
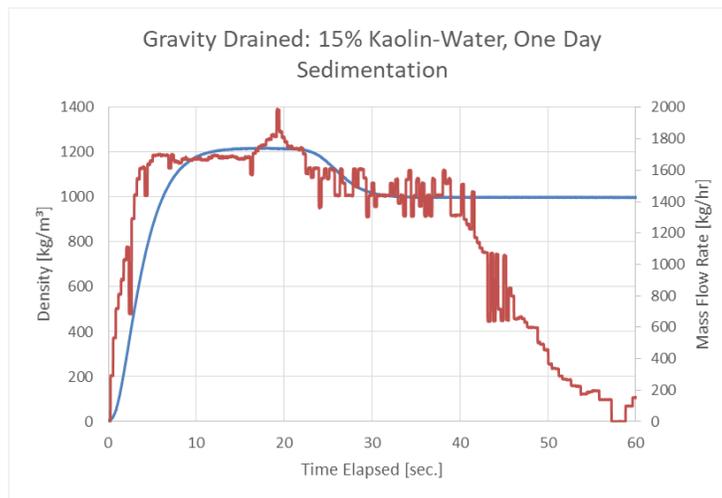
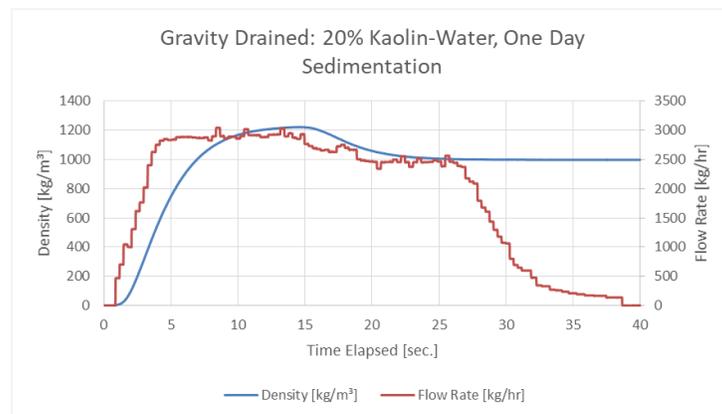
Figure 7. Density-mass flow plots for 10 % vol (top), 15 % vol (middle), and 20 % vol (bottom) kaolin-water simulants in the gravity-drained condition.

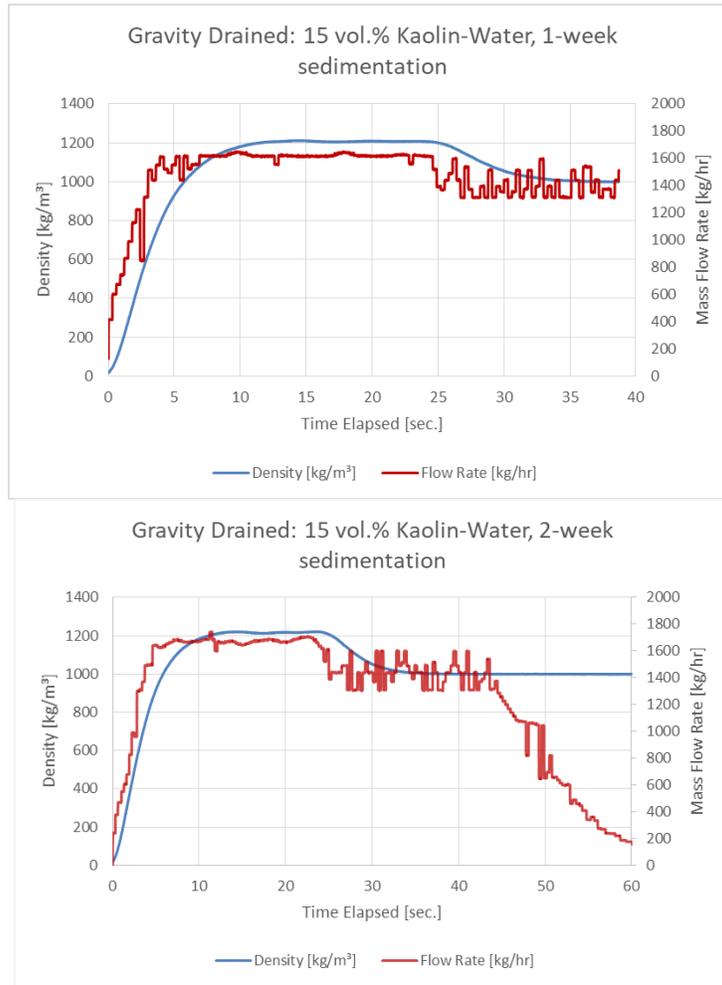
Figure 8. Density-mass flow plots for 15 % vol at one-week of sedimentation (top) and at two-weeks of sedimentation (bottom) of kaolin-water simulants for the gravity-drained condition.

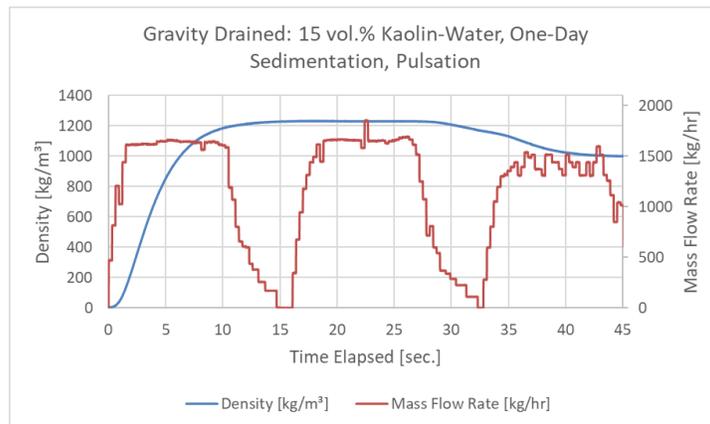
Figure 9. Density-mass flow plots for 15 % vol at one day sedimentation of kaolin-water simulants for the gravity-drained pulsation mode.

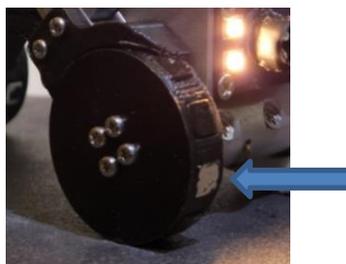
The current rover uses magnet wheels (Figure 11) to keep it attached to the metallic surface. The number of the required magnets and size of the wheels were calculated based on the torque of the motors as well as space available. The incorporation of the magnetic wheels was tested against blunt objects. It was shown that the rover can now overcome 90-degree angled obstructions with ease. The pull-off force of the rover increased from 5 to 9 lbs due to the orientation of the magnetic poles within the wheels.

Figure 11. Magnetic wheels.

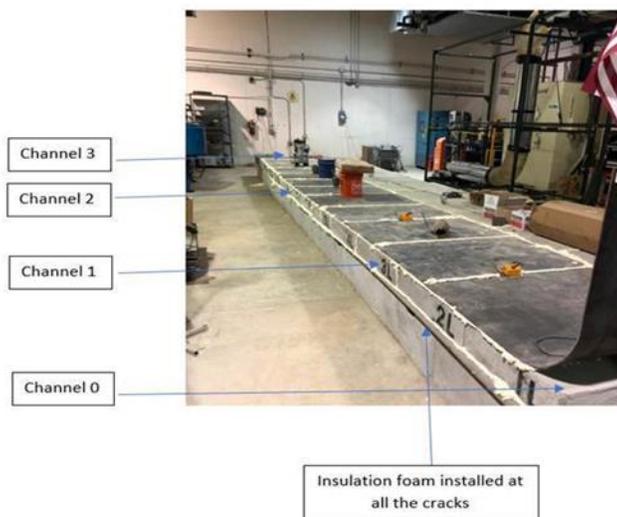
The process of heating will include blowing hot air into the channel using two heating fans placed at the central plenum and annulus. The blower’s temperature and flow rate will be adjusted to attempt to maintain roughly 130°F in the channel. Side channels (branches) will be blocked using a thermal insulation foam and filler material. The gaps between the primary liner plates and the space between the plates and the concrete sections along the air slot channel will be sealed using insulation foam. Thermocouple probes will be inserted into the channel via the side channel gaps and insulation at four points (C0, C1, C2 and C3 in Figure 15). These four points will be used to obtain real-time temperature measurements. K-type thermocouples with 4 feet bendable metal probes connected to a USB-UTC 8-channel data acquisition system will be used for temperature monitoring.

Figure 15. Durability test mockup.

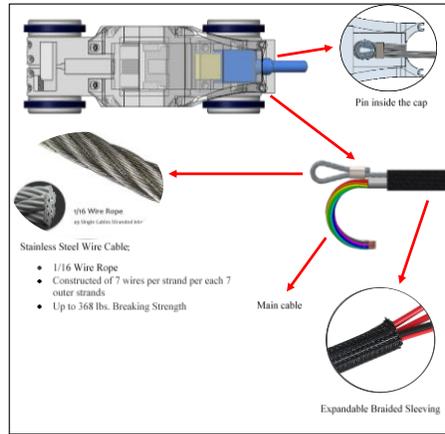
The emergency retrieval test will assess if the rover is capable of being withdrawn from within the channel in the event of a unit failure, or if the unit falls from the tank. To assist with emergency retrieval, the rover is equipped with a tether that is secured with a locking cap. The tether consists of the main cable, a stainless-steel wire cable for strength support and expandable braided sleeve (Figure 16). The stainless-steel wire cable has up to 368 lbs. of load before failing. The tether may be pulled manually from grade through the riser, annulus, and refractory to retrieve the unit. The test will evaluate whether the tether and locking cap can withstand the loads applied to the crawler during the retrieval process.

Figure 16. Tether details.

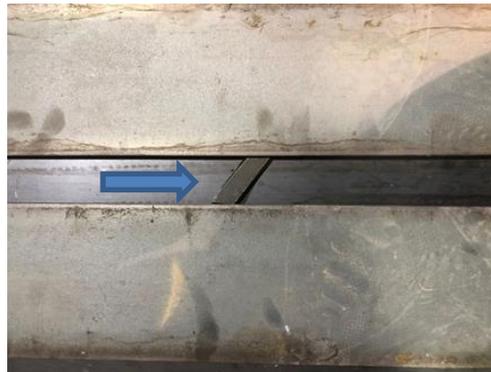
The weld seam test will assess the mini rover’s ability to traverse weld seams on the primary liner of the tank. Shown below is the oblique/blunt weld seam test which challenges the rover’s capabilities to overcome the orientation of seams in the worst-case scenario. The weld seam plates will be placed near the central plenum. The rover will be required to traverse the weld seams while pulling the tether, extending the entire length of the mockup.

Figure 17. Oblique/Blunt weld seam.

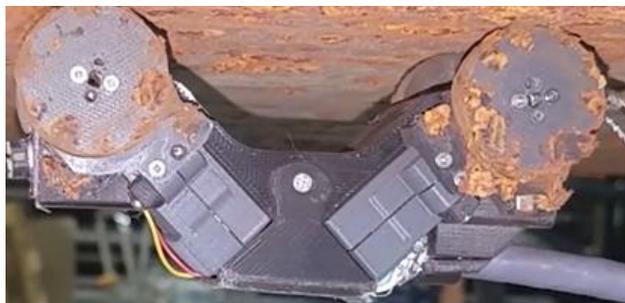
The corroded surface test will assess the rover’s ability to traverse corroded surfaces (Figure 18) without change in the unit’s performance. A critical issue will be the observation of corroded material accumulation on the magnets and its effect on performance. Now that the magnets have been relocated to the wheels, the fenders/scoops system will be observed to ensure functionality.

Figure 18. Corroded surface test.

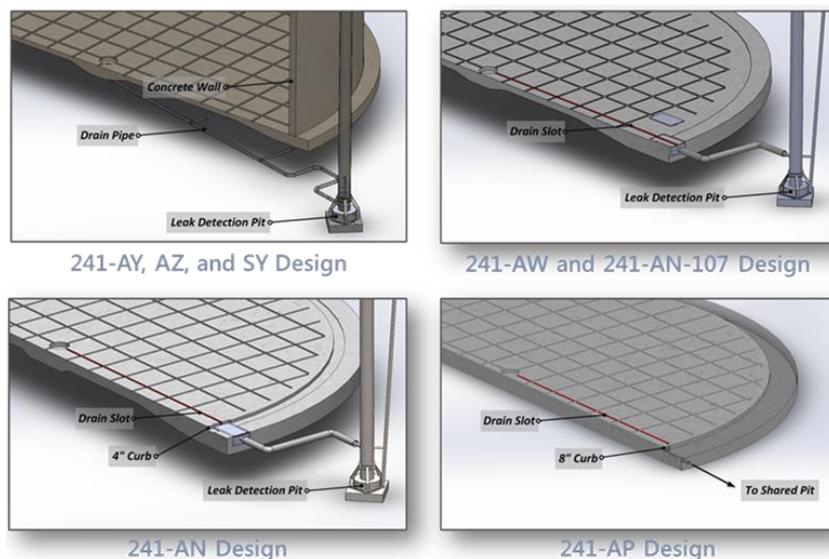
The only viable access to the secondary liner, under the refractory region, is through the leak detection system. In most Hanford tanks, the system consists of a leak detection pit connected to a DN 150 (NPS 6) drain pipeline providing access to drain slots in the concrete foundation under the secondary liner. The drain slots in the foundation consist of a maze of channels about 115 mm (4.5 inches) with 65 mm (2.5 inches) high. As illustrated in Figure 19, most configurations use an entry manifold that slopes up from the drain pipeline to the plenum in the middle of the tank [1].

Figure 19. Leak detection systems at Hanford's DSTs.

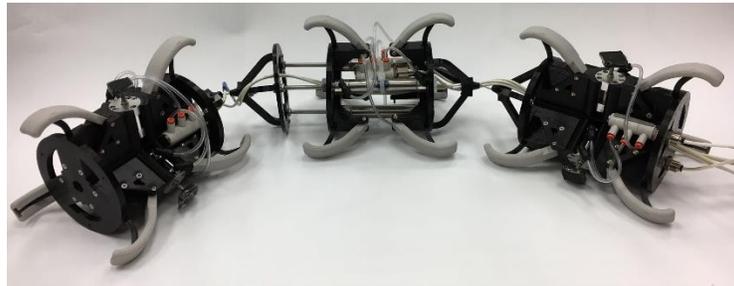
Figure 27. Peristaltic delivery pipe crawler prototype.

The peristaltic crawler operates using pneumatic actuators on the same peristaltic principles of other inspection tools previously developed at FIU [3]. The crawler's current design has front and back grippers and a middle expansion module. The modules are attached with articulating joints that allow the unit to maneuver through pipe bends. The actuators are radially distributed in each module, allowing a hollow core convenient for carrying payloads, instrumentation, and cabling. The crawler also uses spring-loaded guides that assist in passing through the harsh environments found in the existing DST's drain pipeline with significant sediments, buildup, and scaling. Figure 28 shows the drain lines' current conditions from previous unsuccessful inspections at Hanford. The guides drastically reduce the crawler drag while minimizing potential sediment accumulation and bulldozing effect during inspections.

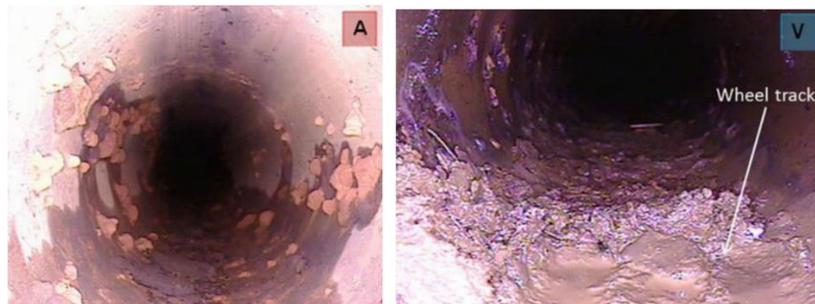
Figure 28. Drainpipe existing sediments and buildup.

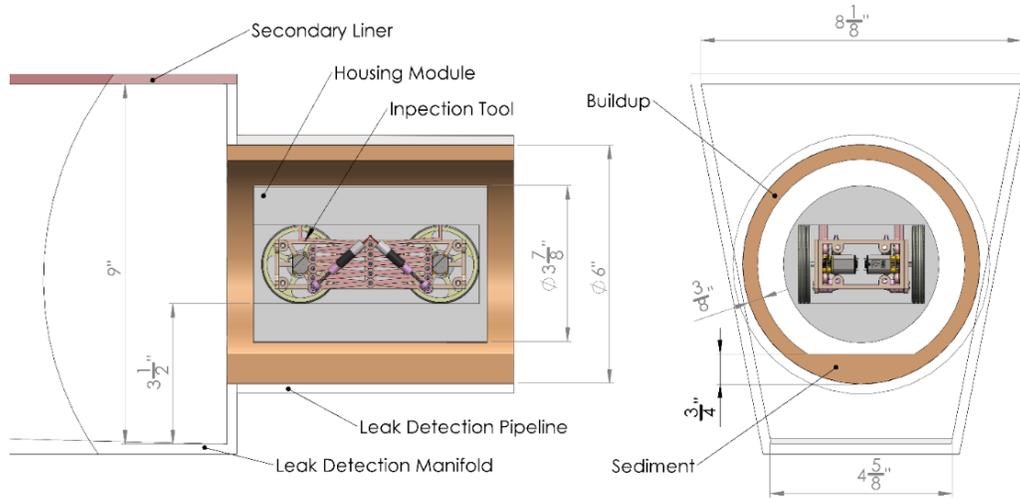
As illustrated in Figure 29, at drain slot entry, the distance between the rover and the floor is about 3.5 inches (89 mm), which requires a deployment apparatus to deliver the inspection rover from the housing module to the floor of the leak detection manifold. The pipe crawler modules are about 4 inches in diameter and are centered by guides to avoid existing sediment and buildup in the leak detection pipeline.

Figure 29. Housing module.

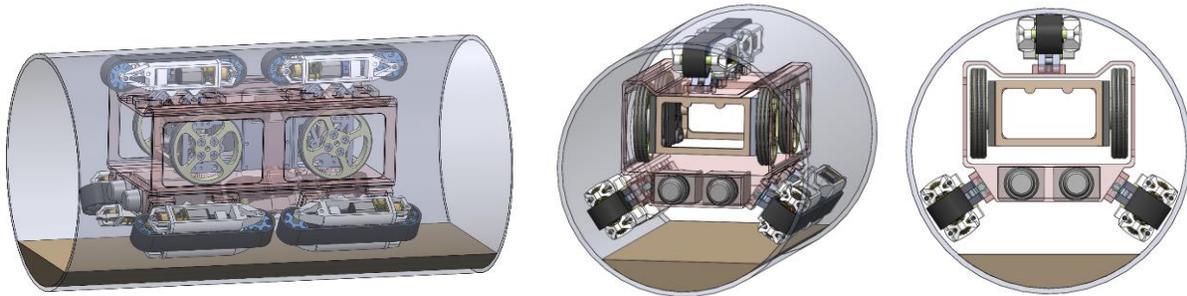
Finally, as illustrated in Figure 13, an electric version of the delivery pipe crawler using tracks can have a more compact design with fewer moving parts than the previous peristaltic crawlers. The proposed electric crawler carries the inspection rover using a system of three tracks. The tracks design considers a 3/4-inch tall deposit of sediment accumulated at the bottom of the pipe.

Figure 32. Track-driven delivery pipe crawler conceptual design.

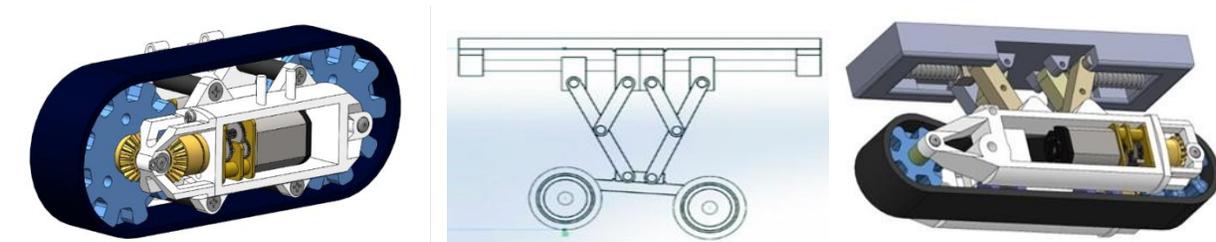
Figure 33 illustrates the current design of the track-driven suspension. The track uses two lateral geared motors powered by a bevel gear transmission. The track tension is adjusted by tightening or loosening screws at the gears' bearing mount. The independent tracks are attached to the crawler's frame using a scissor link suspension. The spring suspension provides an extra degree of freedom, allowing the tracks to push up and down and tilt, always keeping traction against bends, depressions, and eventual buildups.

Figure 33. Tank suspension design.

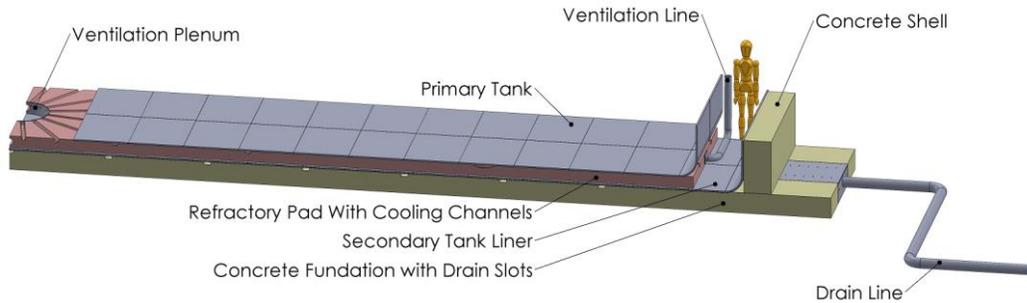
Exhaustive full-scale tests were designed to verify and validate the secondary liner inspection tool using the FIU's full-scale sectional mockup. The mockup, illustrated in Figure 35, is intended for real-scale tests and evaluation of robotics and sensor technologies [2].

Figure 35. DST's full-scale sectional mockup.

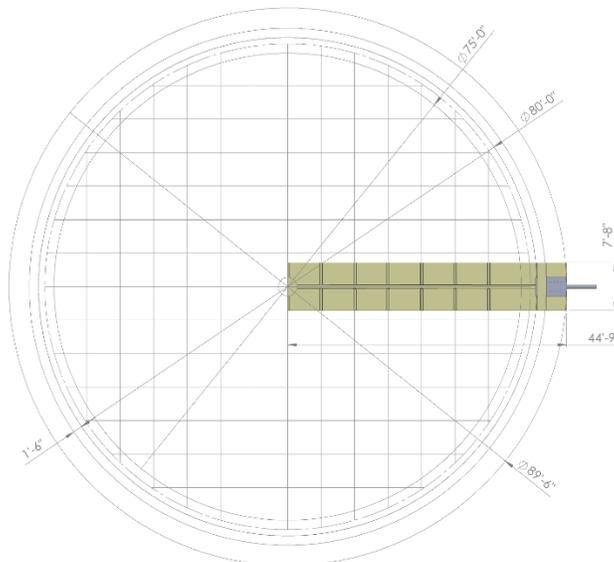
As illustrated in Figure 76, the mockup will cover approximately 7% of the DST's foundation.

Figure 76. Foundation drains channels layout.

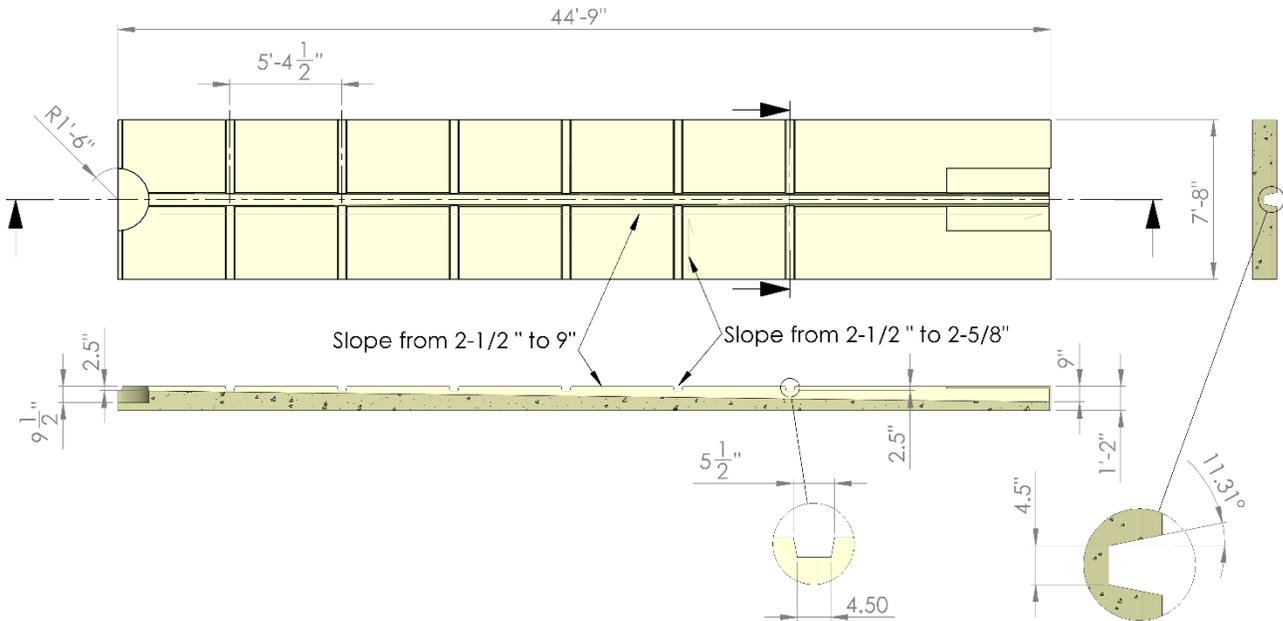
Figure 77 shows the layout of the concrete foundation in the mockup under the secondary tank liner. The foundation leak detection system has a maze of sloped drains. The drains are precisely sloped and angled according to the DST's shop drawings in the mockup.

Figure 77. Concrete foundation with drain slots.

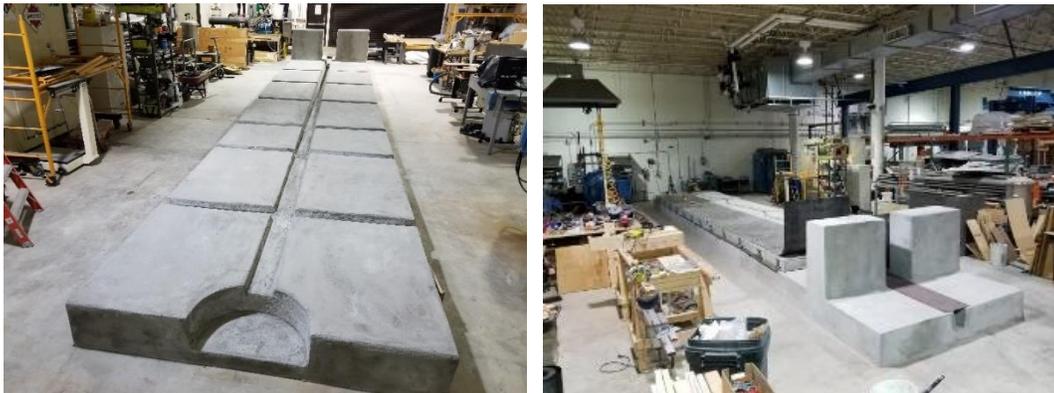
The mockup foundation and refractory pad are wood, coated with concrete held together by a metal mesh. As shown in Figure 36, this combination provides a modular and lighter structure combined with surface properties similar to the DST ones.

Figure 36. FIU's DST's full-scale sectional mockup.

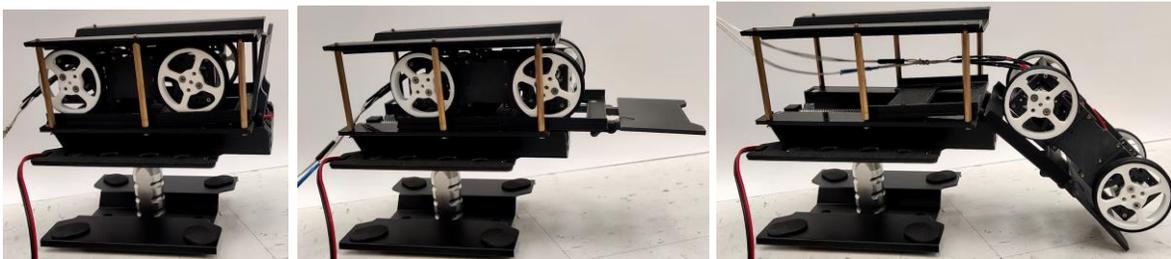
Figure 42. Housing module with ramp prototype.

Figure 42 shows tests of the current prototype deploying the instrumentation rover using a retractable ramp. The rover successfully drives out the module; however, it requires designing a foldable guide that would funnel the rover back inside the module using the narrow ramp without precise reverse maneuvers.

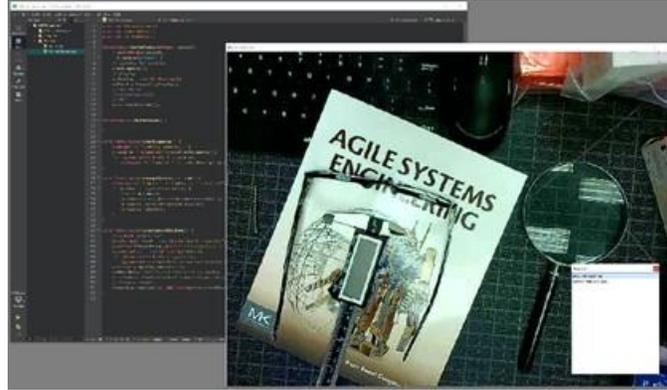
Figure 43. Control box's GUI.

Figure 43 shows a seminal graphical user interface (GUI) developed for the system's control box. The current version is operating system agnostic and can visualize and record all cameras attached to the box's embedded computer. In addition, the GUI is tailored to interact with the operator using touchscreen monitors, suitable for field operations, not needing a keyboard or mouse. The GUI will also be used in other inspection tools currently being developed at FIU.

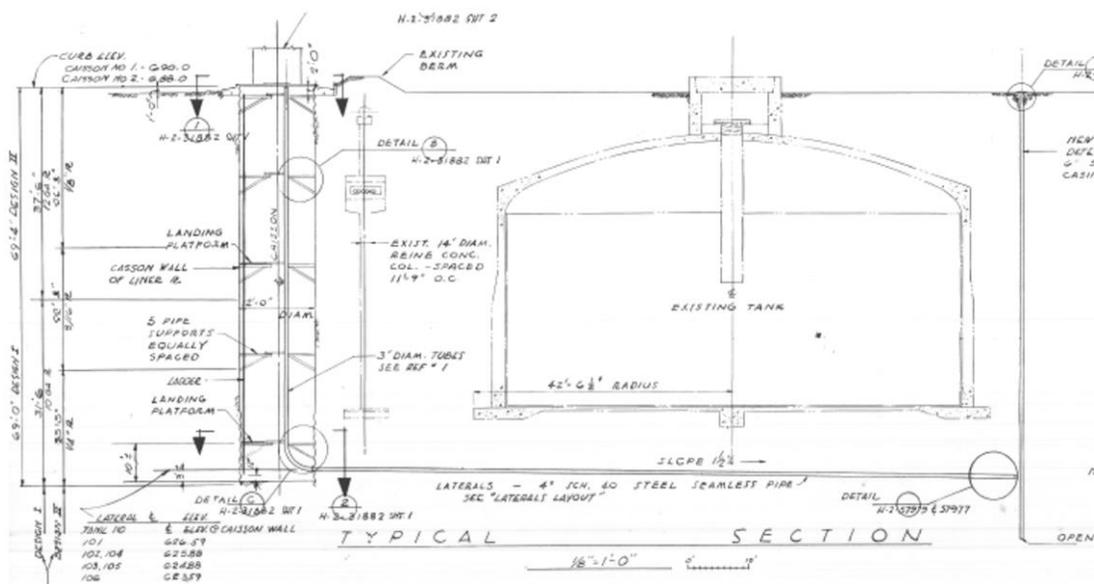
In the 1960s, to enhance tank leak detection capabilities, caissons were dug in both the A and SX tank farms with horizontal pipes installed under the tanks to allow gamma logging [1]. As illustrated in Figure 44, these horizontal pipes (laterals) were routinely monitored for gross gamma activity. The appearance of gamma activity in a lateral would indicate a possible tank leak. The laterals were installed about 10 ft below the bottom of the tanks after the tanks were constructed. Each lateral is a 3-in. pneumatic stainless steel tubing and is enclosed in a 4-in. carbon steel pipe. The laterals are horizontal and extend radially from a large caisson (12-ft diameter) that is located between up to four tanks. The access to each lateral is through a separate vertical tube (also made of 3-in. pneumatic stainless steel) that extends up to the floor of the lateral shack. The lateral tube transitions from vertical to horizontal at the bottom of the caisson through a 90° elbow with a 4-ft bend radius.

Figure 44. Single shell tank's laterals.

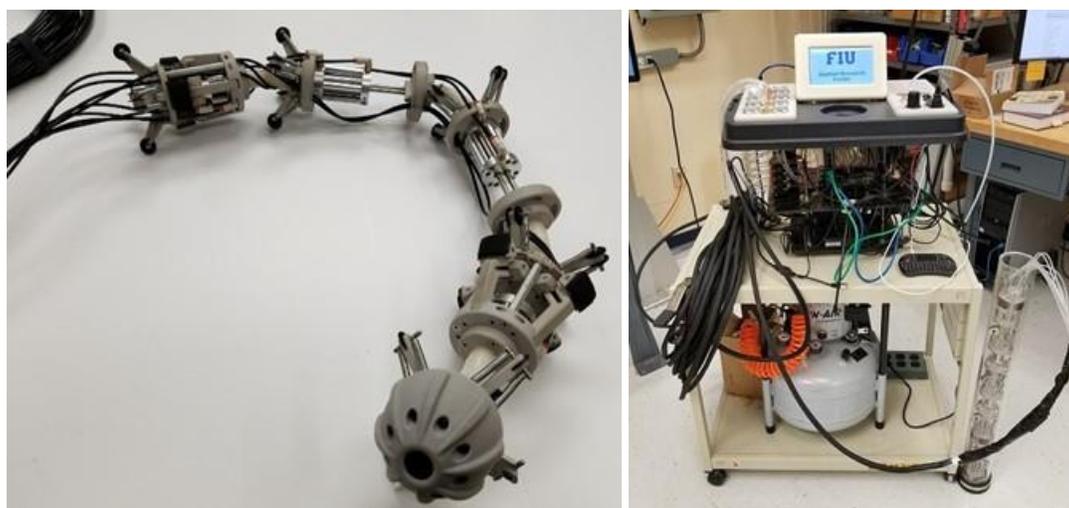
Figure 46 shows the existing 4-inch pipe crawler that was originally designed to navigate through DST air supply lines and provide a visual inspection of the central tank plenum. Requested by WRPS, the system has been tweaked to navigate through the laterals, crawling the vertical lines connected by 4-foot radius bends to horizontal lines running under the tank. The tweaking in the existing system consists of streamlining the overall crawler design, retrofitting the embedded electronics, integrating payload, and incorporating automated cable management.

Figure 46. FIU's existing 3-inch crawler.

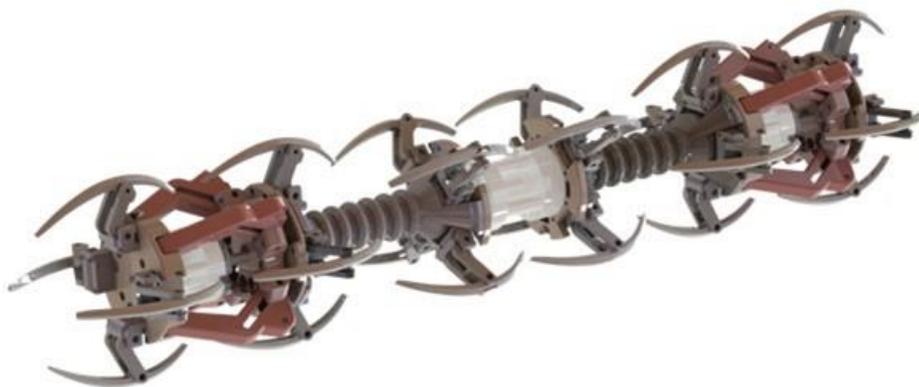
Figure 48. Crawler current design.

As shown in Figure 48, the module guides were streamlined, and the two gripper and two extender modules were fitted with more robust components. The crawler guides were oriented toward the 3-inch diameter, expanding to a natural position in a 4-inch pipe. The guides contract with the reach of the extended members and fold flush into the crawler.

The guide mechanism consists of a torsional spring, two support arms, the guide, and a block to join the assembly to a flange. Compared to the previous suspension, this version is similar in function; however, it is much more modular and has a greater range of motion. It folds flush to the crawler modules and does not compromise room between units, potentially freeing up space for bends or unexpected obstacles in the pipe.

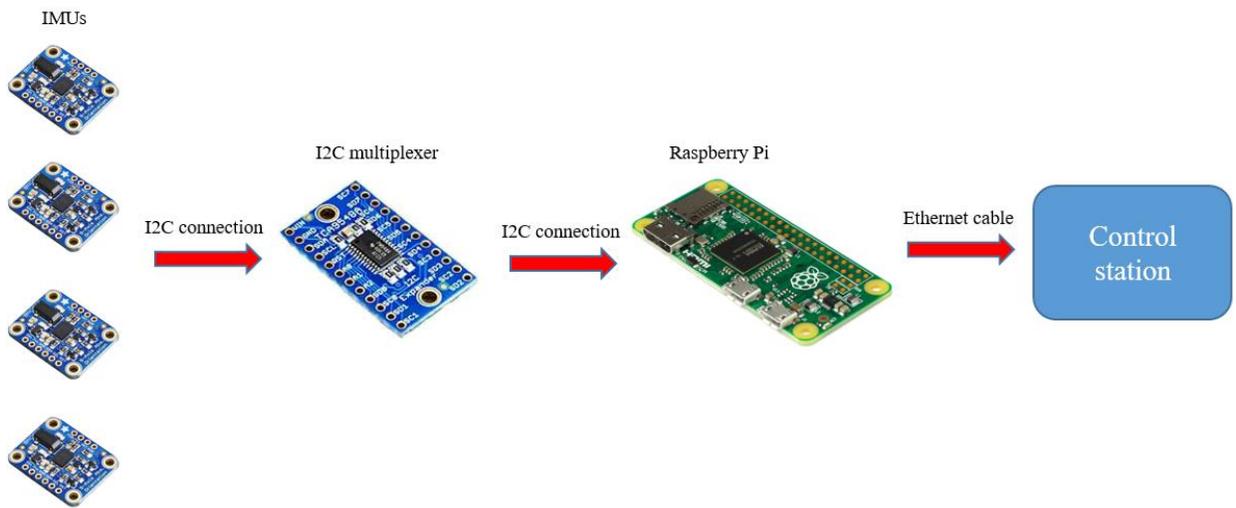
Each module has also been equipped with Inertial Measurement Units (IMU) for attitude estimation, fusing data from accelerometers, gyroscopes, and magnetometer, as sketched in Figure 52.

Figure 52. Schematic of IMUs communication

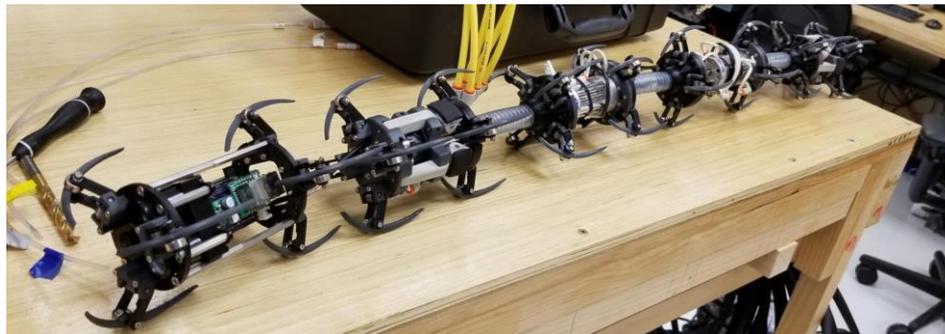
Figure 54 shows a functional prototype of the pipe crawler that has been rigorously tested to evaluate the unit’s behavior in realistic conditions.

Figure 54. Current pipe crawler prototype.

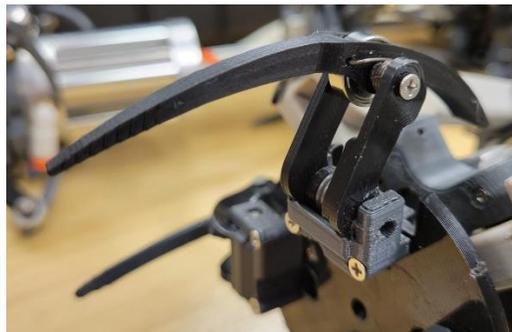
Figure 55. Improved guides.

Figure 55 shows that the current guides improved by adding rolling bearings, significantly reducing contact friction.

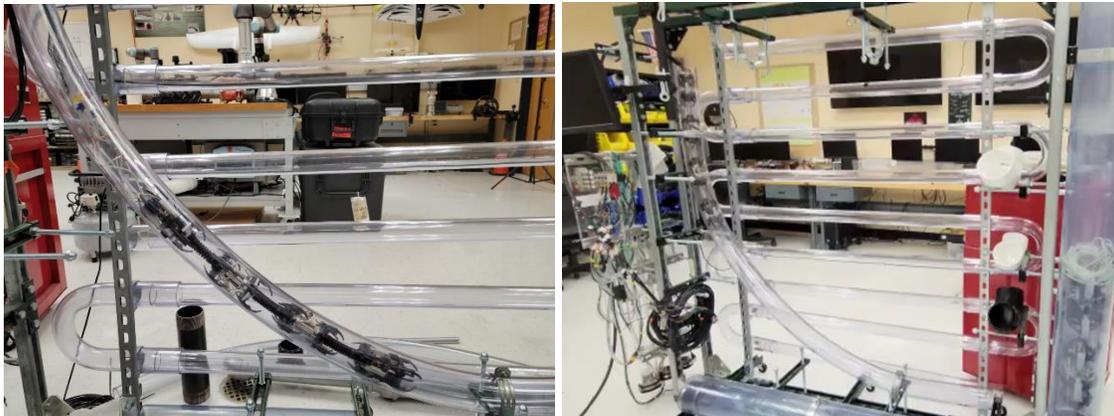
Figure 57. Pipe crawler bench-scale testing.

Figure 57 shows the pipe crawler successfully being tested in a bench-scale mockup. The mockup was originally designed to test other pipe crawlers developed at FIU.

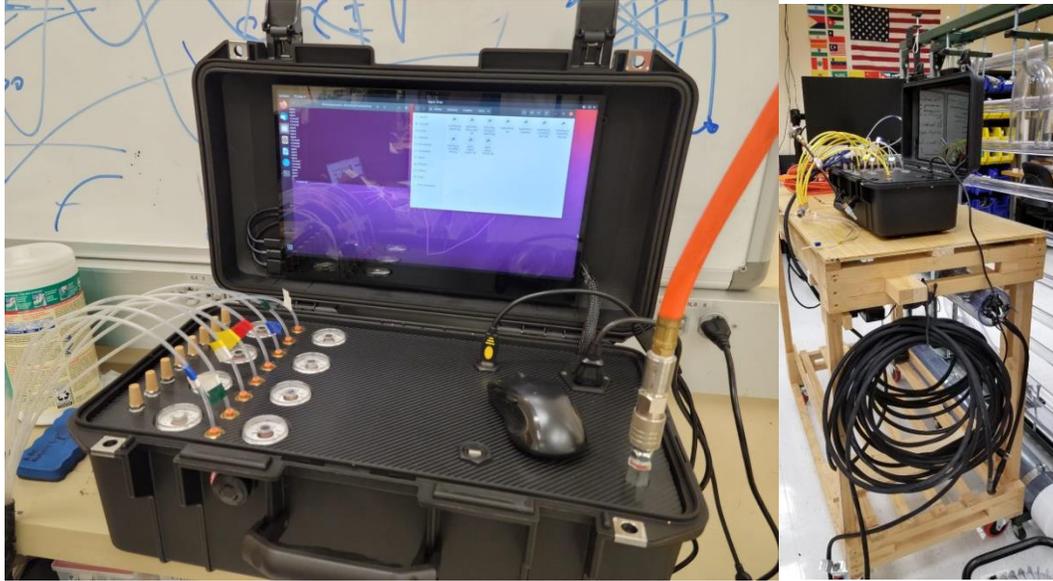
Figure 58 shows a portable control box retrofitted to test the pipe crawler.

Figure 58. Pipe crawler portable control box.

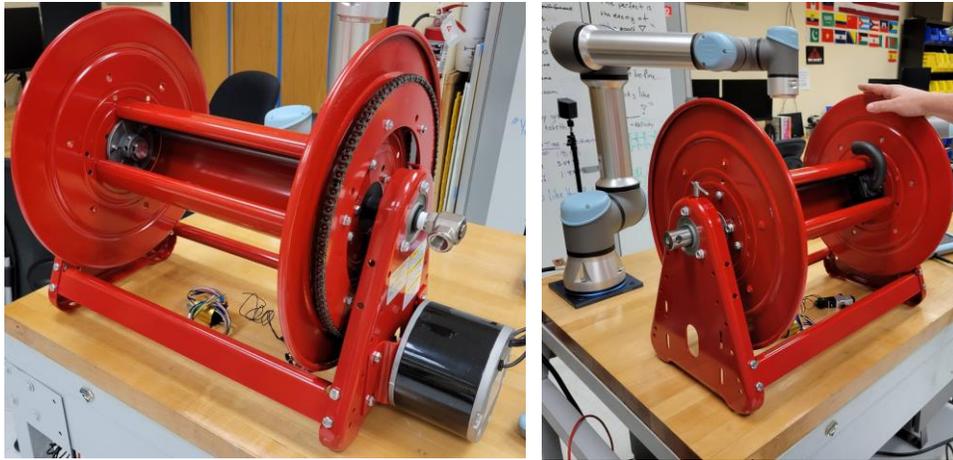
Figure 59. Tether reel and potential slip-ring.

Figure 59 shows a motorized tether reel that has been automated to deploy the inspection tool.

Figure 60 shows the integration, disassembly, drilling and reassembly of a slip-ring to provide an Ethernet connection to the reel drum and consequently power the pipe crawler during the deployment.

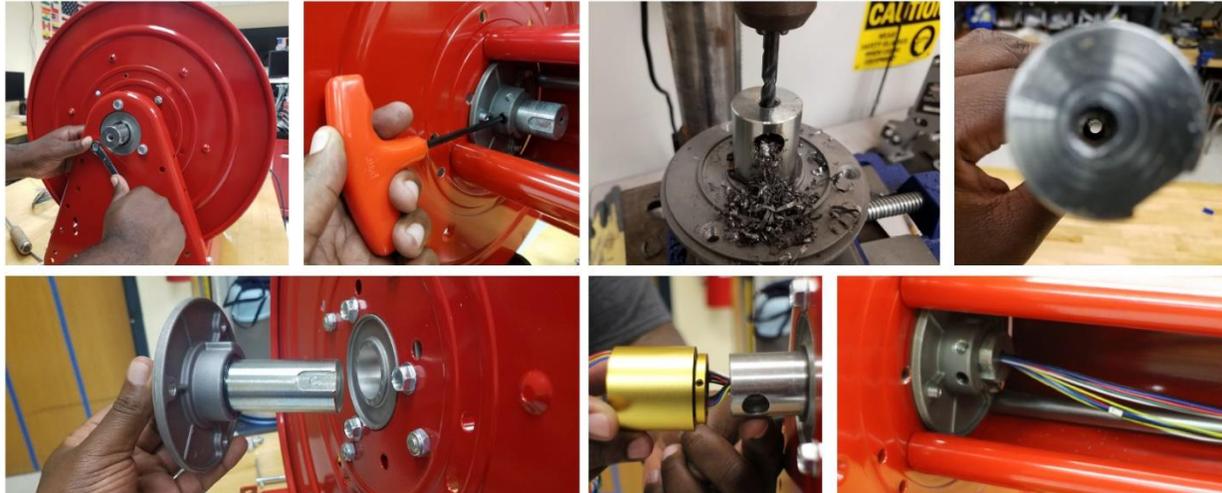
Figure 60. Ethernet slip-ring integration.

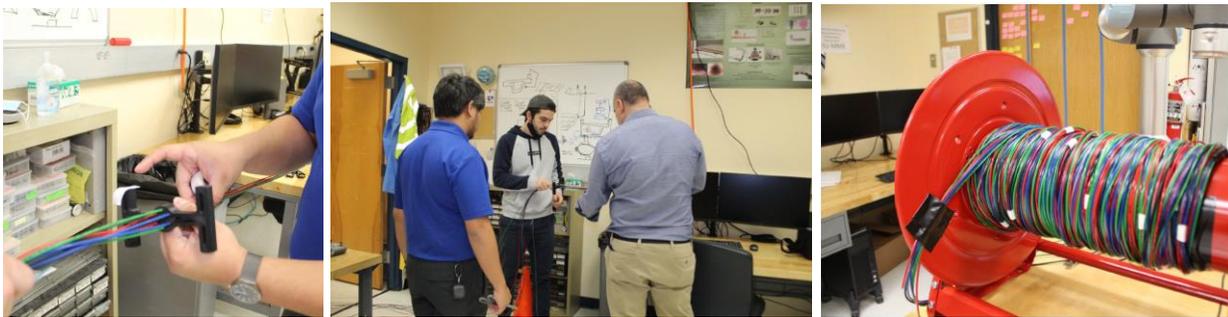
Figure 61. Tether assembly.

Figure 61 shows the tether assembly with six pneumatic lines, an Ethernet cable, and a retrieval steel wire. The tether will be sleeved using a polyester fray-resistant expandable sleeve.

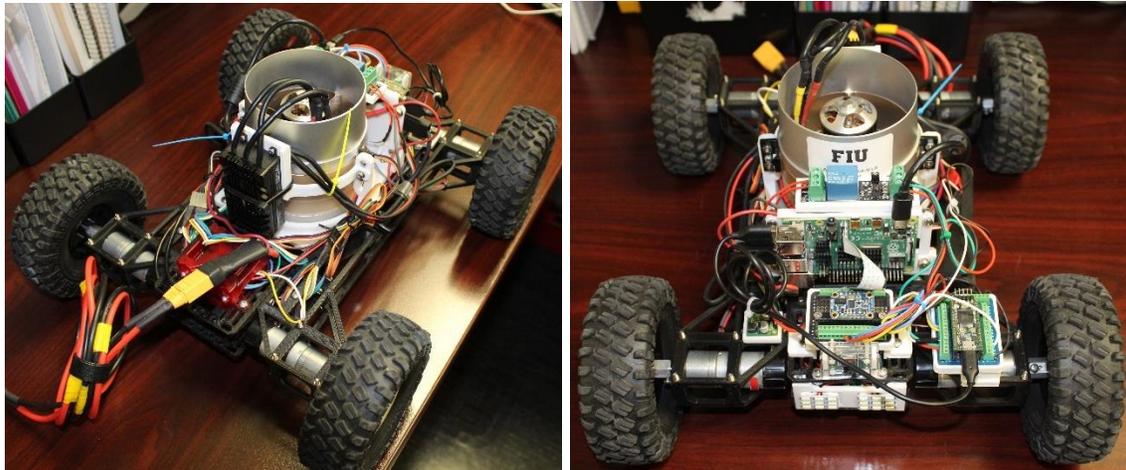
A platform that included a 90mm electronic ducted fan (EDF) was developed and evaluated for its ability to adhere and traverse along the a concrete surface. The single EDF unit, depicted below in Figure 62, was tested on a small-scale wall mockup with varying surface conditions. The single fan unit was also equipped with an IMU sensor to measure the roll, pitch and yaw of the platform. This sensor information will be used to autonomously control the thrust level of the EDF unit allowing the teleoperator to focus on maneuvering the platform to a desired location.

Figure 62. Single EDF based platform.
