YEAR END TECHNICAL REPORT

September 29, 2020 to September 28, 2021

Chemical Process Alternatives for Radioactive Waste

U.S. Department of Energy

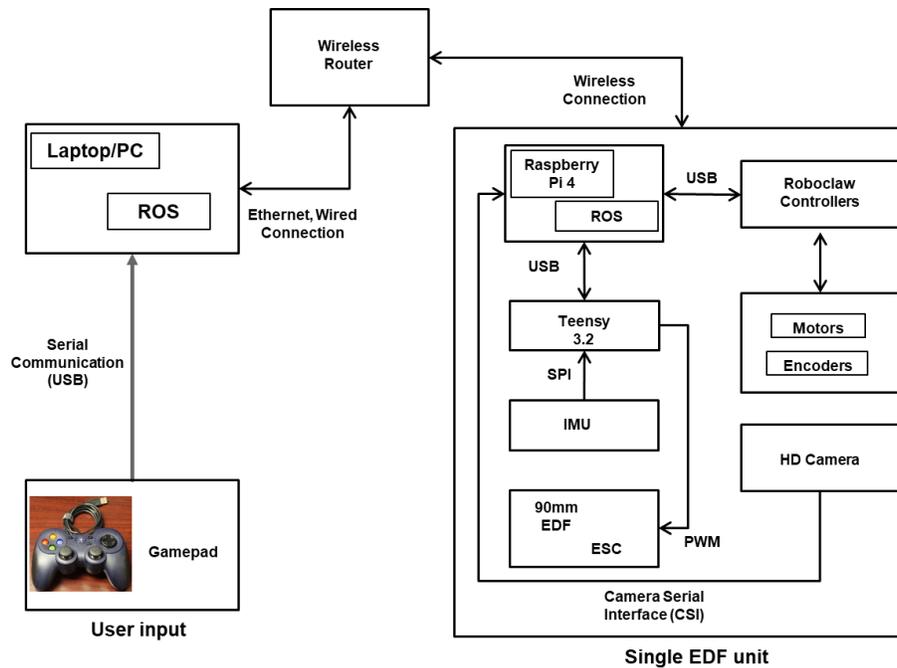
In addition to the IMU sensor, the platform is also equipped with a camera, motor encoders, smart motor controller, front light source and onboard processing. Figure 63 gives an overview of the existing technology and capabilities of the single EDF platform. The system is designed to operate via a connected ethernet line or via Wi-Fi and makes use of a middleware ROS for seamless sensor and package integration. ROS provides a paradigm called node, which allows for specific topics or data to be accessed remotely and then processed for an informed action plan. The single EDF unit was also equipped with larger wheels with protruding treads for robustness and adaptability over a surface with varying conditions.

Figure 63. Control system breakdown for the single EDF platform.

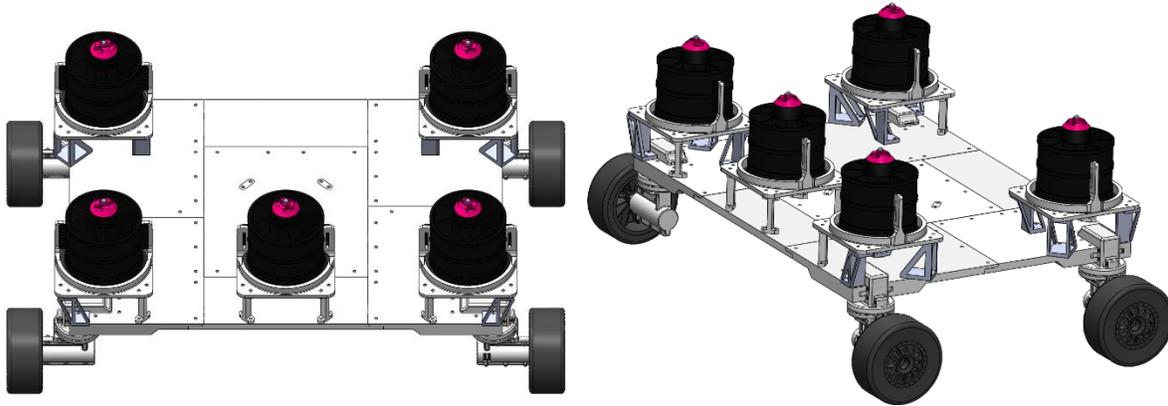
Figure 64. Multi-fan omnidirectional platform.

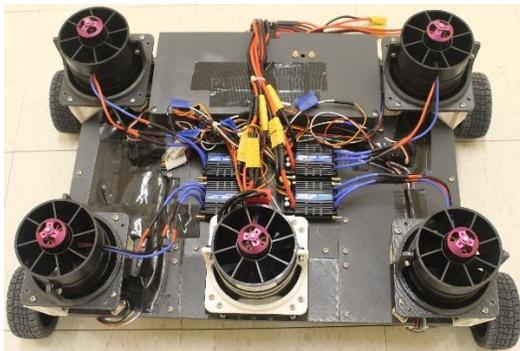
A prototype was constructed of the multi-fan system once the CAD design was finalized. The larger unit consisted of five 90mm EDF units placed in a predefined configuration so as to offset the higher center of gravity and modular control system. The chassis of the system was 3D printed using segmented joints because of the print-bed size limitation. The unit dimensions are 16 inches in width, 22 inches in length and 5 inches in height. Figure 65 and Figure 66 show the fully assembled unit from different vantage points.

Figure 65. Top view of multi-fan platform with control box unit.

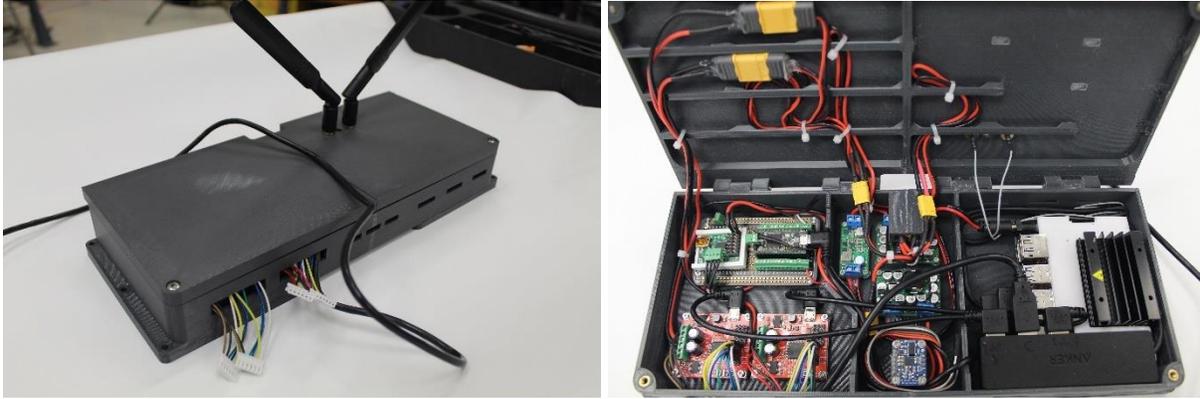
Figure 67. Completed control system unit.

The control system for the multi-fan model was derived from the same system used in the single EDF platform but equipped with a higher end computer on a chip - Nvidia Jetson Nano - for onboard processing. The completed control box, Figure 67, is a self-contained system which was designed to be modular. It can function as a plug and play control unit, operating a variety of mobile platforms. The control box can connect and communicate with all the fans and sensors on the platform using a generated PWM signal and serial communication, respectively.

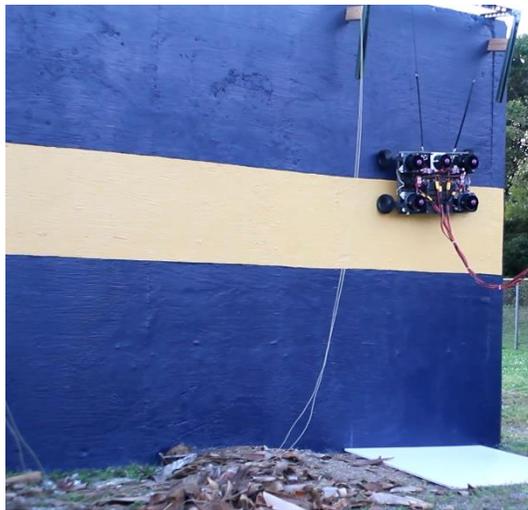
Initial tests of the platform included test runs on multiple wall conditions ranging from smooth to pitted and rough surface conditions, Figure 70 and Figure 71. It was found that with the current setup of the platform (weighing 17 lbs), it was able to traverse and maneuver along the surface with the EDF units operating 80-90% of the full thrust capacity. This would fluctuate due to the voltage drop along the line. This problem was alleviated with the use of lower gauge lines for power delivery. This change, however, introduced another issue related to the mass of the tether line increasing to the point where it began to affect the performance of the platform.

Figure 70. Smooth-like or pristine surface condition.

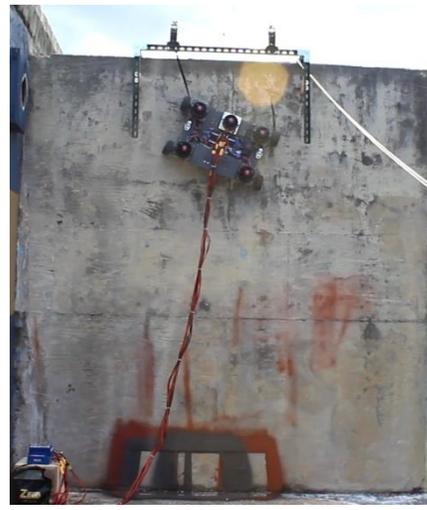
Figure 71. Rough wall condition with surface debris.

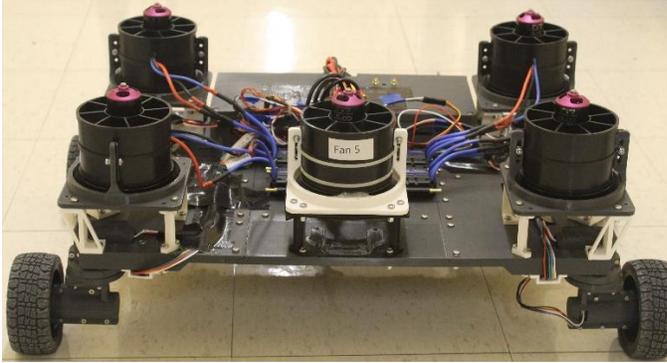
In order to increase the operational safety factor of the system, the 3D printed chassis was replaced with a new chassis fabricated from carbon fiber sheets, Figure 72 and Figure 73. The weight of the new chassis, along with lowering the number of screws and connections reduced the platform's weight by three pounds which in turn allowed the EDF units to operate at a lower thrust level. The reduced thrust level also leads to less power consumption when compared to data from previous test runs. Another benefit of the reduced weight is the lowering of the transverse force acting on the drive modules while adhered to a vertical surface. This leads to the drive modules experiencing less deformation, extending the operational time of the modules.

Figure 72. Multi-fan system with 3D printed chassis.

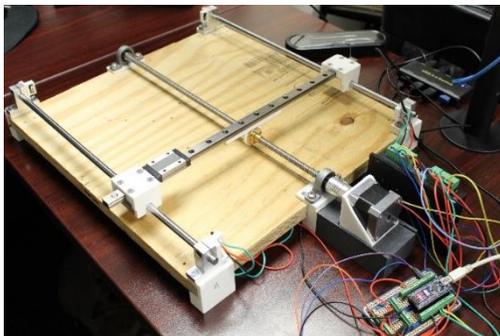
A physical mock-up of the lead screw-based coating system was prototyped with the use of basic stepper motors as a placeholder for the motor which must be designed and built in-house for low weight, high torque, and speed control. A simple program was then written to test the initial setup for movement along with Y-direction, as depicted in Figure 76. The CAD design now includes the location of the second motor along with a design of the adaptor for securing a test piece (i.e., a camera or spray nozzle). Figure 77 shows the partially assembled coating mechanism which now includes multiple limit switches to initiate motor shutdown at the extremes and for initializing the system upon boot up.

Figure 76. Lead screw-based coating application system.

Two coating application system designs were developed with one actuated using a lead screw setup, Figure 74, as opposed to a timing belt construction, Figure 75. In the CAD design, there are two leads screws placed perpendicular to one another to allow the adaptor piece to move in a 2-DOF plane. This simpler design will allow for more accurate control of positioning and speed of the adapter piece.

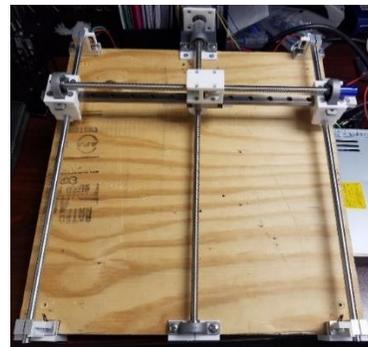
Figure 77. Partially assembled coating mechanism with portable power supply.

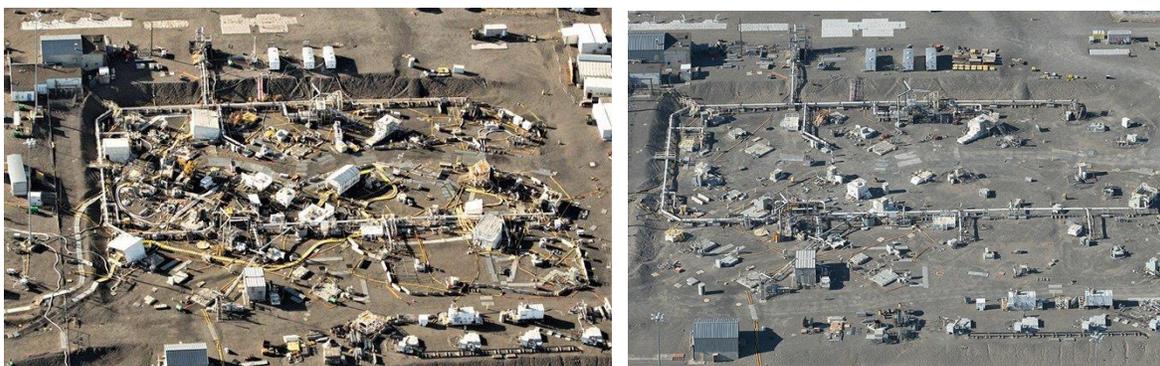
Figure 82. Hanford's Tank Farm retrieval operations in September 2016 (left) and 2018 (right).

As exemplified by Figure 82, changes in Hanford's Tank Farm due to retrieval operations [1] and the constant need to manually reconfigure the surveillance mobile platform's mission plan could become a burden to site engineers, which would also be the case in analyzing the captured data over time.

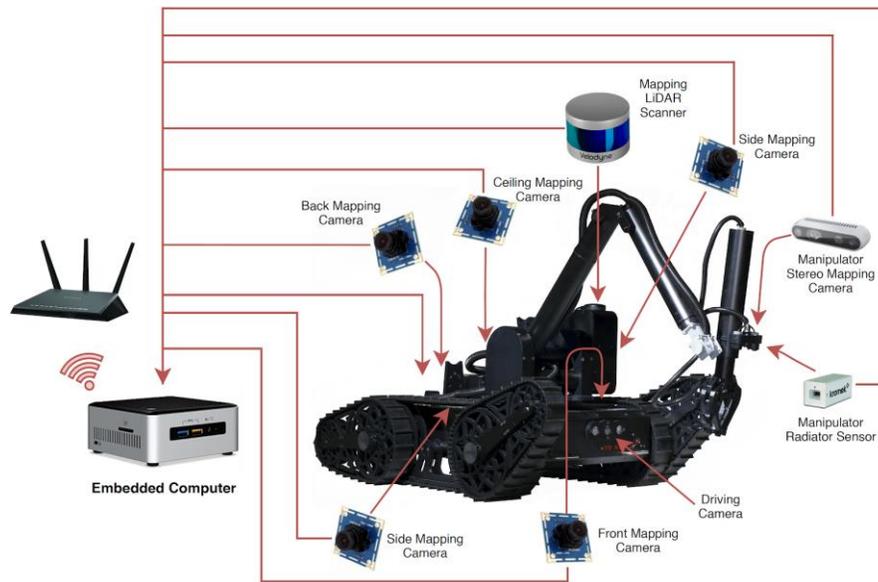
The proposed framework uses several heterogenous imaging sensors and gamma radiation detectors to construct an immersive environmental map, as illustrated by Figure 83. The framework stores high-resolution maps for digital twin reconstruction and keeps reduced-order ones for navigation and control. The framework also innovates using a robust localization algorithm fusing many sources of odometry (basically ICP, IMU, and visual), suitable in monotonous environments such as hallways and tunnels.

Figure 83. Mobile platform integration.

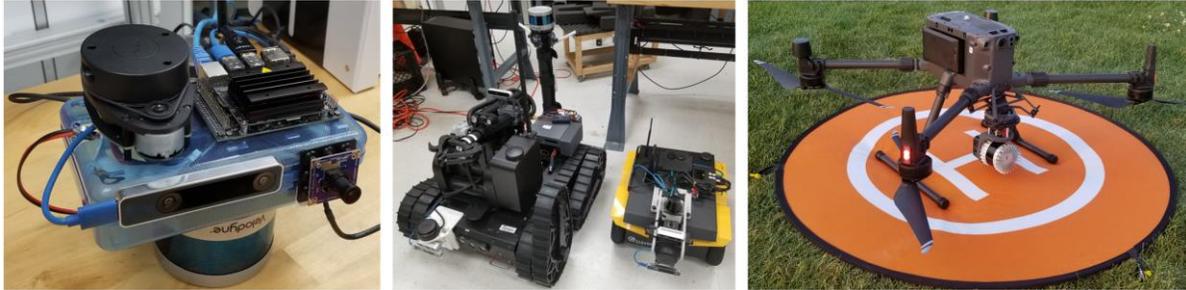
Figure 84. FIU's mobile platforms.

Figure 84 shows the handheld, ground, and aerial mobile platforms used in our in-house tests. The platforms have been customized, integrating several perception sensors to navigate nuclear

facilities, and generate high-fidelity tridimensional digital twins fused with radiation measurements simulated using synthetic gamma sensors.

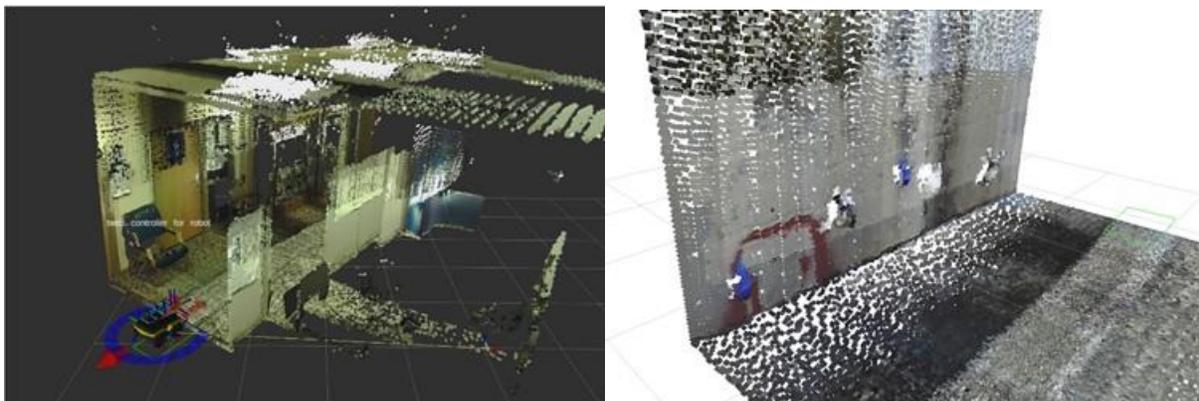
Figure 85. Indoor (left) and outdoor (right) colored point cloud topographic maps.

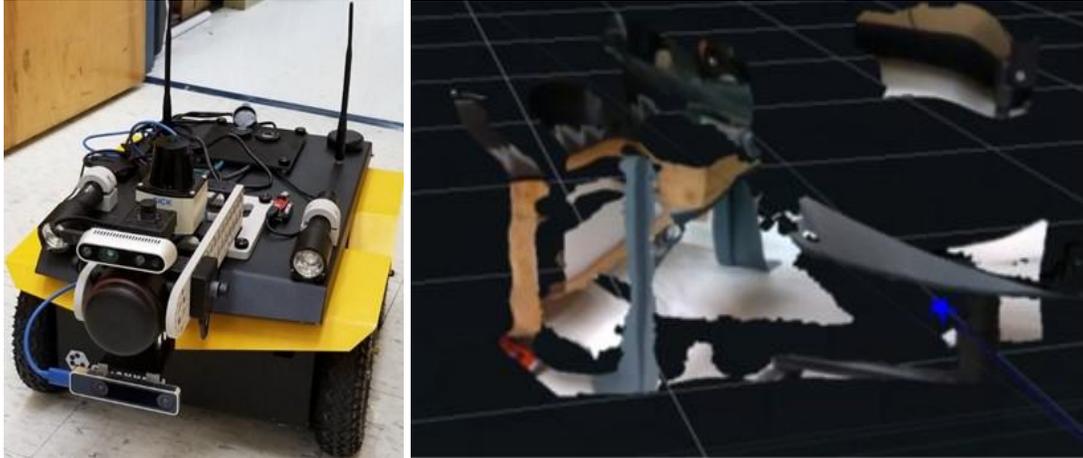
Figure 86. High density colored point cloud from Intel Realsense D435 Depth Camera.

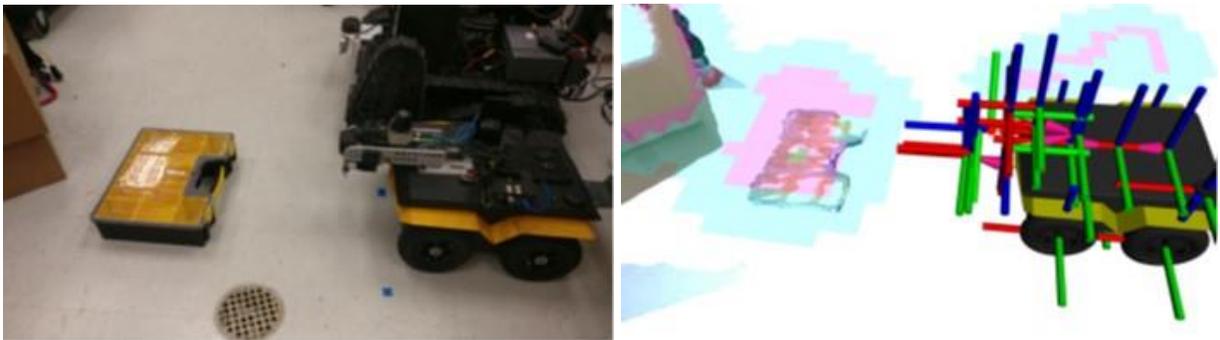
Figure 87. Improved object detection.

The depth camera was mounted to a lower spot on the mobile platform, improving navigation and capturing floor-level obstacles. After the sensor location tweaking, the robot successfully detected lower height obstacles such as the toolbox shown in Figure 87. Objects with lower height, such as chair legs, were not previously detected by the navigation framework.

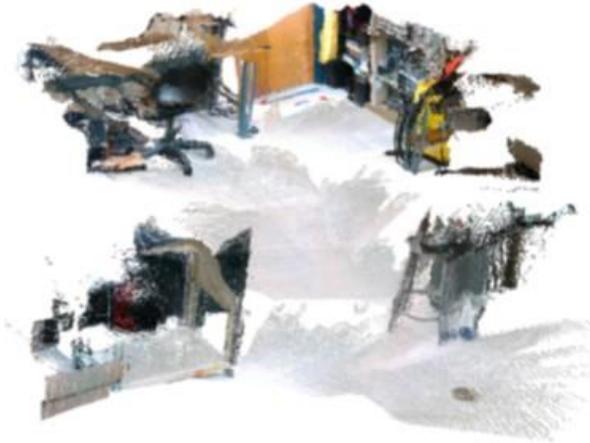
Figure 90. Improved captured map by fused data from a 3D camera.

Our previous localization algorithms rely on sensory fusion odometry from wheels, visuals, and Inertial Measurement Units (IMU), poised by eventual dead reckoning inaccuracies. Adding a 3D camera to our localization algorithm has improved our environmental maps' accuracy, such as in Figure 90. The improved odometry algorithms also incorporate colored point clouds from 3D cameras fused by the Real-Time Appearance-Based Mapping (RTAB-Map) application, which minimizes inaccuracies implementing loop closure in its simultaneous localization and mapping (SLAM) algorithm.

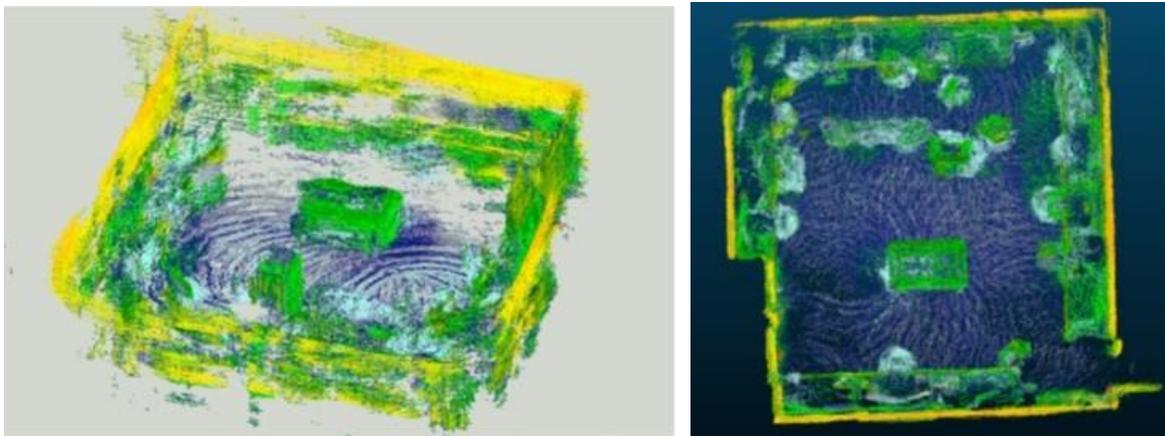
Figure 95. Original ICP point cloud (left) and improved map fusing IMU (right).

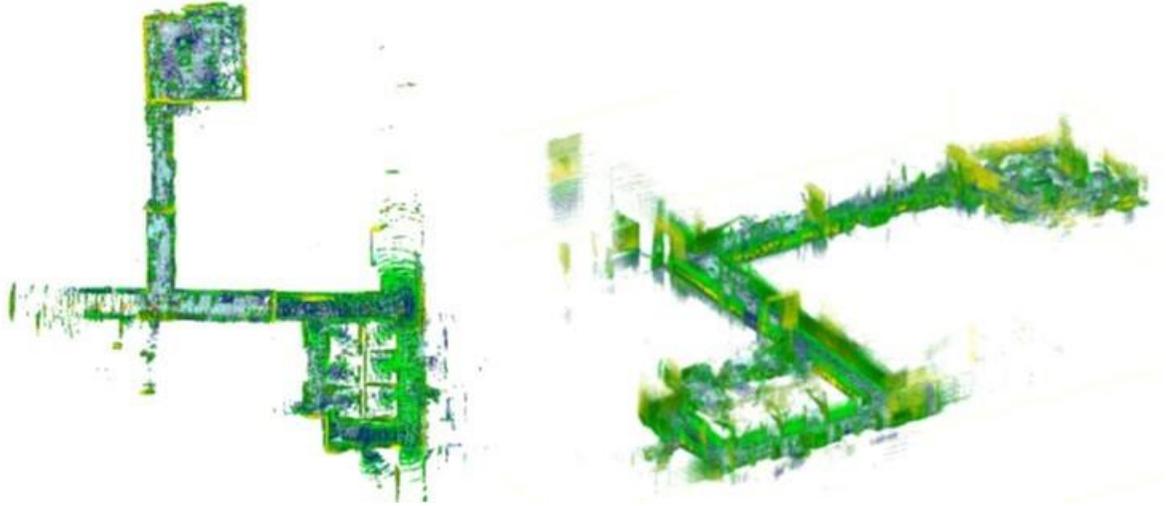
Figure 96. Captured maps from FIU's corridors.

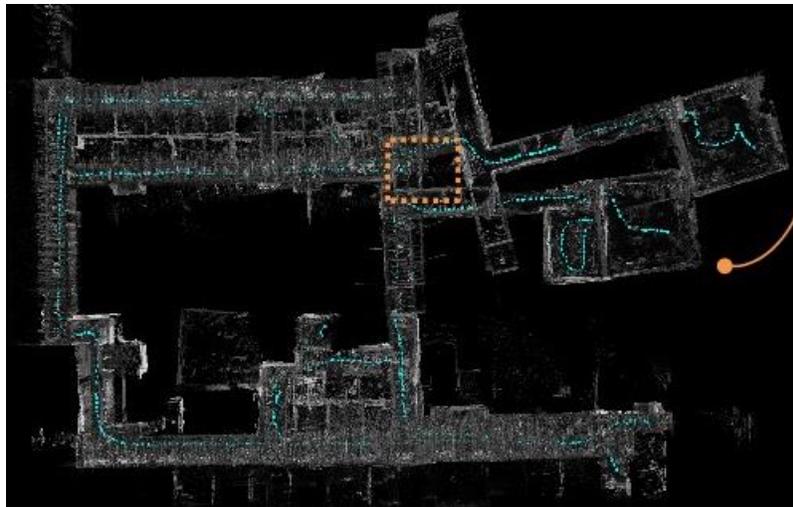
Figure 97. Closed loop failure in the localization algorithm.

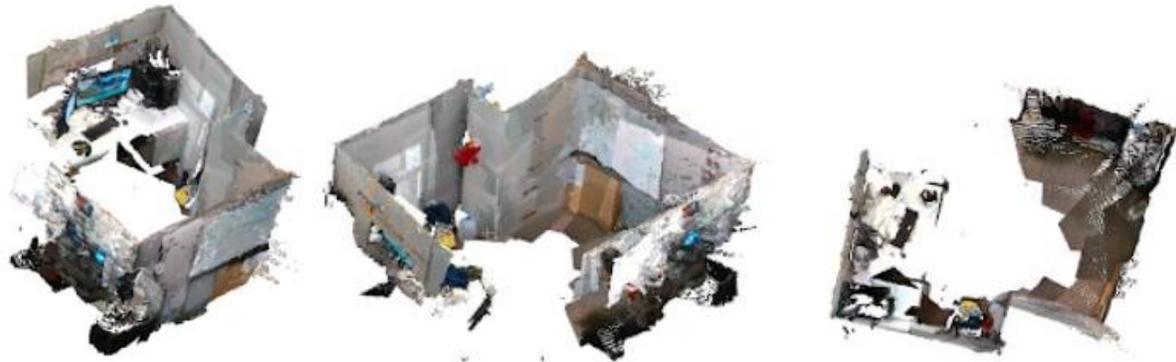
Figure 101. Processed data after cleaning and registration.

Figure 101 shows a preliminary digital twin reconstructed from multiple raw datasets captured with boxy. The raw point clouds were preprocessed in CloudCompare, using several cleaning and filtering algorithms, including Statistical Outlier Removal (SOR) and noise filter, duplicate point, and floating-point removal. Filtering by simple feature (SF) values was also tested to reduce the density and noisy points. The point clouds registration used the picking point pair method for rough registration and ICP for fine registration. The ICP algorithm searches for the nearest points in two adjacent scans and calculates the transformation parameters, but it still requires rough registration before using it. The root means square (RMS), which is the remaining distance between two scans, was minimized tremendously using the ICP algorithm. After merging the dataset scans, the overlapped sections were carefully removed, producing smooth and coherent digital twins.

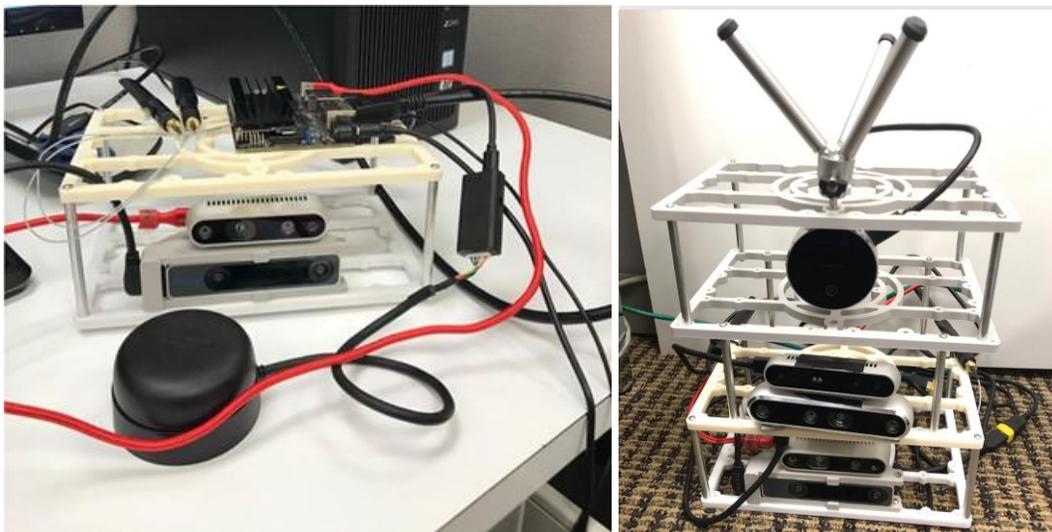
Figure 104. Original (left) and improved (right) "boxy" handheld mapping device.

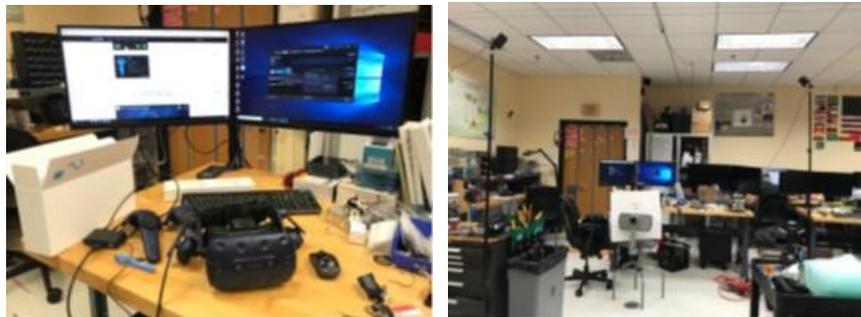
Figure 106. FIU's Robotics Laboratory VR headset system.

The VR headset system shown in Figure 106 has been used not only for immersive digital twin visualization but will also provide user interaction with our mobile mapping platforms.

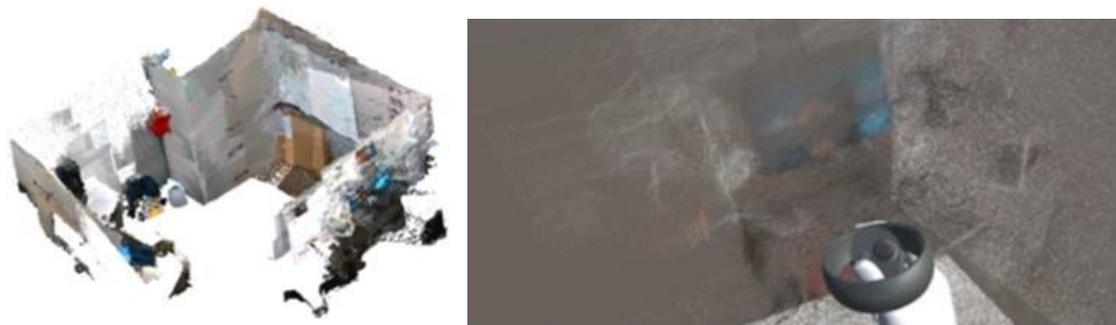
Figure 107. Preliminary virtual reality immersion tests.

Figure 107 shows a preliminary VR test, where the DOE Fellow explores her cubicle using the headset's controllers. The Fellow was able to experience stepping in the point cloud dataset and interacting with the cubicle's virtual environment.

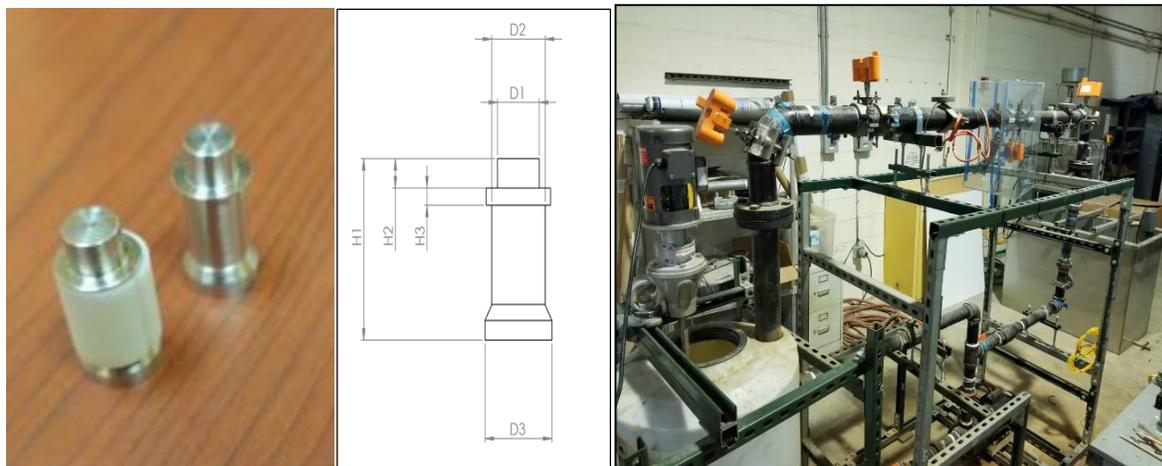
Figure 108. a) SRNL coupon b) dimensions and c) experimental pipe loop.

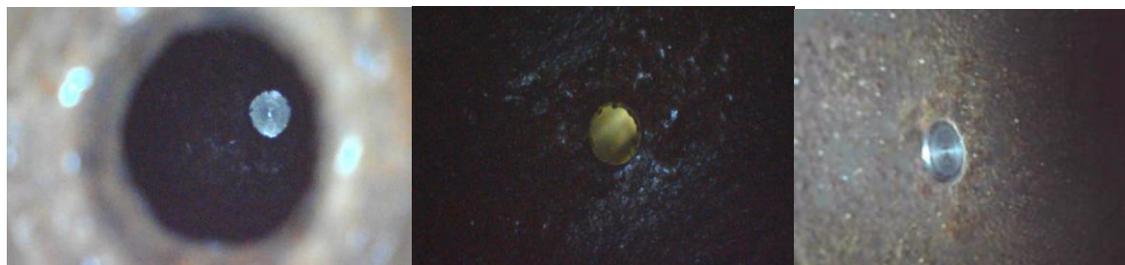
Figure 109. Borecope images of the coupons in the pipe loop.

To quantify the erosion taking place in the pipe, the coupons were weighed and measured using a balance and caliper before being inserted. The surface of the coupon head was also viewed under a microscope and photographed for later comparison after erosion had occurred. During the test, measurements were taken in situ using an Olympus V260-SM UT pencil sensor [5] that was modified to fit specifically in the provided channel within the coupon. Thickness measurements were collected every 30 minutes from both a handheld UT pencil sensor and the permanently mounted UT sensors on the loop. After testing, the coupons were removed from the pipe loop and measurements were taken again in order to quantify mass and height loss, and validate the measurements taken by the pencil sensor. The coupons were tested on the pipe loop with varying sand and water slurry mixtures and grit sizes. Upon completion of the carbon steel coupon testing, this year the next phase of testing has been initiated with stainless steel coupons to evaluate the erosion effects on the stainless-steel material. The pipe loop was thoroughly cleaned by circulating water and the SRNL coupons were inserted. The new coupons were tested using sand and water mixtures. The pipe loop at FIU has been updated with changes to the pump and installation of the coupons. During the process, the coupons were unable to flush with the inner surface of the pipe loop. Hence, the coupons were machined to have a tight fit in the pipe sections for appropriate testing. The borescope images of the coupons in the pipe are shown in Figure 109.

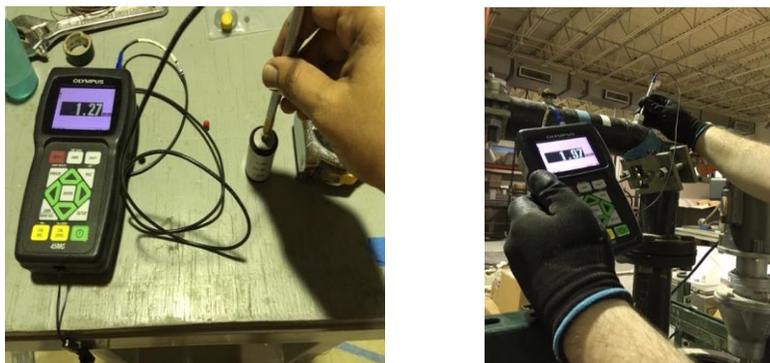
Figure 110. a) UT sensor calibration and b) real-time coupon thickness measurement.

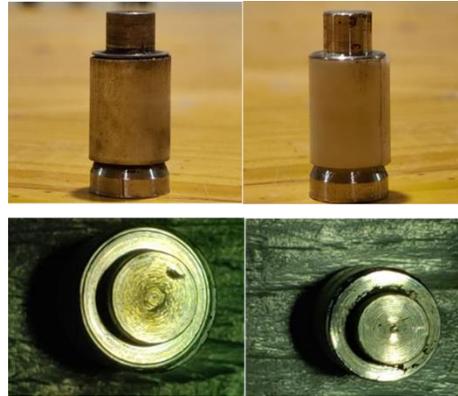
Figure 111. Eroded Coupon surfaces removed from the elbow and bottom sections of the pipe.

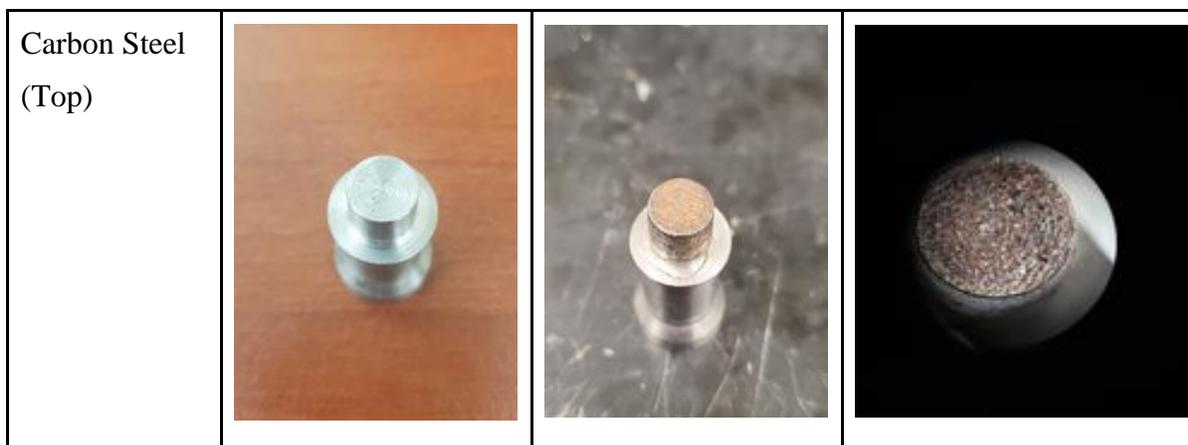
Table 6. SRNL Coupon Test Results (Images)

Pre-test Image	Post-test Image	High Resolution Surface Image (post-test)
Carbon Steel (Bottom)

Coupon weights and heights were also measured under pre- and post-test conditions. Test results are listed in Table 7 and Table 8 for the pre- and post-testing respectively. Geometric dimensions for the coupon are shown in Figure 108. The parameters of importance are H1, H2 and D1. Considering the coupon heights, it is observed that there was no significant change in the SS coupons as expected, while the CS coupons reduced in height explaining the surface erosion. It is evident from the tables that all the coupons show mass gain except for one of the stainless-steel coupons. Hence, the mass gain in this case can be explained as particle agglomeration and corrosion effects. Also, it was noticed that the other geometric dimensions (diameters D2 and D3, height H3) did not change indicating intact fit of the coupon in the pipe hole.

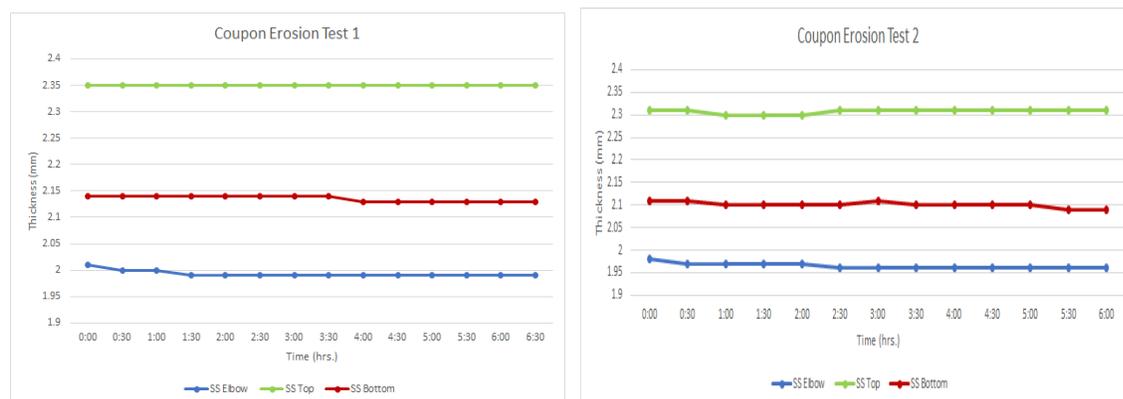
Figure 112. Results of Coupon Erosion Test 1 and Test 2.

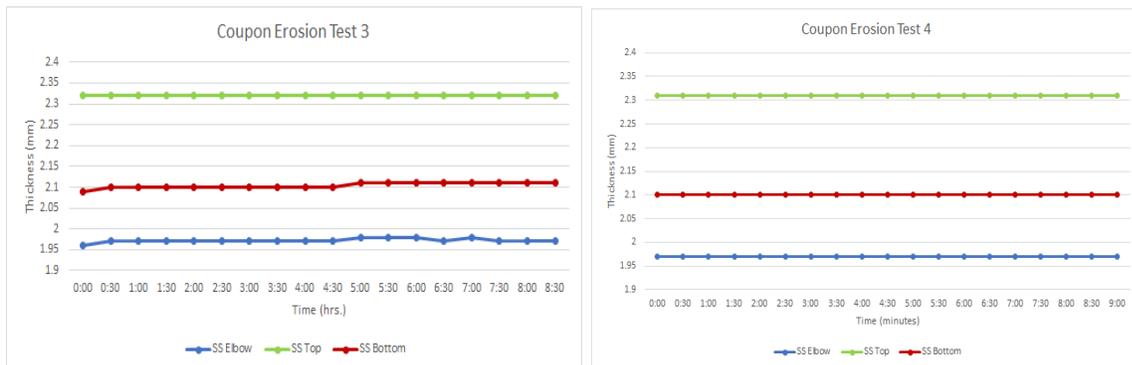
Figure 113. Results of Coupon Erosion Test 3 and Test 4.

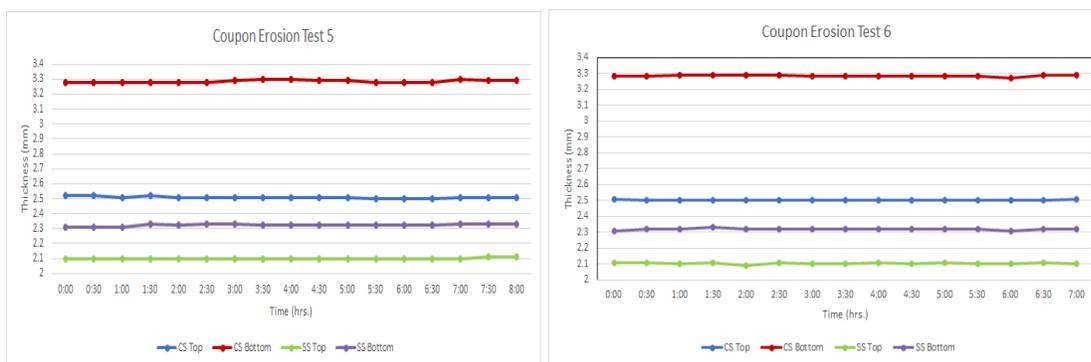
Figure 114. Results of Coupon Erosion Test 5 and Test 6.

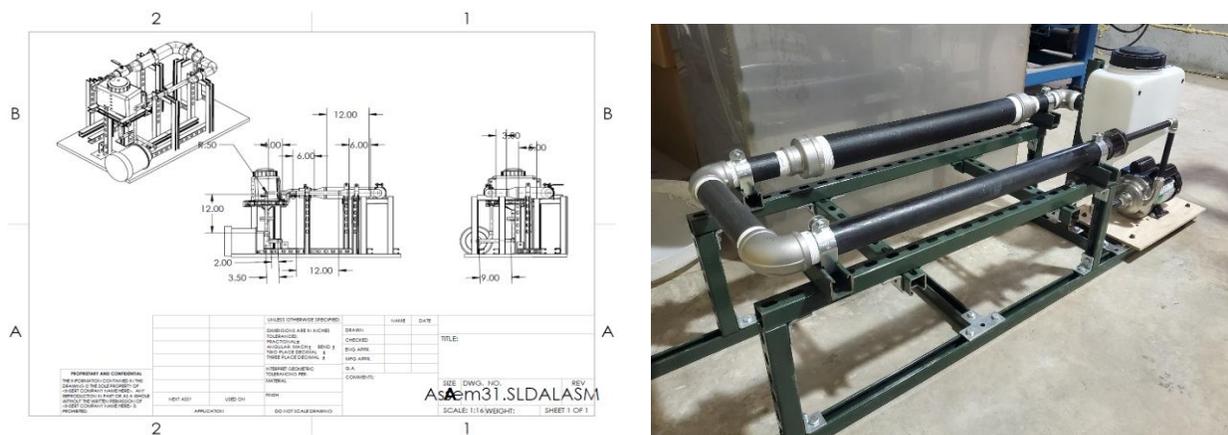
Figure 115. a) Bench scale loop development CAD drawing and b) assembled loop.

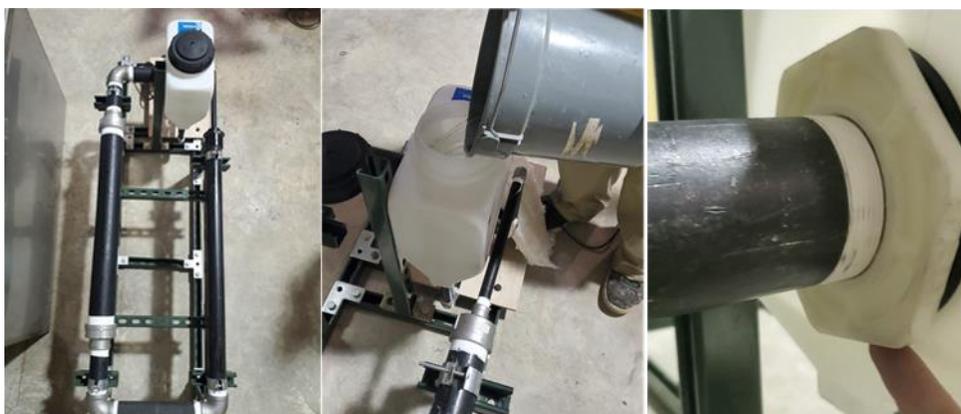
Figure 116. a) Bench scale loop, b) water testing and c) pipe leak.

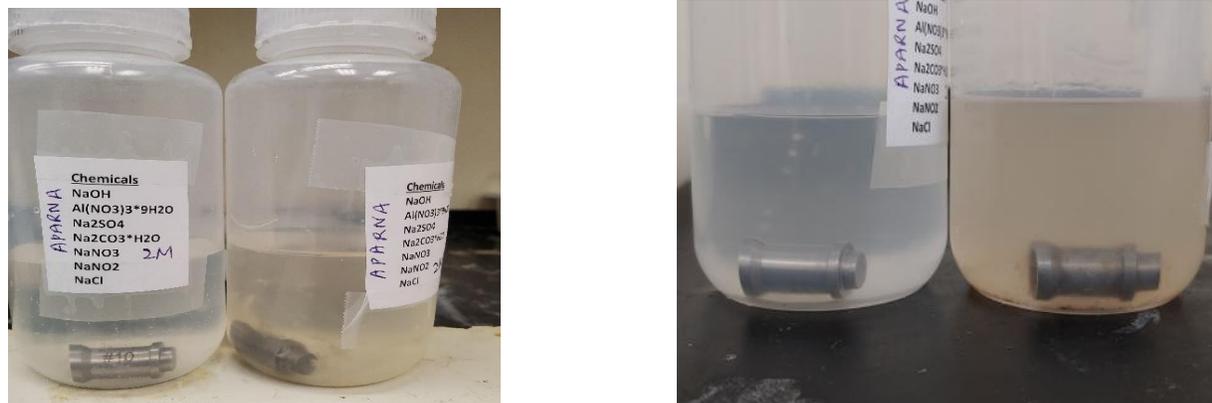
Figure 117. SRNL coupon immersion tests initial (Day 1) (left) and current (Day 35) (right).

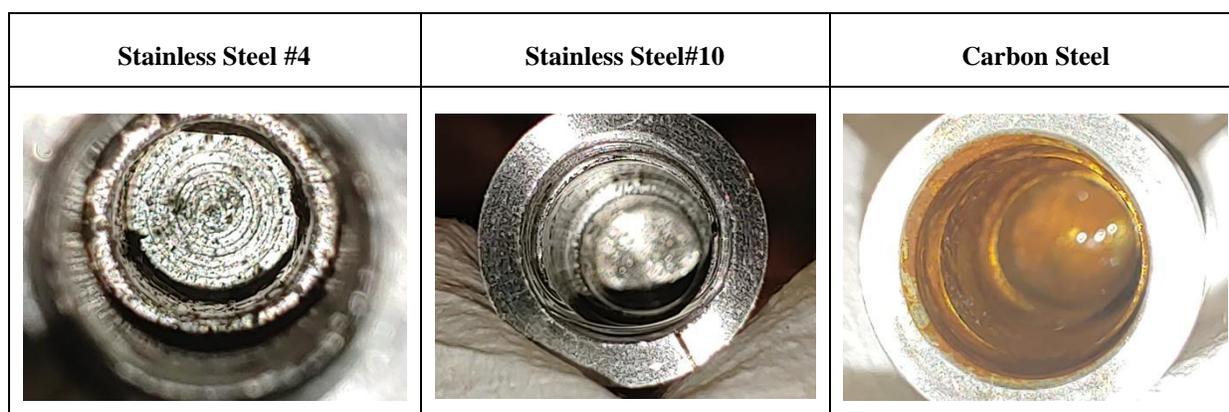
Figure 118. Visual corrosion inspection of the CS and SS coupons (2M).

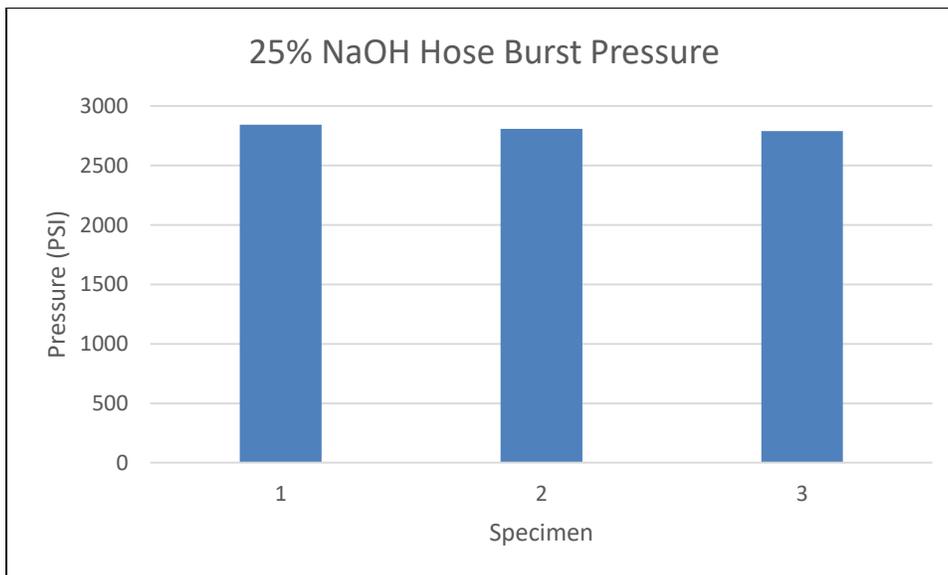
Figure 123. Hose burst pressure for specimens aged with 25% NaOH.

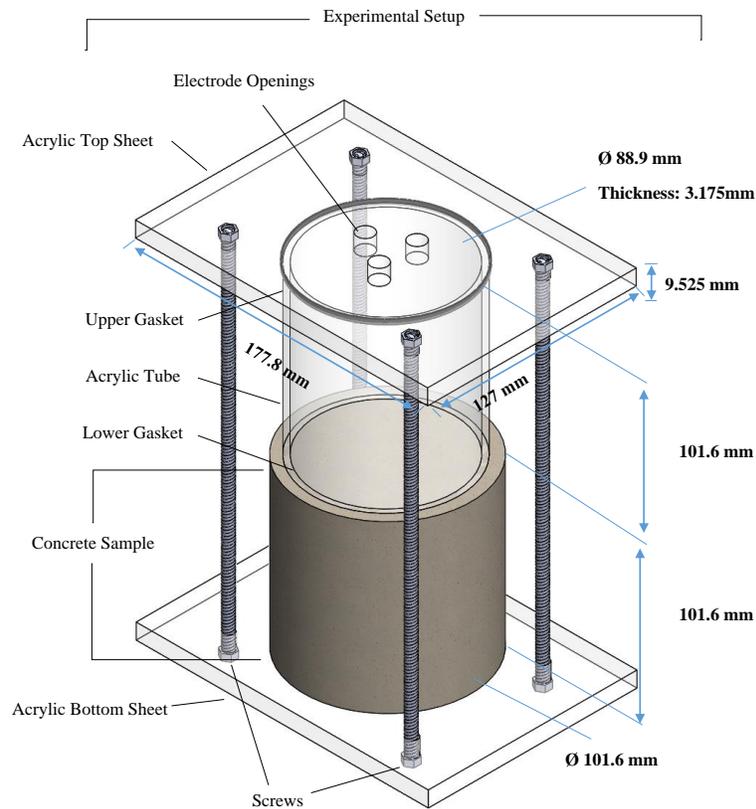
Figure 124. Schematic of test setup for concrete exposure to acid solutions.

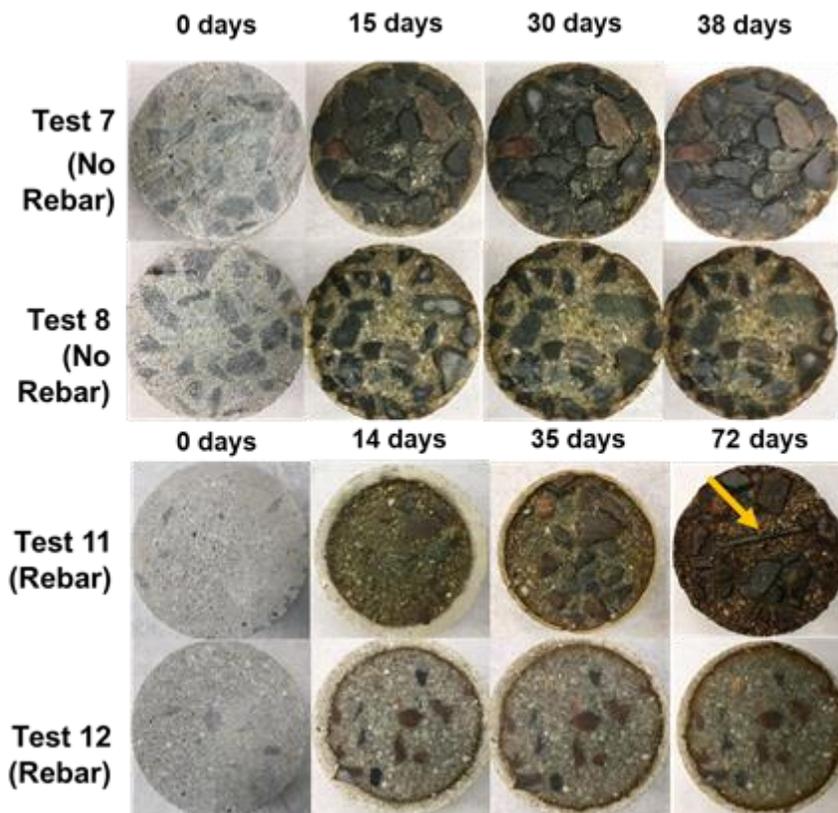
Figure 125. Comparative images of the top view of concrete specimens before and after enhanced aging conditions of Test 7, Test 8, Test 11 and Test 12. The arrow on Test 11 points to the exposed rebar.

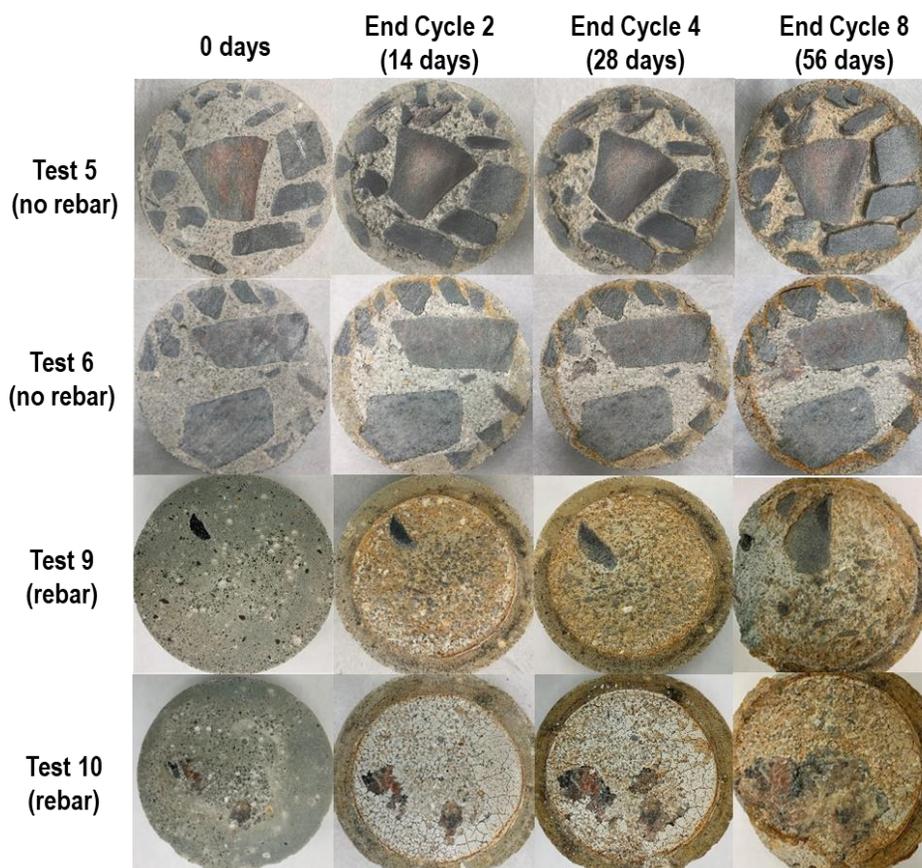
Figure 126. Images of the top view of concrete specimens before and after the end of each standard aging cycle of Test 5, Test 6, Test 9 and Test 10.

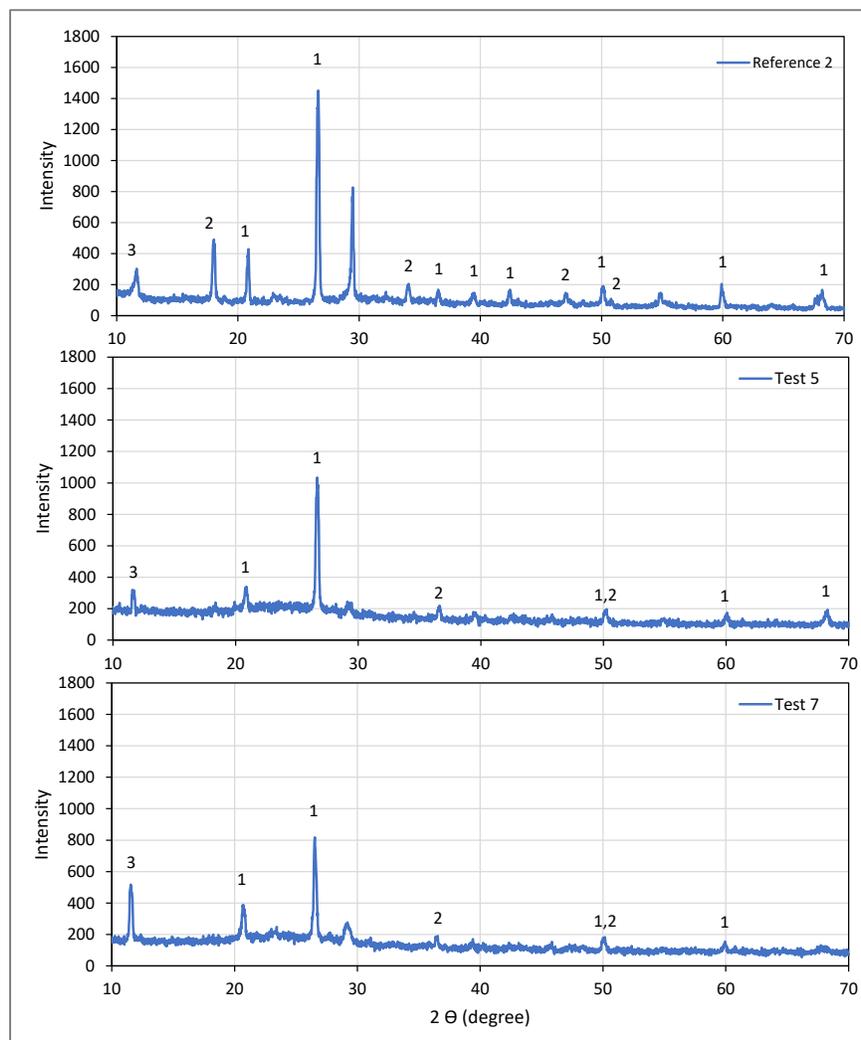
Figure 127. XRD spectra of concrete matrix samples before (reference) and after (Test 5 and Test 7) aging. 1-Silicon oxide (Quartz), SiO_2 , 2-Calcium hydroxide (Portlandite), $\text{Ca}(\text{OH})_2$ and 3-Calcium sulfate hydrate (Gypsum), $\text{CaSO}_4(\text{H}_2\text{O})_2$.

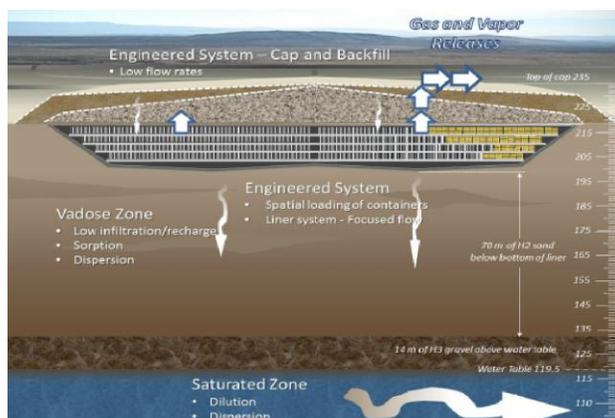
Figure 128. Features of the Integrated Disposal Facility [3].

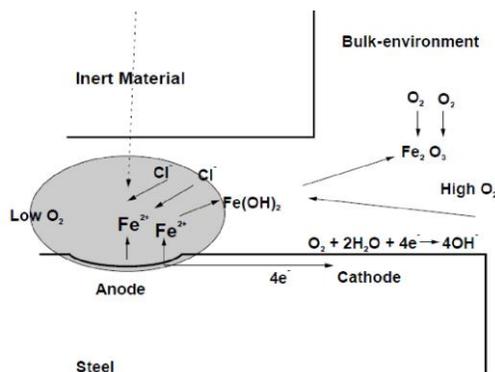
Figure 129. Schematic of the crevice corrosion [7].

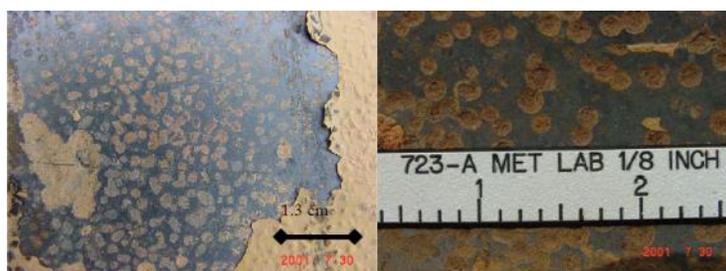
Figure 130. Large areas of macroscopic pitting on lid surface of B-25 container [10].

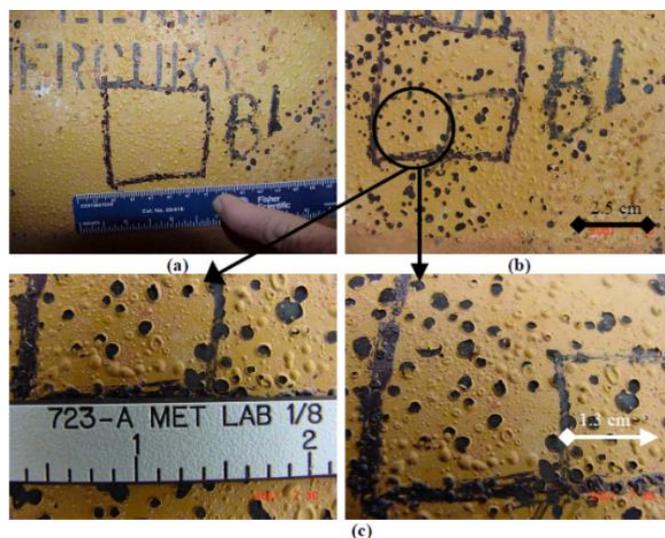
Figure 131. Coating blisters on the surface of B-25 container (a) Intact blisters, (b) broken blisters, (c) broken blisters showing intact primer [10].

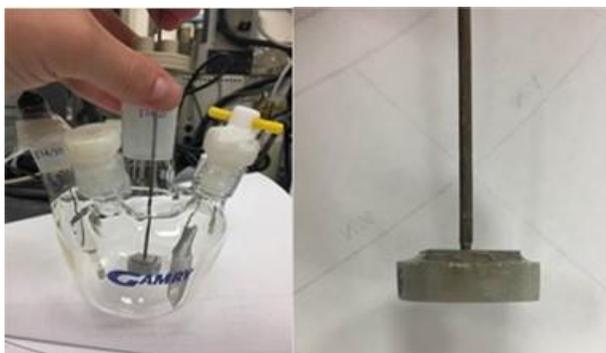
Figure 132. Experimental setup (left) and the sample (right) for electrochemical measures.

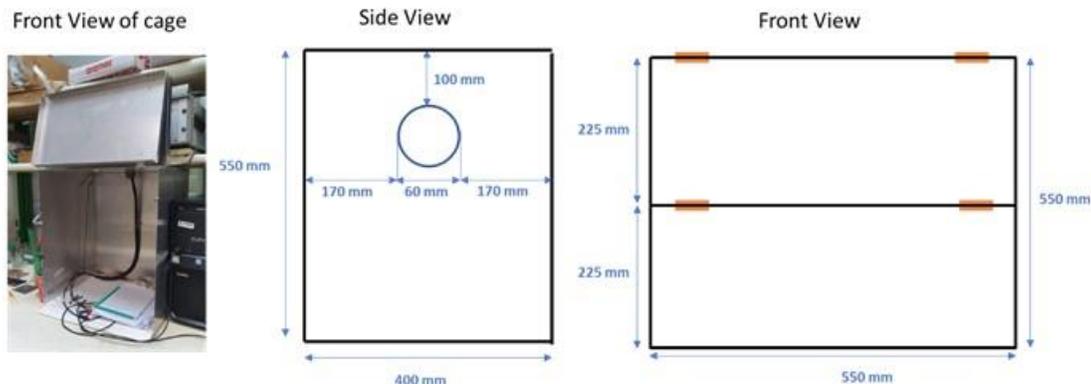
Figure 133. Schematic of the Faraday cage. Image of similar cage (left), Side view (middle) and front view (right).
