## **YEAR END TECHNICAL REPORT**

September 29, 2021 to September 28, 2022

# **Chemical Process Alternatives for Radioactive Waste**

U.S. Department of Energy

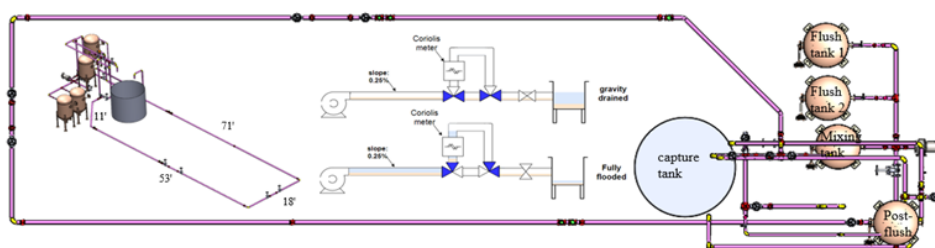
Figure 1. CAD model of the 165-foot pipeline used for flushing experiments.

The experimental set up consists of a test loop composed of 3-inch schedule 40 carbon steel pipes and fittings (Figure 1 and Figure 2). This test loop can perform various functions such as slurry circulation, pump cleaning, flushing, sediment and water retrieval, and post-flush circulation. The pipeline was sloped at the rate of 0.15% (to emulate conditions at Hanford Site and facilitate gravity draining) [5]. A 15 HP centrifugal pump controlled by a variable frequency drive (VFD) is used to circulate the simulant, flush with water, and conduct post-flush analyses. The fluid level, flow speed, and fluid density are monitored using sensors – the VEGAPULS 11 radar sensor and the Krohne Optimass 1000 Coriolis meter, respectively - that report the status of these parameters in real time.

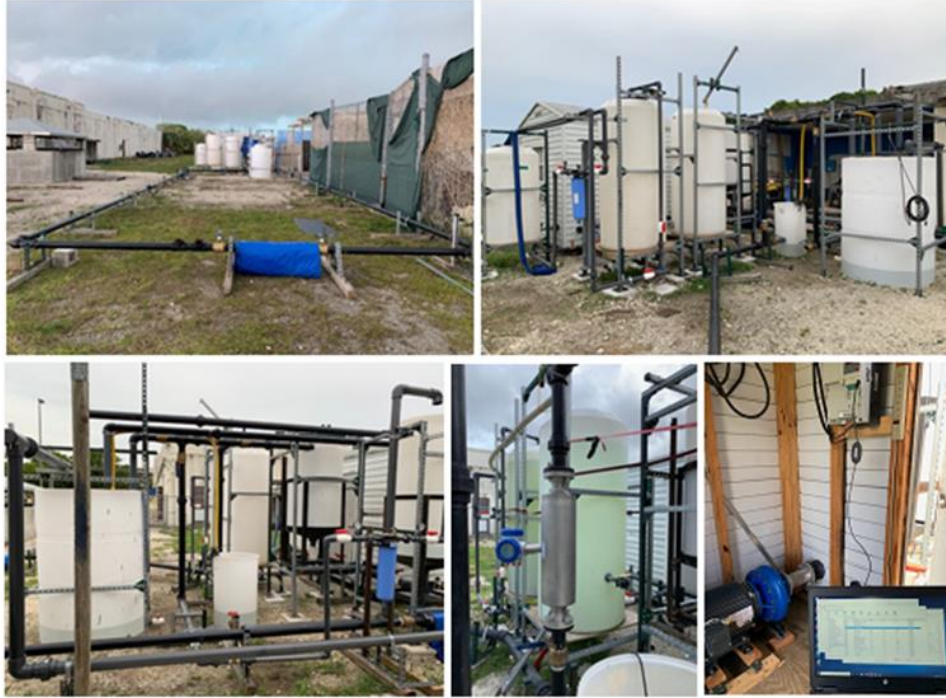
**Figure 2. Constructed 165-foot pipeline for flushing experiments.**

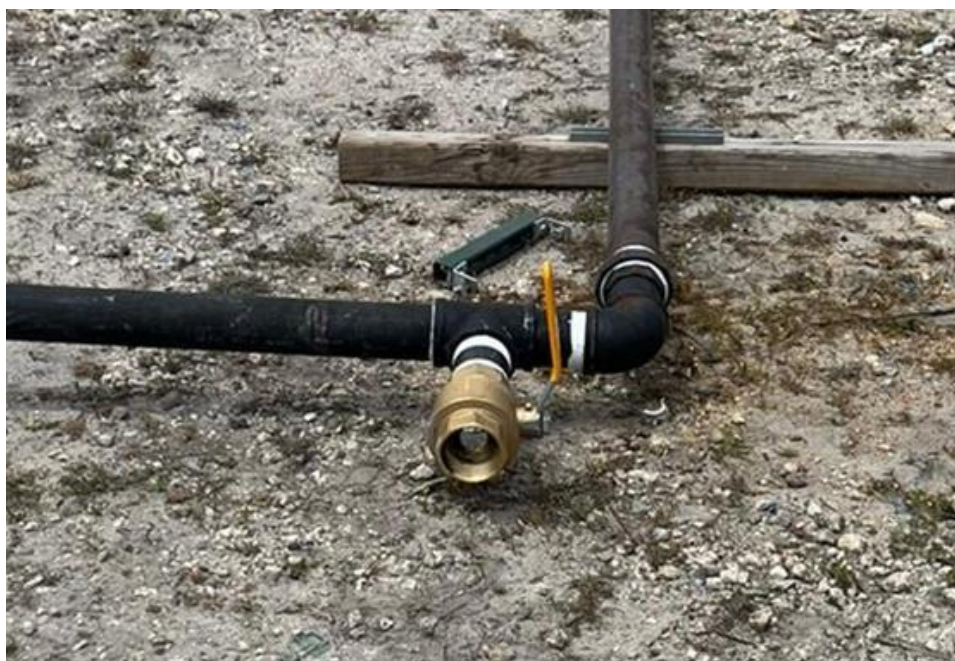
**Figure 5. Gravity drained discharge valve at the 90-degree section of the flushing loop.**

During the data collection for the 165-foot loop, it was noticed that for the gravity draining operation, some water remained inside the line after the draining completed when observing the clear section. This was likely due to the original gravity drain discharge valve at the tank farm, shown in Figure 5, being higher than the affected portion of the line. For the 165-foot loop, the volume of water that would remain inside the line was enough to not adversely affect the sedimentation of the kaolin. By relocating the gravity drain discharge valve inline at the far end of the loop, the potential risk of water remaining in the loop and adversely affecting the gravity-drain operation is minimized, especially for larger solid concentrations.

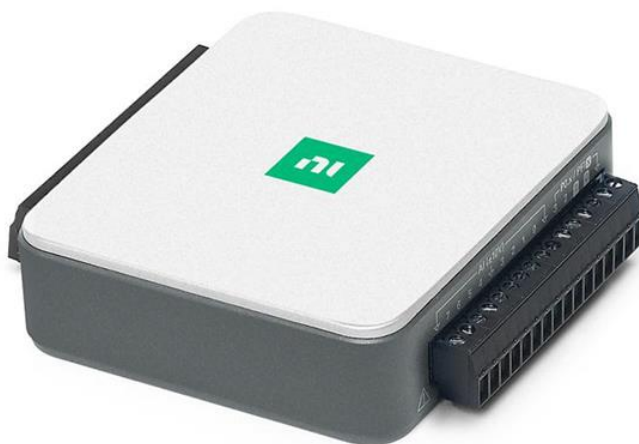
**Figure 6. NI-USB6001 Multifunction I/O data acquisition unit.**

- c. The flow rate sensor was connected to a PRO-FLO200 Flow Batching Totalizer that converts the digital pulses of the flowmeter to a 4-20 mA output. This totalizer was connected to Channel 2 on the data acquisition system. The change in current was monitored while the VFD frequency was varied from 0 Hz to 50 Hz, with the standard operating frequency used in testing (35 Hz) as an intermediate value.

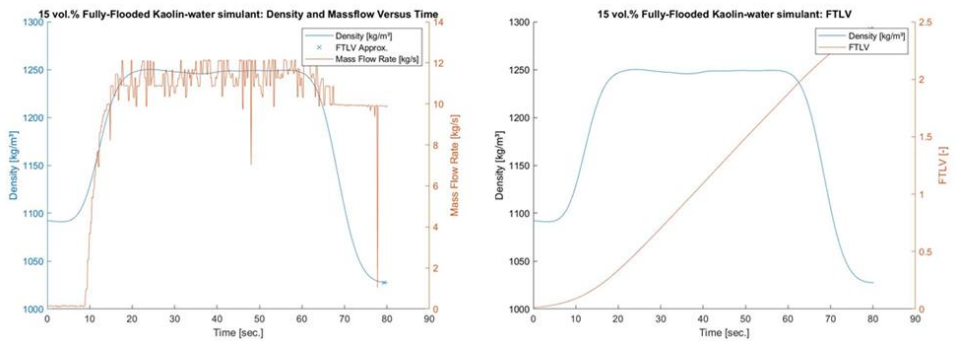
**Figure 8. 15 vol.% fully-flooded kaolin water simulant: (left) density and mass flow vs time (right) approximate FTLV.**

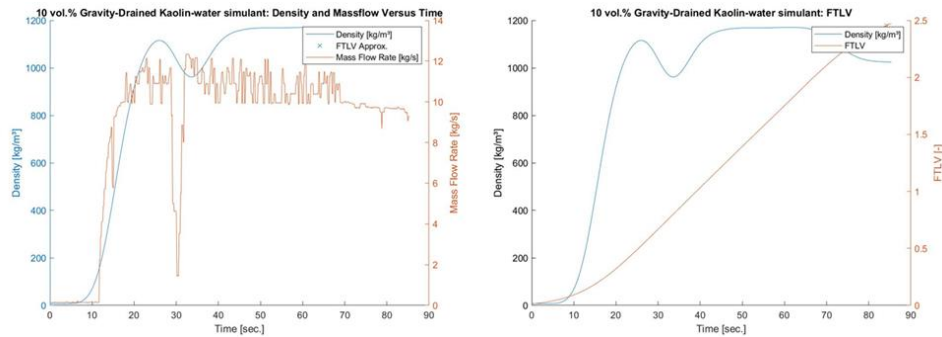
**Figure 9. 10 vol.% gravity-drained kaolin water simulant: (left) density and mass flow vs time (right) approximate FTLV.**

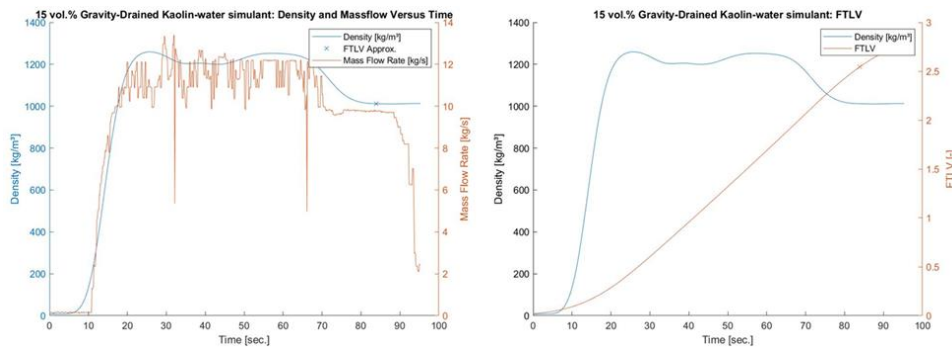
**Figure 10. 15 vol.% gravity-drained kaolin water simulant: (left) density and mass flow vs time (right) approximate FTLV.**

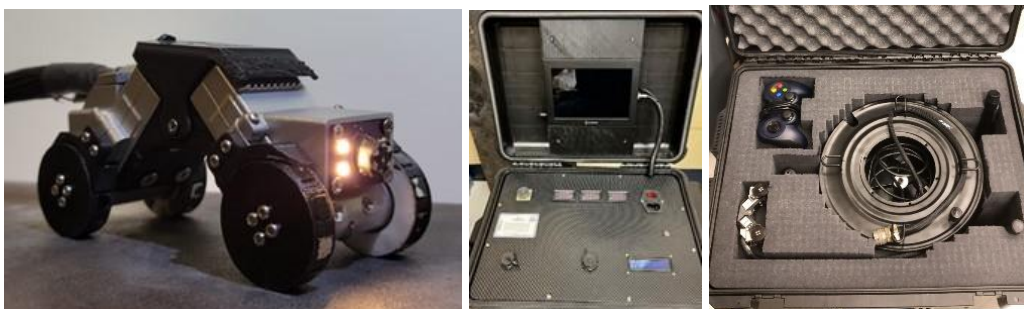
**Figure 12. FIU's Mini Rover inspection tool system.**

Upon completion of the WRPS-approved testing performed at Florida International University's full-scale mockup, and working directly with the subject matter experts involved with the tank integrity inspection program, the mini rover system was deemed fit to deploy at Hanford's Cold Test Facility. Figure 12 shows FIU's Mini Rover inspection system.

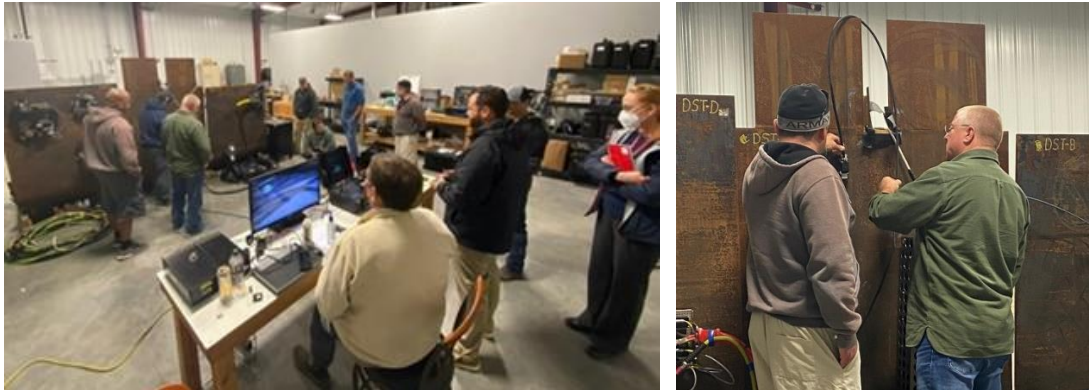
**Figure 13. Mini rover tested at IVITS facility and actual deployment at AP-105.**

rover. The mini rover managed to surpass the expectations of all personnel present during the rigorous tests it encountered and was unanimously voted to be deployed the following day.

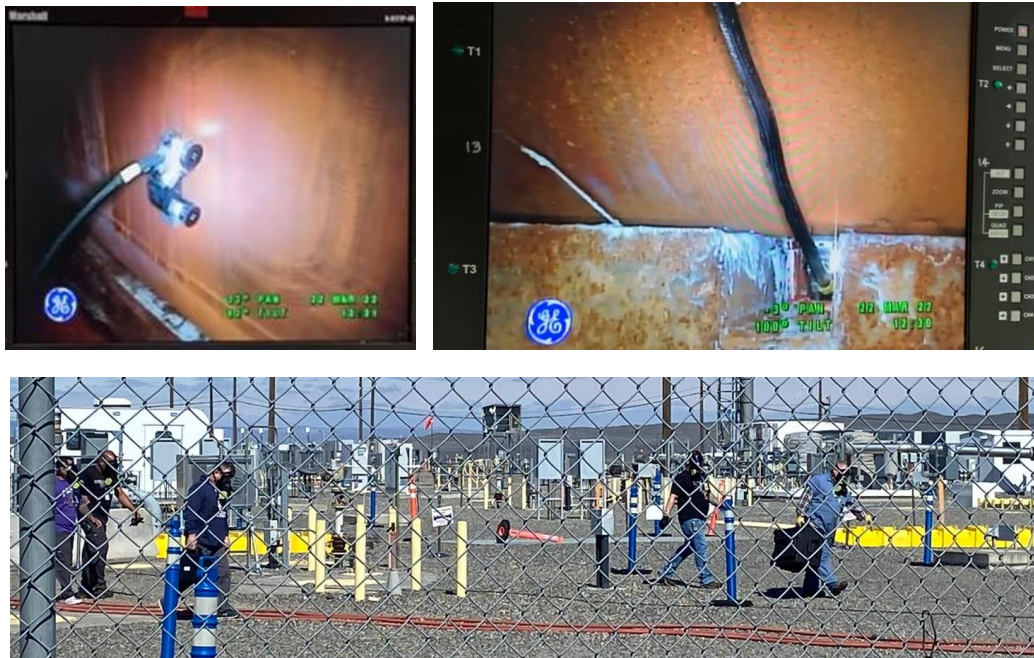
**Figure 14. Hanford AP-105 DST deployment.**

After the training and evaluation at IVITS facility, the mini rover was successfully deployed at Hanford to inspect the AP-105 DST, as illustrated in Figure 14. The rover was deployed through the riser located at grade and lowered down via the deployment tray. Upon being lowered to the appropriate length, the rover traversed down the tank wall in the annulus and entered the refractory air slot. Upon the successful inspection of the refractory slot, the rover returned to the deployment tray and was retrieved with its condition operating at full capacity.

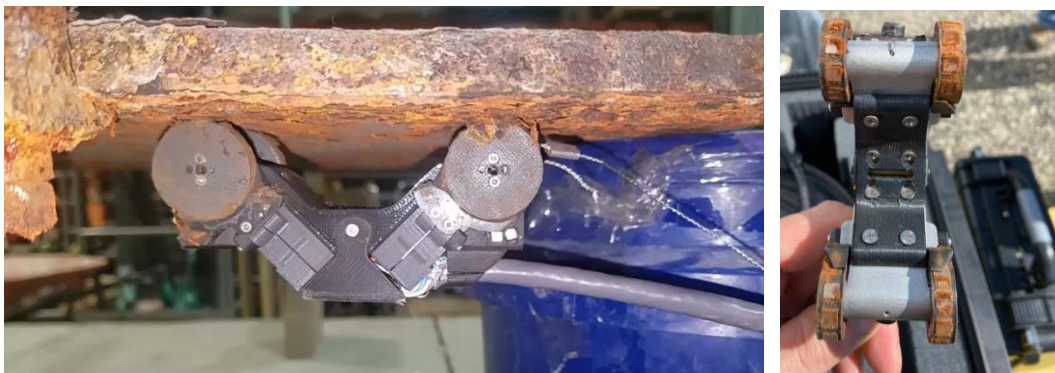
**Figure 15. FIU’s in-house testing (left) and retriever rover after AP-105 DST deployment (right).**

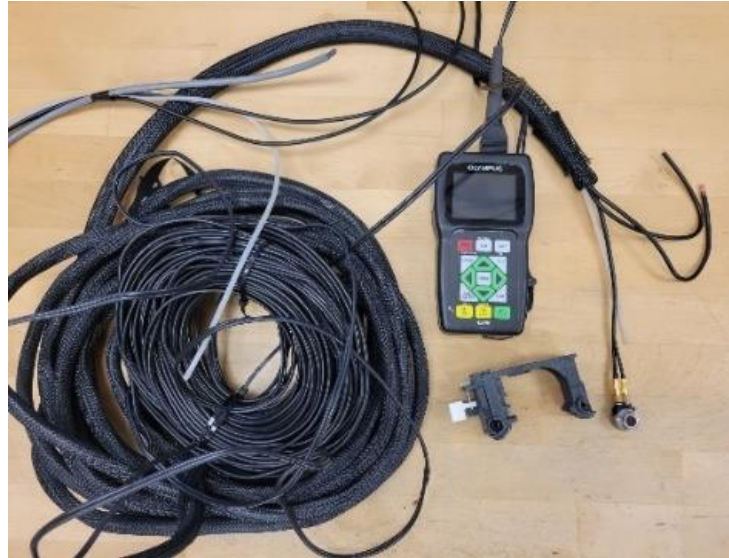
**Figure 17. Current UT rover sensing equipment.**

Figure 17 shows the UT rover’s sensing equipment, a significant challenge in the chassis redesign. The current system integrates an ultrasonic sensor probe, 100 feet tether, and gage to measure primary liner thicknesses. A polyurethane tube within the tether delivers the couplant water required by the sensor.

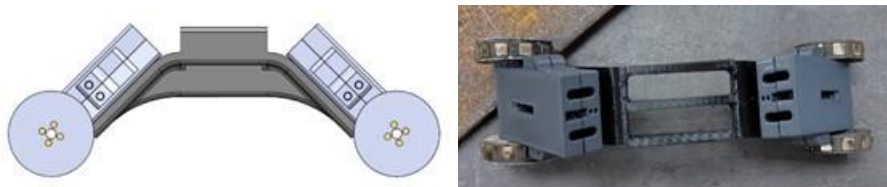
**Figure 18. Compliant UT rover chassis.**

Figure 18 shows the redesigned flexible chassis. The compliant UT rover chassis was prototyped to tackle oblique weld seams and maintain magnetic adhesion to the primary liner.

With the successful deployment of the mini rover at Hanford’s tank farm, design changes were incorporated to the original UT Rover. The major changes consisted of the magnets being transferred from the body to the wheels and reduction of the overall size of the rover chassis. Minor changes included improved sensing device, software framework, and hardware. The UT probe mechanism was also redesigned to accommodate the new changes. A flexible chassis was also incorporated to accommodate traversing over oblique weld seams the rover will expect to encounter during deployments.

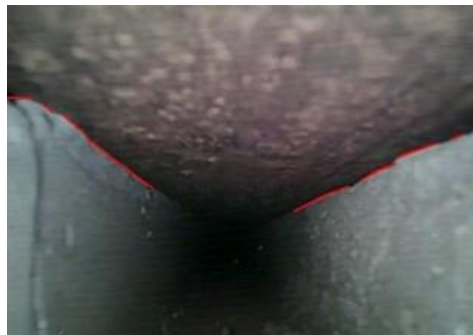
**Figure 20. Channel edge detection on FIU’s full-scale mockup channel.**

FIU’s efforts were also dedicated to exploring and adapting machine vision software to guide the ultrasonic (UT) sensor rover. Extracting surfaces using machine vision techniques can provide the inspection tool with semi-autonomous navigation capabilities and accurate identification of ideal sampling locations for probe ultrasound measurement and create a baseline for future comparison. Identifying the channel features allows the rover to perceive spaces from a single monocular camera. The extracted features fused with inertial measurement unit (IMU) attitude estimations can potentially generate a tridimensional map of inspected areas, visualizing UT sensor measurement locations and other critical features within the refractory channels. Figure 20 shows an initial attempt to detect the channel edges using a classical computer vision algorithm.

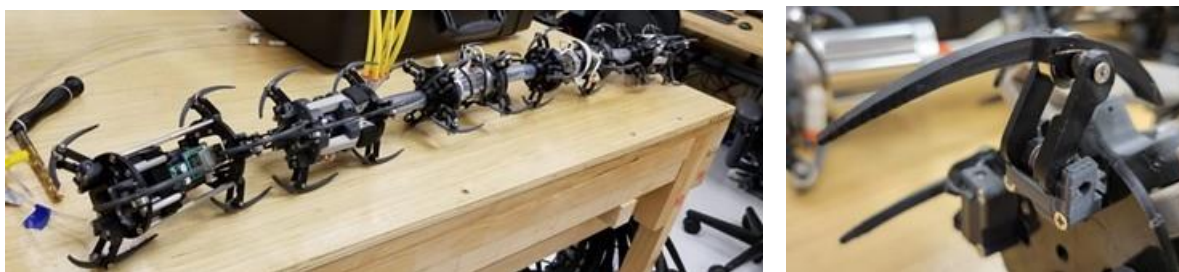
Figure 23. Current pipe crawler prototype (left) & improved guides (right).

The modules' curved guides were streamlined to reduce further friction and correct failures observed during initial testing. Figure 23 (left) shows a functional prototype of the pipe crawler that was rigorously tested to evaluate the unit's behavior in realistic conditions. Improvements included the addition of rolling bearings to the guides. This helped in significantly reducing contact friction. Improved guides are shown in Figure 23 (right).

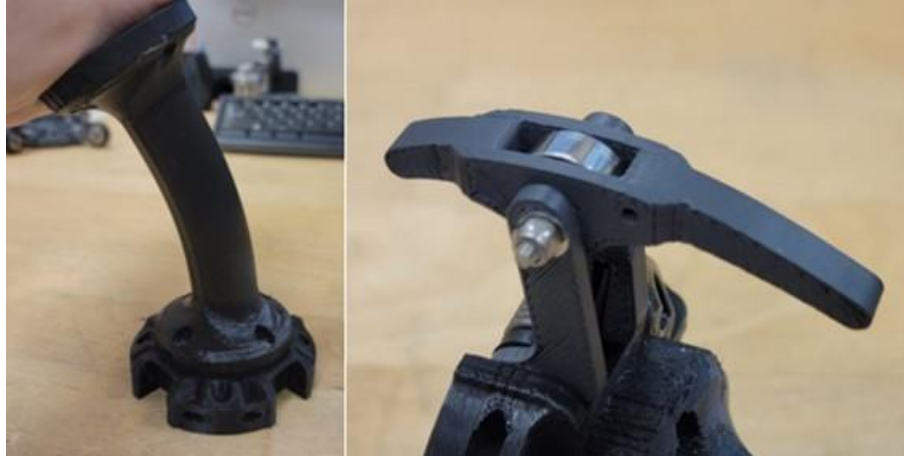
**Figure 24. 3D printed inter-module flexible connection (left) and strengthened guides (right).**

The inter-module flexible connections and module guides' design were also revisited, as shown in Figure 24. The redesigned links use a monolithic 3D printed compliant part securely fastened to the modules' flanges, eliminating inconsistencies in the previous adhesive joint. The suspension guides were shortened and strengthened solving reported structural issues without compromising functionality.

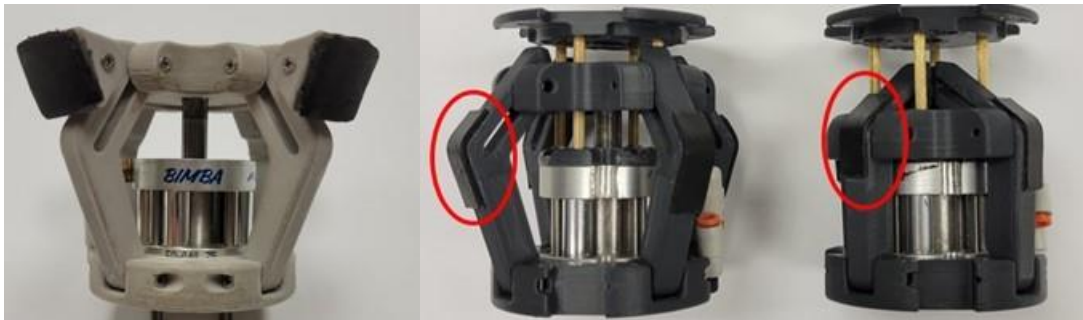
**Figure 25. Original (left) and redesigned gripper arms (center and left).**

Figure 25 shows the redesigned brake mechanism in the gripper modules, improving anchoring strength by shortening the arm's length, and eliminating the articulating pads at the end for better force transfer. A higher gripper strength sustains higher carrying payloads during the peristaltic motion, which is crucial for deploying the gamma sensory modules.

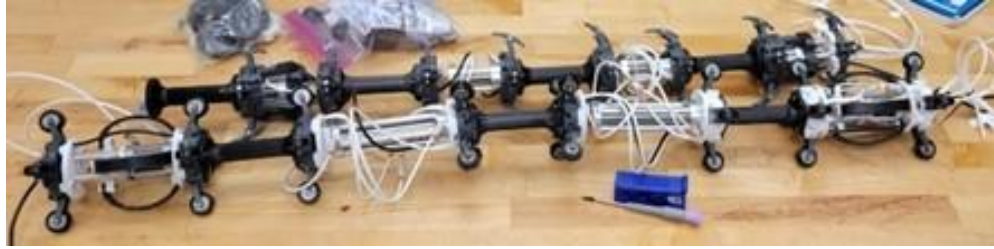
Figure 28. New crawler prototype shown with the older version.

Figure 28 shows FIU's final prototypes, the original crawler and the slightly modified prototype with larger actuators. The two versions were deployed at Hanford's Cold Test Facility.

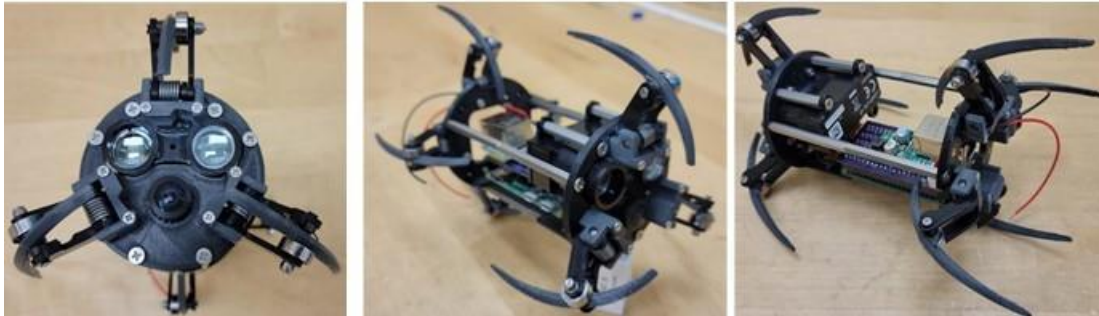
Figure 29. Electronics module with a forward-facing camera and range finder.

An electronics module, shown in Figure 29, was also developed and is located at the front end of the pipe crawler. It currently houses a range finder, single board computer, wide-angle camera, and a female Ethernet port. The single board computer is utilized to transfer the live video feed, as well as an interface for potential additional sensing equipment. The module itself has guides surrounding it to provide video and images from the center of the pipe it is resting in.

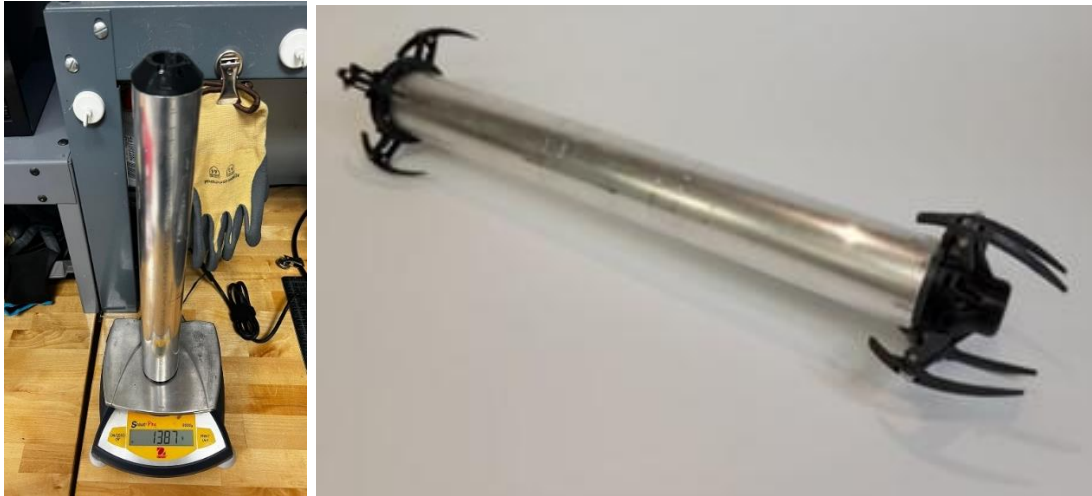
**Figure 33. Mockup sensor payload.**

Figure 33 shows the mockup sensor built according to WRPS's guidance to simulate the payload weight and shape during mockup tests and deployments.

The mockup sensory package has 15” length, 1.9” diameter, and 3 lbs per module in a total of 9 lbs consisting of 3 modules.

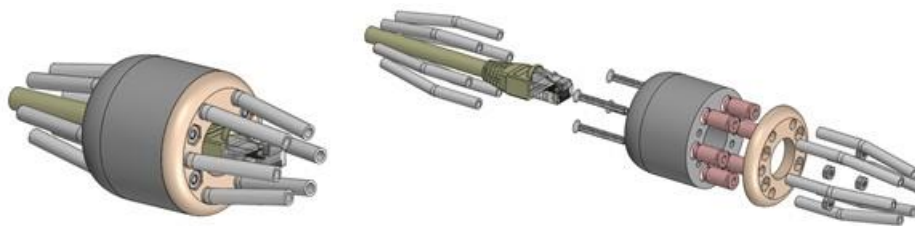
**Figure 35. Tether “egg” for quick detachment.**

The quick-disconnect module shown in Figure 35 was designed to facilitate disconnecting the pipe crawler from the tether. This allows the team to efficiently make changes to the crawler without having to dismantle the tether. The tether “egg” houses an RJ45 slot, six push-to-connect straight pneumatic fittings, and a slot for a steel rope. The main housing (large cylinder) seals the components with a lid secured by 4 screws along the circumference. Tubes and wiring remain within the crawler to avoid removing each pneumatic fitting. The steel rope is secured with two loops, the tether and the crawler’s, joined with a shorter length than other cables to ensure tension is only on the steel cable.

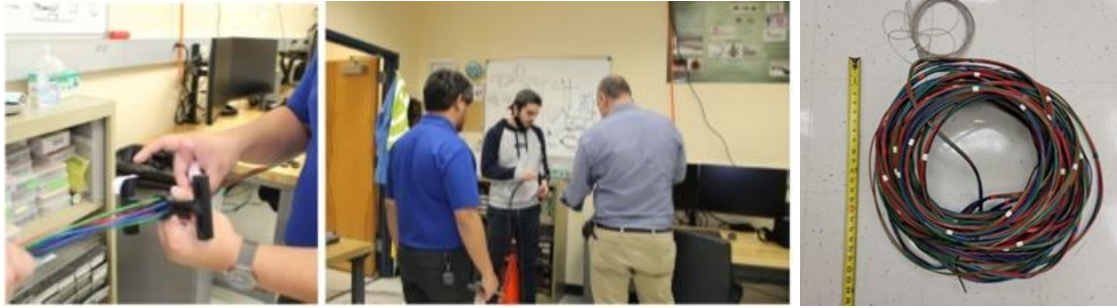
**Figure 36. Tether assembly.**

Figure 36 shows the tether assembly with six pneumatic lines, an Ethernet cable, and a retrieval steel wire. The tether was sleeved using a polyester fray-resistant expandable sleeve.

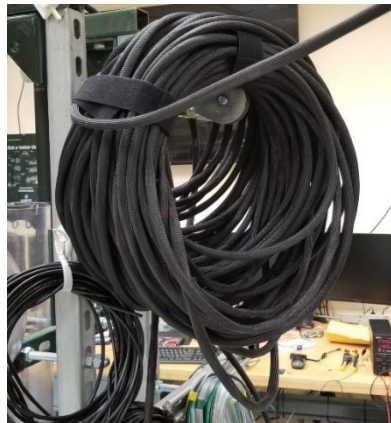
**Figure 37. LGS tether.**

Figure 37 shows the 240-foot assembled tether, containing six pneumatic lines for locomotion, an Ethernet cable for communication and electric power, and a steel cable for retrieval.

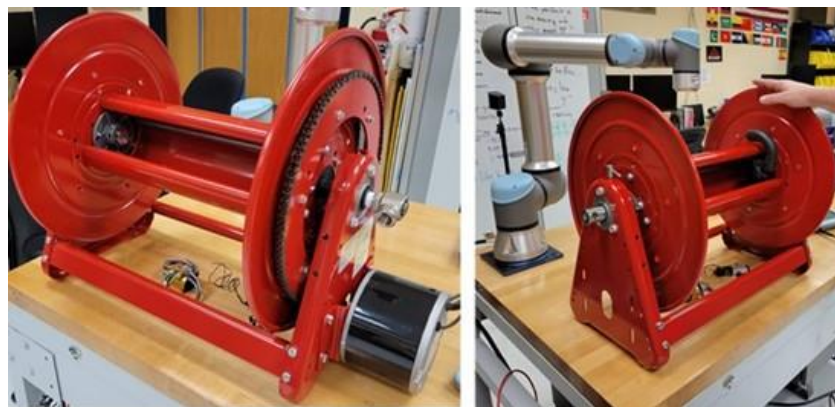
**Figure 38. Motorized cable reel.**

Figure 38 shows a motorized tether reel automated to deploy the inspection tool.

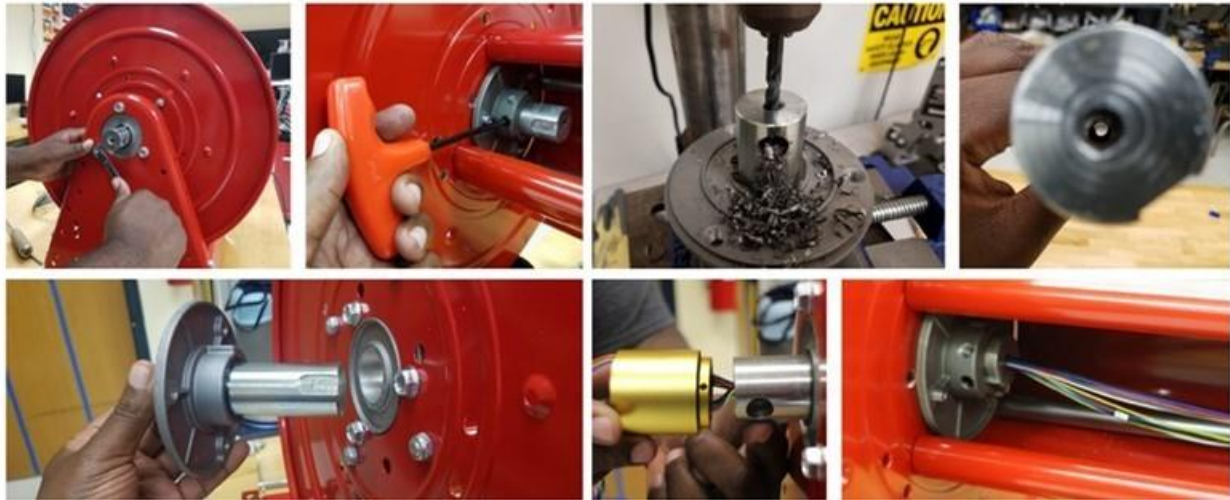
**Figure 39. Ethernet slip-ring integration.**

Figure 39 shows the integration, disassembly, drilling and reassembly of a slipring to provide an Ethernet connection to the reel drum, consequently powering the pipe crawler during the deployment.

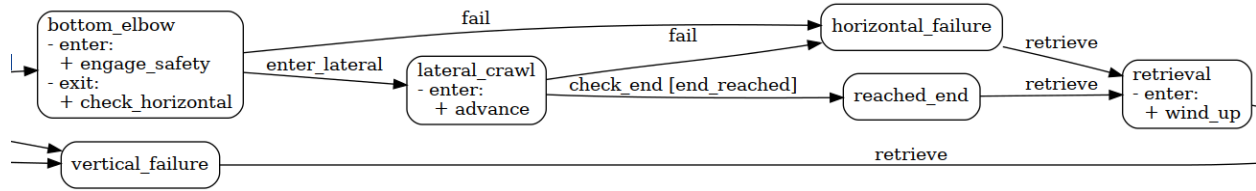
**Figure 43. State Machine Diagram (section).**

Figure 43 shows a representative section of the flowchart diagram of the state machine program, which handles the transitions between the operational states of the lateral inspection. Each state represents a specific position of the pipe crawler during the operation. The transitions between states have specific conditional checks to control the different functions of the crawler and to perform specific state-related tasks. The state machine operation was selected for the lateral inspection operation since the machine can be triggered to transition to a failure state or to a premature retrieval state in case of unexpected obstacles or system malfunctions.

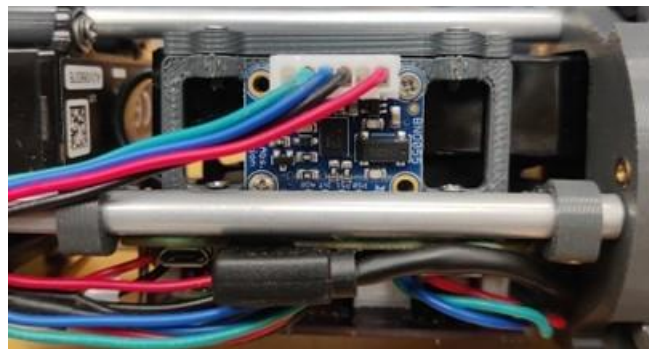
**Figure 44 . BN055 IMU in front module.**

The LGS uses a robust localization technique fusing many sources of odometry. Figure 44 shows a nine-degrees-of-freedom inertial measurement unit (IMU) mounted in the front module. The IMU has been used exclusively for attitude estimation, probing the front module’s pitch angle to determine transitions between vertical and horizontal sections during lateral scans.

The inspection tool estimates position by counting forwarding crawl commands and measuring distances to the end of the lateral unit using the front lidar. The LGS team intends to improve the current localization system by fusing IMU inertial and tether length estimations. The implemented IMU inertial estimation algorithm integrates instantaneous acceleration and angular velocities over time to estimate longitudinal changes in position during forwarding crawling movements. The final position estimate uses an extended Kalman filter estate estimator to fuse all sources of odometry.

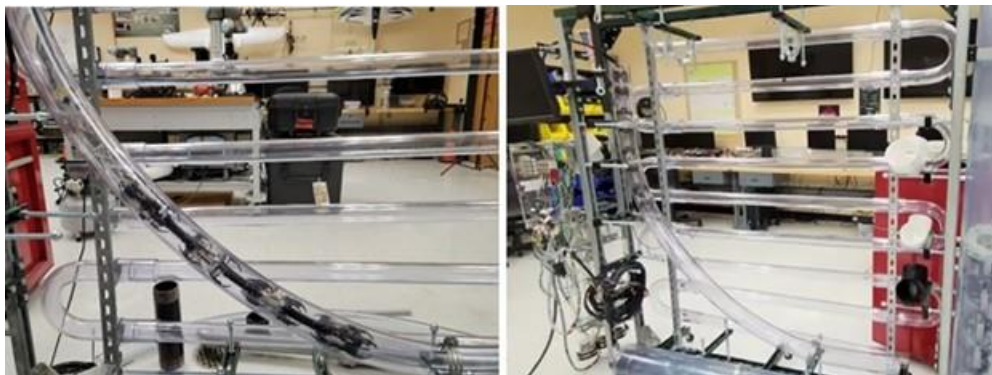
**Figure 46. Pipe crawler bench-scale testing.**

Figure 46 shows the pipe crawler successfully being tested in a bench-scale mockup. The mockup was originally designed to test other pipe crawlers developed at FIU.

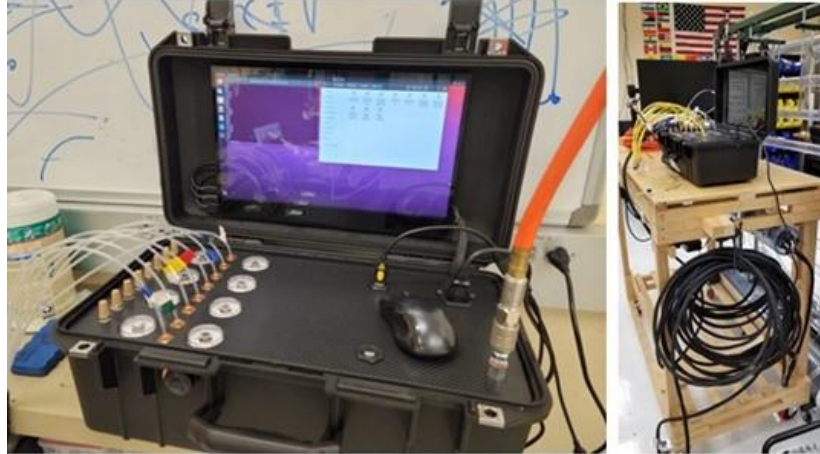
**Figure 47. Portable control box.**

Figure 47 shows a portable control box retrofitted to test the pipe crawler, also field deployment and quick troubleshooting.

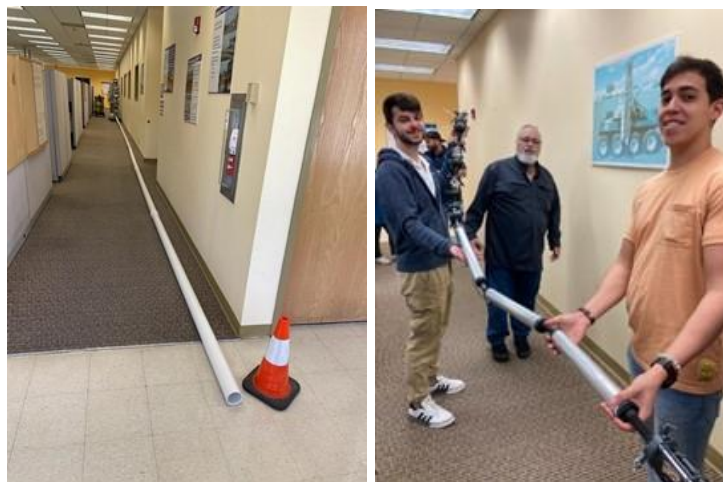
**Figure 49. Length of straight section for the in-house testing.**

Figure 49 shows preliminary system integration tests using an extended elbow and 100 ft of straight pipe. The figure also shows the crawler's three sections that emulate the radiation sensors. The crawler successfully navigated through the swept elbow and through the straight sections.

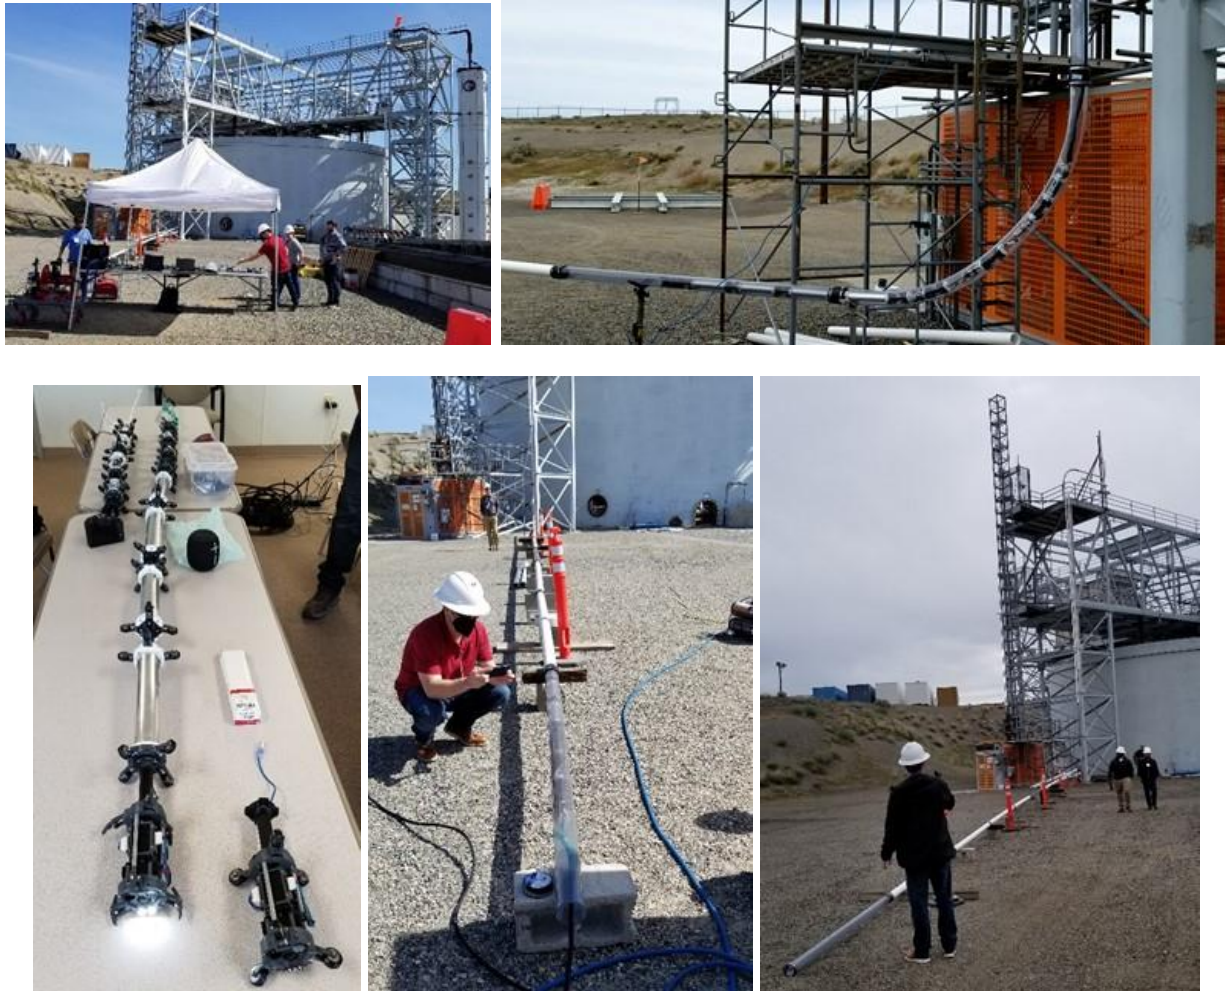
Figure 51. Cold Test Facility deployment.

In March 2022, the LGS crawler was successfully deployed at WRPS's Cold Test Facility in Hanford, Washington. Figure 51 shows test images from the facility.

The tests simulated FIU's peristaltic crawler carrying gamma sensor modules being deployed through a single shell tank's lateral. The sensor payload is a mockup based on a sensor deployed in 2005. The weight and size of the payload were coordinated with Hanford's engineers and scientists. The deployment tested the crawler's mobility throughout bends and the functionality of the cable management developed by WSU, as well as the overall accuracy of the system.

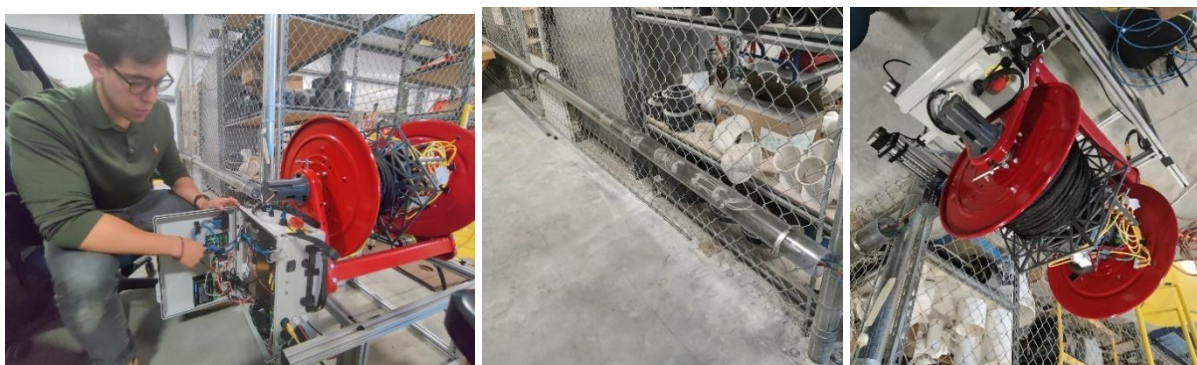
**Figure 54. DOE Fellow, Josue Estrada, interning at WRPS performing robotic crawler and reel synchronization test at CTF in Hanford.**

As pictured in Figure 54 efforts were also dedicated to finalizing the feedback control framework that synchronizes the Pipe Crawler and Reel System, which includes: a) finalizing control nodes for reel and pipe crawler control, b) tuning synchronization of the reel, crawler, and winder, and c) testing pipe crawling through mockups using ROS action servers.

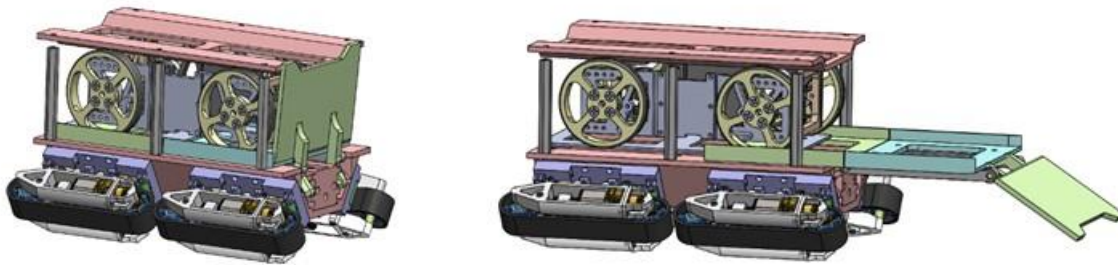
**Figure 56. Model of rover in housing module with deployable ramp.**

Figure 56 shows the CAD model of the marsupial system including the housing module and the instrumentation rover. The housing module shown in the figure includes the 4 bottom modular tracks that will transport it through the 6-in diameter pipe.

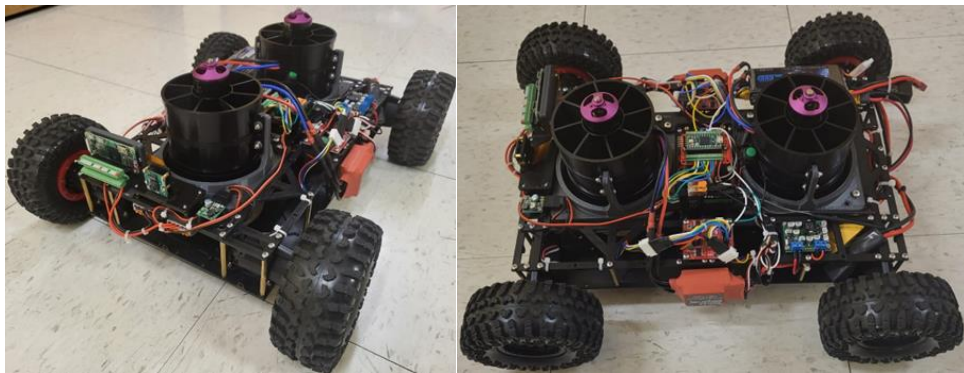
**Figure 61. Dual EDF unit.**

A platform that included two 90mm electronic ducted fans (EDF) was developed and evaluated for its ability to adhere and traverse along a concrete surface. The dual EDF unit, depicted below in Figure 61, was tested on a small-scale wall mockup with varying surface conditions. The design for the vector thrust module is being refined FEA simulation and topological optimization to reduce the overall mass of the unit and reinforcement areas for increased robustness.

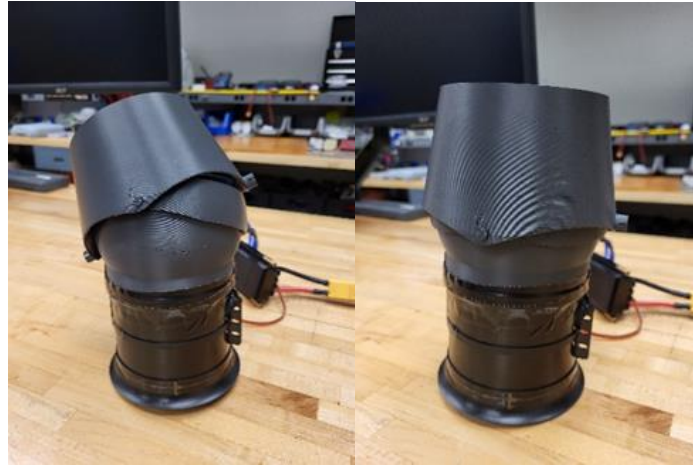
**Figure 63. Basic CAD model with 3D printed components..**

As a result of the construction of the supportive arm unit, the next task was the development of a gimbal setup which will be used to control the thrust vector generated by the EDF units on the platform. A basic CAD model, Figure 63, was developed with individual components 3D printed using ABS, to confirm that the geometric restrictions designed into the unit did not compromise the maneuverability of the gimbal setup.

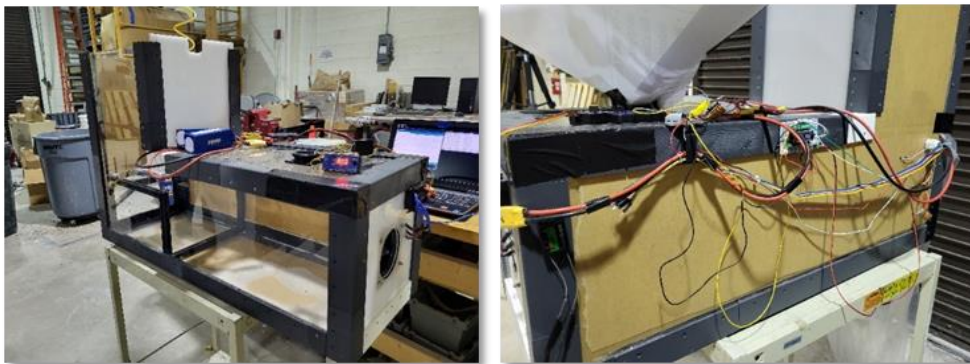
**Figure 64. Sand ingestion setup with integrated sensors.**

Finally, a sand ingestion test was performed to determine the effects of debris entering the ingestion portion of the EDF unit. The experimental setup, Figure 64, included a chamber designed to direct the inlet flow of air towards a secondary EDF fan which will act as a proxy to the fan on the mobile platform. The ingestion unit was constructed to aid in performing ingestion tests and gather data and develop a model which will be used to investigate the areas of blade degradation, thrust generation reduction via material in flow and filtering. An IMU (inertial measurement unit), load cell, tachometer (to measure the fan speed) and current sensor. All of the sensors are being monitored via a microcontroller and the data generated is being saved as a text file to be post processed.

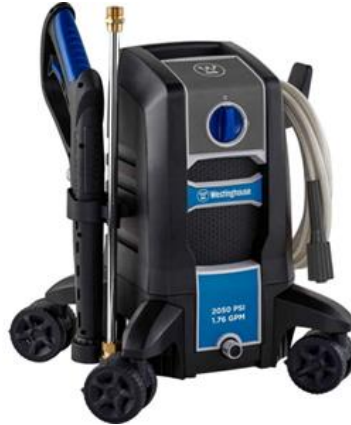
**Figure 67. Electric pressure washer.**

An experiment was designed to measure the forces generated when a fluid is ejected from a nozzle at specific pressures. The setup included setting up a pressure washer, Figure 67 below, and scale to measure the force generated by the interaction between the fluid and contact surface. Meetings were held with Sherwin Williams, Carboline and Belzona coating companies with the aim of determining what coating system would provide the optimum results.

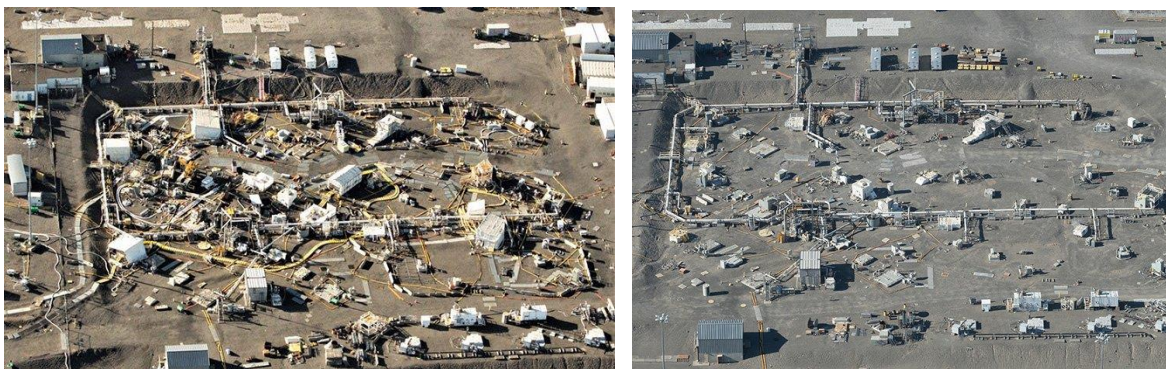
**Figure 70. Hanford's Tank Farm retrieval operations in September 2016 (left) and 2018 (right).**

As exemplified by Figure 70, changes in Hanford's Tank Farm due to retrieval operations [1] and the constant need to manually reconfigure the surveillance mobile platform's mission plan could become a burden to site engineers, which would also be the case in analyzing the captured data over time.

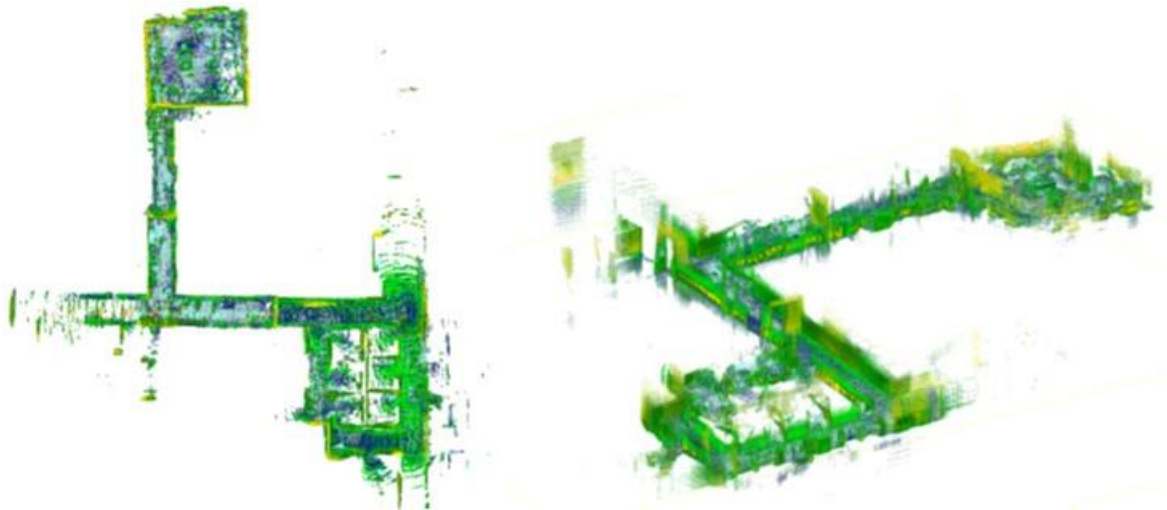
**Figure 74. Captured maps from FIU's corridors.**

Figure 74 shows a map captured from the Robotics Laboratory's hallways, demonstrating the improvement in long-distance surveys and minimal distortion in right-angle turn captured as obtuse corners in previous mapping.

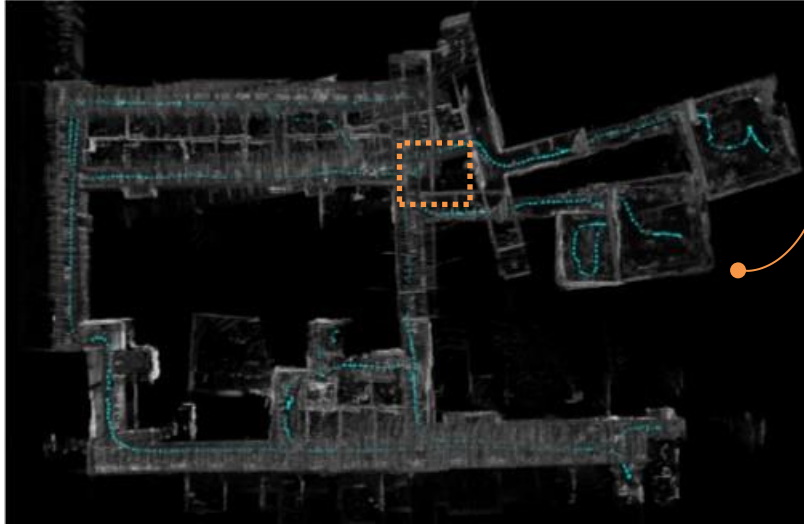
**Figure 75. Closed loop failure in the localization algorithm.**

Despite the improvements, the mapping framework needs further tweaking in areas with fewer geometric features. As highlighted in Figure 75, in the case of a specific small hallway, a jump occurred due to closed loop failure in the localization algorithm.

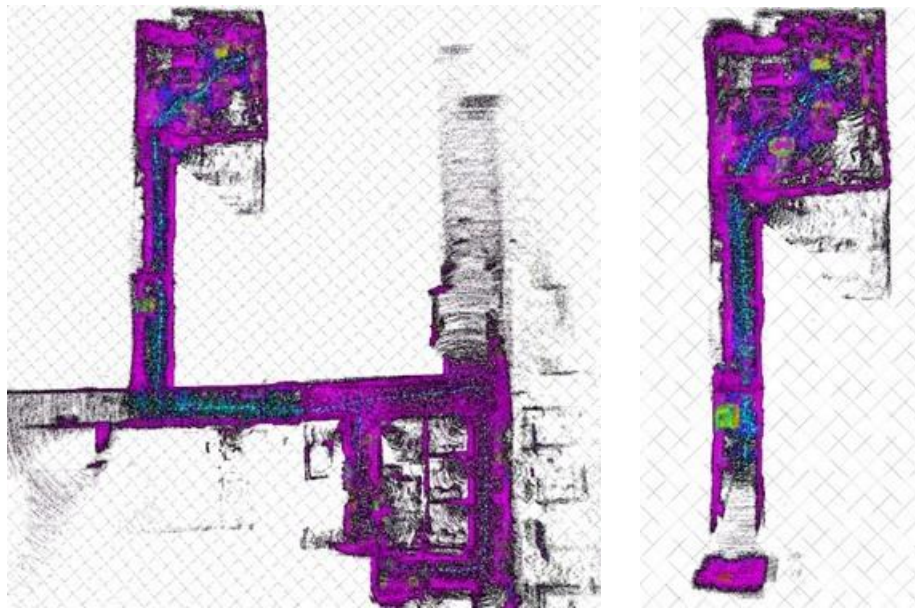
**Figure 76. Indoor maps manually (left) and autonomously (right) generated.**

Figure 76 shows tridimensional maps generated manually and autonomously, replicating the trajectory where the paths are shown in cyan.

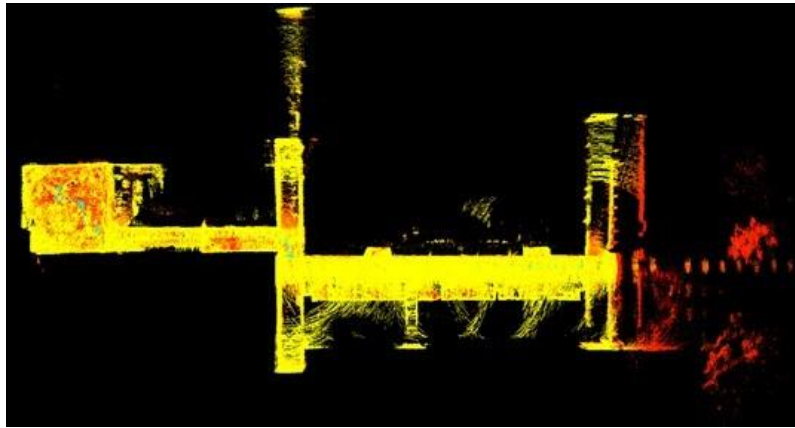
**Figure 77. Partial region of ARC constructed using in-house navigation framework.**

Figure 77 shows a new region of the indoor environment where the navigation framework was tested to demonstrate an ability to generalize with new locations.

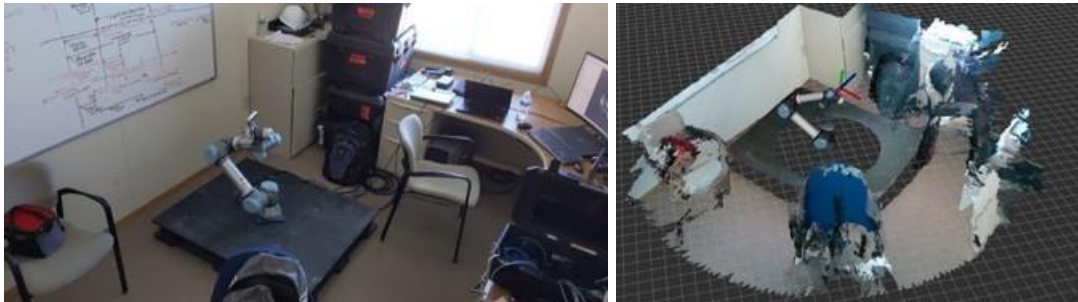
**Figure 83. Environment mapping using a depth camera attached to a manipulator.**

Figure 83 shows tridimensional probabilistic occupancy maps generated from point clouds captured using depth. The occupancy maps are safety features allowing the manipulator to operate safely without colliding with the environment.

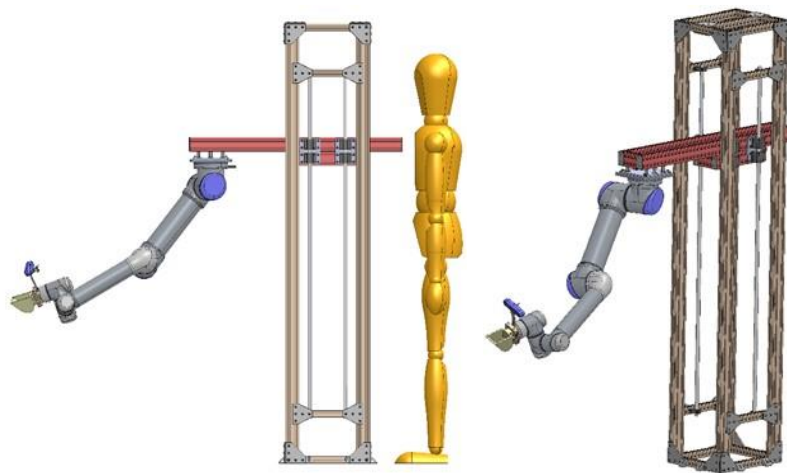
**Figure 84. FIU's stand design.**

The robotics team at FIU is also supporting the DOE Fellow, Joel Adams, during his current summer internship at Hanford, by developing and building a vertical stand and tooling to simulate off-riser sampling at single-shell tanks using dexterous robotic manipulators. Illustrated in Figure 84, the motorized stand design uses a hoist and linear guides to lift the manipulator off the ground. There are plans to replace the stands with a cable system deployment at the tank farms.
