## **YEAR END TECHNICAL REPORT**

September 29, 2021 to September 28, 2022

# **Chemical Process Alternatives for Radioactive Waste**

U.S. Department of Energy

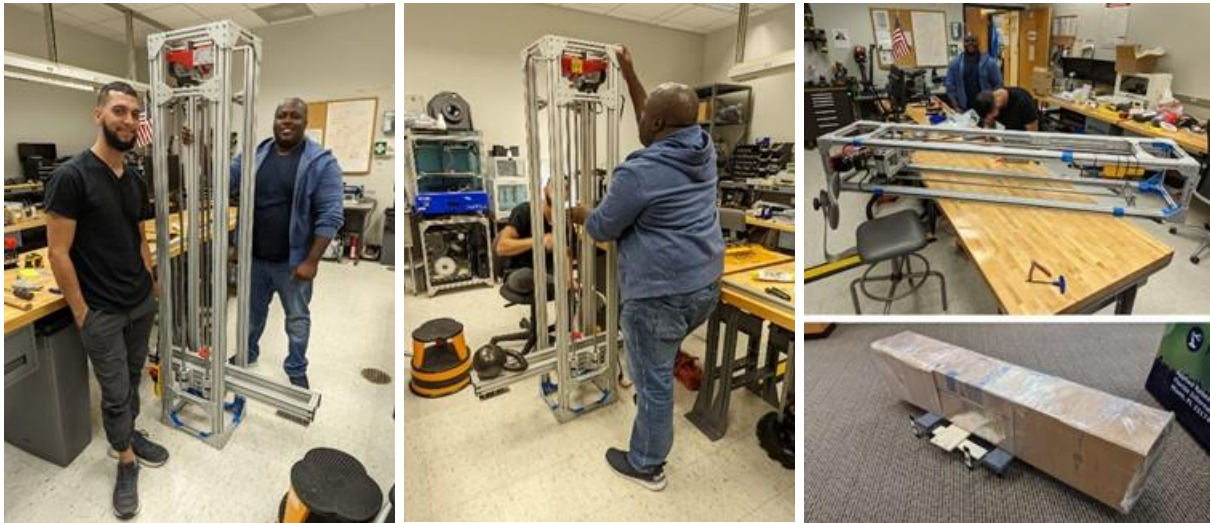
**Figure 85. FIU’s robotics team developed a motorized stand to be used by DOE Fellows interning at WRPS in Hanford.**

Figure 85 shows the motorized stand built at FIU successfully lifting 45 pounds, equivalent to the manipulator weight. The system was shipped to WRPS’s Cold Test Facility (CTF) for demonstration as part of the DOE Fellow summer internship.

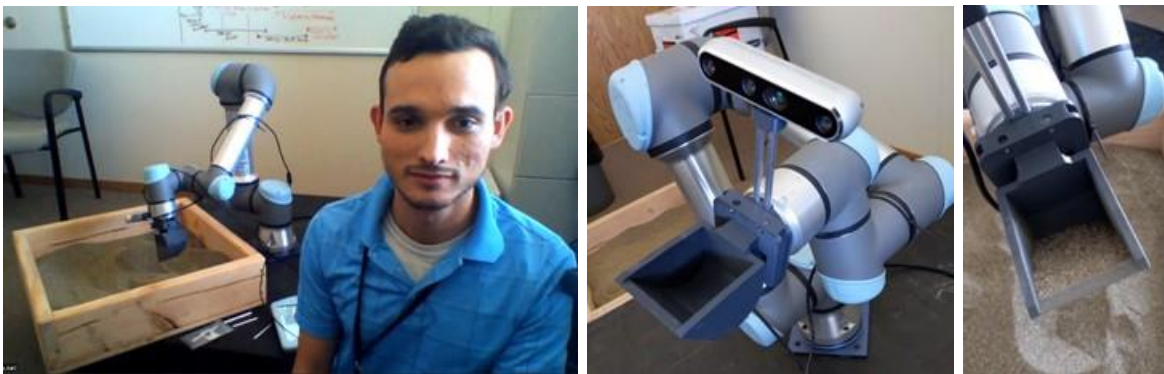
**Figure 86. DOE Fellow summer internship at Hanford.**

Figure 86 shows pictures of DOE Fellow Joel Adams’ internship research activities, deploying tools and algorithms developed at FIU in coordination with WRPS site engineers.

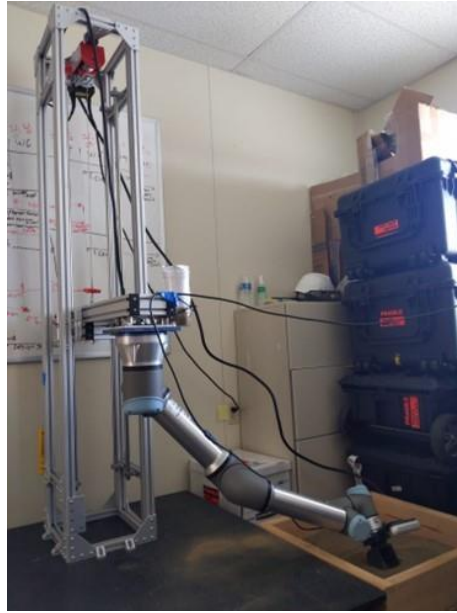
**Figure 87. UR5e off-riser sampling demonstration scooping simulant.**

The demonstration included assembling the robot on an upside-down mount, simulating riser deployment, to reach into a constructed testbed of simulant, as shown below in Figure 87.

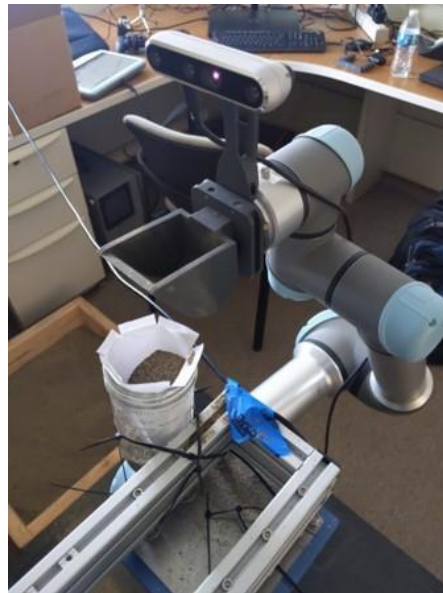
**Figure 88. Collected simulant sample.**

Figure 88 shows the robot after collecting the simulant by pouring it into a collection jar. The robot was programmed to scoop floor samples using a passive end effector developed at FIU. The system uses tridimensional maps constructed with an integrated stereo camera to perform sampling actions with obstacle awareness and collision avoidance.

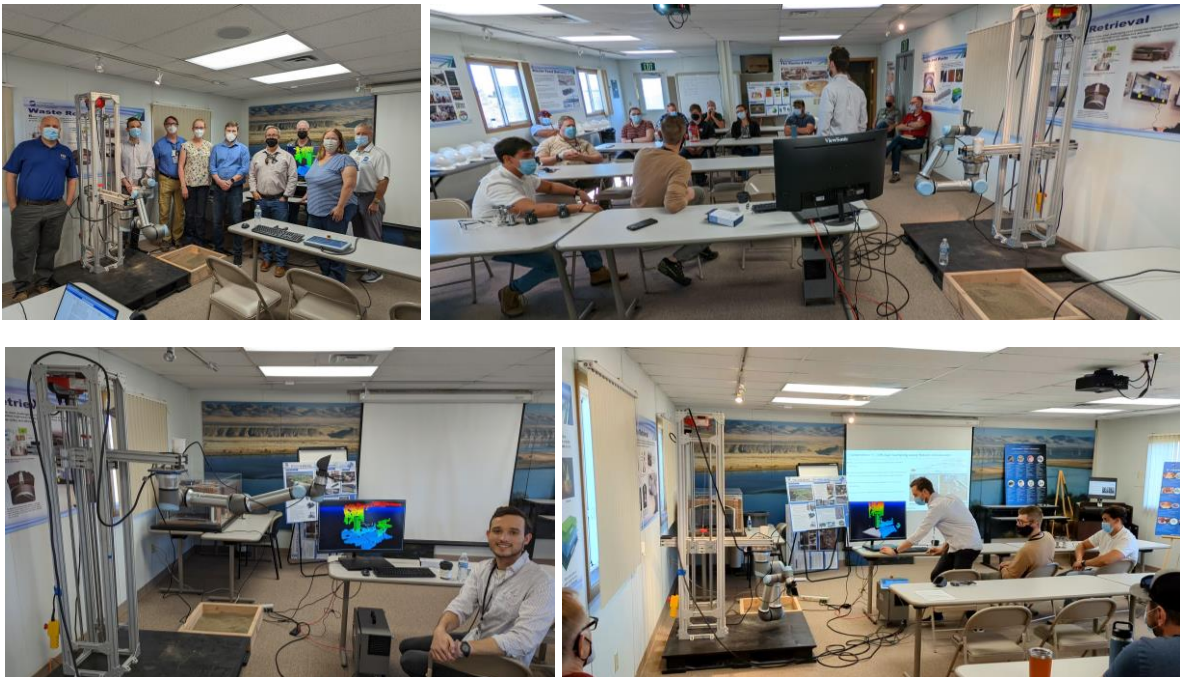
**Figure 90. Off riser sampler demonstration at Hanford.**

On Summer 2022, the off-riser sampler was successfully demonstrated at Hanford’s Cold Test Facility in Richland. Figure 90 shows images of the Cold Test Facility technology demonstration. There were a number of operators and WRPS management personnel on-site to evaluate the potential of the sampler. The off-riser sampler managed to surpass the expectations of all and WRPS request FIU to continue the development. However, considering smaller risers and radiation hardened solutions.

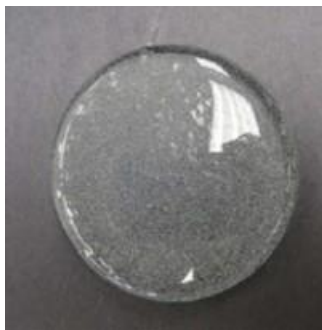
**Figure 91. Sample image of Frit 625.**

Next, additional information on the glass frit similar to SRNL glass frit #803 was obtained, and meetings were conducted with the SRNL scientists to finalize the test matrix to initiate the experimental testing. Comparing both frit types, it was noted that compared to Frit 803, Frit 625 includes Al<sub>2</sub>O<sub>3</sub> and had a slightly lower total alkali concentration (sum of Li<sub>2</sub>O and Na<sub>2</sub>O). SRNL scientists provided information on studies conducted using Frit 625 that revealed the target frit composition (%wt.) of Frit #625 as Al<sub>2</sub>O<sub>3</sub>(1%), B<sub>2</sub>O<sub>3</sub> (8%), Li<sub>2</sub>O (7%), Na<sub>2</sub>O (6%) and SiO<sub>2</sub> (78%).

Finally, quotes were obtained for the glass frit # 625 as suggested by SRNL scientists. The frit size available with Bekeson glass LLC, for our experiments, possessed a particle size in the range of 70 to 180 microns. Among those, max weight % greater than 177 microns is 2%, and max weight % < 74 microns is 10%, meaning higher weights with larger size particles in the mixture. Frit availability is in 4.25-gallon plastic pails that contain approximately 40-50 lbs per pail. The original proposed test matrix developed for testing with glass frit is provided in Table 1. Initial testing included only glass frit in increasing volumetric concentration. Sand was to be added during the last three phases of the testing.

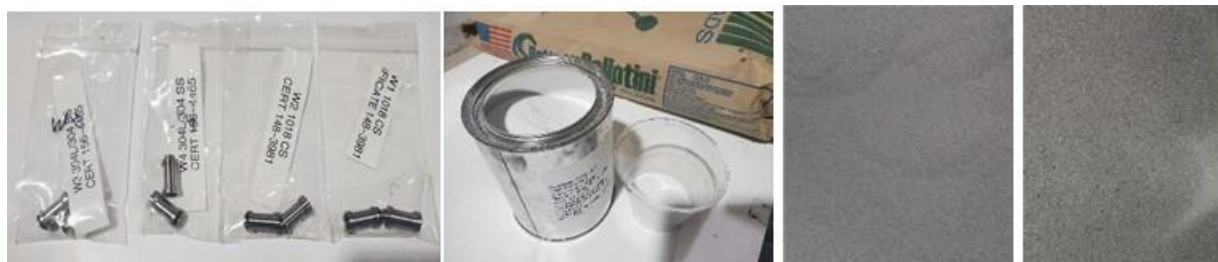
Figure 92. New SRNL coupons (left), 803 glass frit & AE glass bead samples (center) and granular structure (two on the right).

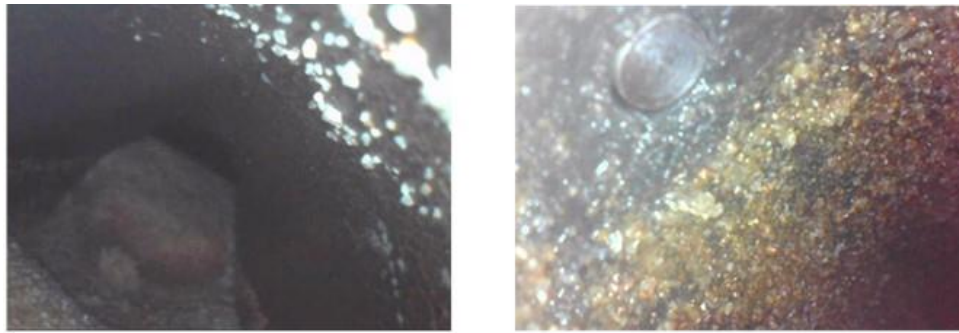
**Figure 93. Borecope image of the sand deposited inside the pipe (left) and cleaned pipe section (right) with flushed coupon.**

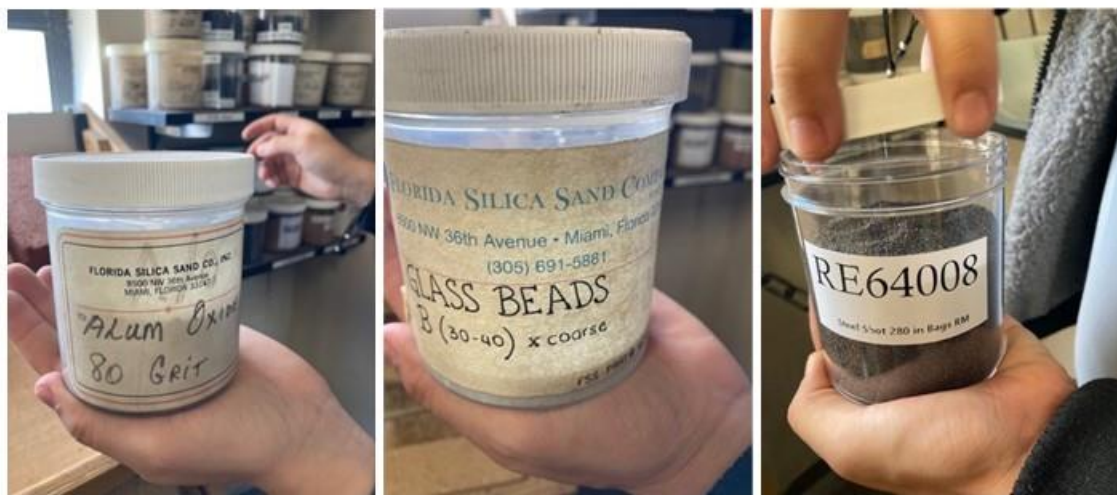
Figure 95. Different erosion simulant options.

After minimal erosion, using simulants suggested by the site contacts, in the initial round of testing, additional materials were also considered that include aluminum oxide, steel shots and larger glass beads.

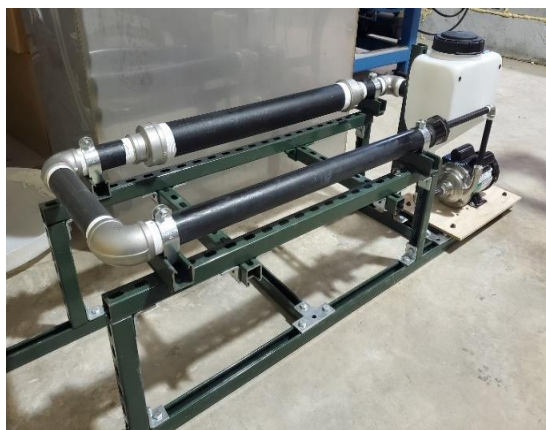
**Figure 97. Bench scale flow loop.**

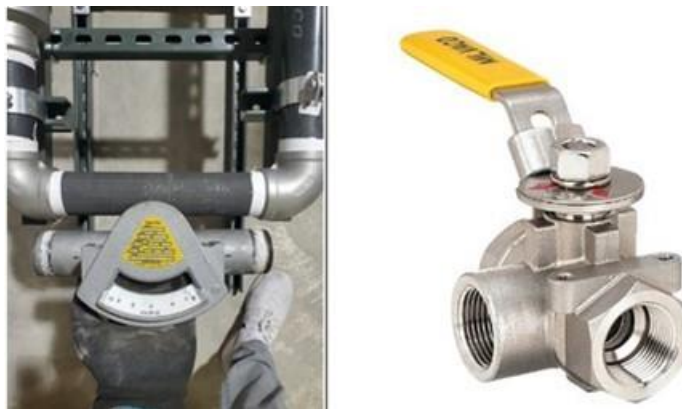
**Figure 98. Flow meter to replace 12-inch pipe section (left) and 3-way ball valve (right).**

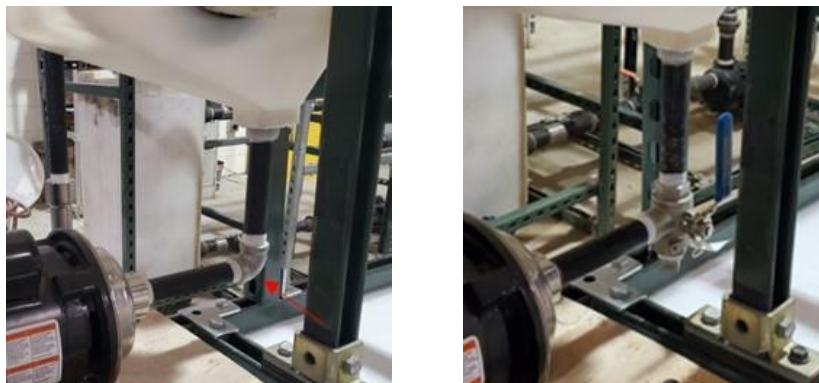
**Figure 99. 3-Way ball valve location (red arrow) (left) and installation (right).**

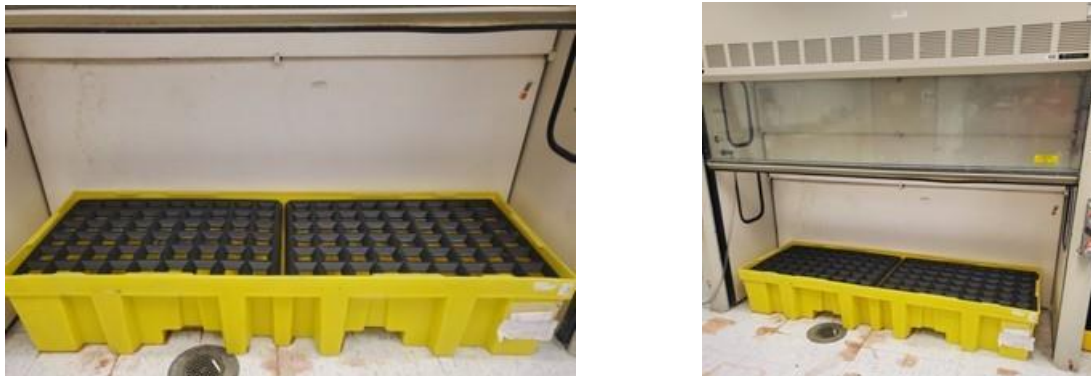
**Figure 100. Inline polypropylene spill deck (secondary containment) inside fume hood.**

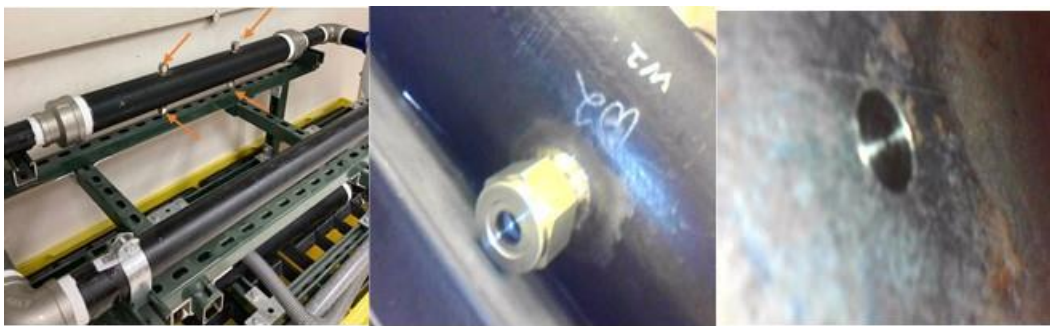
**Figure 101. Coupon locations (arrows) (left), coupon joint (center) and borescope image of the coupon (right) in the pipe loop.**

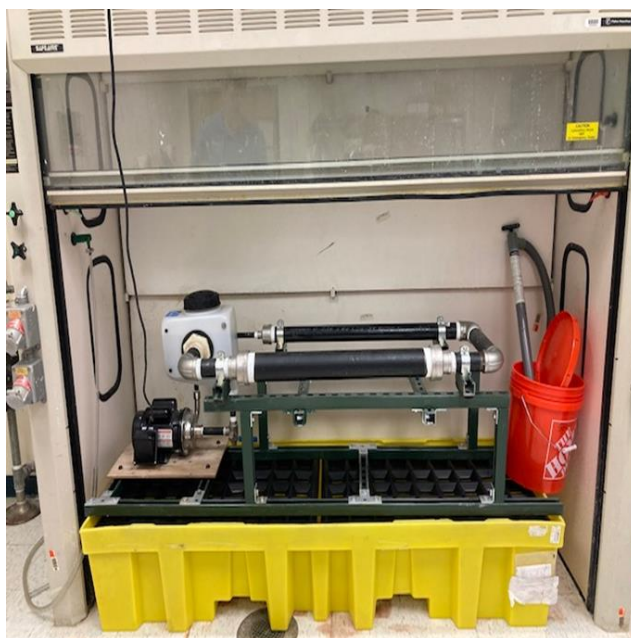
Figure 102. Assembled bench scale loop inside the fume-hood for caustic simulant testing.

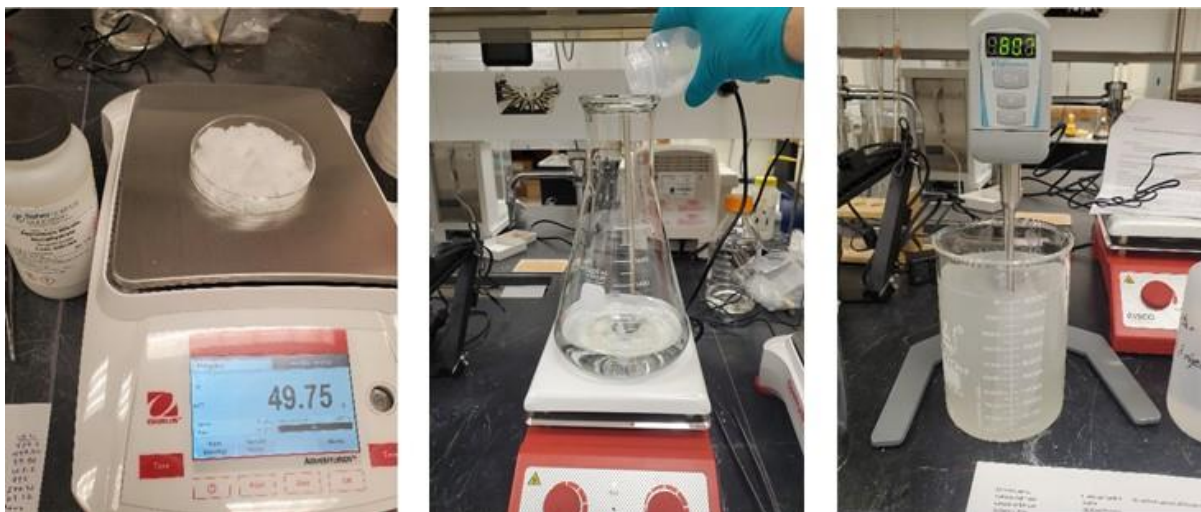
Figure 103. Caustic solution preparation -weighing (left), mixing (magnetic stirrer) (middle) and mechanical stirring (right).

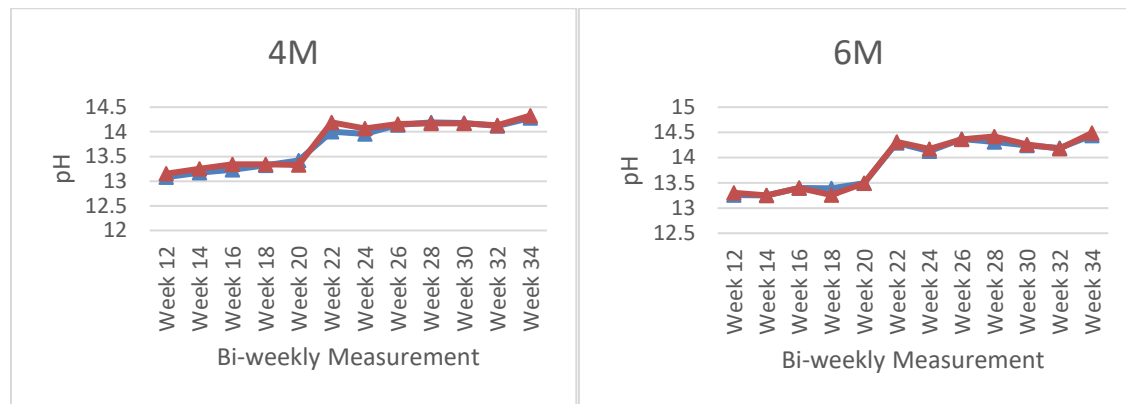
Figure 104. Static coupon test results for pH change in 4M and 6M solutions.

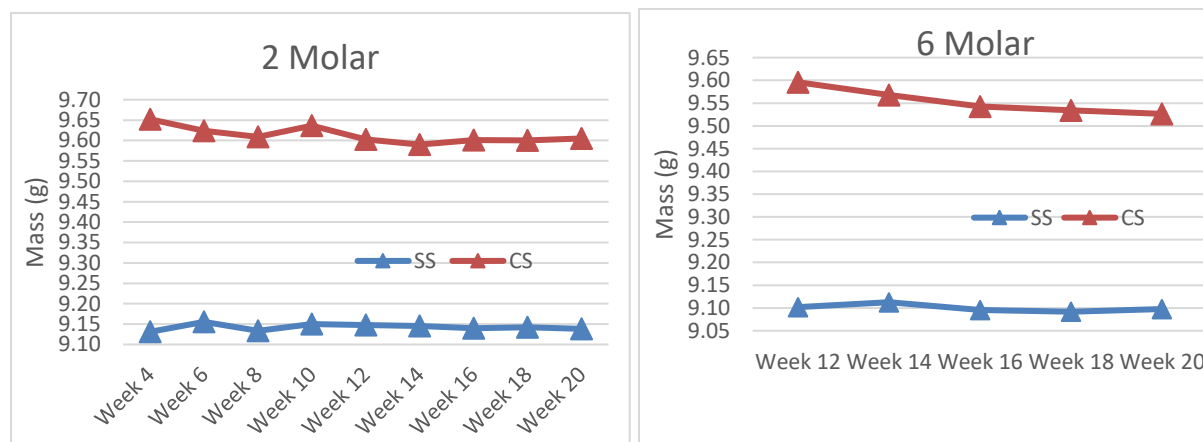
Figure 105. Mass change in 2M and 6M solutions.

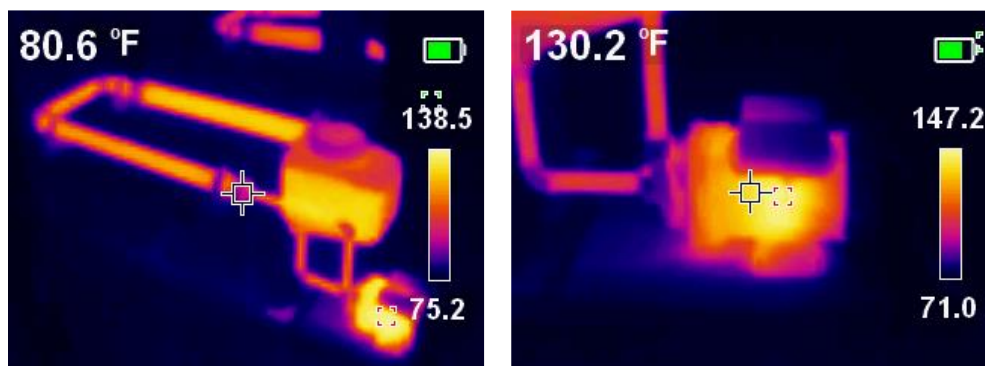
**Figure 106. Thermal images of the bench scale loop during water tests.**

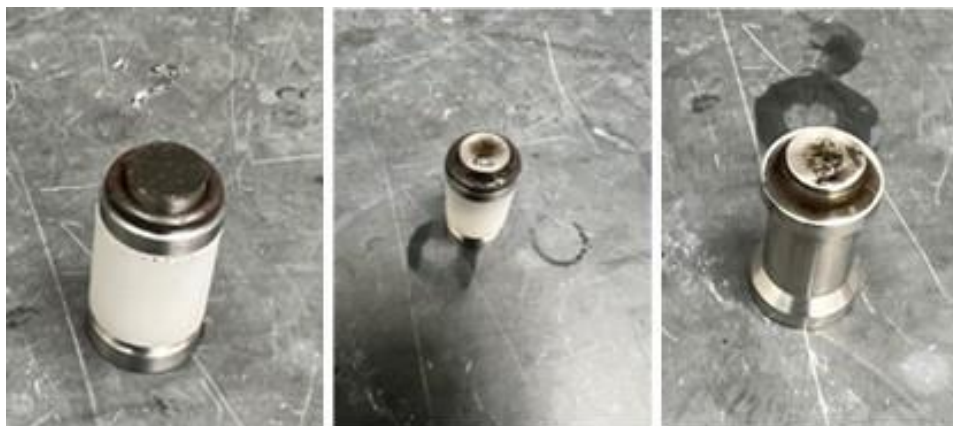
Figure 107. Sample coupon images (before cleaning).

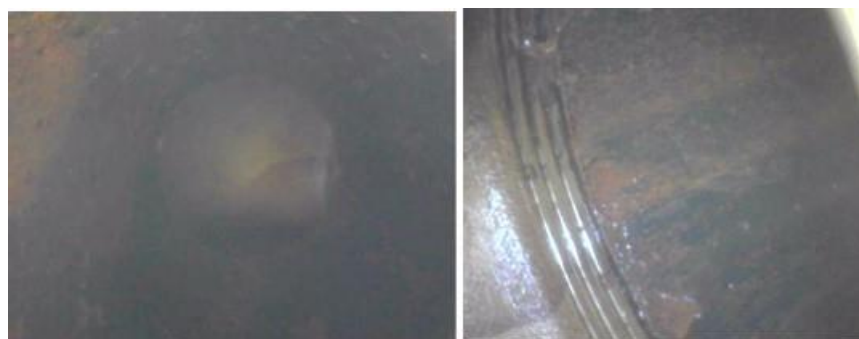
Figure 108. Pipe surface – internal 3-inch section (left) and eroded, corroded pipe threads (right).

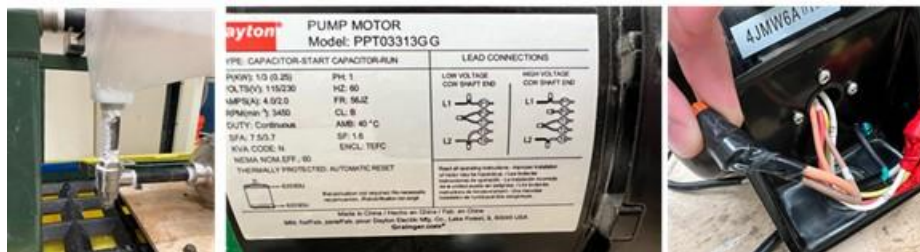
**Figure 109. Chemical precipitates (left), pump wiring configuration (center) and new wiring (right).**

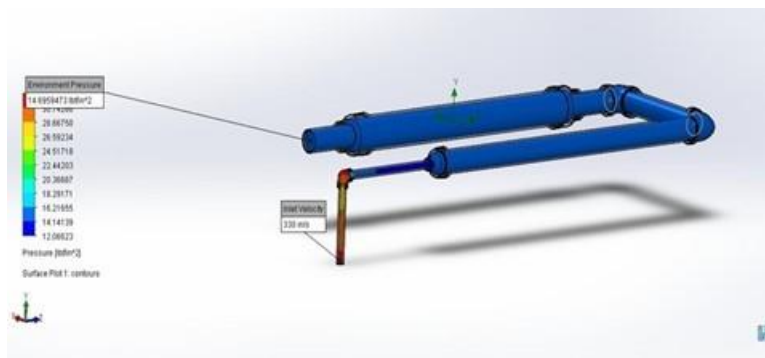
**Figure 110. Surface pressure distribution in the bench scale pipe loop.**

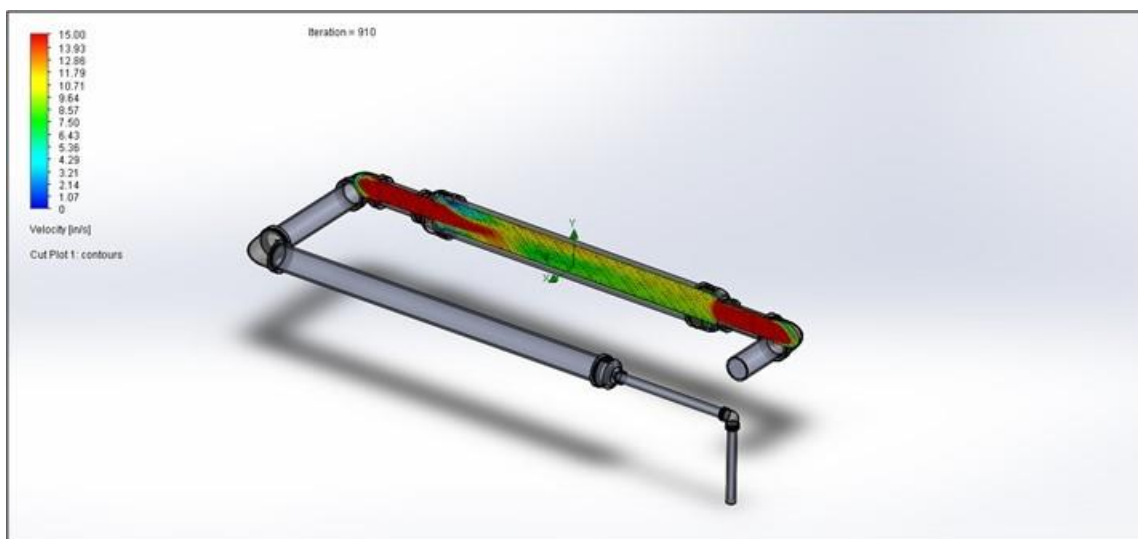
**Figure 111. Trimetric view of loop system with velocity cut plot of test section.**

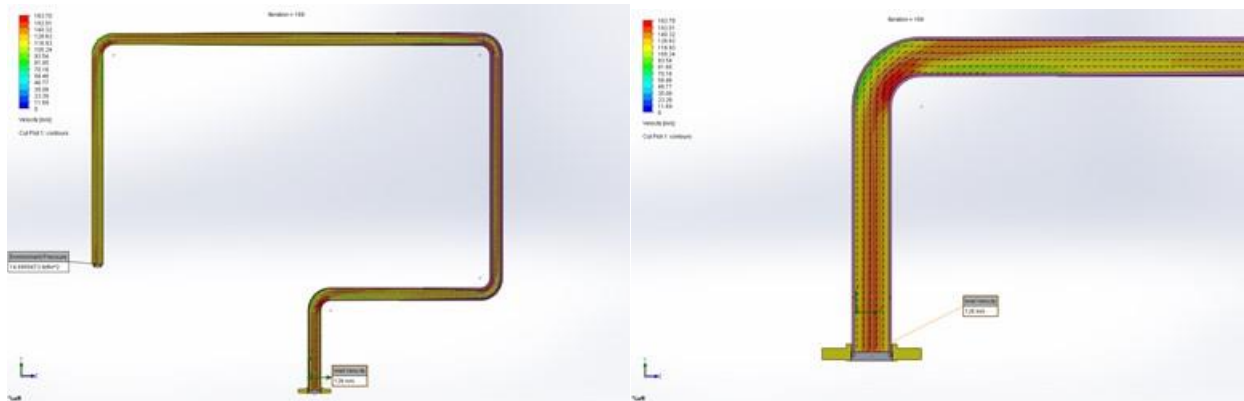
**Figure 113. CFD simulation of the engineering scale loop (left) and inlet bend velocity contours (right).**

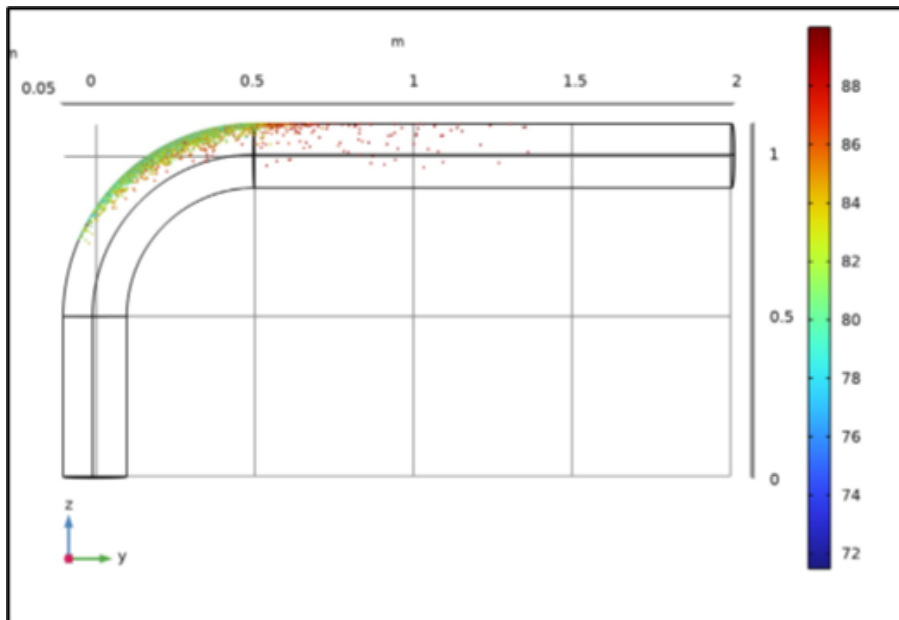
**Figure 116. Solid particle trajectories with concentrations near the elbow [1].**

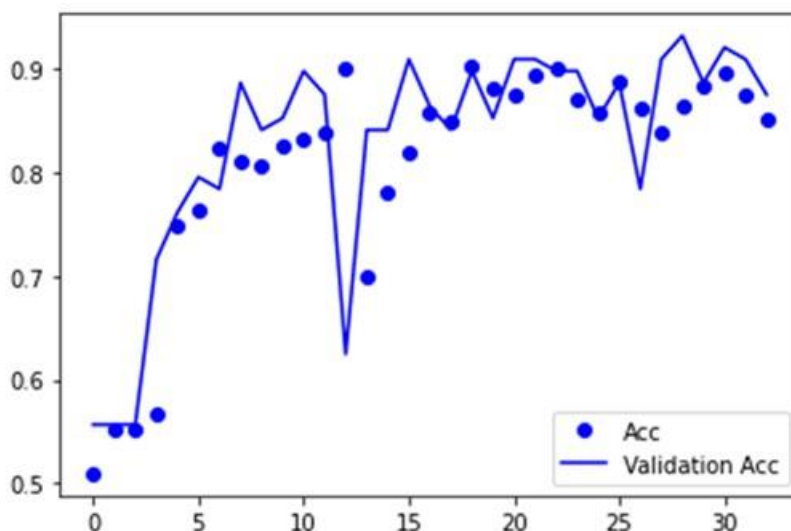
**Figure 117. Corrosion prediction accuracy results using the developed CNN machine learning model.**

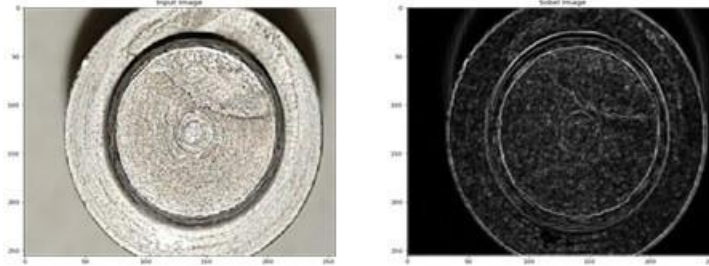
**Figure 118. Edge detection on a coupon surface image.**

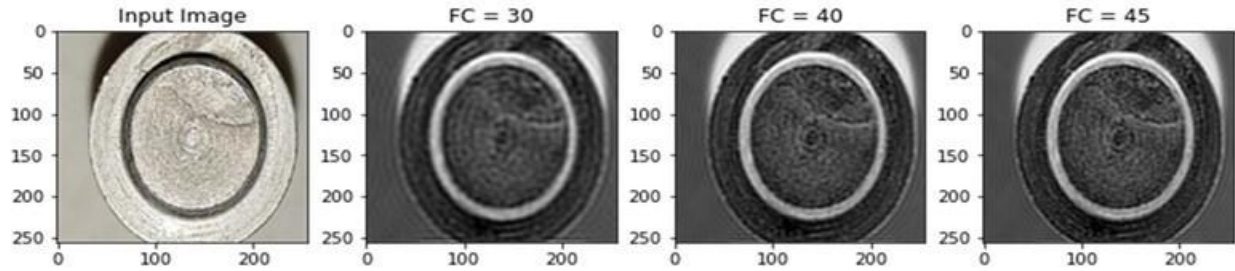
**Figure 119. Noise Reduction on a coupon.**

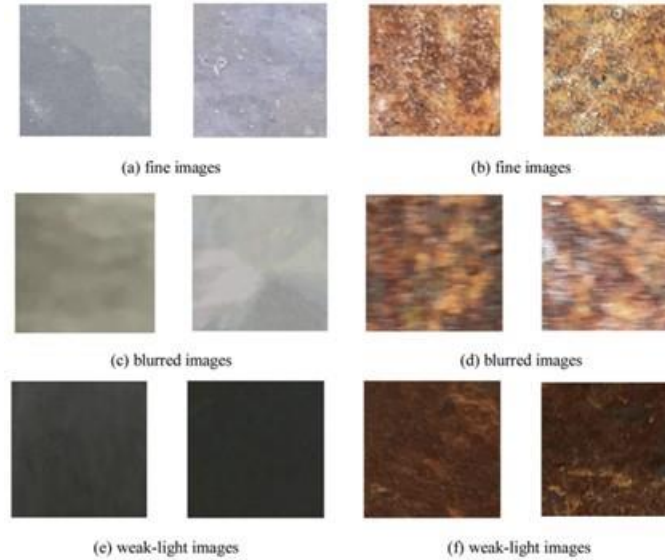
Figure 120. Non-corrosive (grey/black) and corrosive (brown) image classification [2].

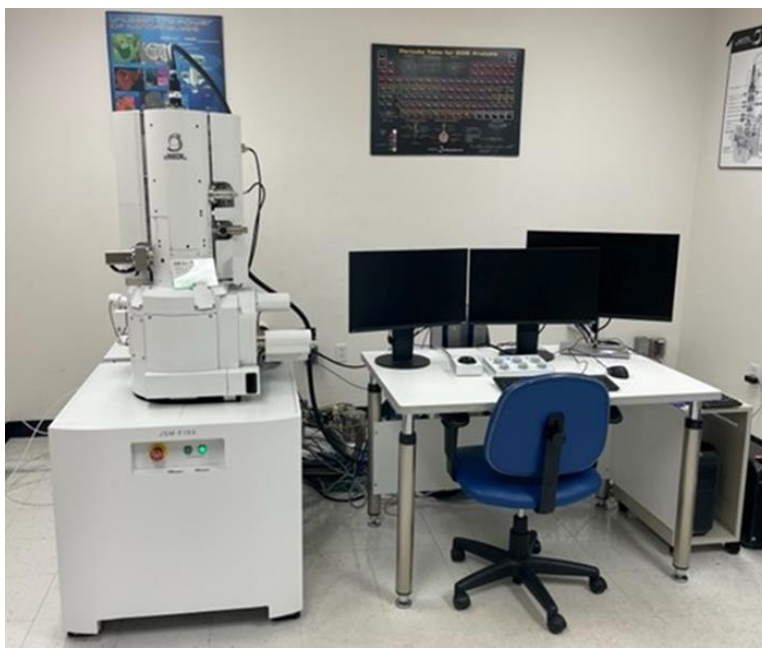
Figure 123. Joel SM-F100 Schottky Field Emission Scanning Electron Microscope.

Figure 123 shows an image of the Joel SM-F100 Schottky Field Emission Scanning Electron Microscope used to perform scanning electron microscopy (SEM) analysis on the specimens.

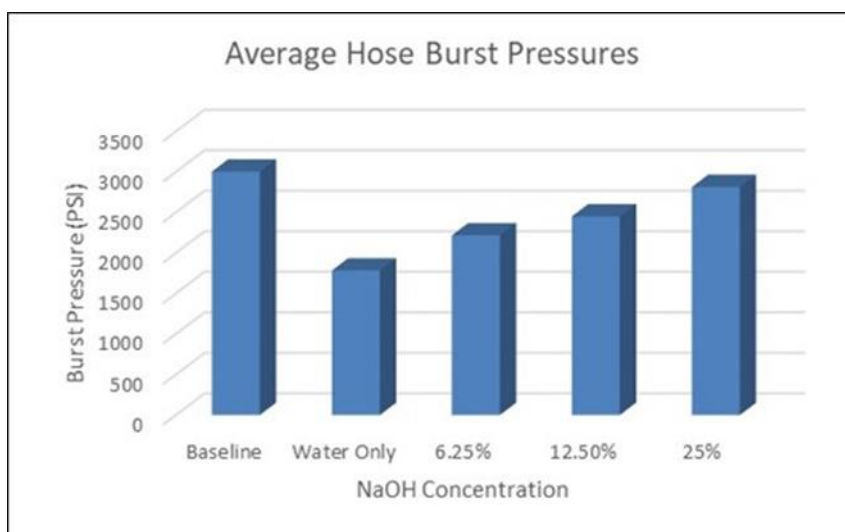
Figure 124. Average hose burst pressures.

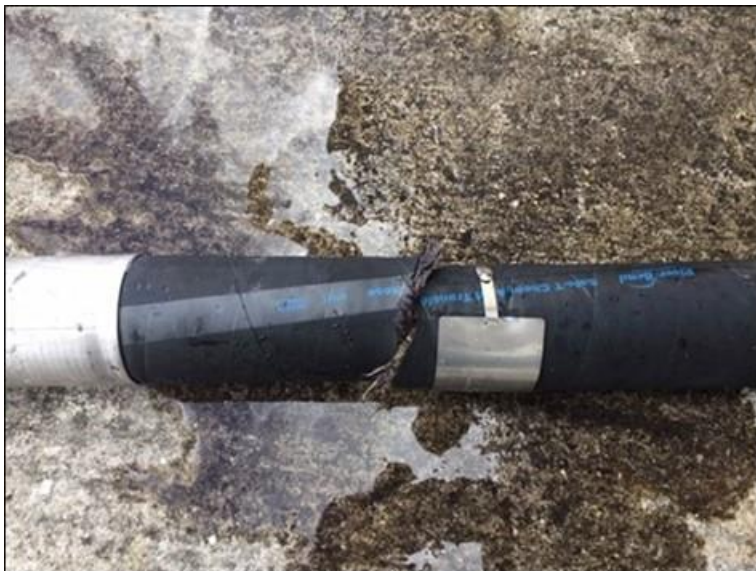
**Figure 125. A rupture hose failure.**

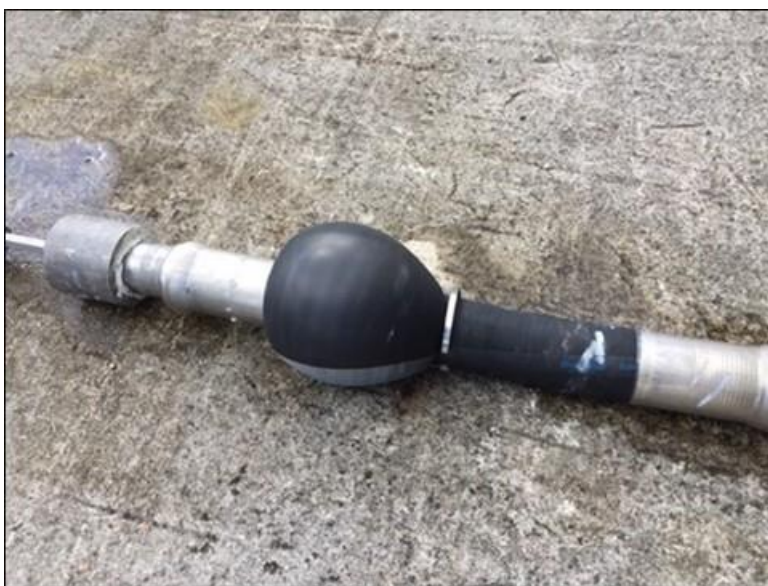
**Figure 126. Internal hose failure.**

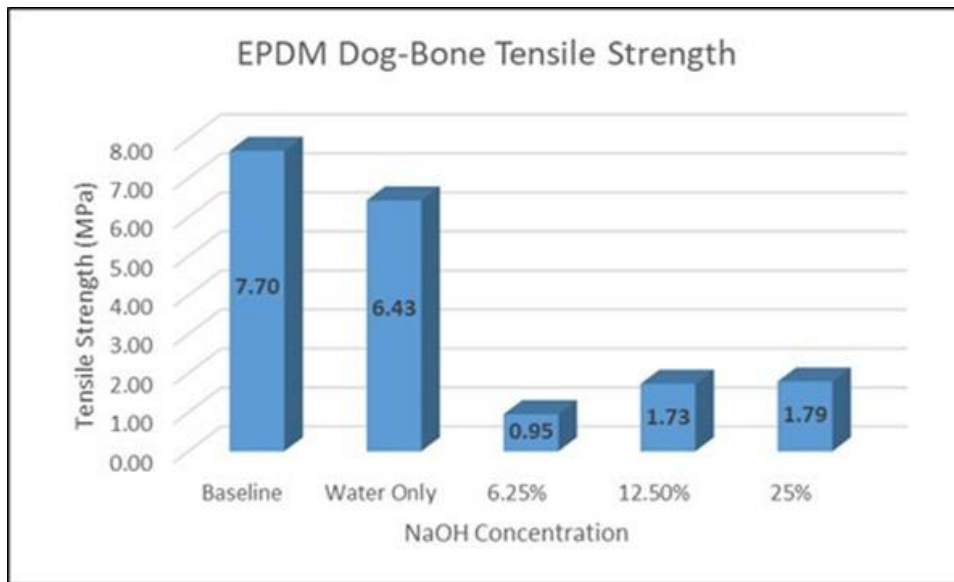
Figure 127. Average dog-bone tensile strength results.

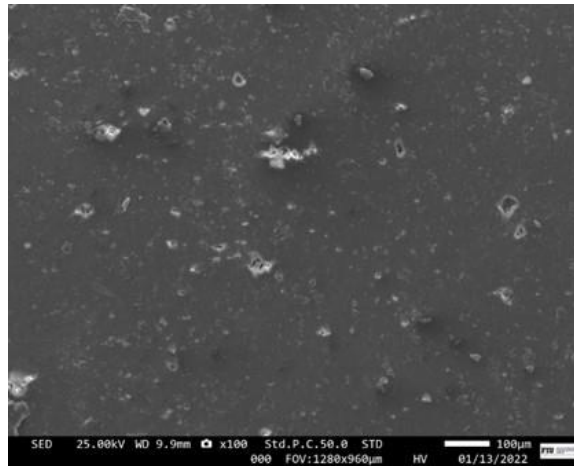
**Figure 132. SEM scan of baseline (unaged) dog-bone specimen @ 100X magnification.**

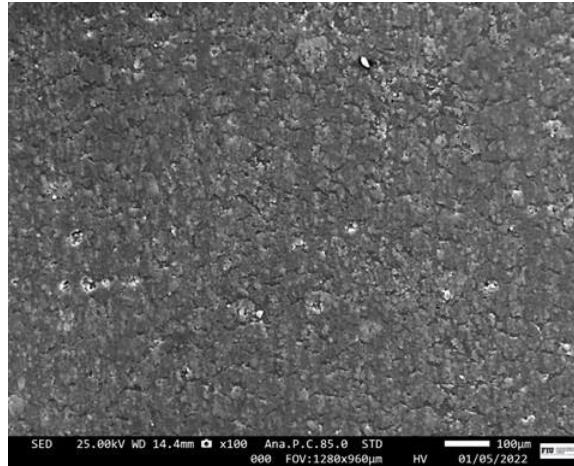
**Figure 137. SEM scan of the inside of a baseline (unaged) hose.**

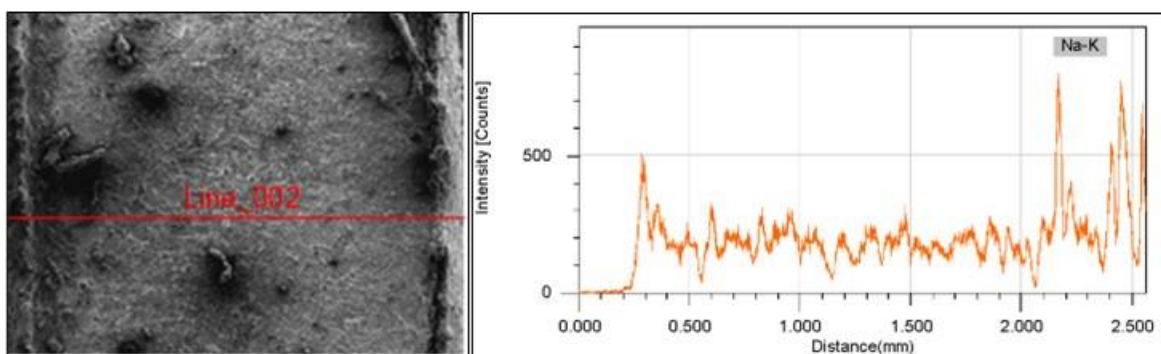
Figure 145. SEM-EDX analysis of a dog-bone aged with 6.25% NaOH solution.

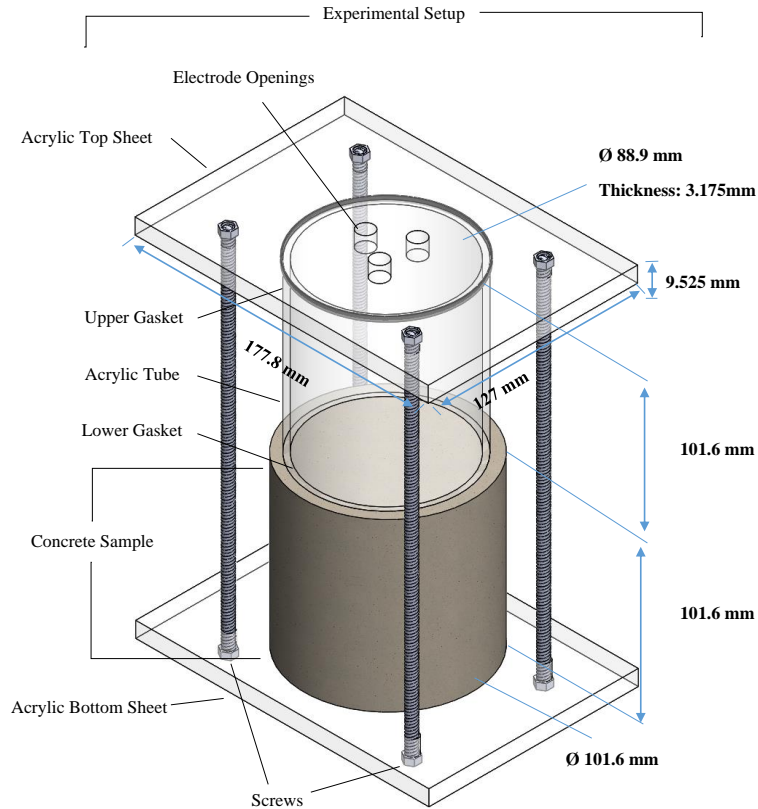
**Figure 156. Schematic of test setup for coatings exposure to acid solutions.**

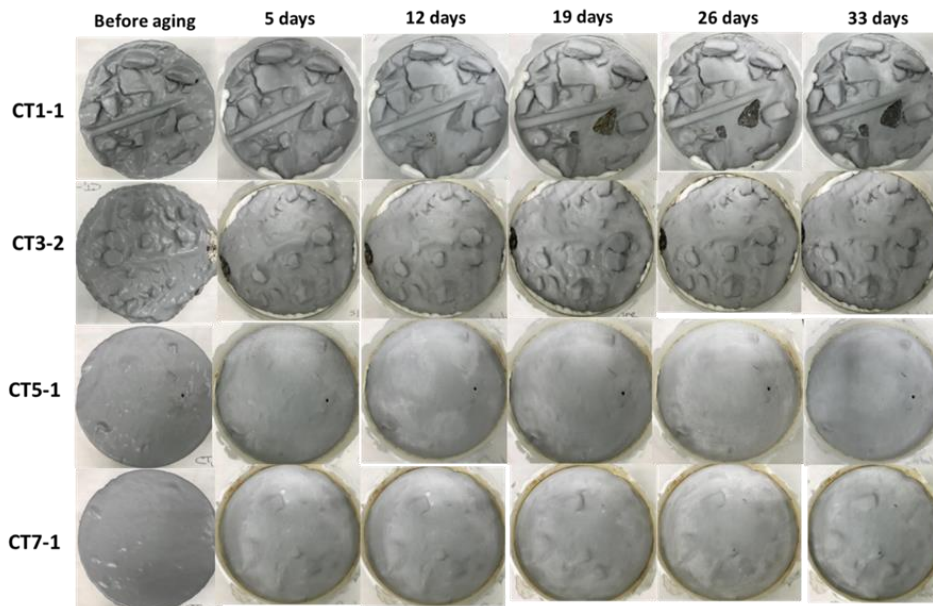
**Figure 157. Images of top view of Carboline-coated samples, with (CT1-1, CT7-1) and without (CT3-2, CT5-1) surface preparation, before and during accelerated aging**

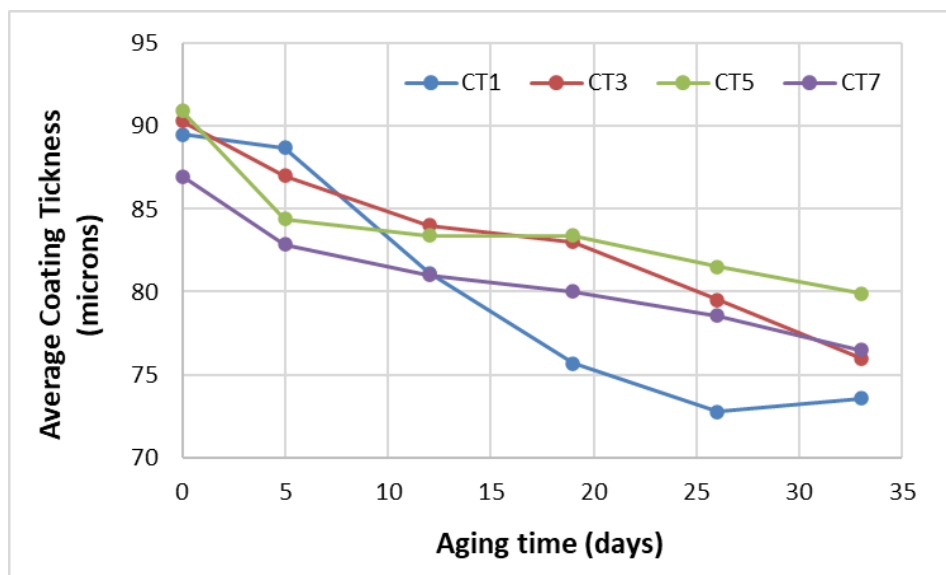
**Figure 158. Average thickness of selected Carboline-coated samples, with (CT1, CT7) and without (CT3, CT5) surface preparation during accelerated aging.**

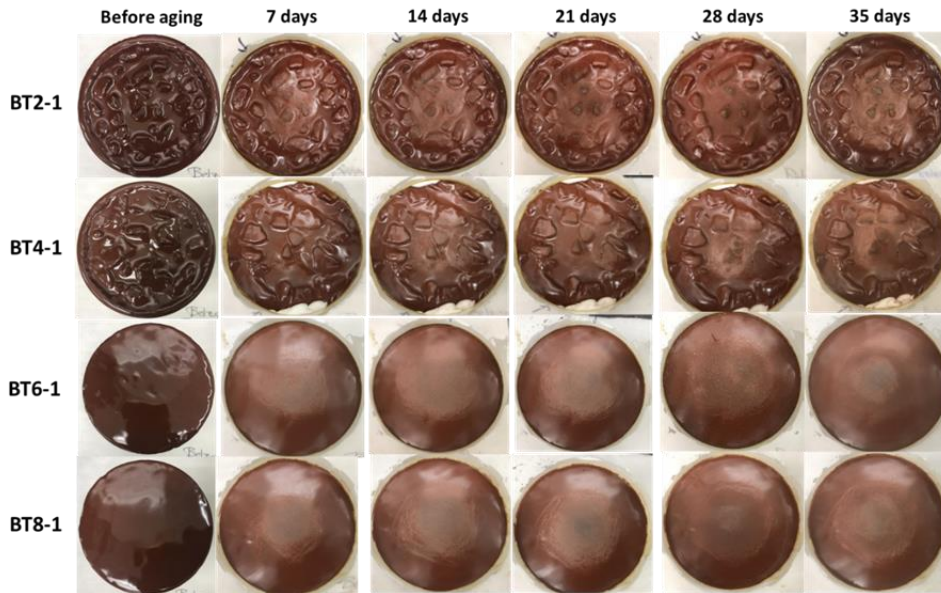
**Figure 159.** Comparative images of the top view of Belzona-coated specimens, with (BT2-1, BT8-1) and without (BT4-1, BT6-1) surface preparation, before and after aging conditions.

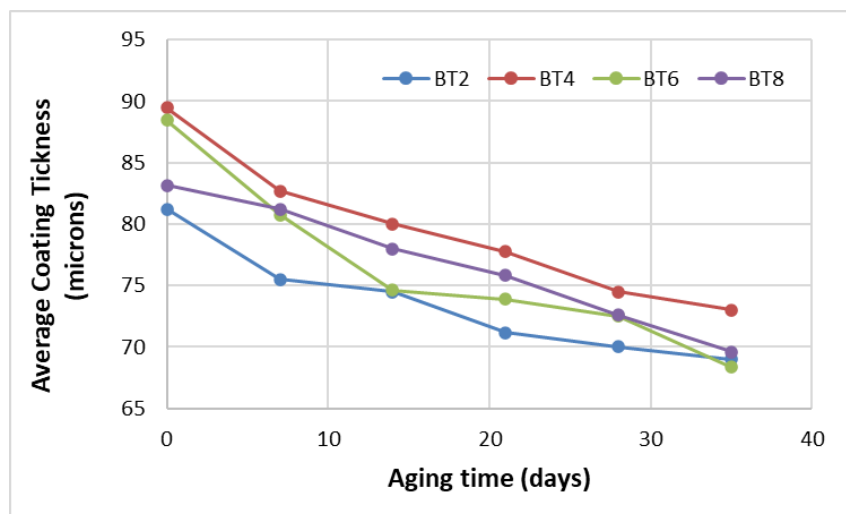
**Figure 160.** Average thickness of selected Belzona-coated samples, with (BT2, BT8) and without (BT4, BT6) surface preparation, during accelerated aging.

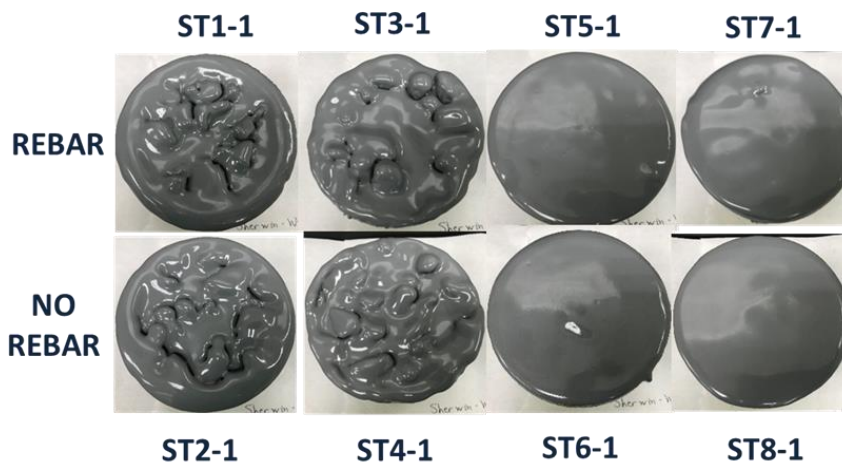
**Figure 161. Top view of Sherwin-Williams-coated samples, with (ST1, ST3, ST5 and ST7) and without (ST2, ST4, ST6 and ST8) surface preparation, at the initial conditions. Only Replicate 1 is presented here, representative of all replicates**

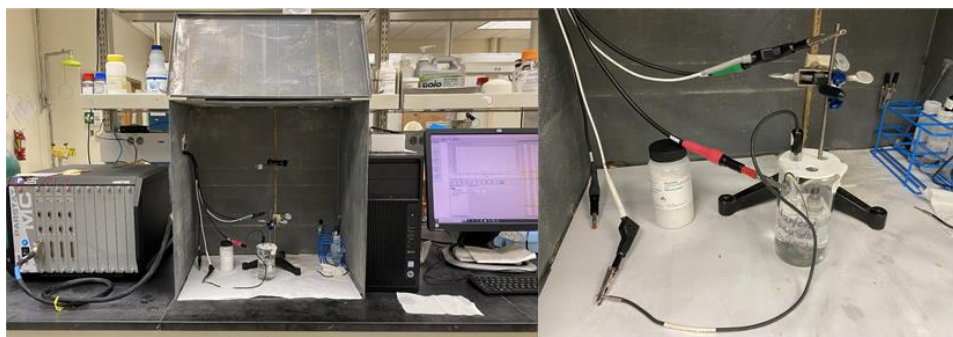
**Figure 162. View of the potentiostat, the Faraday Cage and computer (left image) used for electrochemical measurements. Zoom of the experimental setup (right image).**

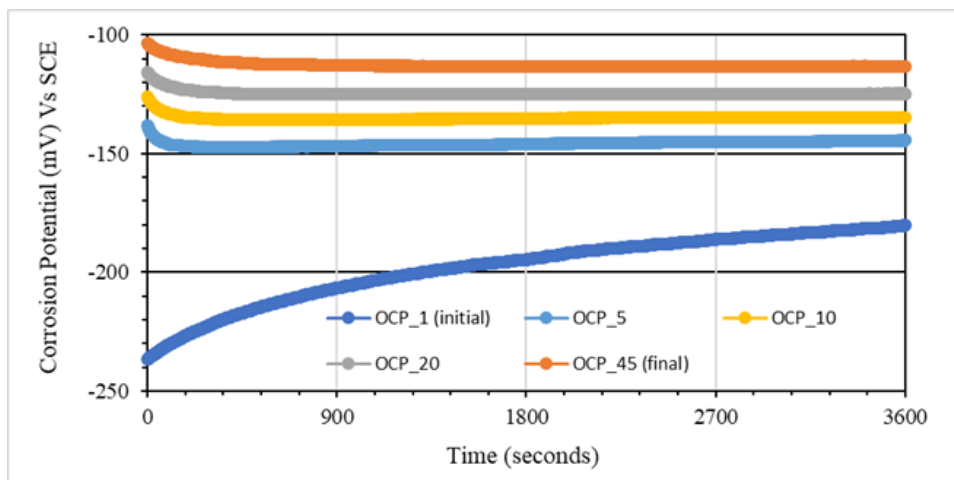
**Figure 163. Corrosion potential for 304 stainless steel canister material at different immersion times in simulated Hanford groundwater A.**

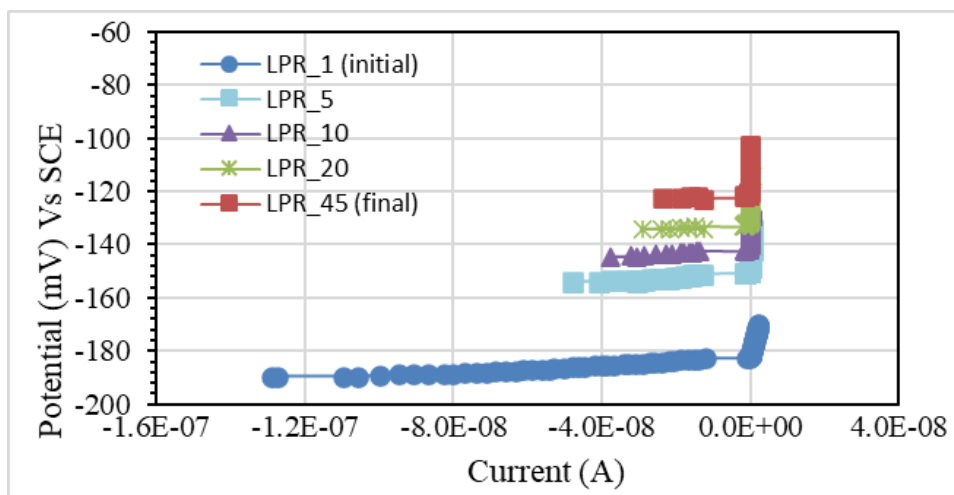
**Figure 164. Polarization resistance plots for 304 stainless steel canister material at different immersion times in simulated Hanford groundwater A.**

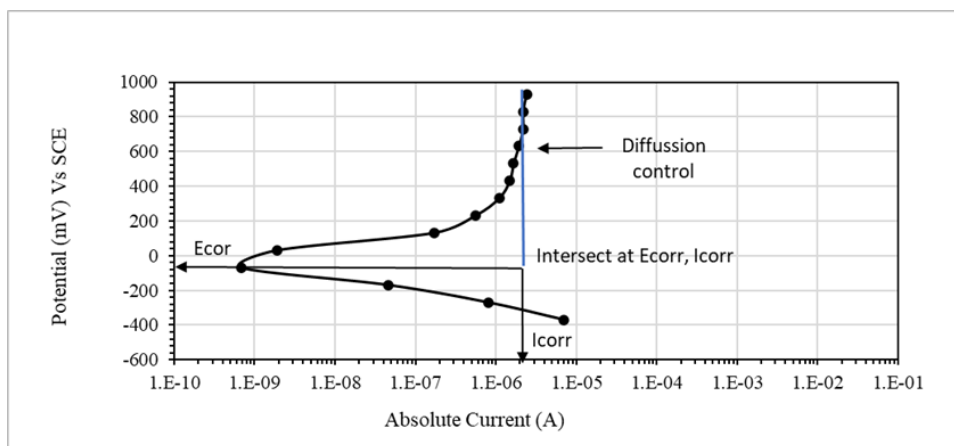
**Figure 165. Polarization resistance plots for 304 stainless steel canister material at different immersion times in simulated Hanford groundwater A.**

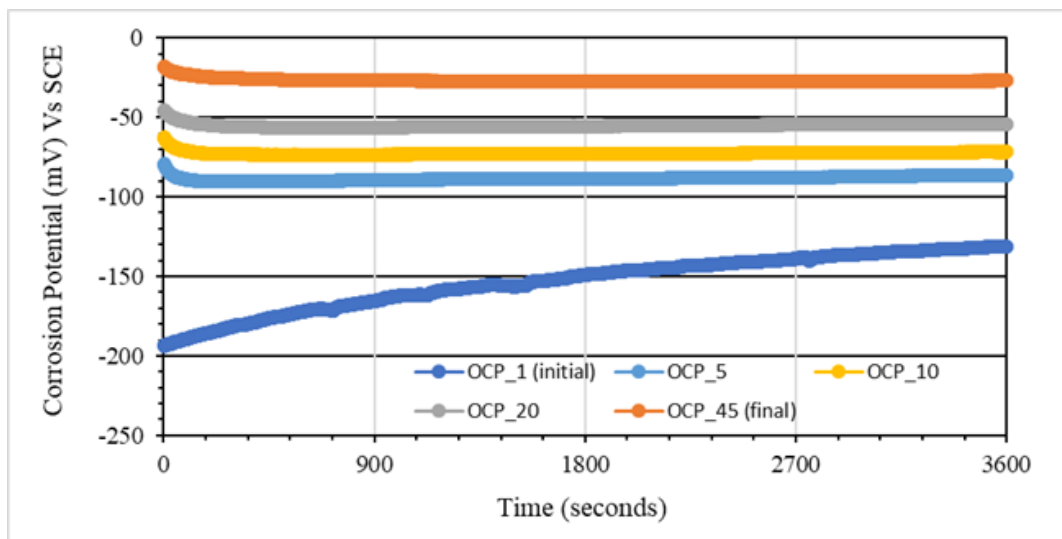
**Figure 166. Corrosion potential for 304 stainless steel canister material at different immersion times in simulated Hanford groundwater B.**
