## **YEAR END TECHNICAL REPORT**

September 29, 2021 to September 28, 2022

# **Chemical Process Alternatives for Radioactive Waste**

U.S. Department of Energy

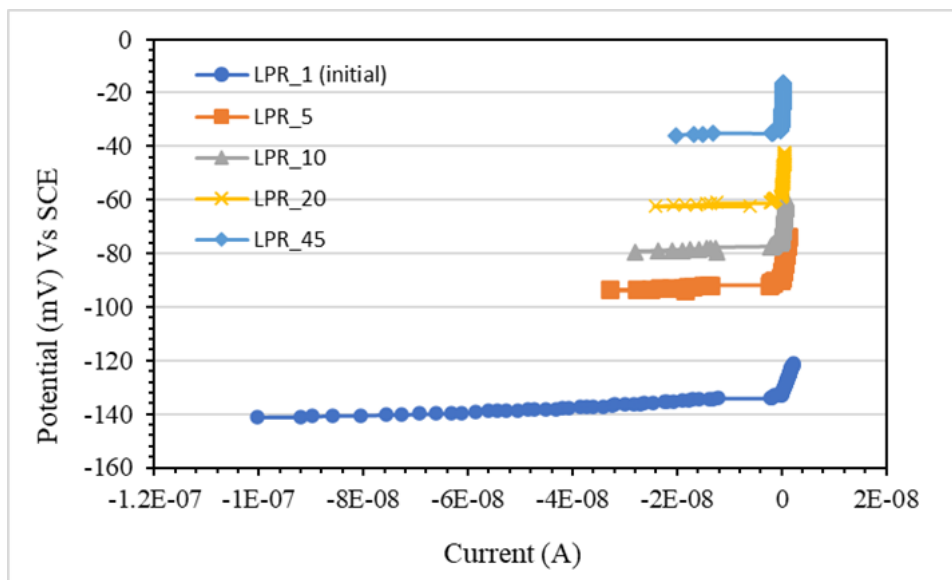
**Figure 167. Polarization resistance plots for 304 stainless steel canister material at different immersion times in simulated Hanford groundwater B.**

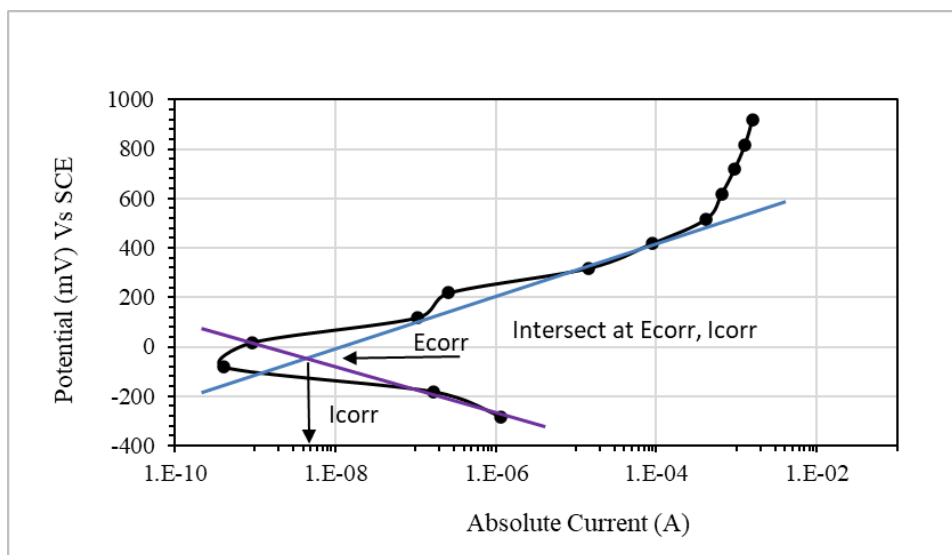
**Figure 168. Potentiodynamic graph for 304 stainless steel canister material at different immersion times in simulated Hanford groundwater B.**
