YEAR END TECHNICAL REPORT

September 29, 2022 to September 28, 2023

Chemical Process Alternatives for Radioactive Waste

Applied Research Center

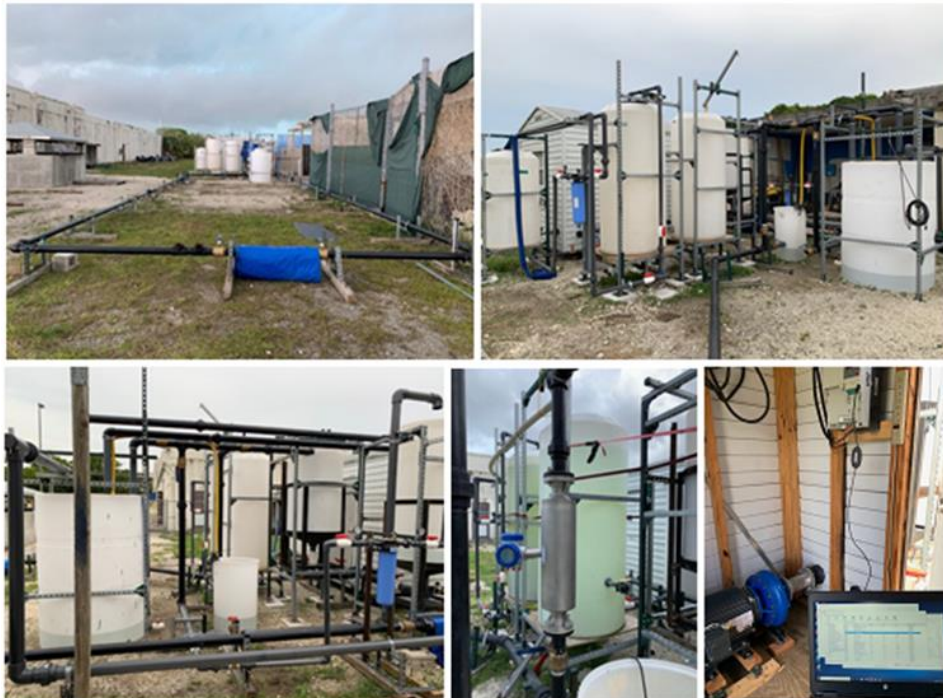
The experimental set up consists of a test loop composed of 3-inch schedule 40 carbon steel pipes and fittings (Figure 1). This test loop can perform various functions such as slurry circulation, pump cleaning, flushing, sediment and water retrieval, and post-flush circulation. The pipeline was sloped at the rate of 0.15% (to emulate conditions at Hanford Site and facilitate gravity draining) [5]. A 15 HP centrifugal pump controlled by a variable frequency drive (VFD) is used to circulate the simulant, flush with water, and conduct post-flush analyses. The fluid level, flow speed, and fluid density are monitored using sensors – the VEGAPULS 11 radar sensor and the Krohne Optimass 1000 Coriolis meter, respectively - that report the status of these parameters in real time.

Figure 1. Major components for flushing experiments.

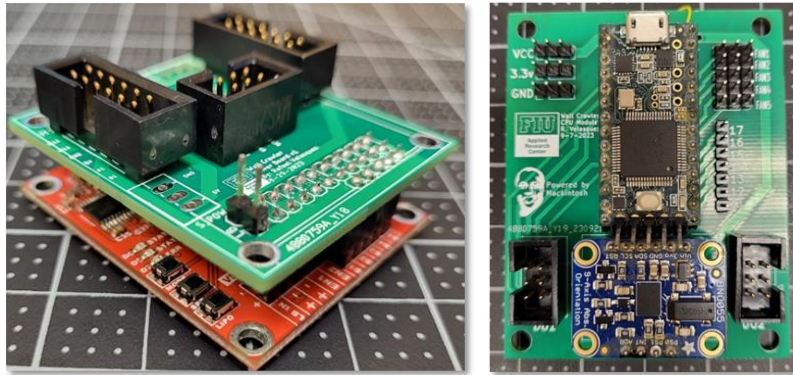
Figure 9. PCB modules for motor controller, microcontroller and IMU integration.

Another improvement was the development of the PCB modules that are used on the large EDF platform to minimize the amount of wiring required for communication to the different electronic components on the platform along with increasing the robustness of the electrical layout. The PCB modules consist of the motor controller module, servo PCB module and a microcontroller and IMU module. Two of which are depicted above in Figure 9. The ability to ingrate the electronic package onto a more configurable package makes the entire setup very modular and creates an easier layout for troubleshooting.

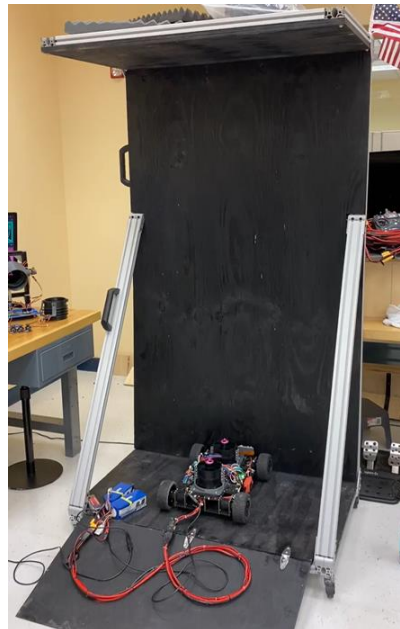
Figure 10. Small-scale wall mockup.

Finally, a small-scale mockup, Figure 10, was constructed with the idea of having a modular testbed which can be used for rapid testing of the different wall crawling platforms. The rapid testing would aid in providing data to improve the overall performance of the mobile platforms while transitioning and moving along a surface at different orientations.

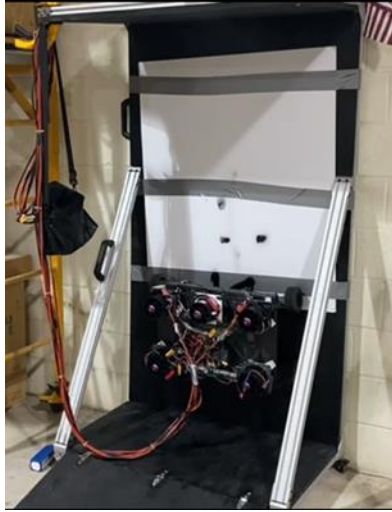
Figure 18. Deployment of spray material on vertical surface.

The completion of the initial testing indicated that system integration of the spray mechanism and the 5-fan EDF platform was a success and tested then began on a vertical surface. Figure 18 below, depicts the large EDF platform completing the transitioning onto a vertical of the small-scale mockup and then deploying the spray material onto the white surface.

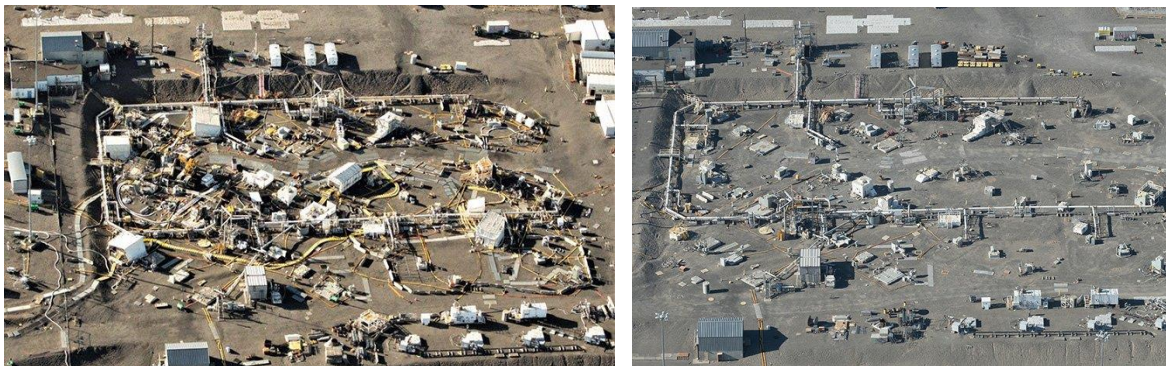
Figure 19. Hanford's Tank Farm retrieval operations in September 2016 (left) and 2018 (right).

As exemplified by Figure 19, changes in Hanford's Tank Farm due to retrieval operations [1] and the constant need to manually reconfigure the surveillance mobile platform's mission plan could burden site engineers, which would also be the case in analyzing the captured data over time.

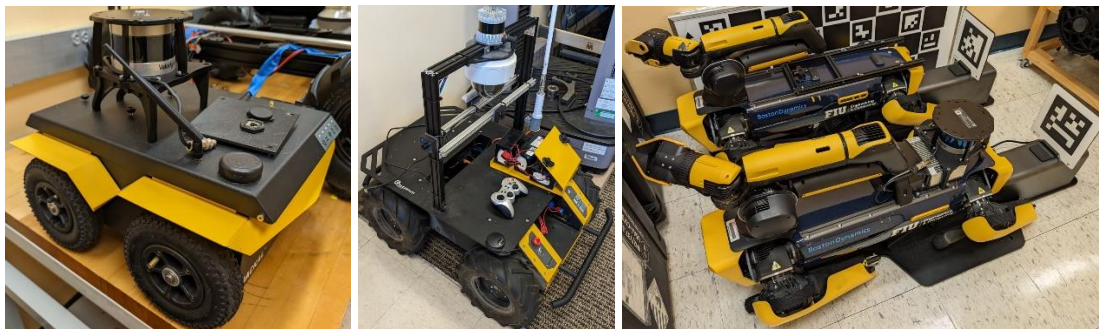
Figure 21. FIU's mobile ground platforms.

Figure 21 shows the ground mobile platforms used in our in-house tests. The platforms have been customized, integrating several perception and gamma radiation sensors to navigate nuclear facilities and generate high-fidelity tridimensional environmental maps.

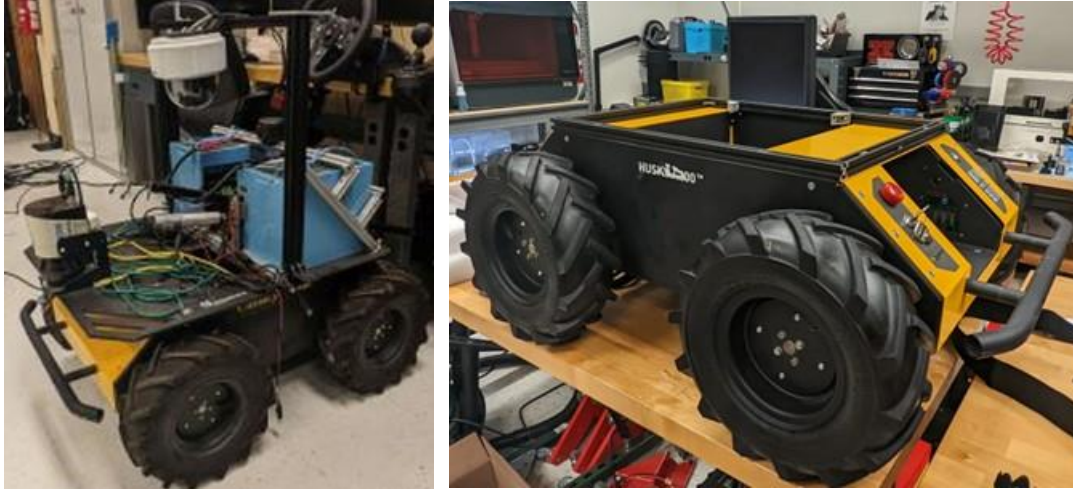
Additionally, the team troubleshooted an all-terrain ground platform donated by WRPS. As illustrated in Figure 24, all the previous robot modifications were disassembled to isolate and determine the causes of malfunction, leading to issues in the platform's embedded computer, which is being upgraded. Ongoing communication with the manufacturer is being maintained to restore the robot to its original state, including missing batteries, mounts, and cover plates.

Figure 24. All-terrain ground platform donated by WRPS (left) and troubleshooting (right).

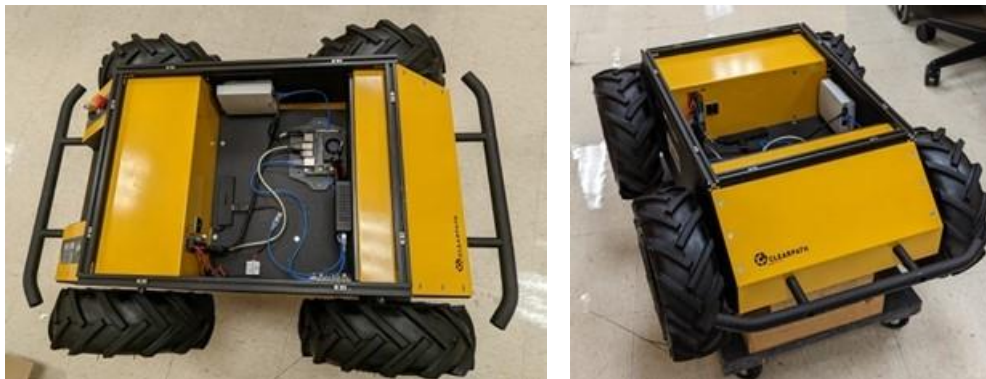
Figure 25. All-Terrain ground platform donated by WRPS.

After determining the source of the platform's malfunction, the all-terrain platform's embedded computer was replaced with a more capable system. The retrofit included mounting the computing unit onto the robot's chassis and installing an operating system. The required support software and drivers were also set up. The overall system was tested, and the motor control units functioned successfully, actuating the robot's wheels. Presented in Figure 25, efforts addressed wiring issues powering the embedded instrument.

Figure 25 shows tests conducted with the all-terrain UGV in a controlled indoor environment, driving around an office space. The UGV captured data on its surroundings, generated maps, and simultaneously understood its position within the facility.

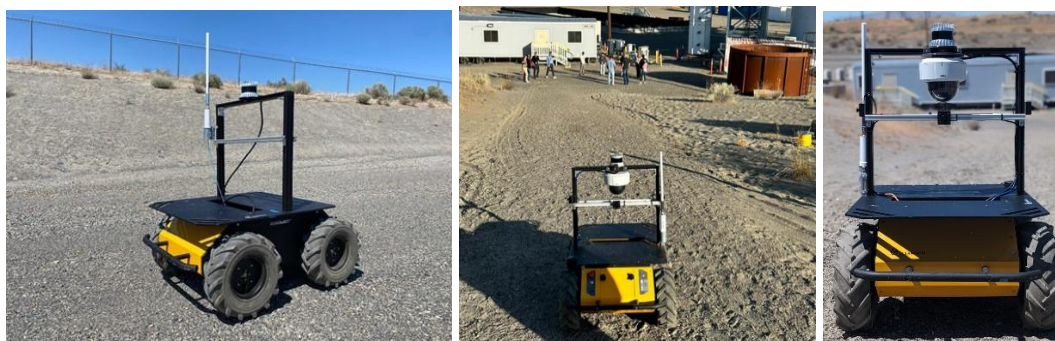
Figure 29. FIU's technology deployed at Hanford's CTF.

Figure 29 shows FIU's technology deployed at CTF. The deployment demonstrated potential uses of mobile robotic platforms to automate above-ground routine operations at tank farms. The effort is part of the WRPS's Engineering and the Chief Technology Officer (CTO) partnership with FIU to develop technology that can possibly assist first responders at Hanford's tank farms.

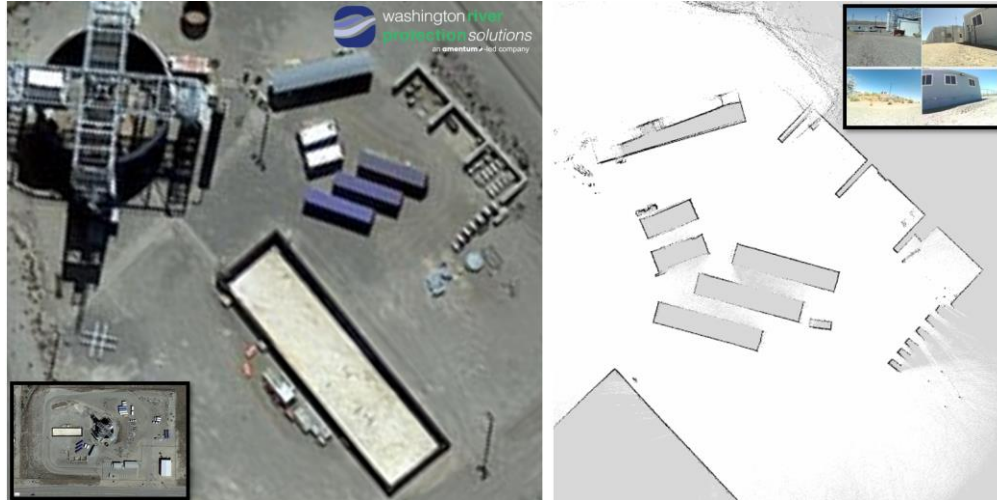
Figure 30. Deployment at Hanford’s CTF.

Figure 30 shows an outdoor map generated during the summer demonstration.

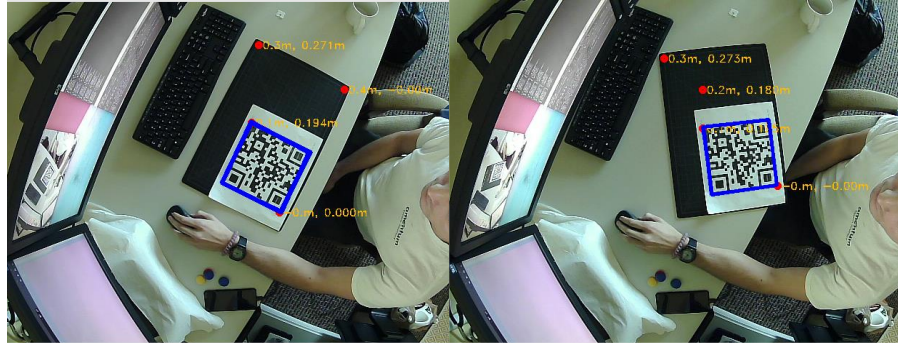
Figure 34. QR code automated calibration.

For the QR code approach, numerous libraries were tested for their recognition capabilities at various angles and lighting conditions. Preliminary tests in Figure 34 illustrate QR code detection in an image to provide four key points related to real-world dimensions.

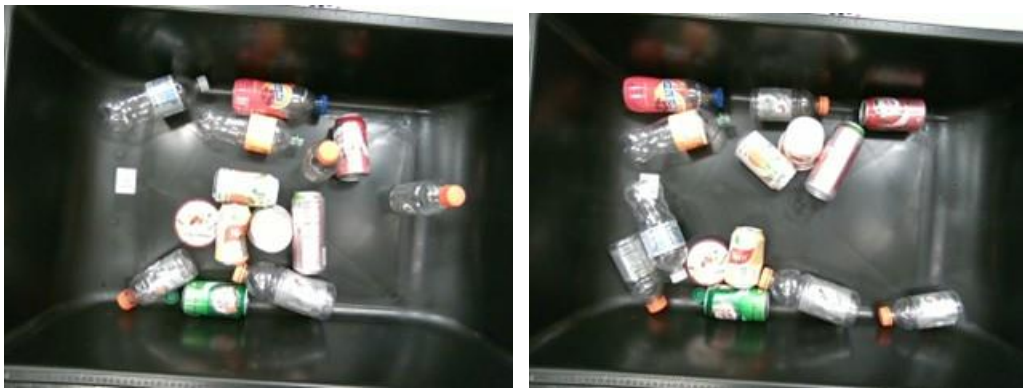
Figure 37. Sample of waste images for training machine-learning prediction model.

The team has also provided training photos of selected waste to create a machine-learning prediction model. The prediction model will be used to classify waste items based on their visual characteristics, which could also aid in grasping gestures and sorting the objects.

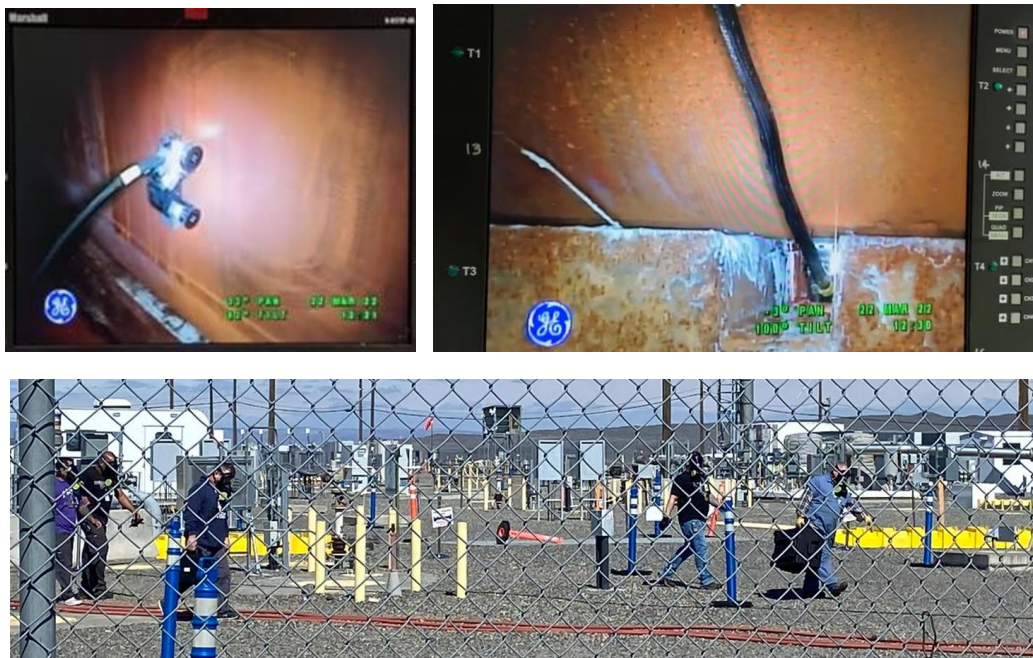
Figure 43 shows images of the tank farm deployment. WRPS technicians operated the rover through the riser located at grade and lowered it down via the deployment tray. Upon being lowered to the appropriate length, the rover traversed down the tank wall in the annulus and entered the refractory air slot. Upon the successful inspection of the refractory slot, the rover returned to the deployment tray and was retrieved successfully.

Figure 43. FIU's miniature inspection rover deployment at AP-105 DST.

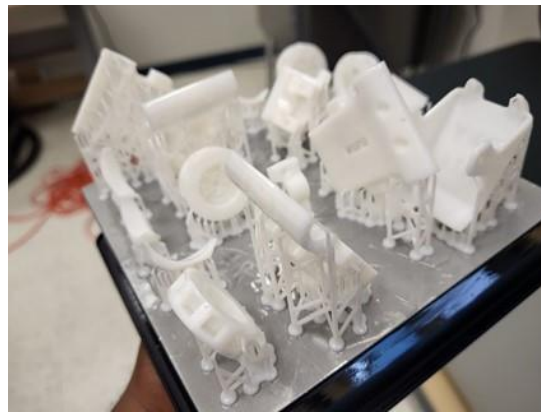
Figure 45. Miniature Rover resin parts before post-processing.

Figure 45 shows the miniature magnetic rover chassis printed using a Stereolithography (SLA) 3D Printer. The finish and resolution of printed surfaces are exceptional, showing promising results in replacing the 3D-printed aluminum components. The selected resin material is very rigid; however, it is brittle. Over-sized components, such as bearings, could not be press-fit without cracking or chipping the chassis, which has required minor redesigning and tolerance tuning.

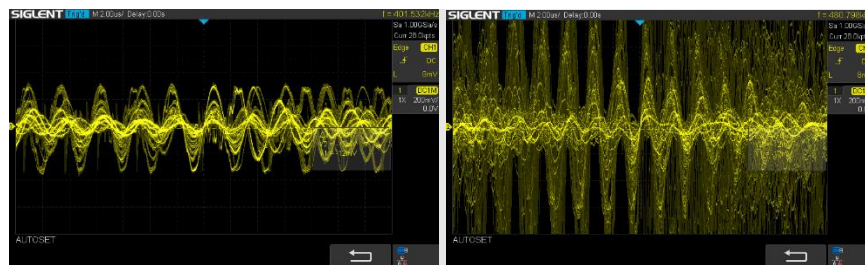
Figure 64. Grounded (left) and ungrounded (right) video feed.

Efforts were dedicated to eradicating the induced noise in the device’s video feed. Motor control signals sent through the 200 feet tether cause artifacts in the analog video feedback, resulting in unclear images. Figure 64 shows digitized waveforms analyzed using an oscilloscope. The team explored several filtering and grounding solutions to the noise problem.

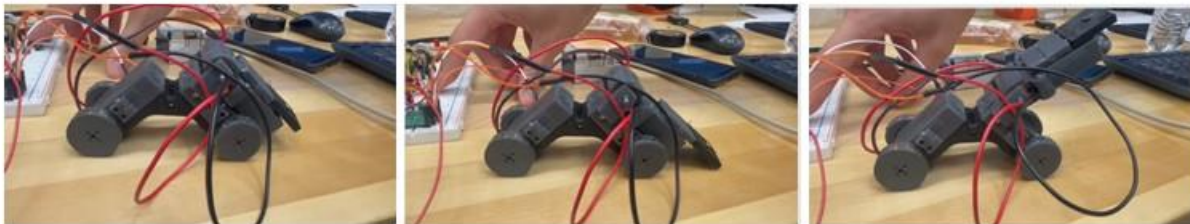
Figure 77. FIU miniature rover's sampling systems.

Figure 77 shows a sampling system's functional prototype. The articulated arm has an ample workspace and can sample material from the tank's primary liner and reach deposits on the concrete refractory channels.

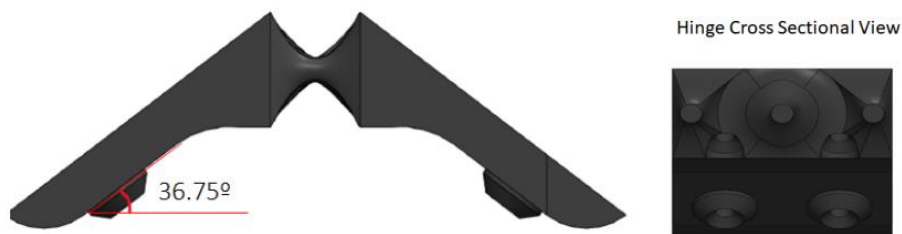
Figure 80. Optimal chassis angle.

Figure 80 shows the current flexible connection angle optimized to maneuver through the refractory channel turns, considering the rover's ideal length and height, including the sampler addition.

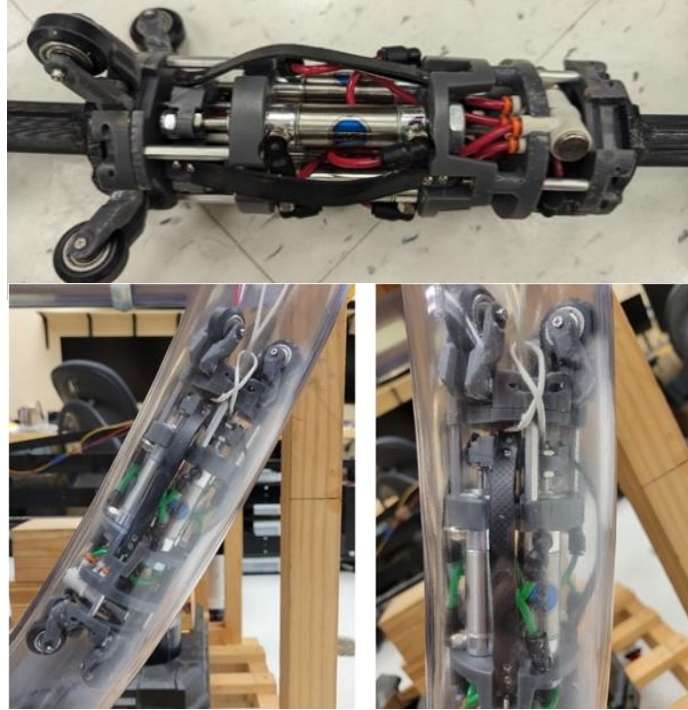
Figure 86. Improved gripper module with independent blades.

Figure 86 shows a functional prototype for the improved gripper design. The gripper uses a rubber blade per pneumatic piston instead of the single flange, attaching the four actuators that move the blades simultaneously. The independent blades better conform to pipe walls, gripping evenly on curved surfaces.

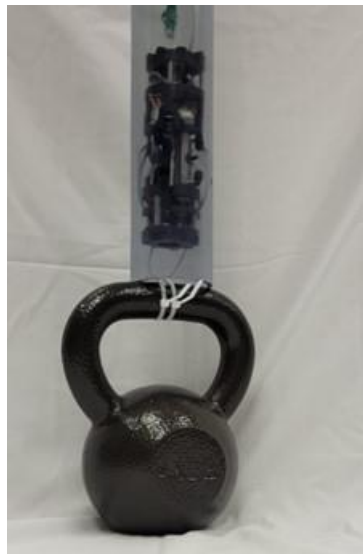
Figure 87. Crawler's gripper module gripping test.

The design improvements on the crawler's gripper module enhanced the previous gripping force from approximately 20 pounds to 45 pounds per module, as demonstrated in Figure 87.

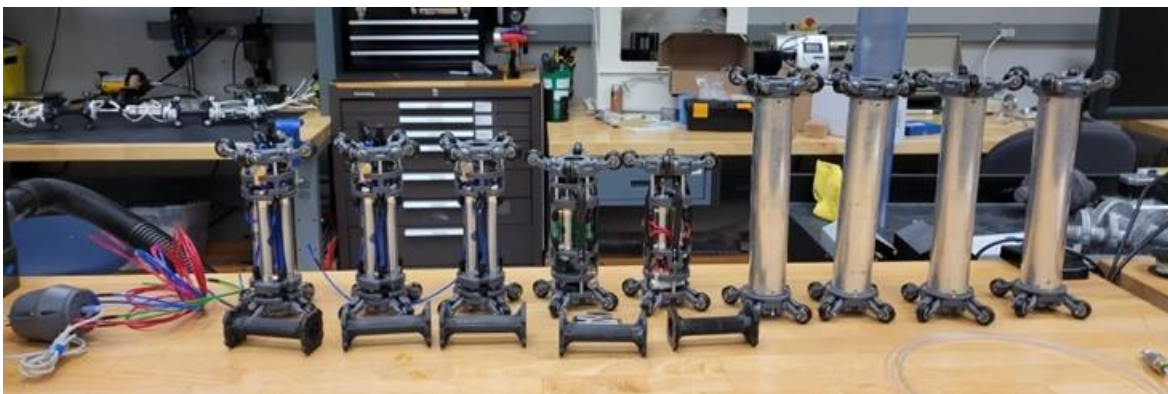
Figure 88. Pipe crawler improved modules.

Figure 88 shows the most current prototypes of the pipe crawler modules, including all improved modules. The improvements also include strengthened wheel guides. The guides center the crawler module, minimizing friction and potential debris accumulation during inspections.

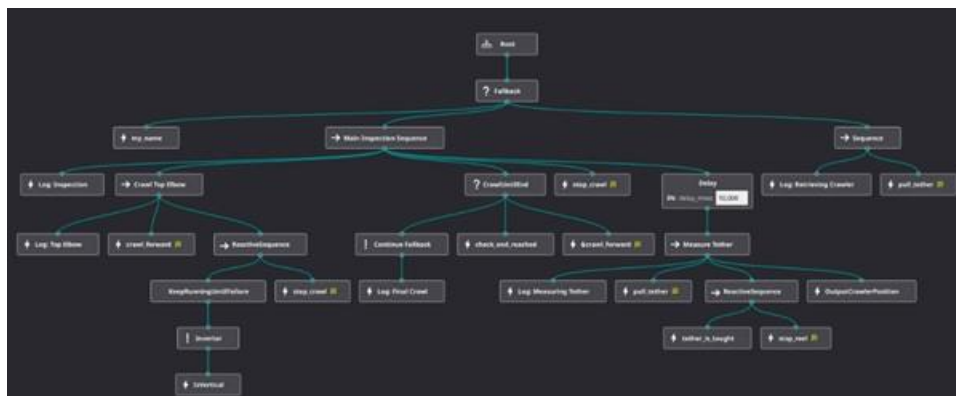
Figure 94. Updated LGS’s behavior tree.

The current position estimation routine ensures that the tether is taut during measurements by reeling back the cable until the frontal module’s IMU detects crawler jerks. Similar combinations of actions are used at many inspection points; thus, they are saved as reusable subtrees. Figure 94 shows the behavior tree’s current state of development.

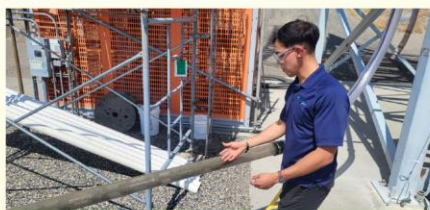
The "Lateral Gamma Scanner" crawler bot is lowered down the pipe and retracted using a reel and cable system.

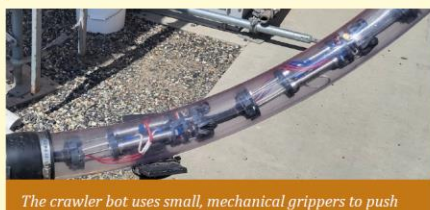
The crawler bot uses small, mechanical grippers to push and pull itself along the inside of a pipe.

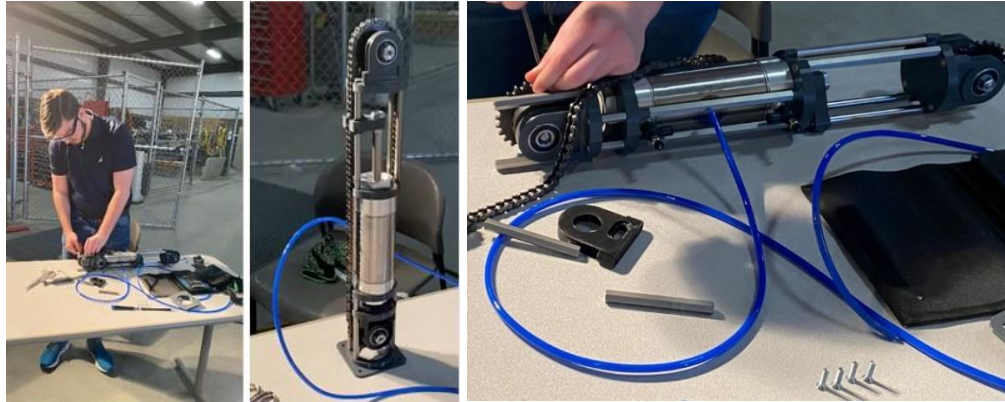
Figure 108. Pneumatic joint’s functional prototype.

Figure 108 shows a functional prototype of the pneumatic joint assembled and demonstrated at Hanford's Cold Test Facility. The lessons learned from the summer interaction with WRPS engineers, and their feedback were crucial to guide the technology development when the Fellow returned to FIU.

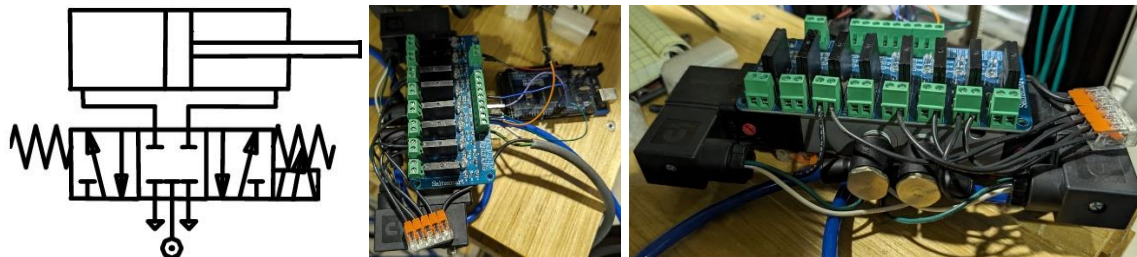
Figure 109. Pneumatic joint’s three-position control schematic (left) and prototype (right).

Each pneumatic joint’s cylinder is actuated by a three-position solenoid valve controlled by solid-state relays commanded by a microcontroller receiving position feedback for a rotary encoder. As illustrated in Figure 109, the solenoids allow the cylinders to stop partway through their motion.

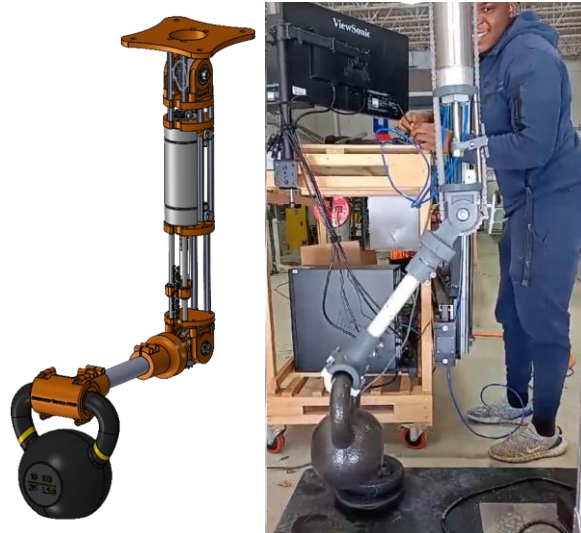
Figure 112. Pneumatic joint’s payload testing.

Figure 112 shows preliminary joint tests lifting 45 pounds to simulate the equivalent required payload.

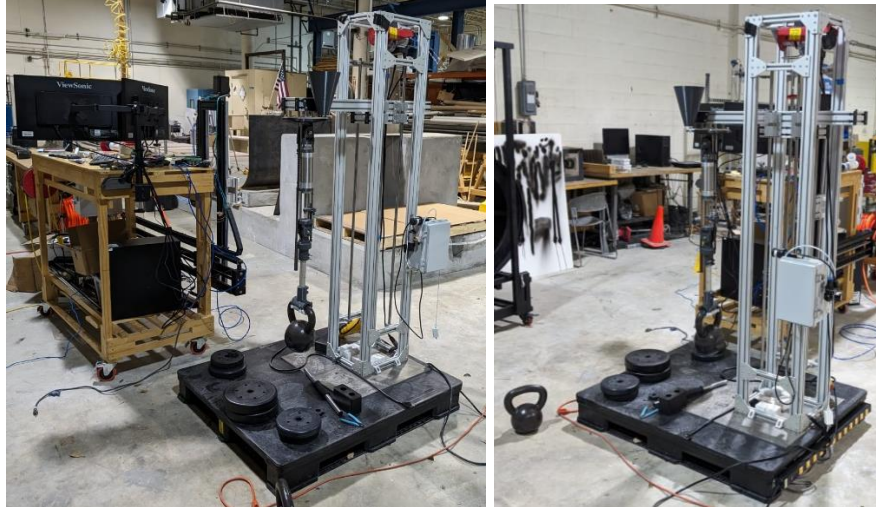
Figure 113. Off-riser sampler’s testing mockup.

Figure 113 shows the test testbed developed to demonstrate the off-riser sampler capabilities. The frame is motorized to simulate the arm’s vertical movement during sampling operation at SST.

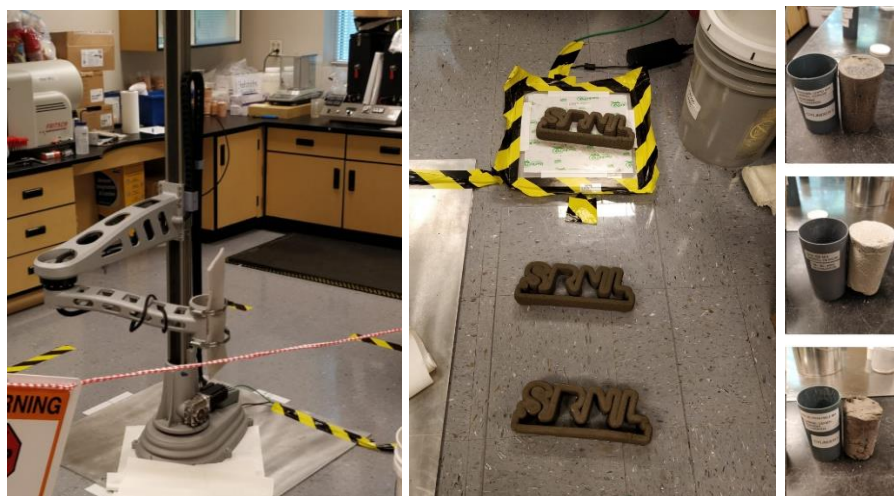
Figure 114. DOE Fellow’s summer results at SRNL.

During the 2023 summer, the DOE Fellow working on the task continued his research interning at SRNL on their 3D printing project, using SRNL’s concrete recipes and printers, presented in Figure 114.

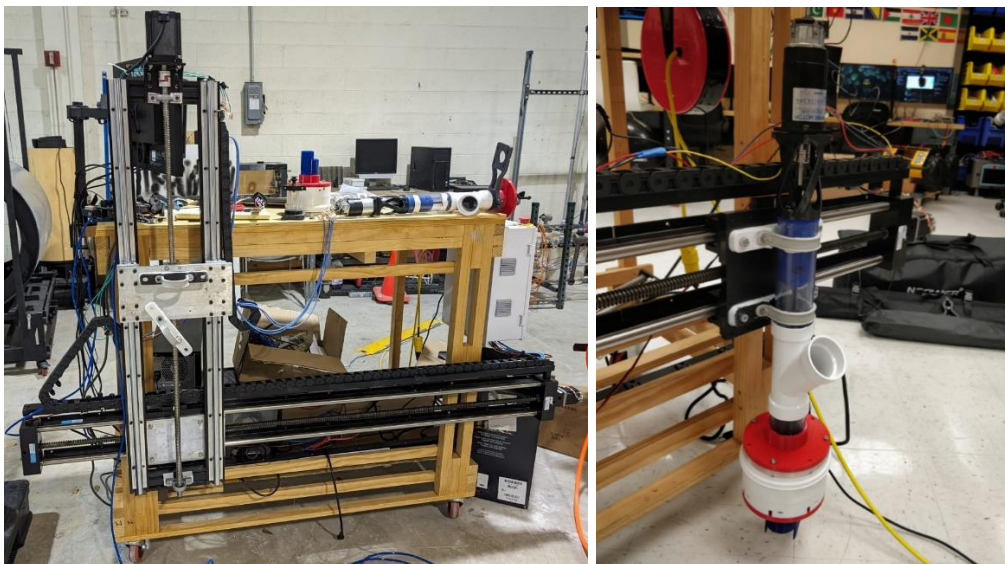
Figure 120. Auger nozzle printer's prototype.

Figure 120 shows our auger nozzle's prototype mounted onto a retrofitted linear motion system built at FIU.

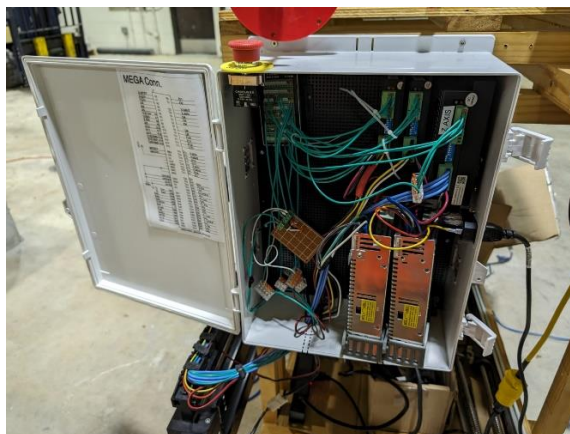
Figure 121. 3D printer's upgraded control panel.

The system's motor controls were upgraded with modern components, shown in Figure 119, for more precise and coordinated movements during printing using a microcontroller running open-source computer numerical control (CNC) machining software.

The control software was fine-tuned, and the extruder's motor was successfully calibrated to ensure accurate millimeter printing. Printing performance issues were addressed through troubleshooting and maintenance procedures to ensure proper operation and preparation for testing with concrete mixtures.

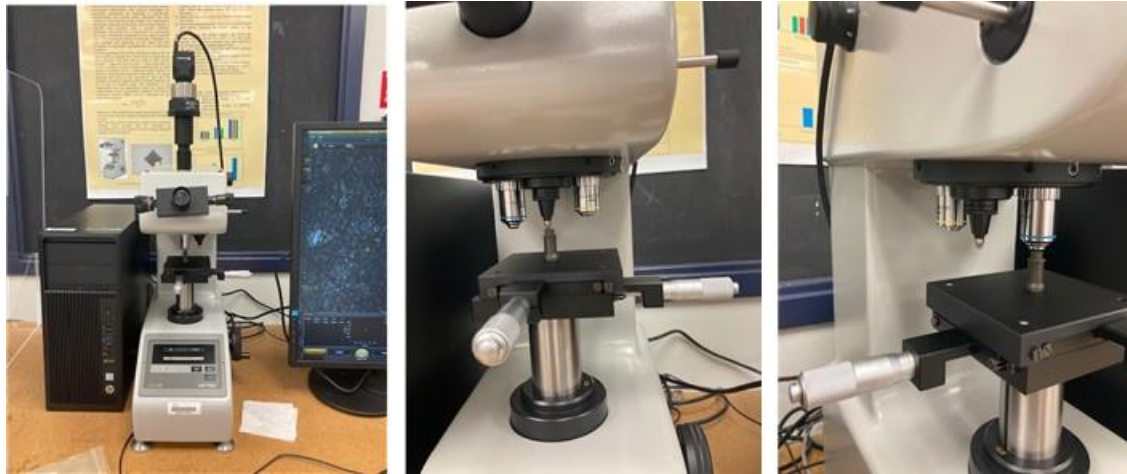
where P is the applied test load, θ is the angle (136°) and D is the average diagonal length of the indentation. The instrument includes software for direct measurements and calculations. The sample (old coupon) placed on the Vickers hardness tester for indentation is shown in Figure 126.

Figure 126. Vickers Hardness Tester (left), sample indentation (center) and surface imaging (right).

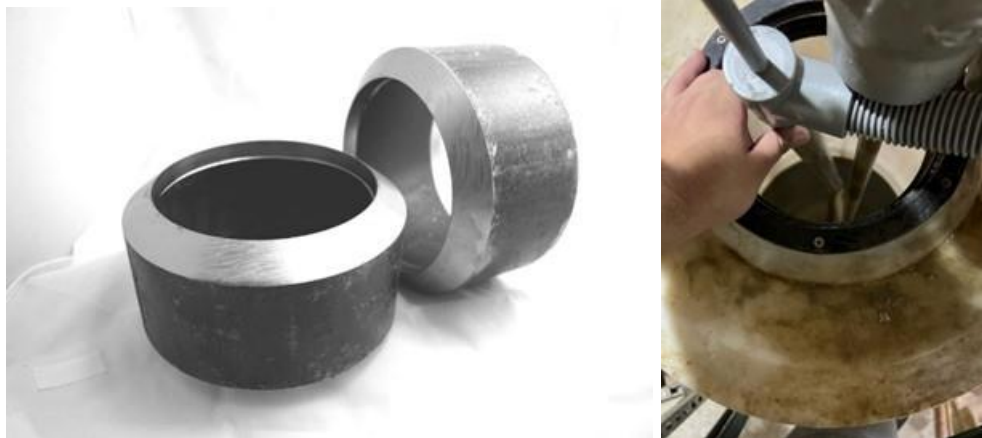
Figure 132. Pipe coupons (6-inch) for making the erosion coupons (left) and manual pump in the reservoir tank (right).

Additional efforts included cleaning the test area in the labs and conducting water tests in the engineering scale loop. Water in the tank has been pumped using a manual pump (Figure 132, right). Additionally, a UT sensor has been calibrated for measurements.

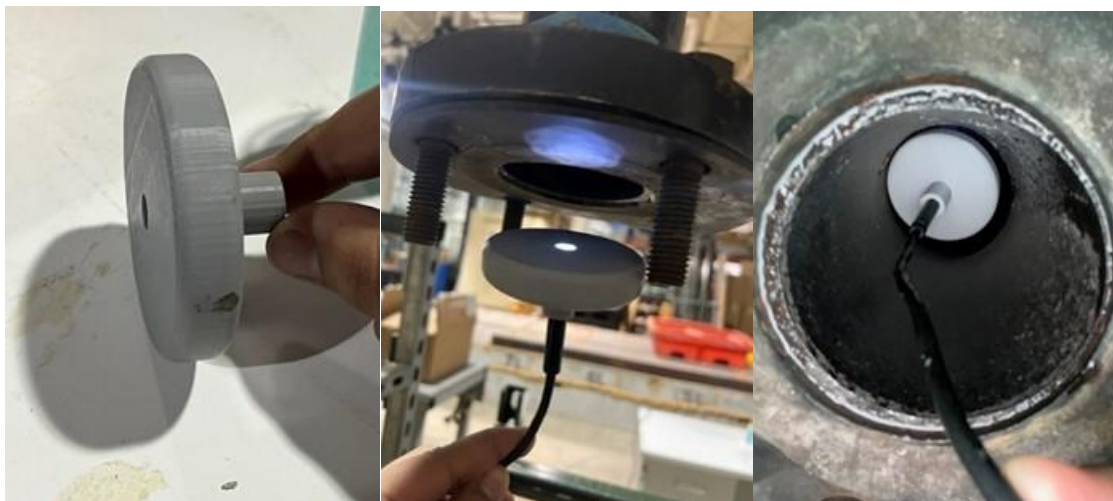
Figure 133. Pipe adapter - 3D printed part (left), fitted borescope (center) and in the pipe section (right).

Coupon images have been captured using a borescope in the pipe. During image capturing, the second set of coupons (in the 3-inch straight section) were not accessible due to the camera being physically unstable at the pipe center. To avoid this, an adapter has been designed and 3D printed so it can be attached to the borescope and the entire pipe internal surface can be easily captured via the camera. The designed adapter and its usage in the pipe with the borescope are shown in Figure 133. The images captured with the stabilized borescope using the designed adapter are shown in Figure 134. These represent the pipe's internal structure (left) with coupon, the straight section (channel) with glass particle bed (center) and the glass deposits in the pipe at a particular section (right).

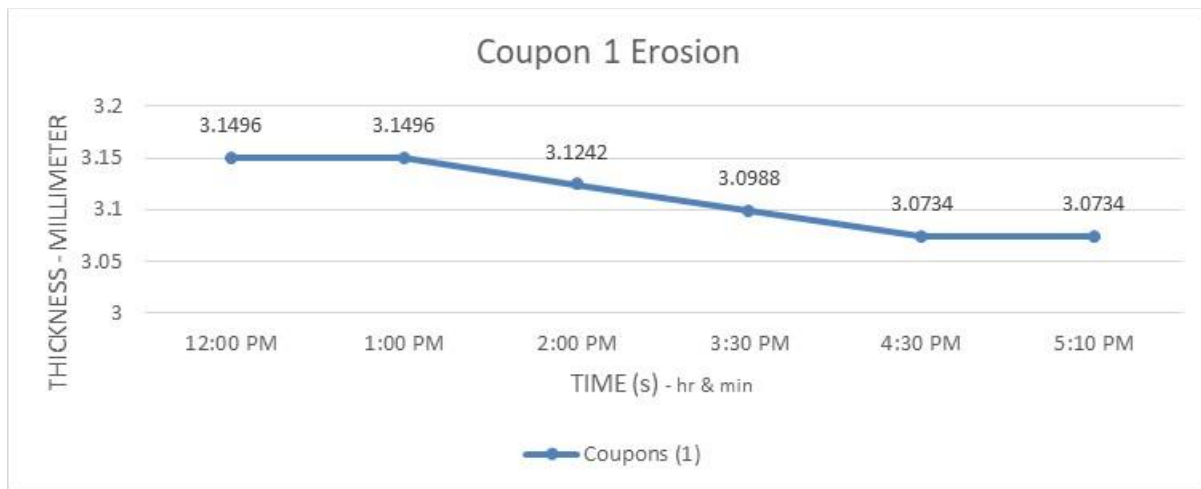
Figure 135. Degradation in coupon placed near the elbow.

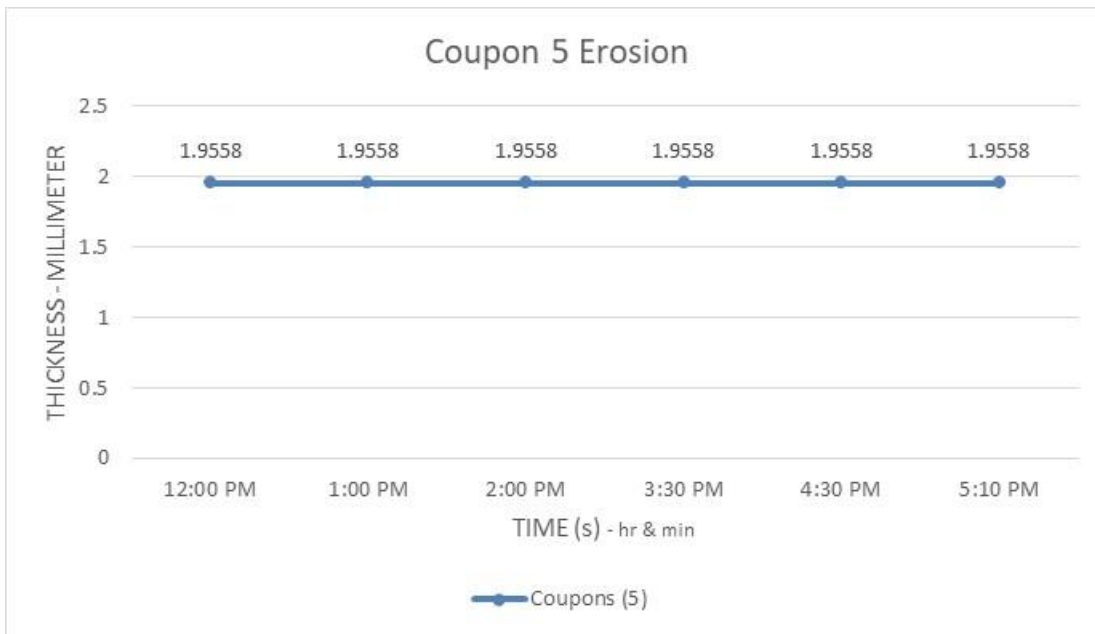
Figure 139. Degradation in coupon placed at the top 3-inch section of the pipe.

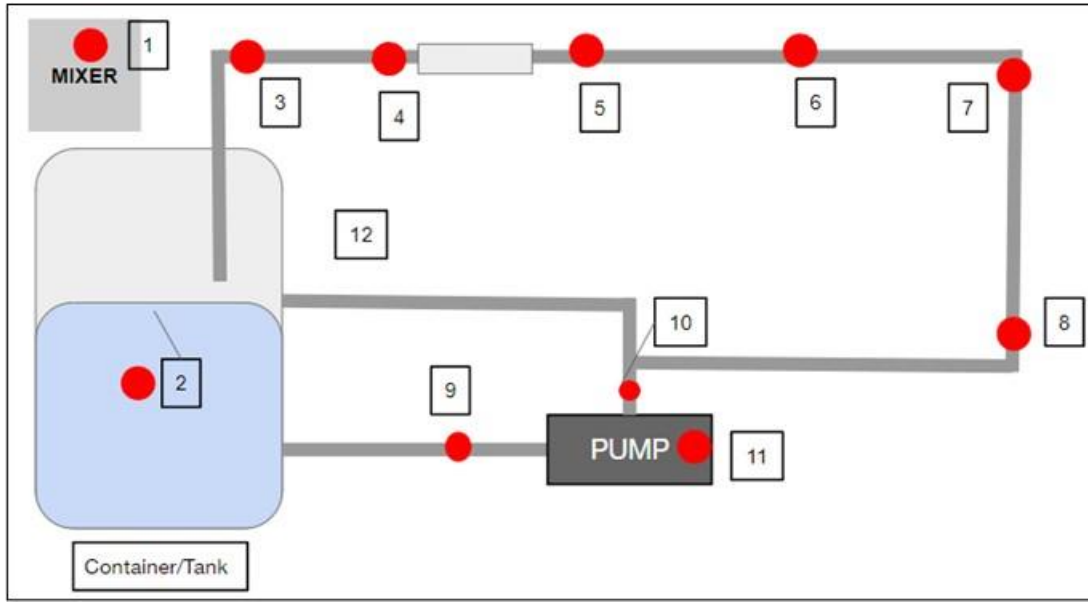
Figure 141. Critical data points on the loop for thermal stability experiments.

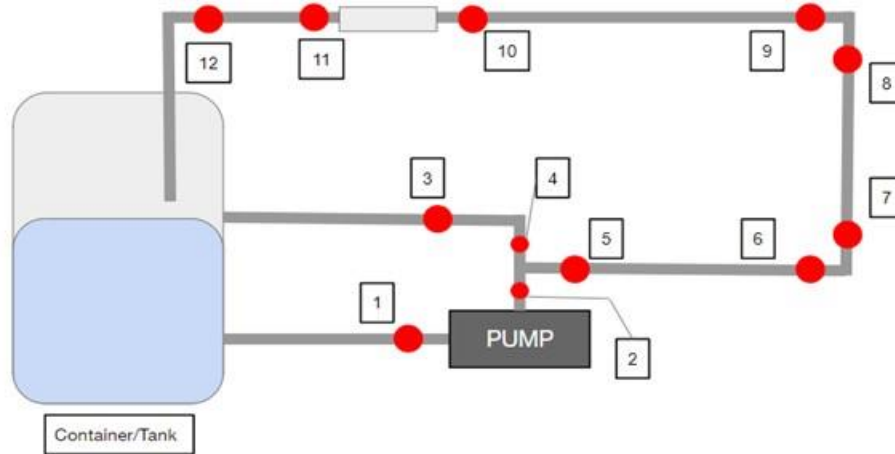
Figure 144. Pipe loop with critical data points identified for degradation study.

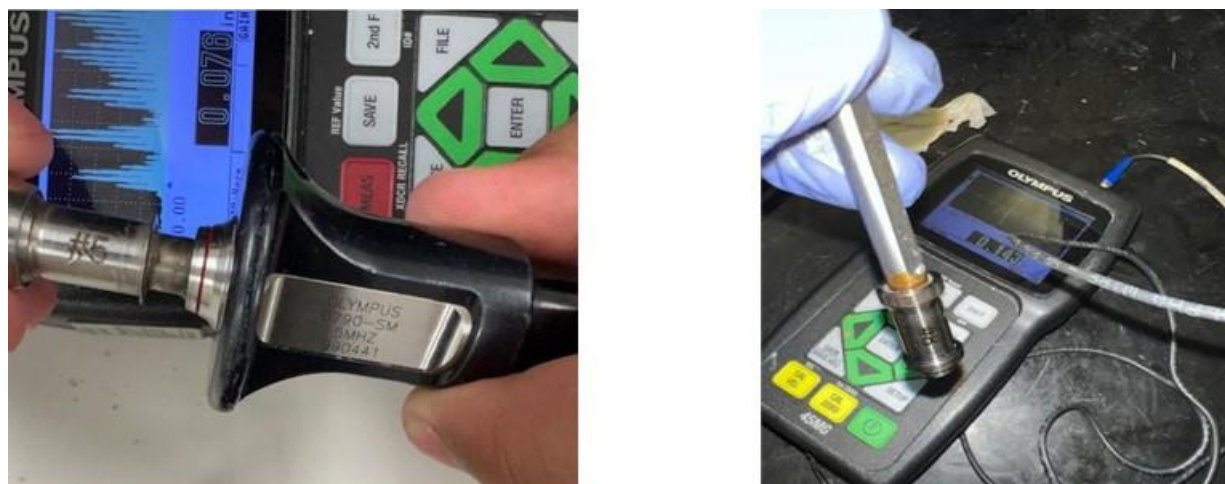
Figure 145. UT measurement of the coupon using two separate sensors (inner and outer coupon surface).

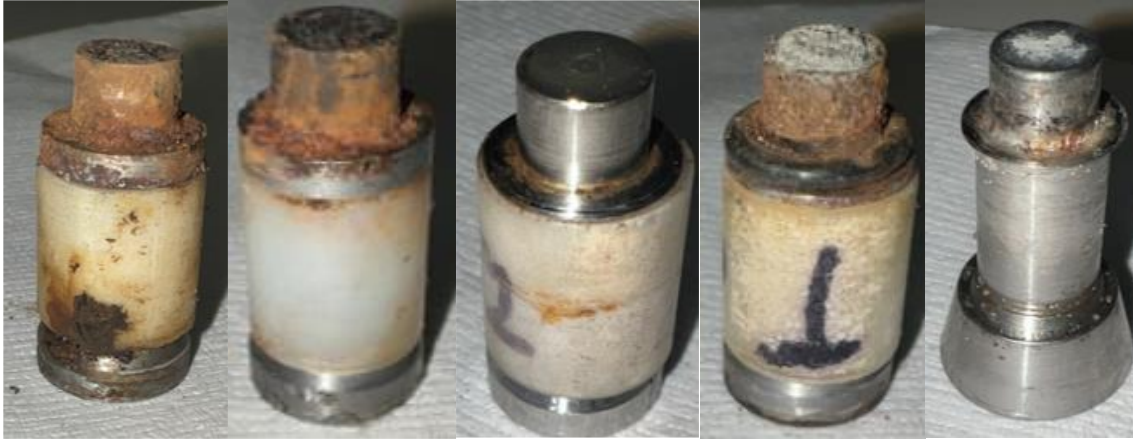
Figure 146. Coupon #1 through #5 (left to right) images taken after completion of the test cycles.

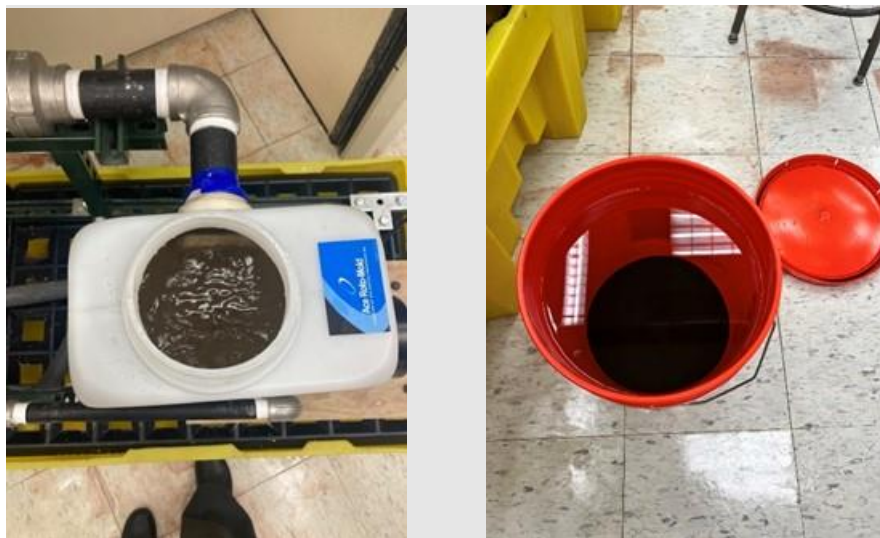
Figure 152. Caustic simulant solution in the tank (left) and after 3 weeks of settling (right).

The first stage of bench scale caustic testing with 2M salt solution was completed, and the tested solution was removed from the tank and stored in a container for settling. The storage container was kept undisturbed for a 3-week period to check the separation and settlement of corrosion particles and salts at the bottom. After 3 weeks, it was observed that the corrosion/rust particles were completely settled at the bottom of the container while the rest of the solution was crystal clear, clearer than the static solution in the bottles with coupons. Hence, the clear solution is currently being examined to check for pH and other chemical characteristics for its reusability. The plan is to decant the fluid and weigh the corroded solid material. Figure 152 depicts the solution before recovery from the pipe loop's tank (left) and after 3 weeks of settlement (right). It is a very significant observation that can be used to measure the corrosion in terms of material loss (mass/weight) of the entire pipe loop.

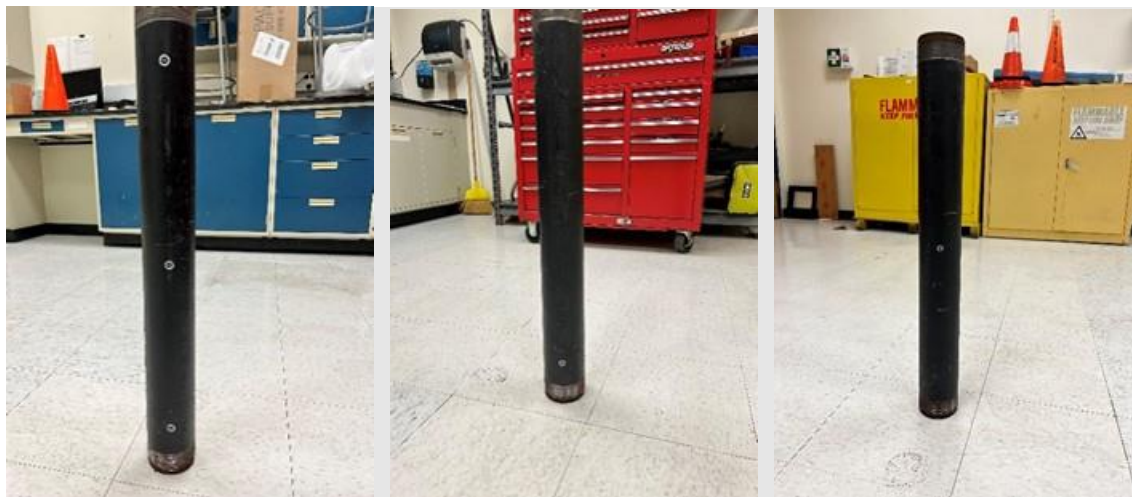
Figure 153. Pipe test section with markings for shipping to SRNL.

Next, the 3-inch test section of the bench scale loop was shipped to SRNL for drilling holes for coupons. The new coupons will be inserted in 5 locations as shown in Figure 153. The locations are determined based on the flow features of the fluid during dynamic conditions. Two locations are close to the junction between the 2- and 3-inch attachment to ensure full flow conditions and to capture any dead volume (air gaps). Two locations are equally distanced from the pipe ends (center) to obtain the erosion at the top and bottom, and one location is on the side for partial flow conditions.

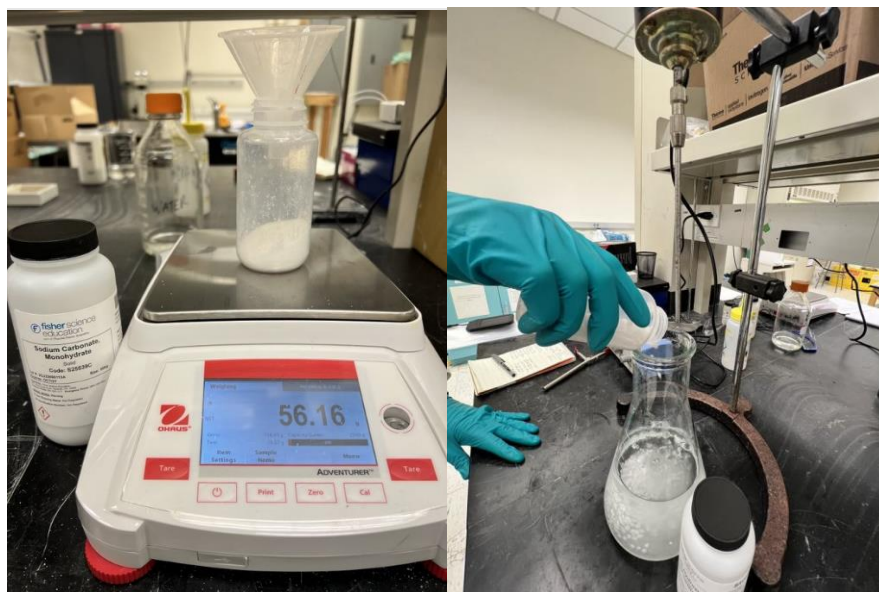
**Figure 154. Simulant mass measurement (left) and experimental set up for mixing the salt simulants (right).**

In November, 6M salt solutions were prepared, SRNL coupons were installed in the loop and the next stage of caustic testing on the bench scale loop has been initiated. 6M salt solution has been prepared in 10 batches using the proportions and recipe provided by SRNL (Figure 154). The total amount of the simulants required for 18L and amount per batch is provided in Table 18. Each of the chemicals is proportioned to a batch size, weighed, and dissolved in distilled water using a mechanical stirrer. The weighing process and experimental setup are shown in Figure 154.

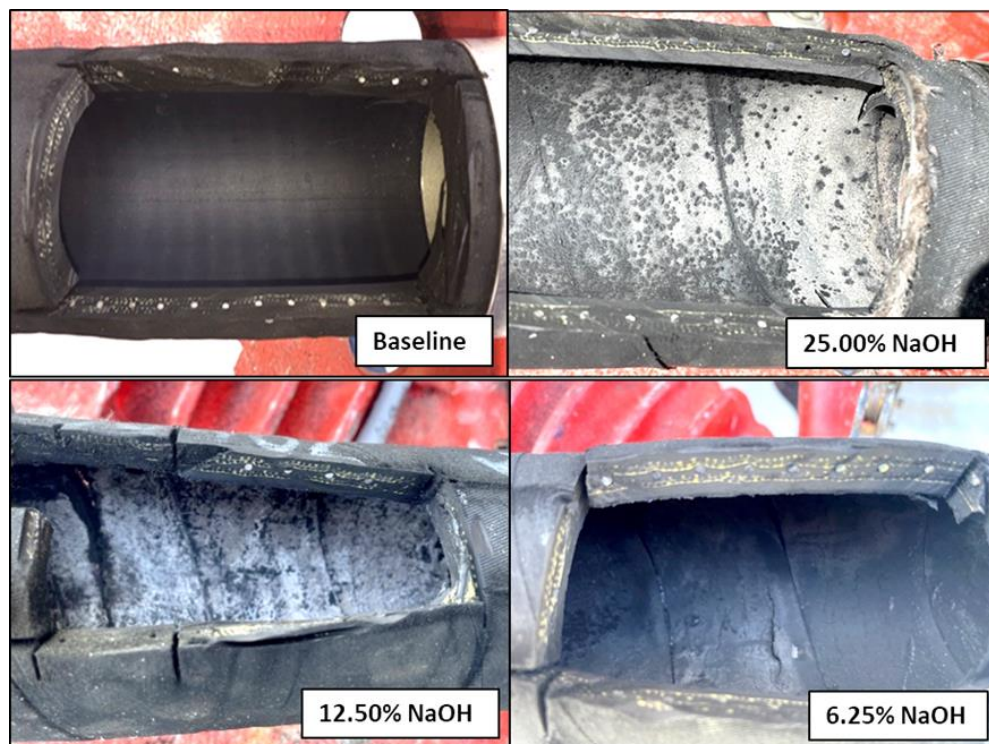
Figure 207. Comparison of the inside of unaged and aged HIHTL specimens.

The first phase of this year's research involved identifying the composition of the white material coating that was coating the inside of the HIHTLs aged at the higher concentrations (Figure 207).

X-Ray Diffraction (XRD) analysis was conducted on the white crystalline substance from the specimens aged in the 12.5% NaOH solution in order to determine its mineralogy. The XRD analysis was done on a Bruker D2 PHASER X-ray diffractometer equipped with a LYNXEYEXET (1D mode, opening $5^\circ 2\theta$) detector and a rotating collimator source; Cu $K\alpha$ radiation, operating at 30 keV. Samples were loaded onto zero diffraction plates ($\text{Ø } 24.6 \text{ mm} \times 1.0 \text{ mm}$ thickness, cavity $\text{Ø } 10 \text{ mm} \times 0.2 \text{ mm}$ depth, MTI Corporation) and scanned from 5° to 90° with a step size of 0.02° , 1s per step. The solid phase identification was conducted via *DIFFRAC.EVA. V5.1 XRD* pattern processing software. Analysis results shown in Figure 208 indicated that the substance is sodium carbonate monohydrate, $\text{Na}_2\text{CO}_3 \cdot \text{H}_2\text{O}$.
