YEAR END TECHNICAL REPORT

September 29, 2022 to September 28, 2023

Chemical Process Alternatives for Radioactive Waste

Applied Research Center

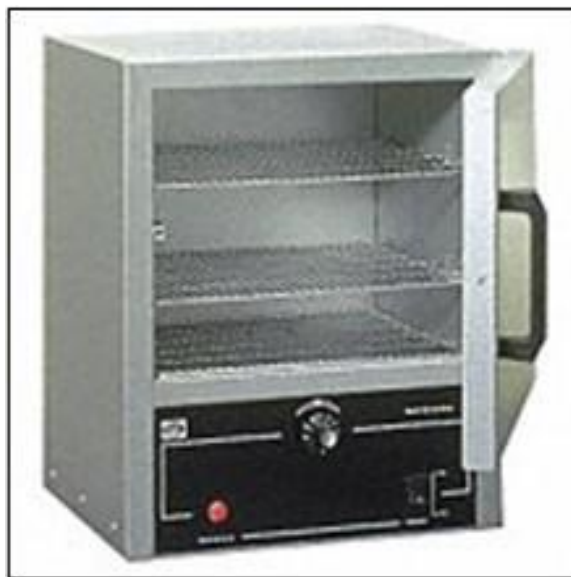
Figure 217. Quincy Lab Analog Oven Model 30.

A Quincy Lab Analog Oven Model 30 (Figure 217) was used to maintain the specimens and aging solution at a temperature of 170°F.

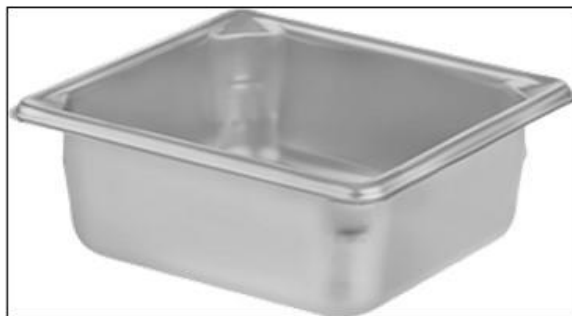
Figure 218. Stainless steel pan.

Stainless steel pans with a capacity of 39 fl. Oz. (Figure 218) were used to contain the specimens along with the aging sodium hydroxide (NaOH) solution.

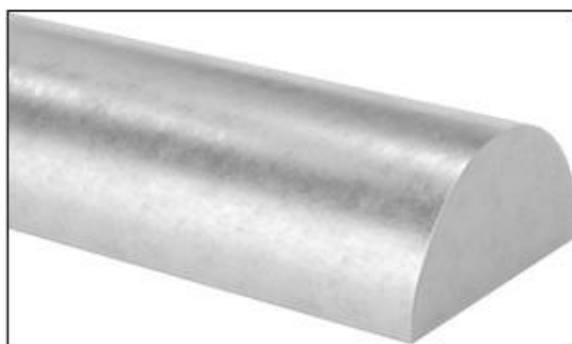
Figure 219. 1/4" stainless steel half-round rod.

Stainless steel half-round rods (1/4") (Figure 219) were placed under the EPDM specimens in order to keep the bottom of the specimens elevated above the pan's floor. This allowed the bottom of the EPDM specimen to be exposed to the NaOH solution.

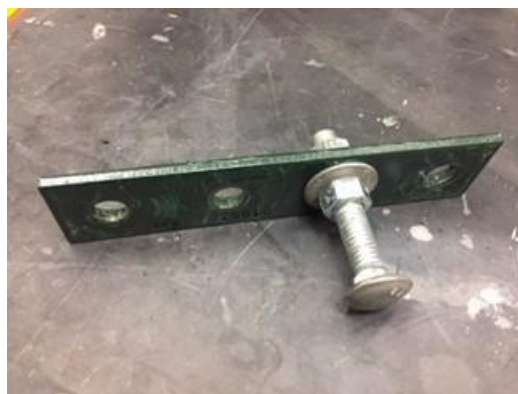
Figure 222. Solution level gauge.

Even though the containers are covered while they are maintained at 170°F in the oven, the solution level within each container drops due to the evaporation of the water component of the solution. Three times a week the level in each vessel is checked and brought back to the correct level by adding water. To make sure the level is brought back to the correct level in each vessel, a homemade level gauge (Figure 222) is utilized.

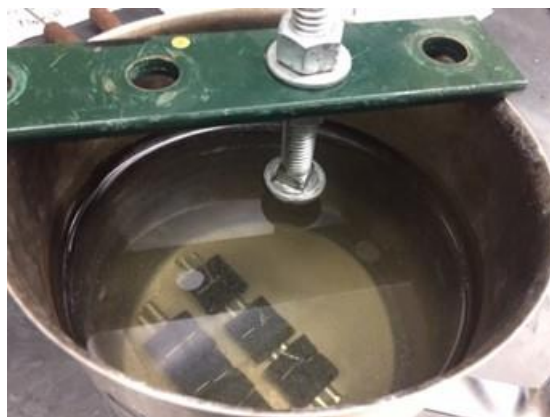
Figure 223. Level gauge being used on a vessel.

The level gauge is placed on top of each vessel and the water is added until the solution level reaches the bottom of the gauge (Figure 223).

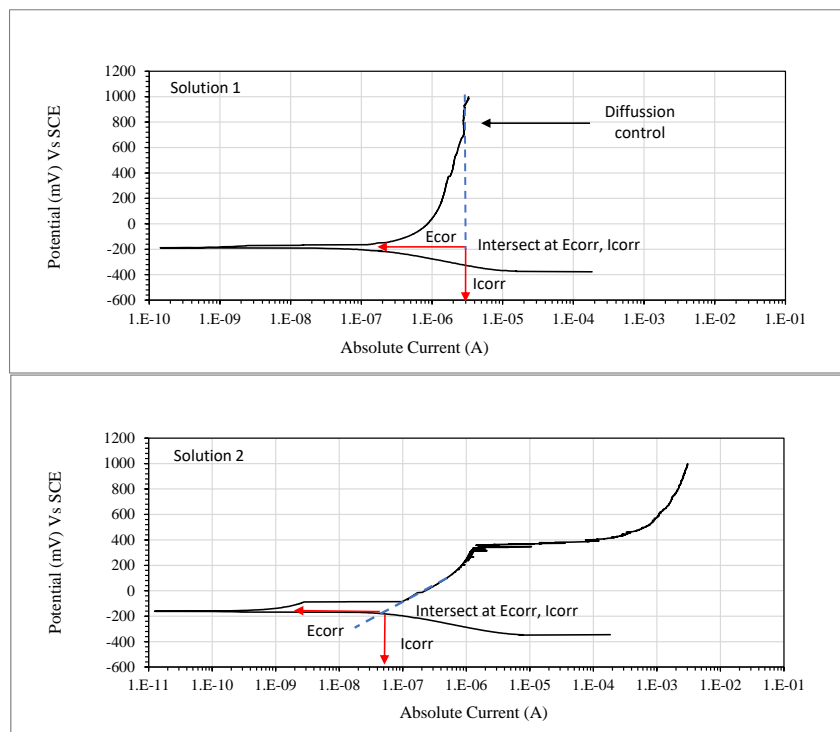
Figure 240. Potentiodynamic graphs for 304 stainless steel canister material when immersed in simulated Hanford groundwaters, solution 1 (top) and solution 2 (bottom).
