2D Dam-Break Analysis of L Lake and PAR Pond Dams Using HEC-RAS

Amanda Yancoskie (DOE Fellow)

DOE-FIU Science and Technology Workforce Development Program
Applied Research Center
Florida International University

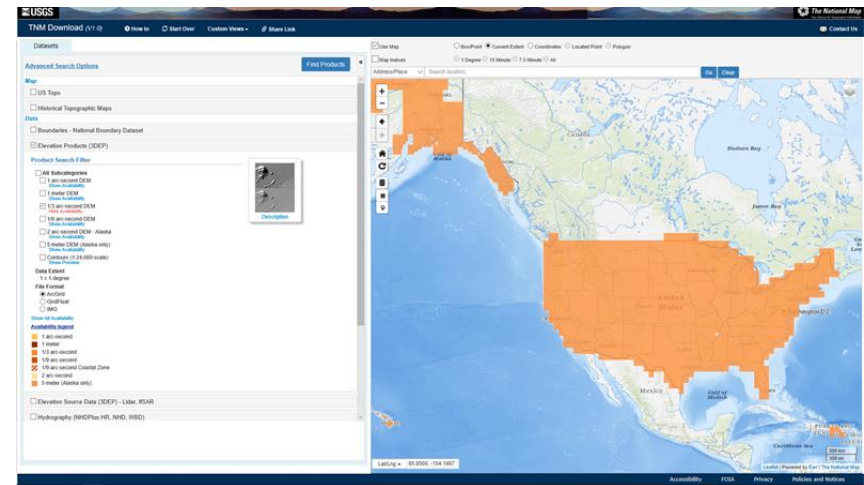
- The 1991 study used cross section data to model the river.
 - Some cross-sections were synthesized.
 - Old input data not 100% compatible with HEC-RAS and incomplete.
- Instead of cross sections, DEM data from the USGS was used for floodplain.
 - 1/3 arc-second (~10m) DEM.
 - No bathymetry data.

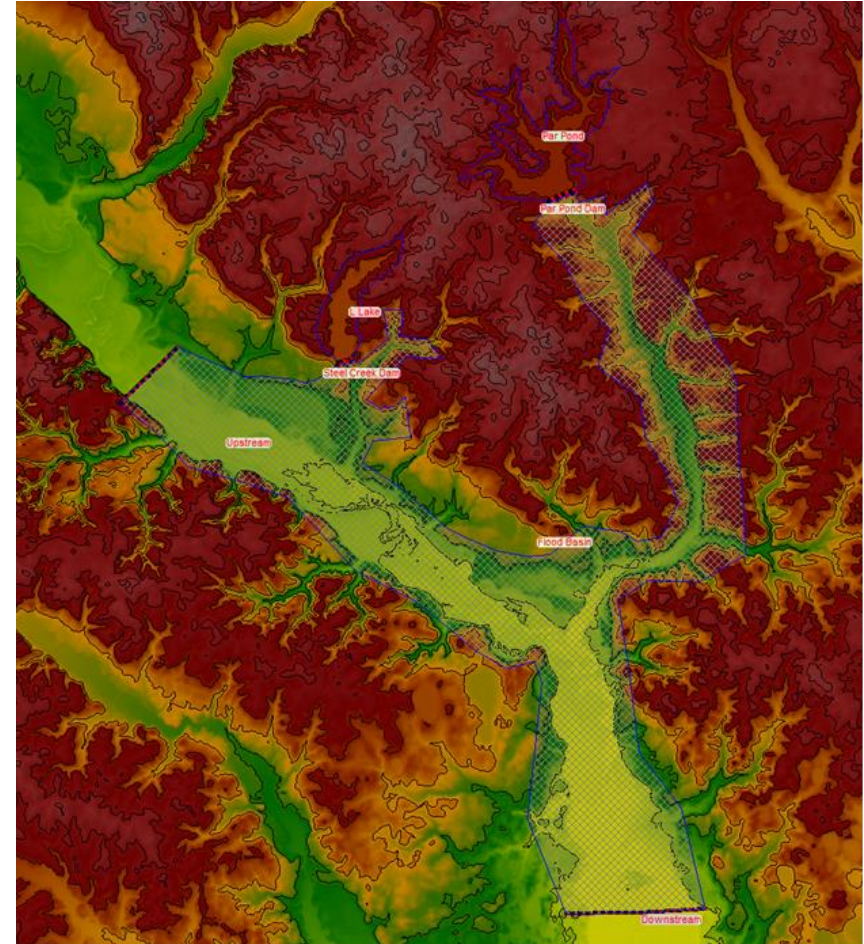
- 2D flood basin was drawn based on terrain contours.
 - Elevation range ~60-300 ft.
 - Single Manning's n value.
 - 250x250 ft grid size.
- Storage areas were inputted as 1D.
 - No bathymetry data.
 - Inflow, outflow, volume vs surface area, and initial water surface elevation (WSE) data was available.

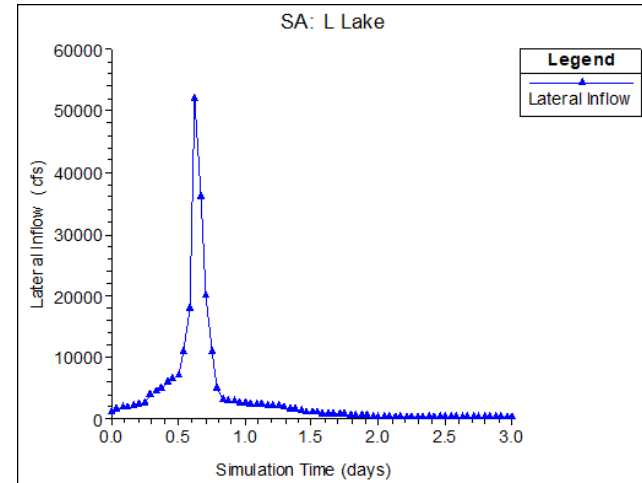
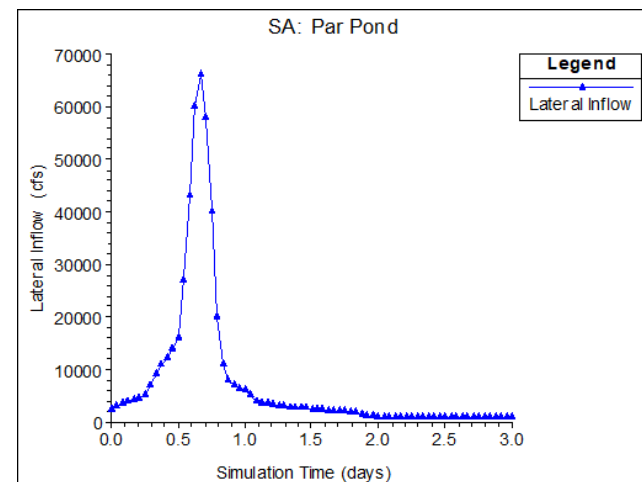
- Taken directly from original 1991 study:
 - Storage areas
 - Inflow hydrographs
 - Elevation vs volume curves
 - Outlet rating curves
 - Initial WSE
 - Savannah River
 - PMF: 87,100 cfs
 - Fair-weather: 9,000 cfs

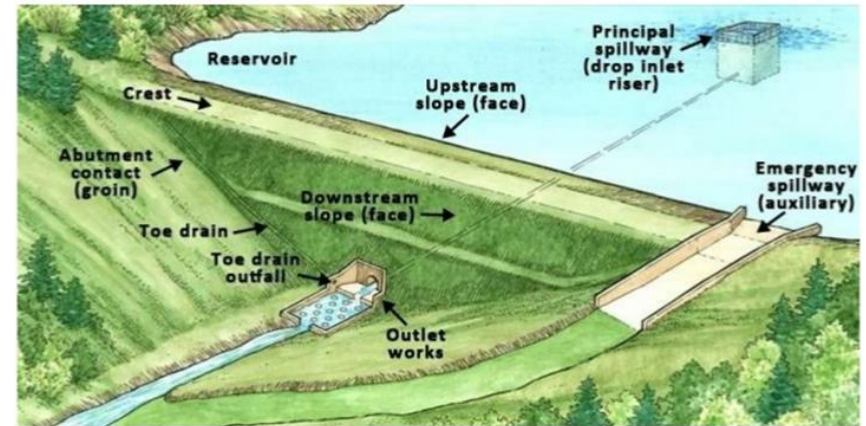
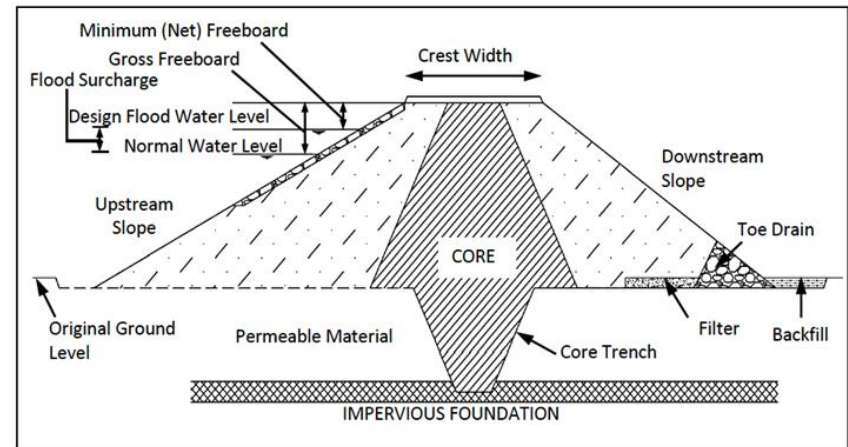
- Earthen rockfill dams
- The Steel Creek dam at L Lake has 6 ft diameter conduit with an upper and lower sluice gate.
- PAR pond dam consist of a weir and sluice gate connected to an 8x8 ft channel.

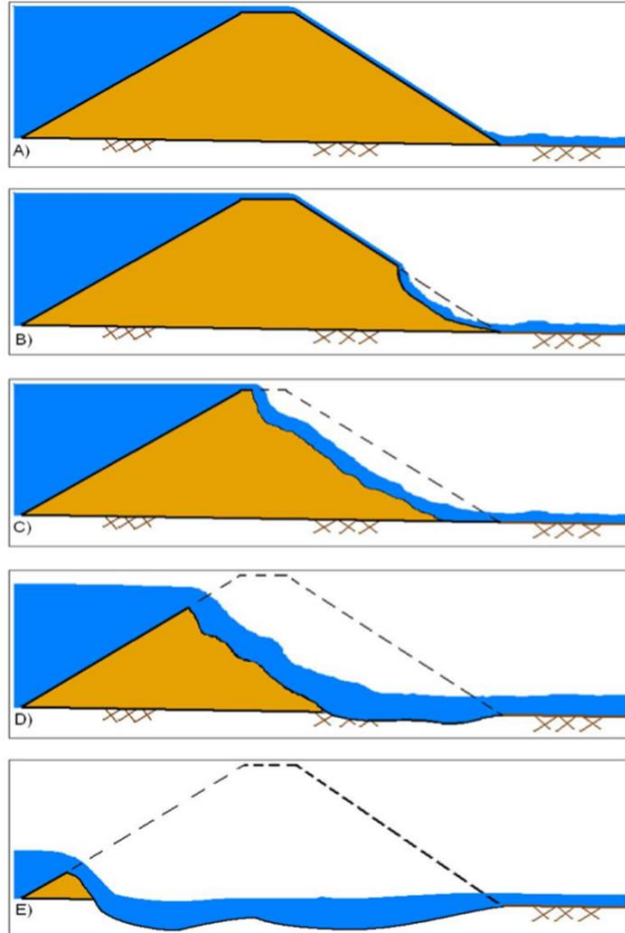
Breach Processes used in HEC-RAS

- Overtopping (left) and Pipe Failure (right)

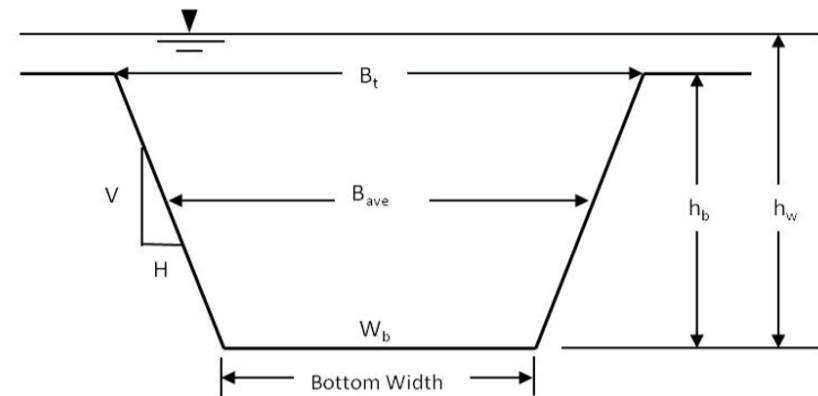
Breach Parameters

Parameter	Definition
B_t	Top width of breach
B_{ave}	Average width of breach
W_b	Bottom width of breach
V/H	Side slope
h_b	Height of Dam
h_w	Water surface elevation
t_b	Breach formation time

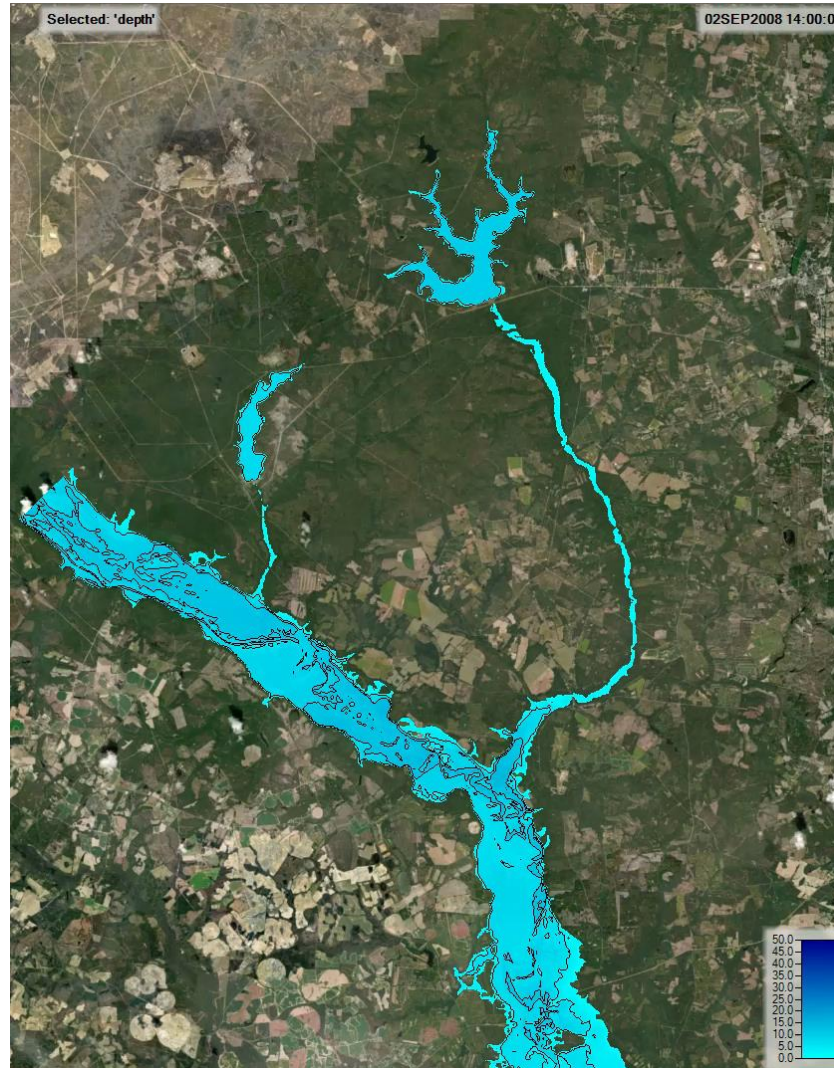
Dual Dam Failure Under PMF Conditions

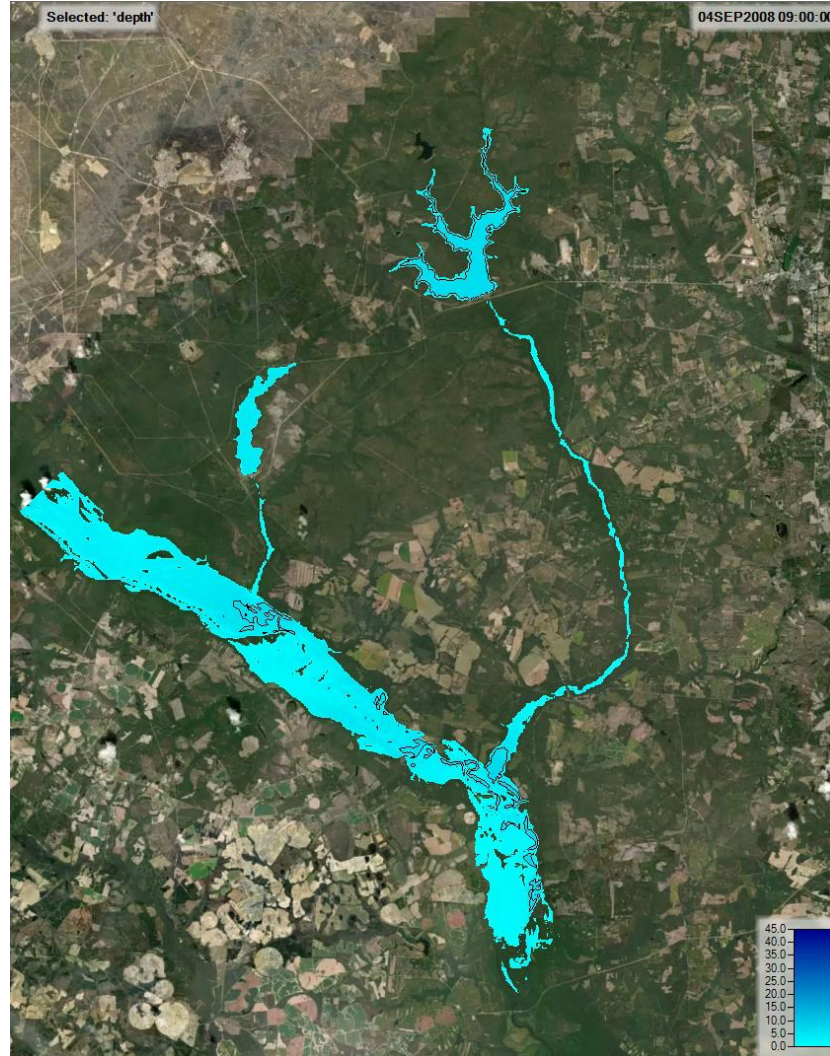
Dual Dam Failure Under Fair-Weather Conditions

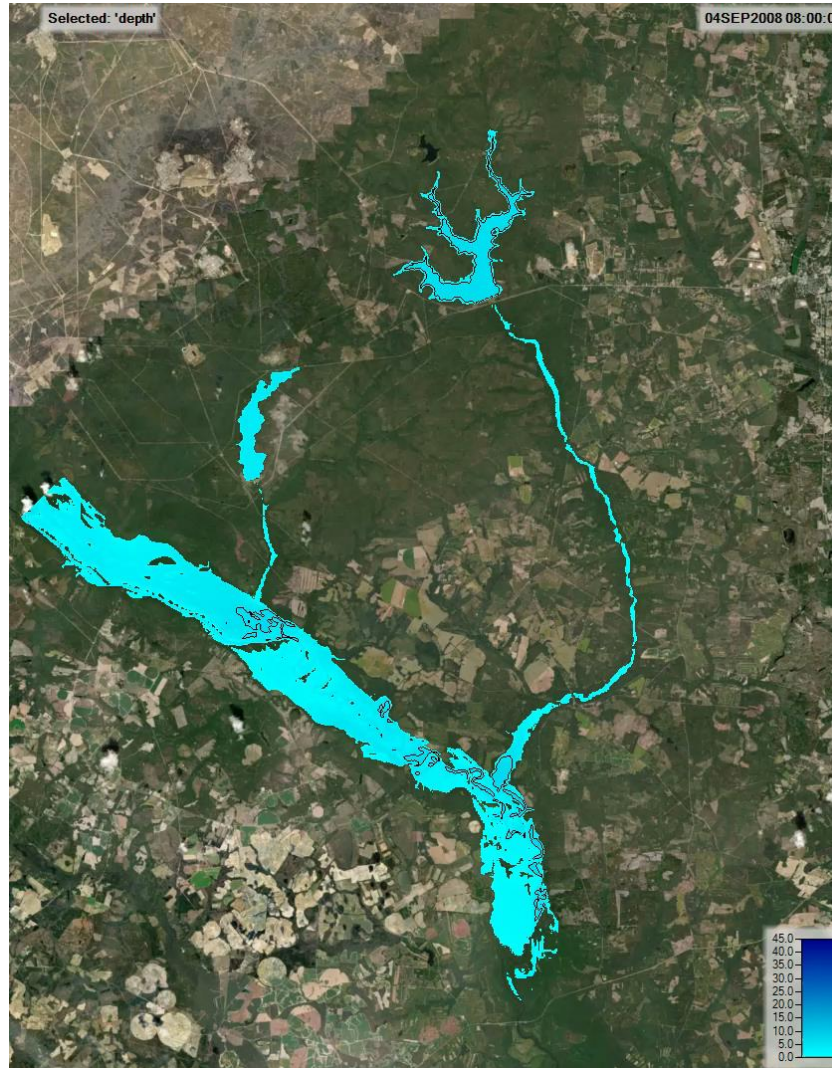
Steel Creek Dam Failure Under Fair-Weather Conditions

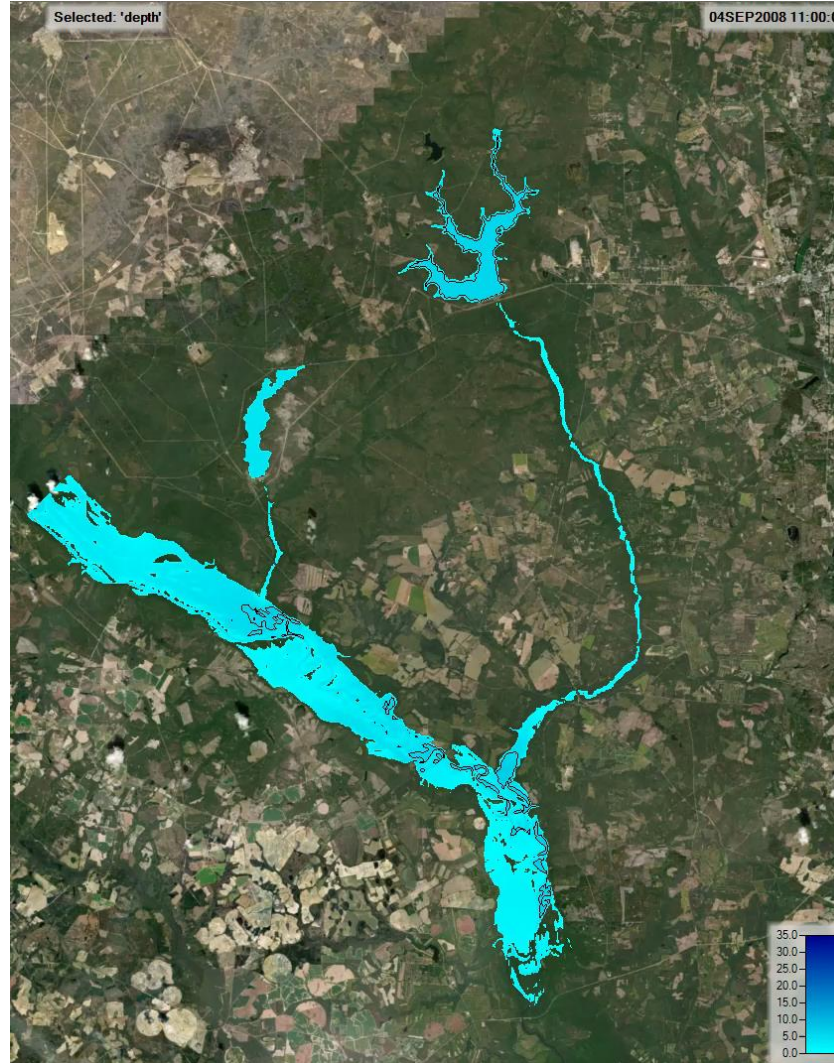
PAR Pond Dam Failure Under Fair-Weather Conditions
